# Annapolis Watershed Salt Marsh Evaluation: Surveying Tidal Barriers Along the Annapolis Basin

Denise Sullivan  
Clean Annapolis River Project  
November 2005

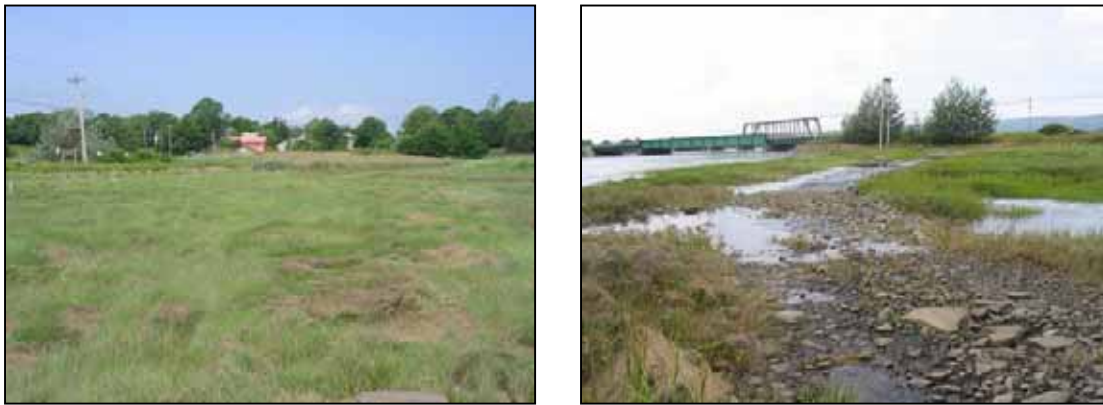
The site is a small area (2 ha) of salt marsh on Allain's River Marsh, behind Charlie's Restaurant in Annapolis Royal. A road with a small PVC culvert placed high in the streambed is partially restricting tidal flow. The road is made of large cobble and gravel and is used as an access route onto an adjacent dyke. During very high tides, the road is overtopped, flooding the upstream marsh. High velocity flows displace rocks and debris, which are visibly moved from the road onto the marsh surface. Small patches of marsh directly above the road are therefore covered in rocks, preventing *Spartina spp.* growth. The property is bordered by Highway 1 to the North and a demonstration area of an Acadian dyke and aboiteau maintained by the Annapolis Royal Historic Gardens to the South. There are several evident signs of tidal restriction at the site, including bank slumping, scour pools, turbulent flow and a large stand of the invasive *Phragmites australis* on the upstream side of the culvert. The land is owned by a local non-profit organization, the Annapolis Royal Historic Gardens Society.

**Figure 2: Landward view of site showing commercial building to the East and Highway 1 to the North (left); and photo showing the barrier being overtopped during a high tide event (right)**

Although the site receives some flooding with every tide, it is clearly restricted. The installation of a larger and better-positioned culvert would allow non-restricted flushing of the upstream marsh. This would reduce the erosion and bank slumping observed on the downstream side and would diminish the spread of the invasive *Phragmites australis* stand on the upstream side. Seeing that the road is currently overtopped during very high tides, flooding of any upstream properties should not be a big concern. When contacted prior to measuring tidal range, landowners expressed no objections with monitoring on their property.

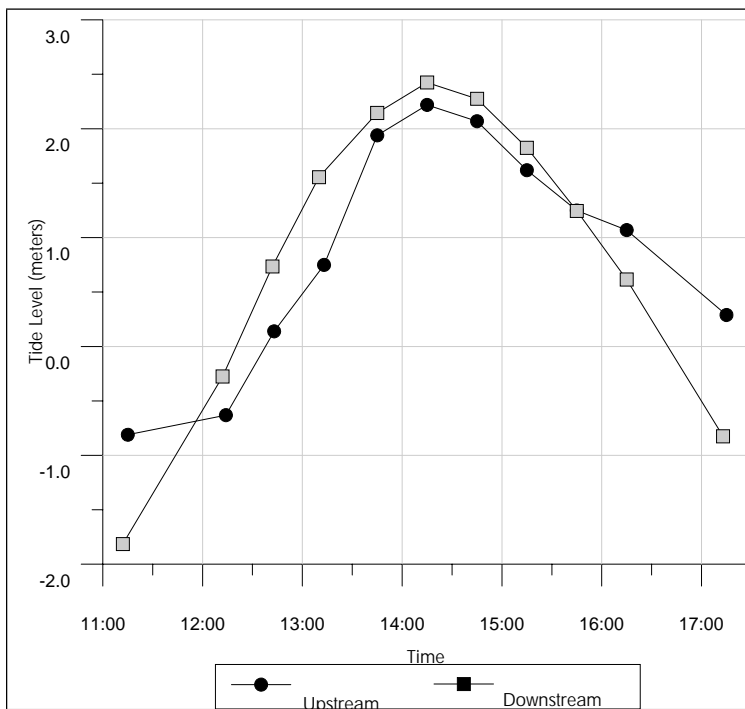
Figure 3: Change in tide levels upstream and downstream of culvert at Allain’s River, Annapolis County

Figure 3 provides evidence of a tidal restriction at the Allain’s River culvert. This occurs because the culvert is both too small and located too high on the channel bed. As seen on the graph, upon arrival at the site, water was pooling on the upstream side behind the culvert. The change in water level on the upstream side was much slower in the beginning, seen by a gentler slope on the curve, and then increased suddenly (13:15) when the road barrier was overtopped. The change between the two sides was then equal, until the tide dropped below the height of the road. At this point, the undersized culvert once again began holding back water, shown by a decreasing slope on the graph.

Flooding of the road only occurs during very high and spring tides. During neap high tides for example, the road does not flood causing the height differential to exist throughout the entire tidal cycle. The effect of the restriction may therefore actually be greater than that observed at the spring tide, when the water levels on the up and downstream sides equalize for over an hour.

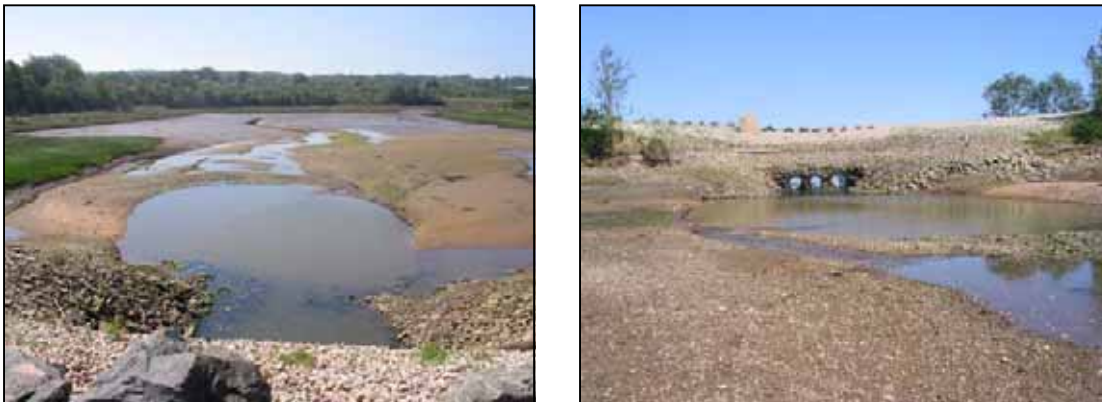
The barrier is a triple concrete culvert beneath the former Dominion Atlantic Railway (DAR) railbed crossing over the Little Joggins in Conway, near Digby. New culverts were installed in the summer of 2004, however their small size restricts tidal flow, as evidenced by two large scour pools and turbulent flow on either side of the barrier. Local citizens use the railbed regularly as a walking trail and an ATV trail to travel to and from either side of the Little Joggins. The upstream side consists of restricted salt marsh (~6ha) that may involve several different landowners and potentially two small tidal creeks further upstream. The downstream side consists of mudflat and poorly developed salt marsh.

Figure 4: The landward view showing large scour pool directly above culverts (left), and a view of the culverts looking downstream (right)

Although the culverts are placed on the bottom of the stream bed, they are of insufficient size to allow unrestricted tidal flushing. The installation of larger culverts or a small bridge would eliminate the time lag between the upstream and downstream peak water levels and restore proper flushing to the upstream marsh. Although the culverts were recently installed, increasing their size would eliminate the strong currents and whirlpools in an area frequented by pedestrians and ATV users.

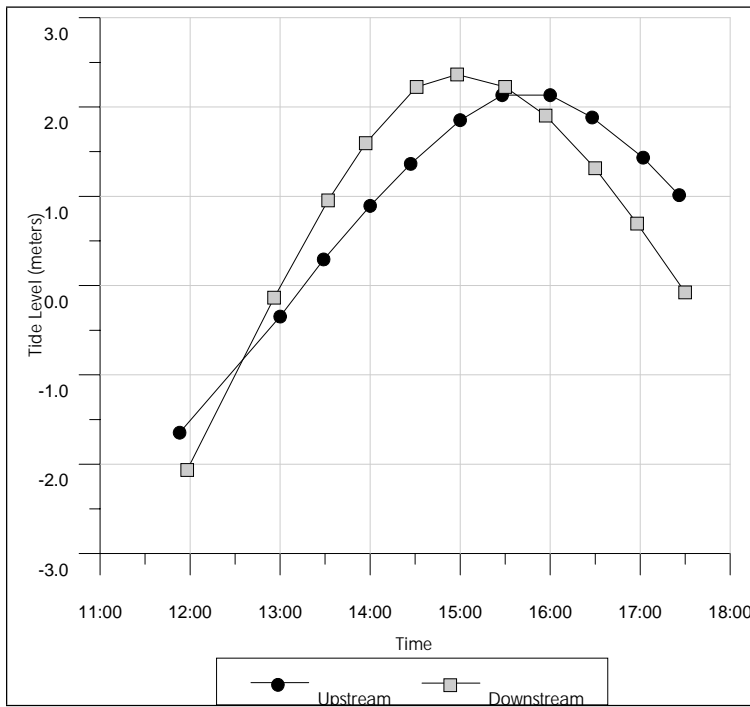
**Figure 5: Change in tide levels upstream and downstream of culverts at Little Joggins, Digby County**

Figure 5 indicates that the culverts, although allowing some degree of tidal flushing, are insufficient in size for the volume of water at the site. The graph shows that there is a lag of almost 1 hour between the upstream and downstream peak water levels. The difference in tide levels on both sides also confirms that the barrier is restrictive. The culverts were submerged for an hour and a half prior to high tide, after which the upstream water level continued to rise while the downstream water level fell. During the falling tide, multiple large whirlpools could be observed on the upstream side and turbulent flow on the downstream side.

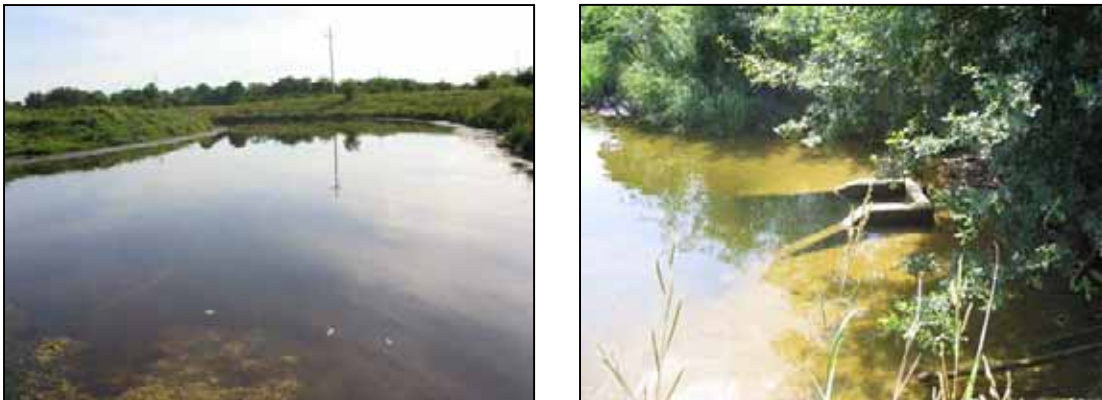
The site (~ 12ha) is located between the Annapolis Royal Marsh and Highway #1 in Annapolis Royal. The land is currently owned by the Town of Annapolis Royal, and is fallow; however the Town is seeking to sell the property as soon as possible. Directly downstream of the dyke is the Lloyd M. Bourinot Sail Centre, used seasonally as a training centre for sea cadets. The site is located upstream of the Annapolis Royal causeway and Nova Scotia Power's Annapolis Tidal Generating Station. The water levels in the French Basin are controlled by opening and closing sluice gates for power generation and therefore fluctuate less than normal tidal levels downstream of the barrage. Restoration of this site would test the feasibility of salt marsh remediation upstream of the power plant. The drainage structure located at the site is an old aboiteau; however the aboiteau opening is restricted or possibly plugged, resulting in large volumes of water pooling on the upstream side, as seen in Figure 6.

**Figure 6: Landward side of dyke showing water pooling behind dyke (left) and photo of drainage structure on downstream side of dyke (right)**

Replacing the small drainage structure with a larger culvert or small bridge would restore tidal flushing to the area. A forced sewer main, which runs underneath the dyke, would require additional caution if the site was restored. The freshwater wetland directly to the South of the property is bordered by a walking trail that is very popular among local citizens. Restoring the area to salt marsh would allow both the fresh and salt water marshes to be observed from the trail and would create a unique learning opportunity for local residents and students.

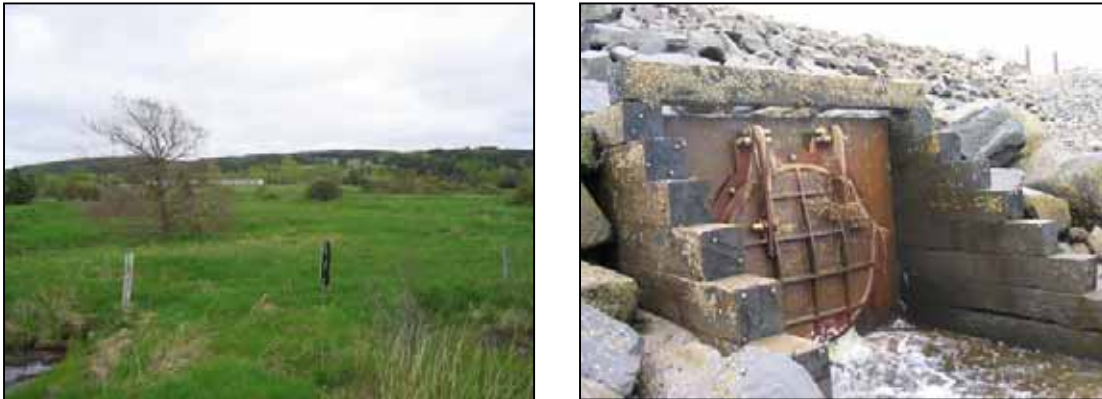
The site is a large area (~ 14ha) of fallow land along Highway #1 across from Dugway Road. There is evidence of an old cow pasture, however the area is presently fallow with several trees and shrubs present. The former DAR railbed is completely restricting flooding and an aboiteau is blocking a small tidal creek that runs through the property. The aboiteau has been breached on a number of occasions in the past with several repairs being needed (P.L. Reardon, personal communication, September 22, 2005). The aboiteau structure has been causing significant erosion on the downstream side, where a narrow stripe of salt marsh exists. An old deteriorating dyke separates the two sites (AC33R and AC34R), however it is not currently being maintained. A gradual increase in slope on the landward side of the site would likely protect land behind the property, including homes and a section of the Annapolis Royal Golf Course; however some new dyke may be needed to protect an adjacent hay field. The area is owned by C.H.R. Holdings Ltd, which consists of several members of a local family. Tidal range was not measured at this site, as the aboiteau is completely restricting tidal flow to the upstream side.

Figure 7: Landward view of restorable area (left) and downstream view of aboiteau (right)

Replacing the aboiteau with a large culvert or bridge would allow tidal flow into the creek and restore this large area to salt marsh. The installation of a small bridge at the site would reduce erosion on the upstream and downstream sides and would eliminate the need for frequent and costly repairs to the aboiteau. The land is not currently being used for agricultural purposes nor is there plans to cultivate it in the coming years. If the old dyke that presently separates the two sites (AC33/34R) was reinforced and maintained, no new flood protection structure would be needed to protect the adjacent hay fields. Alternatively, the old dyke could be removed and a new section built on the property boundary, flooding a larger area while still protecting adjacent land.
