# Broken Brooks 2012

*Salmonidae Outreach,  
Accessibility and Restoration*

By Kristen Wagner  
Fish Habitat Technician  
January 2013

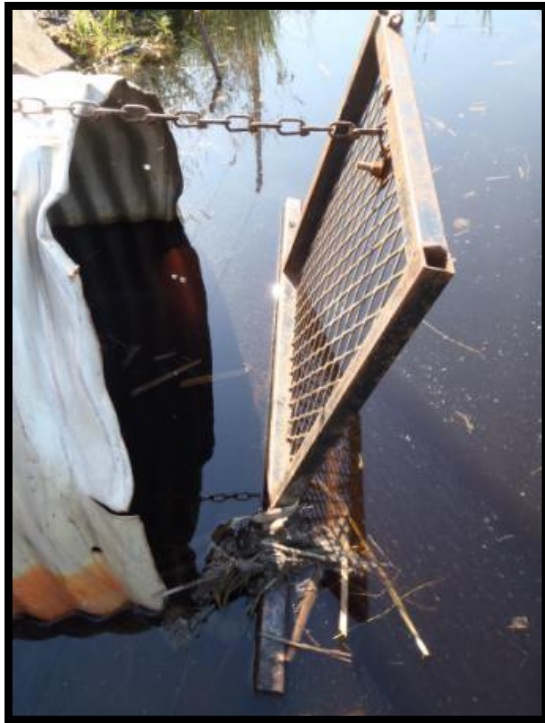
BLK013 had a debris grate at the inflow mouth of the culvert that had collected a large amount of vegetation (Figure 6). Additionally, a beaver dam was present in the outflow mouth of the culvert that was restricting the majority of the water flowing through the culvert (Figure 7). Once the beaver dam had been removed and the inflow grate was cleared, the water velocity increased (Figure 9). However, when CARP staff visited the site 1 week post-debris removal, vegetation and debris had already begun to clog up the inflow grate (Figure 10). It is recommended that the owner of the culvert either remove the inflow grate, or ensure that it receives regular maintenance to remove debris build-ups.

Figure 7. Vegetation build up at the inflow grate at

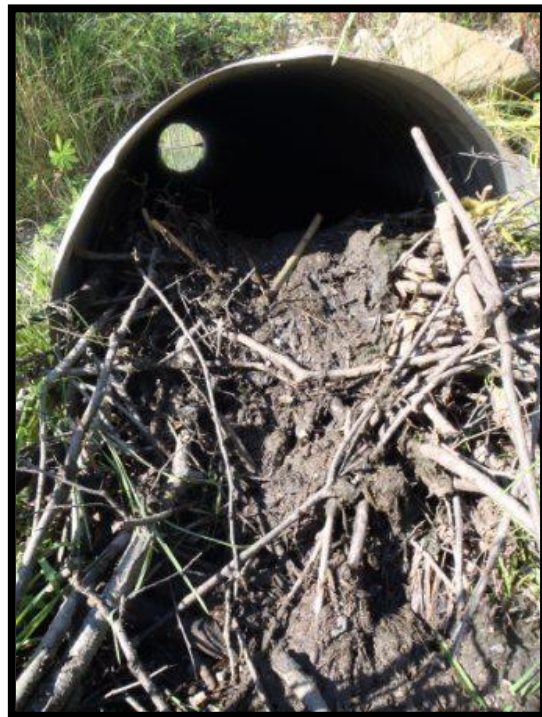
Figure 8. Beaver dam at the outflow of BLK013.

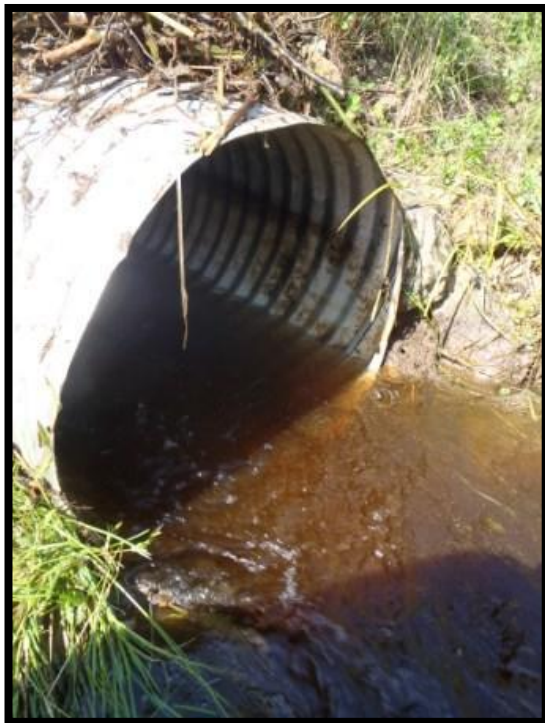
Figure 9. Water flowing through BLK013 after clearing away the beaver dam and unclogging the inflow grate.

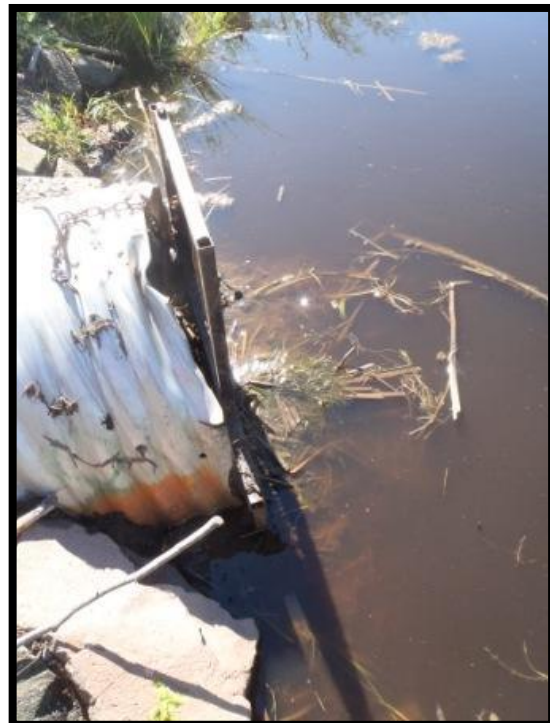
Figure 10. Vegetation build up at inflow grate at BLK031, 1 week post debris removal.

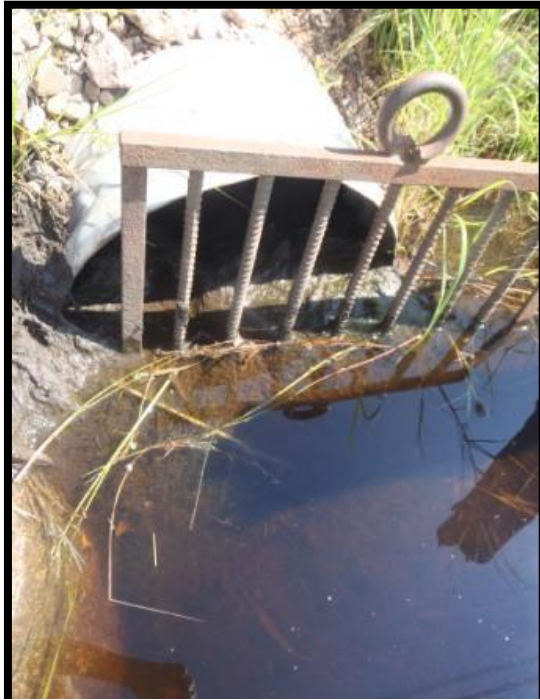
BLK051 also had a debris grate at the culvert inflow, which had a large accumulation of vegetation and sediment build up, restricting water flow through the culvert (Figure 11).

Figure 11. Vegetation and sediment build up at the inflow grate at BLK051.

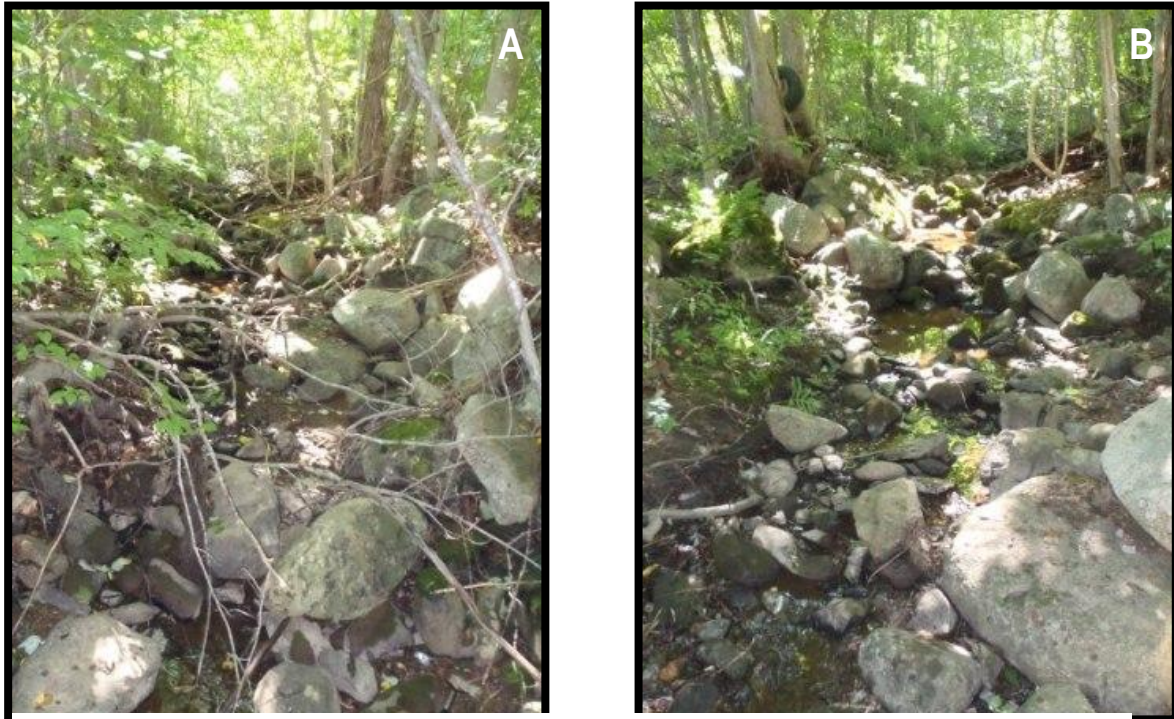
The upstream consists of a boulder step-pool habitat. It appeared to be a dumping ground for garbage, as there was a large quantity of old rusty paint cans, pieces of metal and old tires. There were also fallen branches in and around the stream (Figure 13). Just upstream of the culvert the stream had a built up bar of mud and sediment overtop of the rocks (Figure 14). All of the garbage was collected and disposed of, fallen branches were moved over a rock wall that was lining the stream, and portion of the sediment bar was dug through to allow for water to flow through a channel to the mouth of the culvert.

Figure 13. BLK019 upstream habitat before (A) and after (B) the removal of branches.

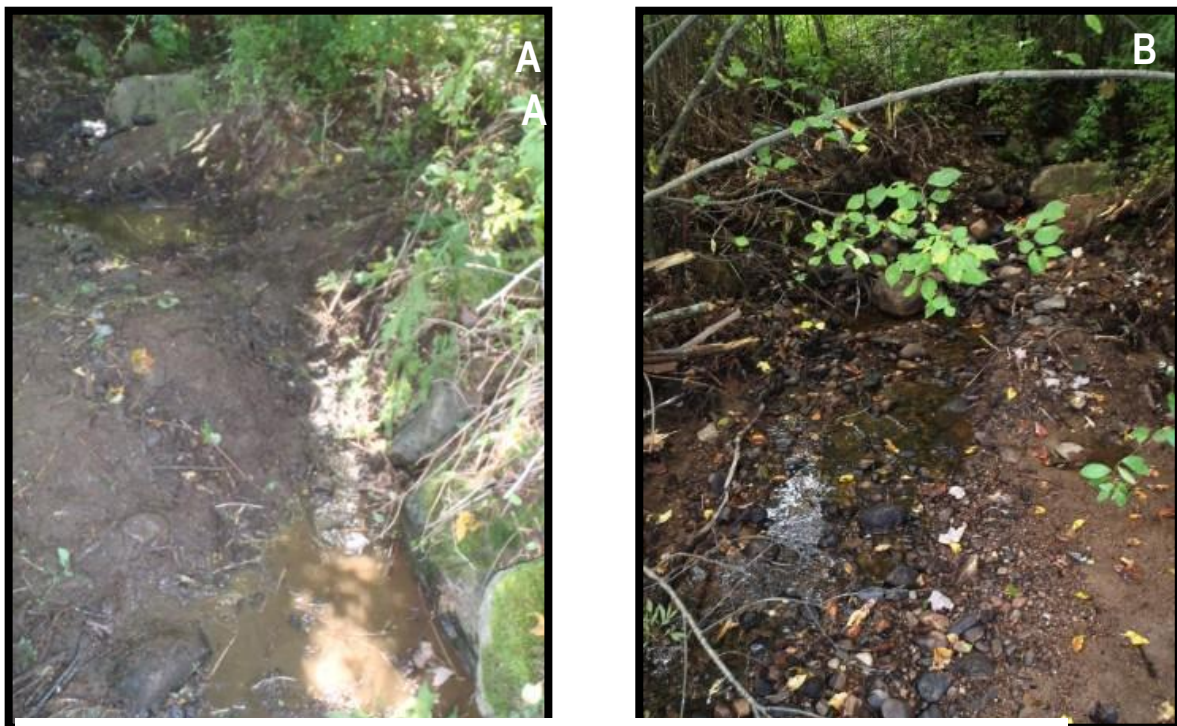
Figure 14. BLK019 upstream sediment build up before (A) and two weeks post-debris removal (B).

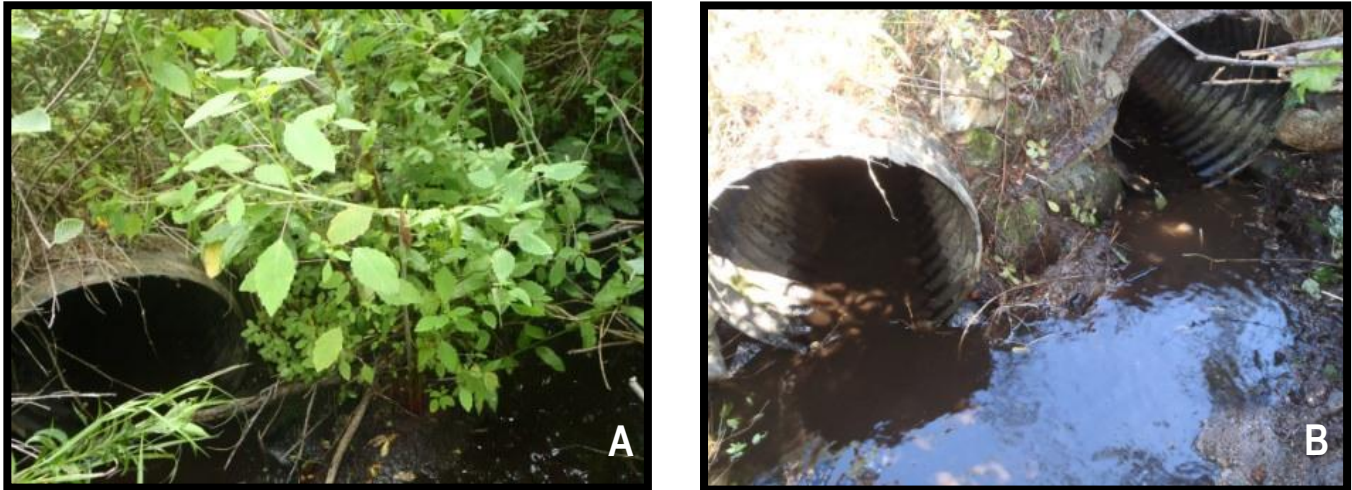
There was a stump of a dead tree between the two culverts, minimizing the amount of water flowing through one of the culverts, and there was also a lot of vegetation growing around the stump (Figure 16). Once the stump was removed, water began flowing through both culverts. Directly downstream of the culverts there were many fallen branches in and across the stream (Figure 17). A handsaw was used to aid in the removal of fallen branches.

Figure 16. BLK047 inflow before (A) and after (B) the removal of the tree stump.

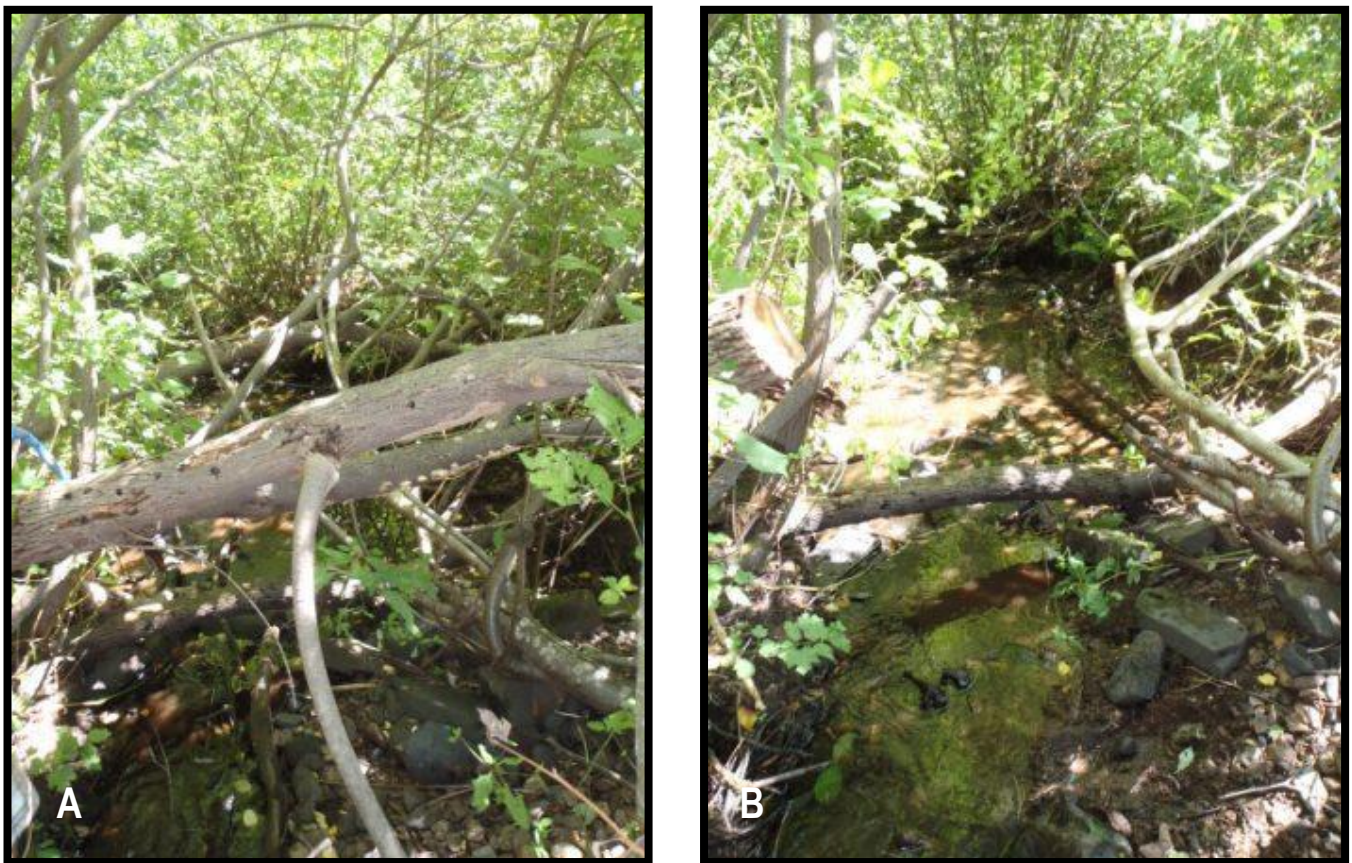
Figure 17. BLK047 downstream before (A) and after (B) debris removal.

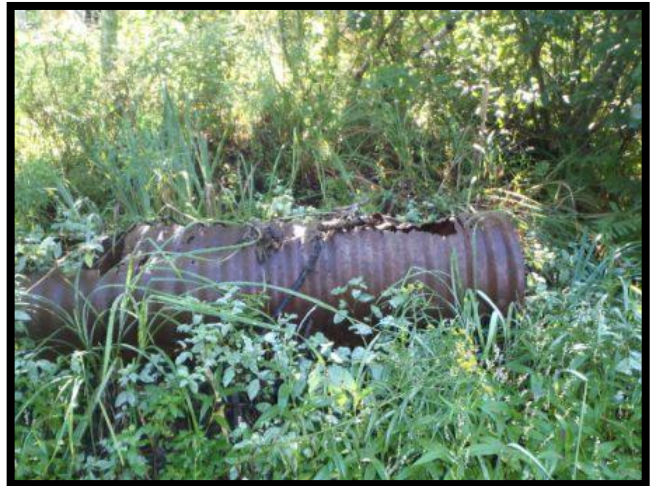
Figure 20. Evidence of a partial culvert removal at MED001.

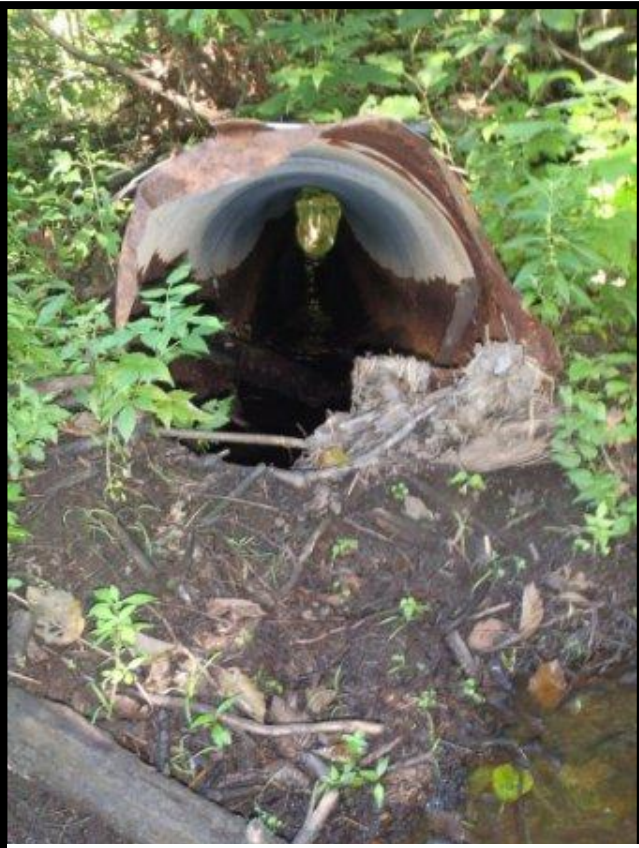
A large amount of sediment had built up around some branches that were blocking the inflow of the culvert, completely blocking water flow through the culvert (Figure 21). Slightly upstream of the culvert there were a lot of old fallen branches littering the banks and the stream. Both the inflow blockage and the fallen branches were removed (Figure 22).

Figure 21. Debris blockage at inflow of MED001.

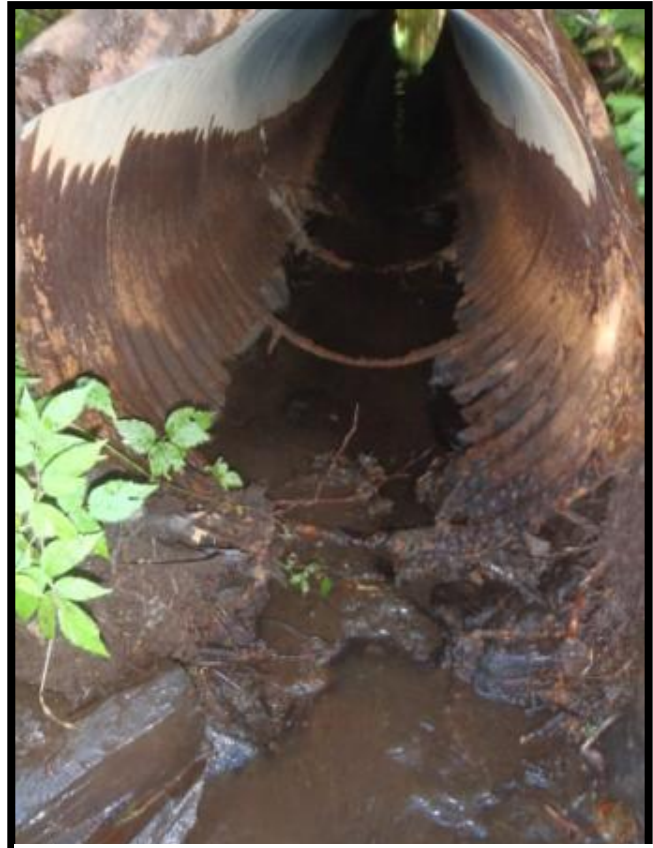
Figure 22. MED001 inflow after debris removal.

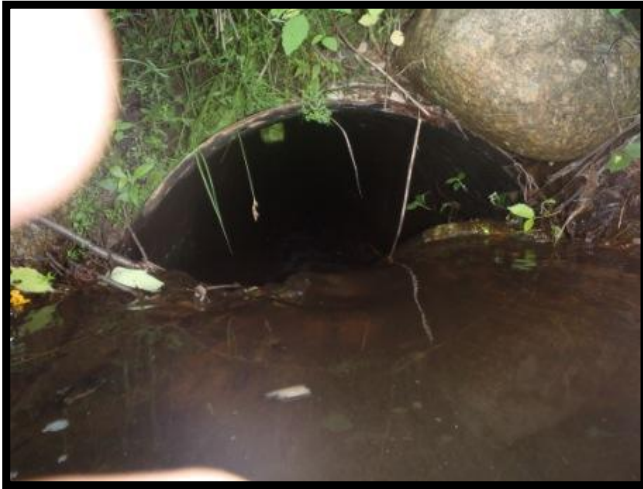
NIC002 had some large boulders around the inflow mouth that had caused an accumulation of branches and sediment causing an inflow drop into the culvert (Figure 24). CARP staff removed the debris build up and moved one of the boulders so an accumulation of debris would not occur in the future (Figure 25). NIC002 is fed both by NIC028 as well as another stream that runs parallel to the road down to the quarry.

Figure 24. Inflow drop at NIC002.

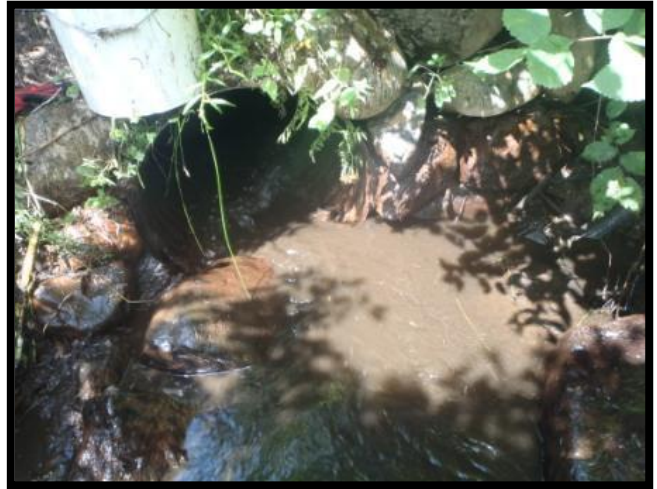
Figure 25. NIC002 inflow after debris removal.

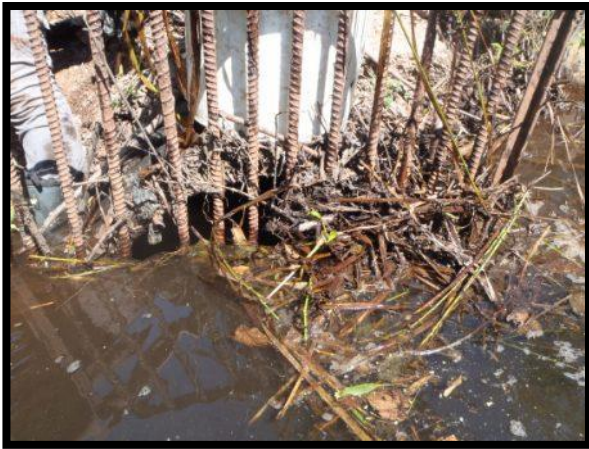
Figure 26. Debris blockage at NIC028.

It is recommended that the owner of NIC028 regularly clears or completely removes the inflow grate. CARP staff noted that with more water flowing through NIC028, there is an increase in water velocity at the outflow of NIC002. If the grate issues at NIC028 are resolved, then NIC002 may have to be reevaluated for velocity issues in the future.

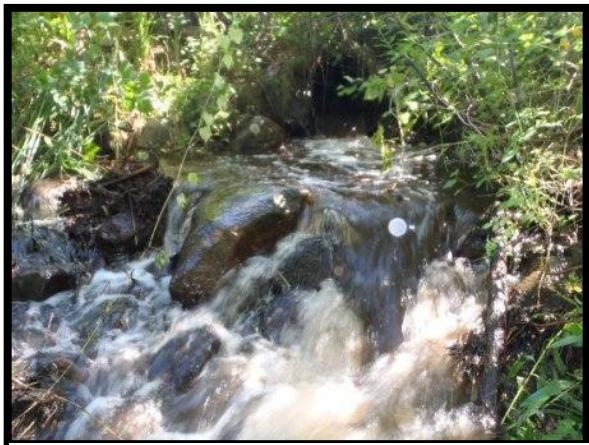
Figure 28. High water velocity downstream of NIC002 after debris removal at NIC028.

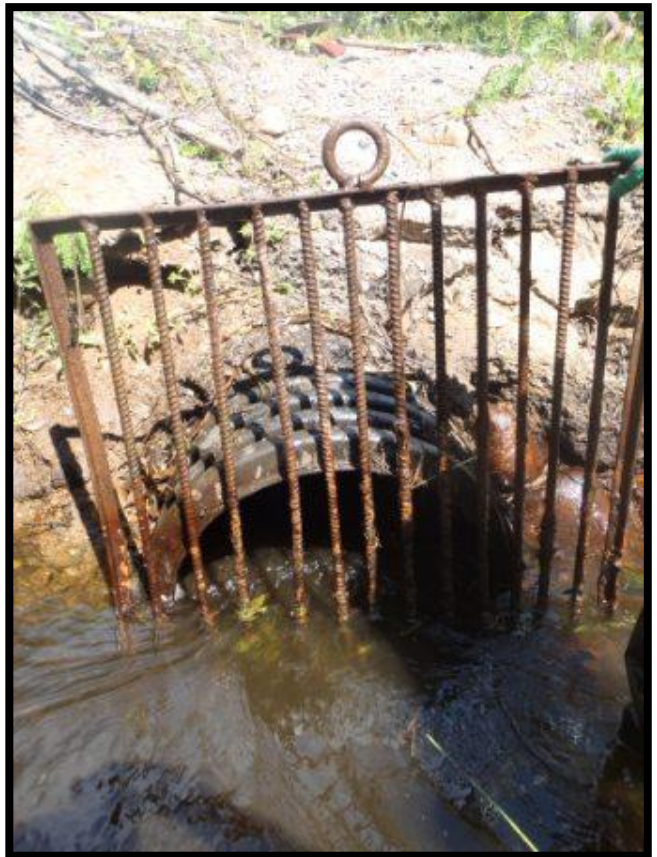
Figure 27. NIC028 inflow grate after debris removal.

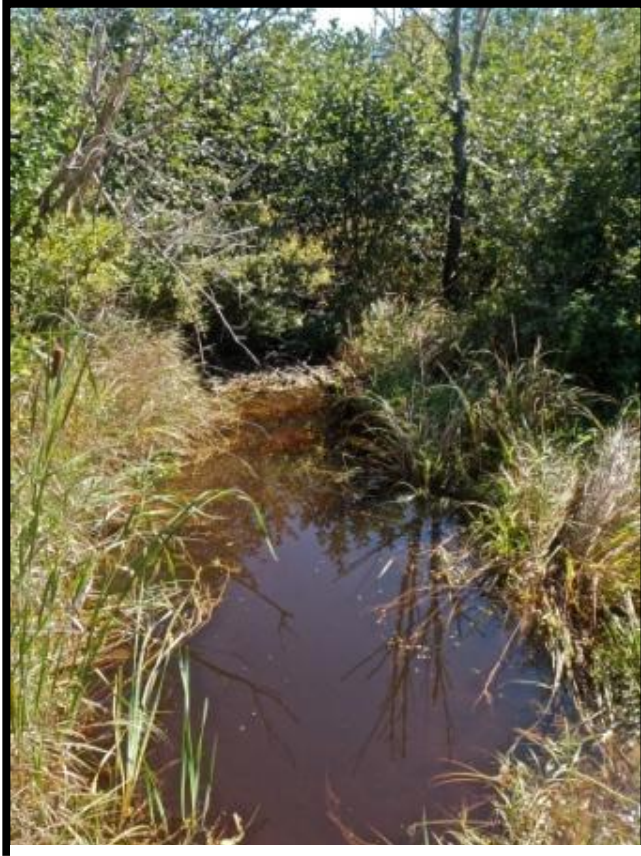
NIC012 is a wooden box culvert, located on Neily Road near Nictaux South (Figure 29). An abandoned beaver dam had been built just downstream of the culvert, restricting any upstream migration of fish through the culvert (Figure 30). When CARP staff went back to the site to remove the beaver dam (Figure 31), a bale of hay had been placed at the inflow mouth of the culvert (Figure 32). The removal of the beaver dam restored access to 0.334 km of upstream habitat, including access to wetland area.

Figure 30. Beaver dam downstream of NIC012

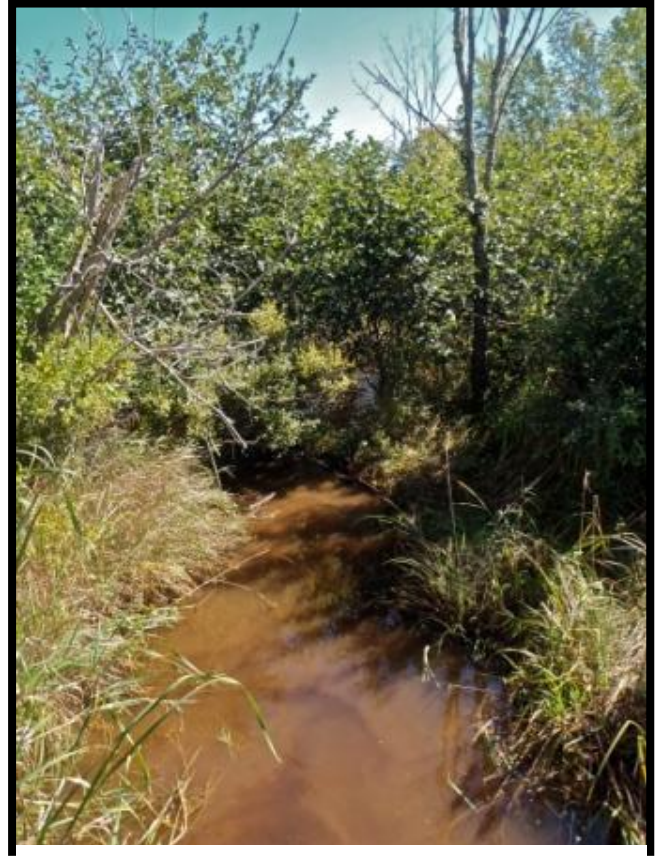
Figure 31. NIC012 downstream after debris removal.

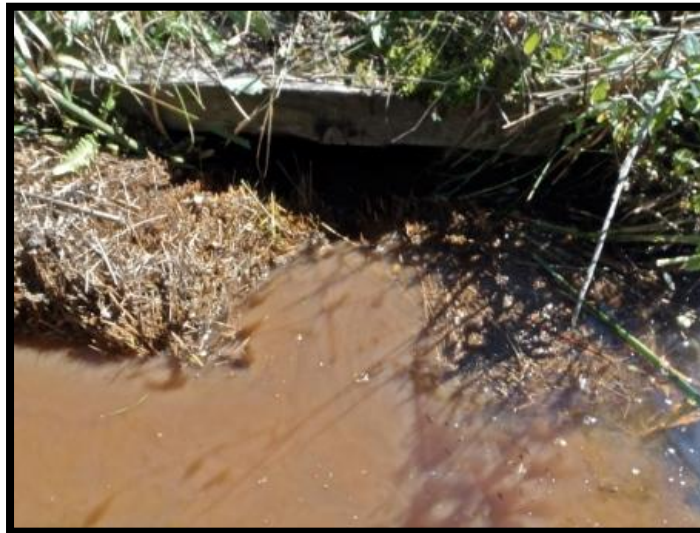
Figure 32. Bale of hay at the inflow of NIC012.

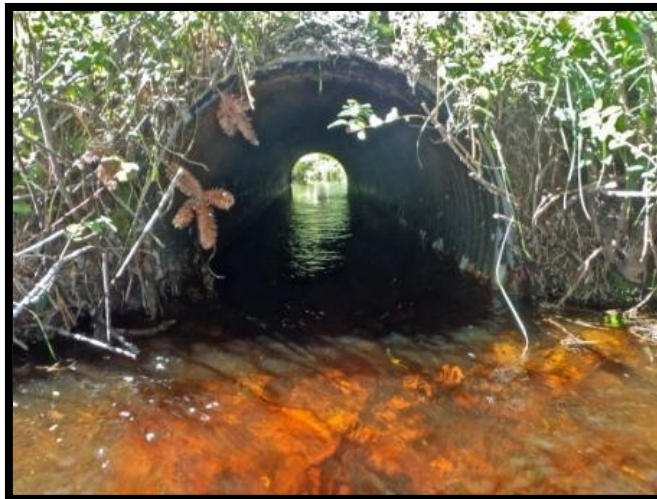
Figure 37. Third culvert at NIC030 after beaver dam removal.

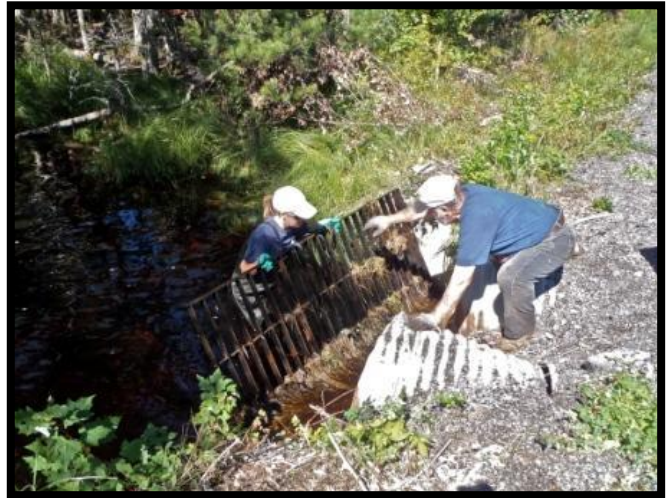
Figure 35. Removing debris blockage at inflow grate at NIC030.

It is recommended that the inflow grate be completely removed, or receive regular (yearly) maintenance.

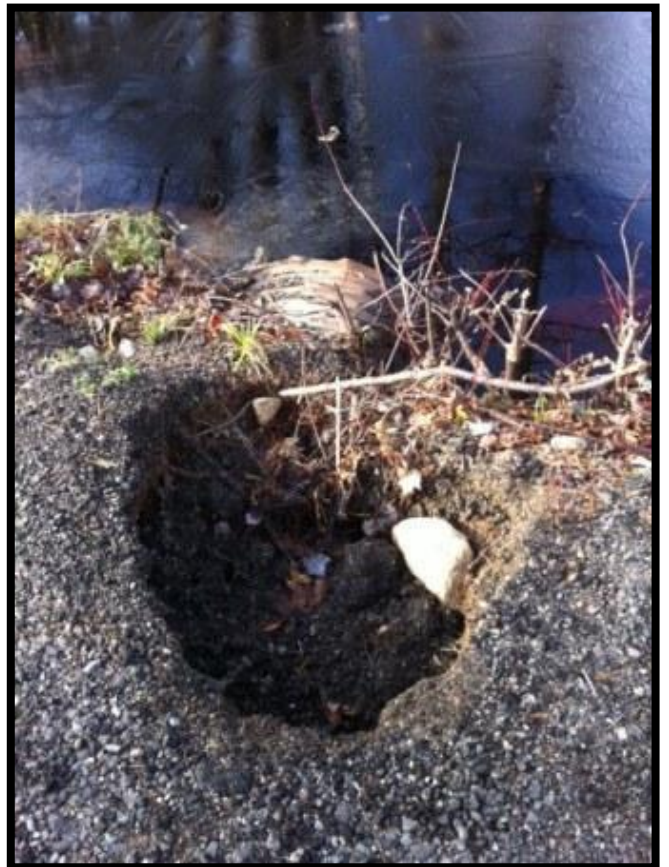
Figure 36. Shoulder of road sinking in beside third culvert at NIC030.

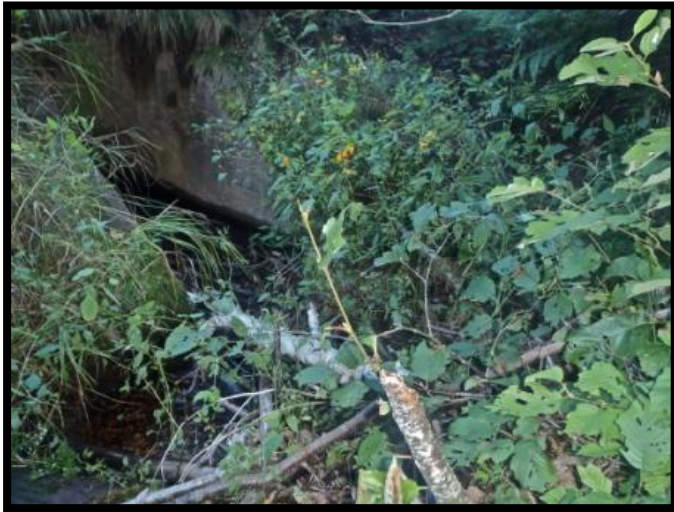
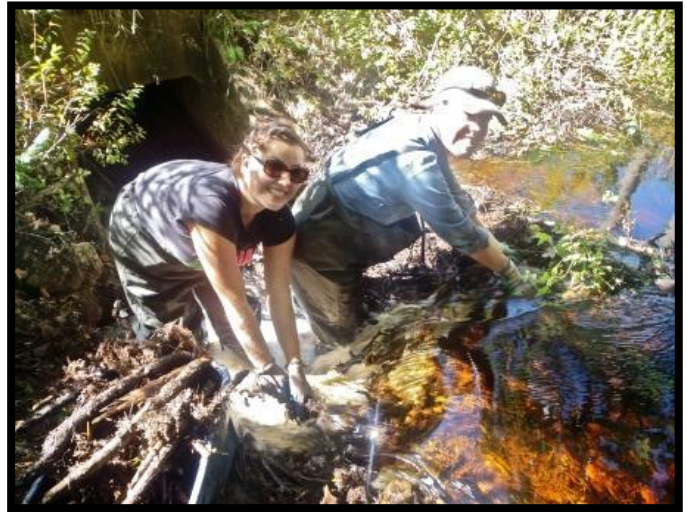
NIC017 is a cement box culvert that runs underneath Highway 10 near Albany Cross (Figure 38). There was a beaver dam at both the inflow and outflow mouths of the culvert and there was very minimal water movement through the culvert. Both beaver dams were removed by hand, restoring water flow through the culvert (Figure 39, Figure 40). The debris blockages at this culvert restrict approximately 0.123 km of upstream habitat.

Figure 39. NIC017 outflow (A) and inflow (B) before the removal of the beaver dam.

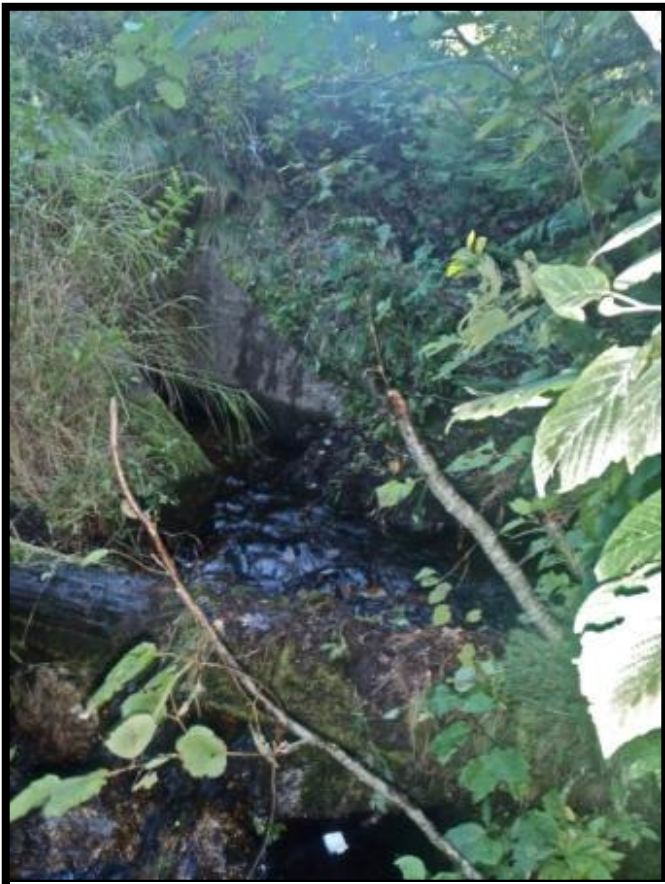
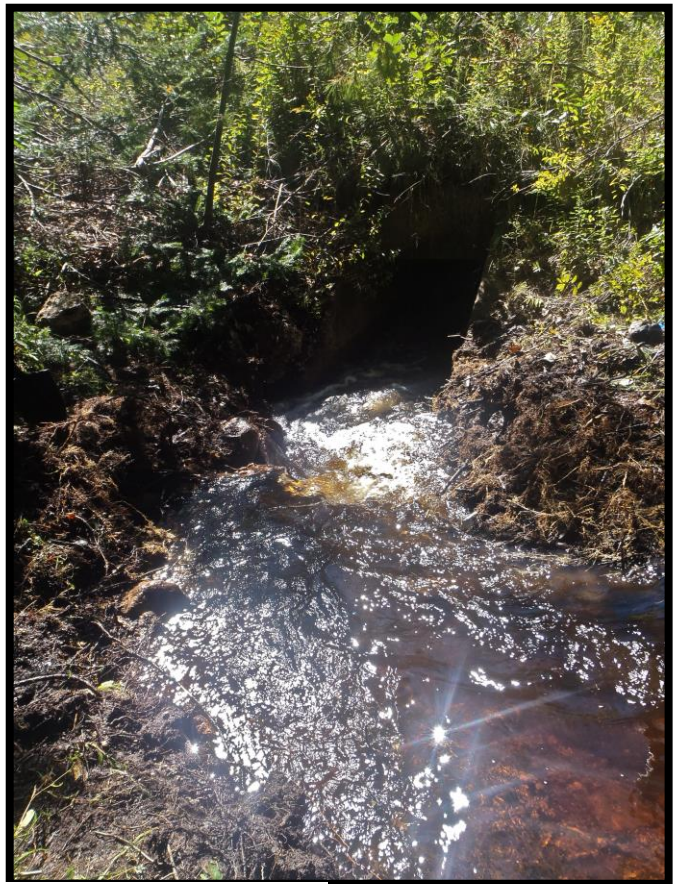
Figure 40. NIC017 outflow (A) and inflow (B) after the removal of the beaver dam.

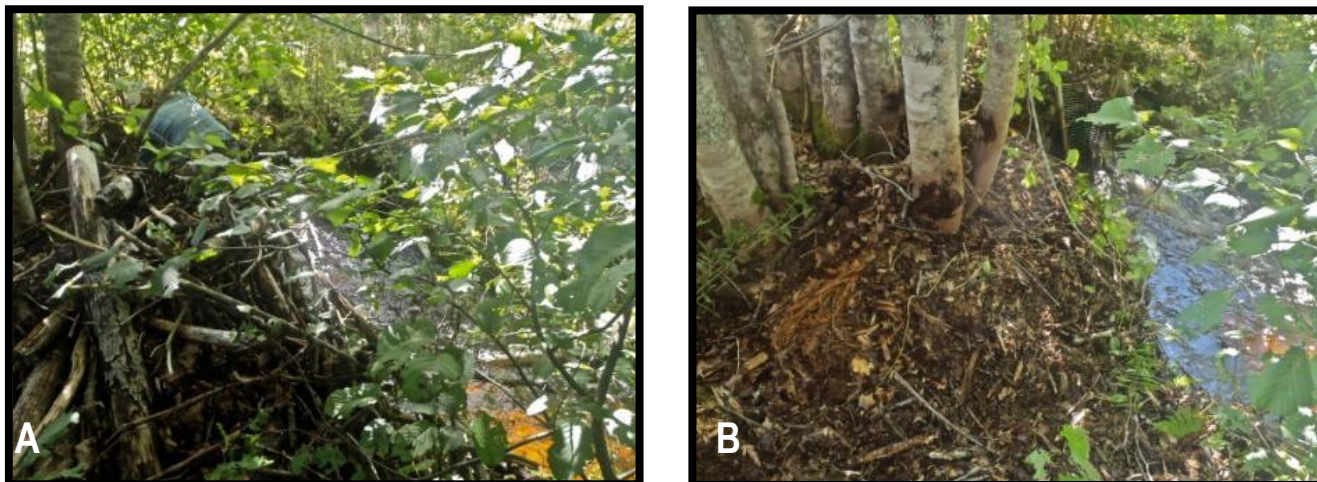
BEZ005 is a circular corrugated plastic culvert off of Highway 10 on Bezant Lake Brook, a tributary to the Nictaux River, near Albany Cross (Figure 41). There is a grate at both the inflow and outflow of the culvert, as well as a large quantity of branches along the banks of the stream (Figure 42). There is 0.074 km of upstream habitat and access to a large wetland area restored by the removal of this debris blockage.

Figure 42. BEZ005 downstream before (A) and after (B) debris removal.

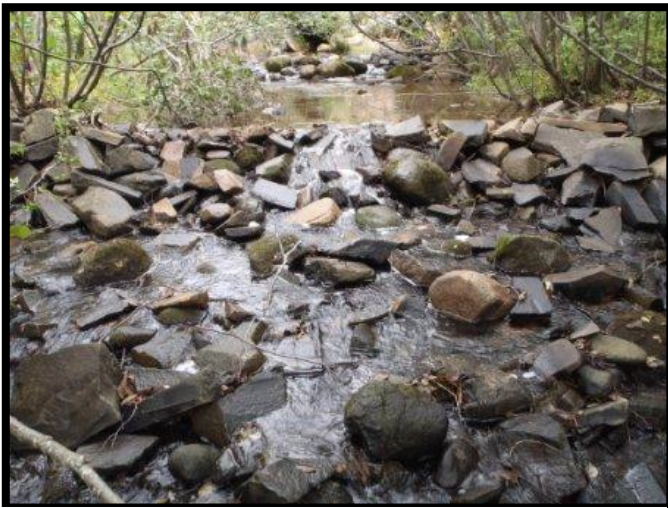
When CARP staff visited TRO010 in September 2012, both Weir A and Weir B appeared to be functioning properly. However, it was noted that although Weir B was backing up the water to Weir A, its slope appeared to be too steep, and would potentially be a barrier to fish passage (Figure 44). To remediate this, Weir B underwent some maintenance, the decrease the grade of the weir (Figure 45).

Figure 44. Weir B at TRO010 before undergoing maintenance.

Approximately 1.5 tons of weir rocks were obtained from the local quarry, and distributed into the stream around Weir B by hand. Since the incipient rock diameter was calculated for Troop Brook in 2010, the same calculated value, 18 cm, was used (Taylor 2010).

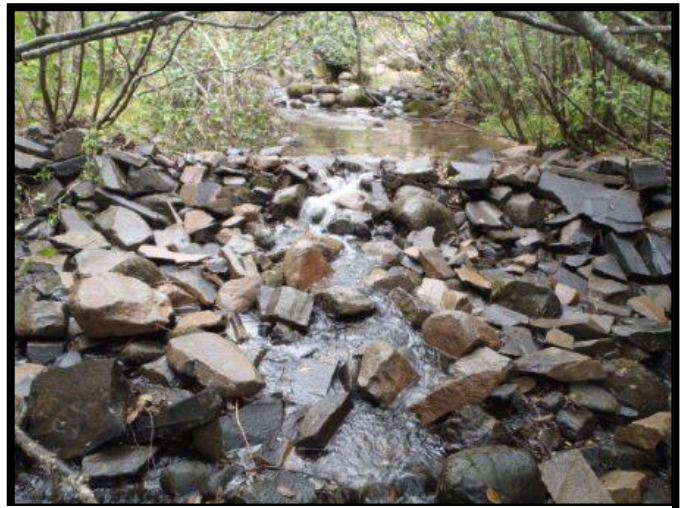
Figure 45. Weir B at TRO101 after maintenance to decrease the slope.

6. TRO010 should be revisited in spring or early summer to ensure Weir B is functioning properly, and is conducive to fish passage.
7. A *Broken Brooks* database should be created in Microsoft Access to simplify data entry. Data from every field season would then be available in one location.
