# Annapolis Watershed Salt Marsh Evaluation: Surveying Tidal Barriers Along the Annapolis Basin

Denise Sullivan  
Clean Annapolis River Project  
November 2005

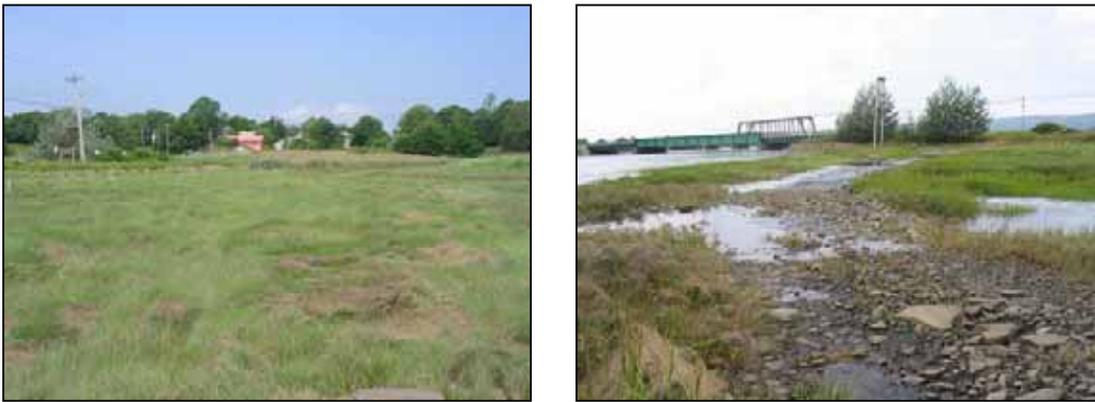
The site is a small area (2 ha) of salt marsh on Allain's River Marsh, behind Charlie's Restaurant in Annapolis Royal. A road with a small PVC culvert placed high in the streambed is partially restricting tidal flow. The road is made of large cobble and gravel and is used as an access route onto an adjacent dyke. During very high tides, the road is overtopped, flooding the upstream marsh. High velocity flows displace rocks and debris, which are visibly moved from the road onto the marsh surface. Small patches of marsh directly above the road are therefore covered in rocks, preventing *Spartina spp.* growth. The property is bordered by Highway 1 to the North and a demonstration area of an Acadian dyke and aboiteau maintained by the Annapolis Royal Historic Gardens to the South. There are several evident signs of tidal restriction at the site, including bank slumping, scour pools, turbulent flow and a large stand of the invasive *Phragmites australis* on the upstream side of the culvert. The land is owned by a local non-profit organization, the Annapolis Royal Historic Gardens Society.

**Figure 2: Landward view of site showing commercial building to the East and Highway 1 to the North (left); and photo showing the barrier being overtopped during a high tide event (right)**

Although the site receives some flooding with every tide, it is clearly restricted. The installation of a larger and better-positioned culvert would allow non-restricted flushing of the upstream marsh. This would reduce the erosion and bank slumping observed on the downstream side and would diminish the spread of the invasive *Phragmites australis* stand on the upstream side. Seeing that the road is currently overtopped during very high tides, flooding of any upstream properties should not be a big concern. When contacted prior to measuring tidal range, landowners expressed no objections with monitoring on their property.

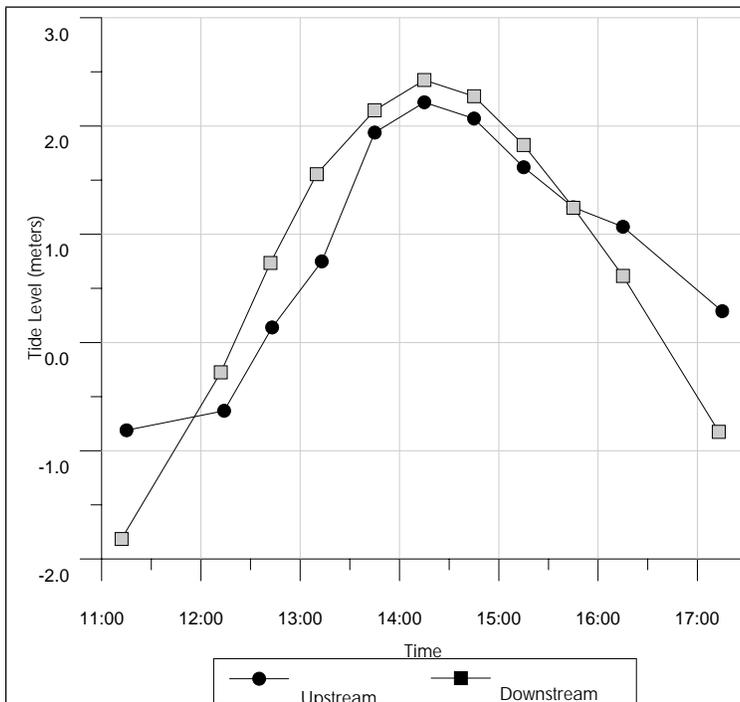
**Figure 3: Change in tide levels upstream and downstream of culvert at Allain’s River, Annapolis County**

Figure 3 provides evidence of a tidal restriction at the Allain’s River culvert. This occurs because the culvert is both too small and located too high on the channel bed. As seen on the graph, upon arrival at the site, water was pooling on the upstream side behind the culvert. The change in water level on the upstream side was much slower in the beginning, seen by a gentler slope on the curve, and then increased suddenly (13:15) when the road barrier was overtopped. The change between the two sides was then equal, until the tide dropped below the height of the road. At this point, the undersized culvert once again began holding back water, shown by a decreasing slope on the graph.

Flooding of the road only occurs during very high and spring tides. During neap high tides for example, the road does not flood causing the height differential to exist throughout the entire tidal cycle. The effect of the restriction may therefore actually be greater than that observed at the spring tide, when the water levels on the up and downstream sides equalize for over an hour.

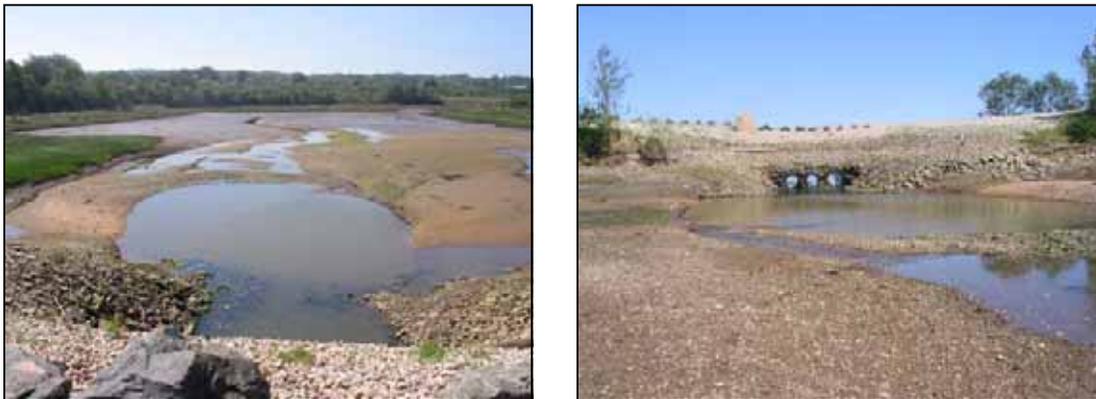
The barrier is a triple concrete culvert beneath the former Dominion Atlantic Railway (DAR) railbed crossing over the Little Joggins in Conway, near Digby. New culverts were installed in the summer of 2004, however their small size restricts tidal flow, as evidenced by two large scour pools and turbulent flow on either side of the barrier. Local citizens use the railbed regularly as a walking trail and an ATV trail to travel to and from either side of the Little Joggins. The upstream side consists of restricted salt marsh (~6ha) that may involve several different landowners and potentially two small tidal creeks further upstream. The downstream side consists of mudflat and poorly developed salt marsh.

Figure 4: The landward view showing large scour pool directly above culverts (left), and a view of the culverts looking downstream (right)

Although the culverts are placed on the bottom of the stream bed, they are of insufficient size to allow unrestricted tidal flushing. The installation of larger culverts or a small bridge would eliminate the time lag between the upstream and downstream peak water levels and restore proper flushing to the upstream marsh. Although the culverts were recently installed, increasing their size would eliminate the strong currents and whirlpools in an area frequented by pedestrians and ATV users.

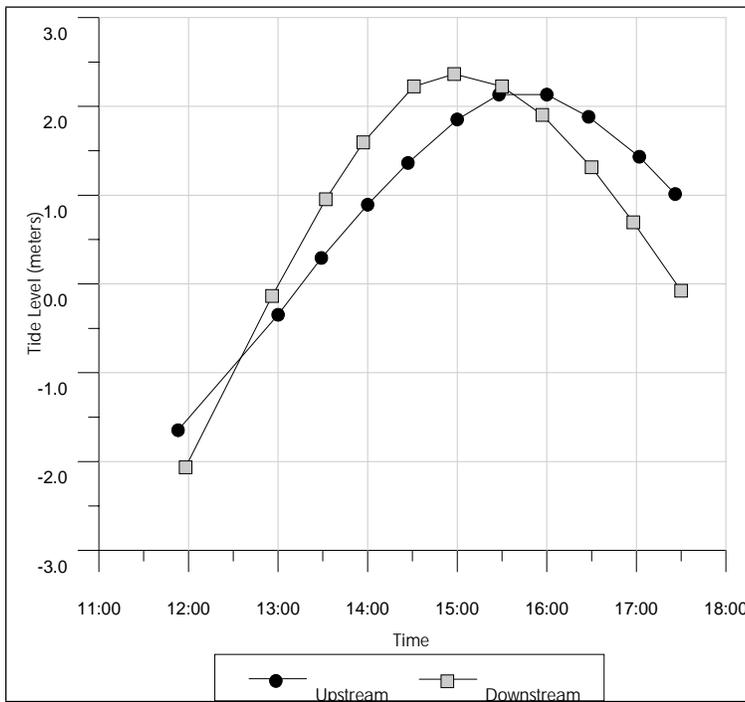
**Figure 5: Change in tide levels upstream and downstream of culverts at Little Joggins, Digby County**

Figure 5 indicates that the culverts, although allowing some degree of tidal flushing, are insufficient in size for the volume of water at the site. The graph shows that there is a lag of almost 1 hour between the upstream and downstream peak water levels. The difference in tide levels on both sides also confirms that the barrier is restrictive. The culverts were submerged for an hour and a half prior to high tide, after which the upstream water level continued to rise while the downstream water level fell. During the falling tide, multiple large whirlpools could be observed on the upstream side and turbulent flow on the downstream side.

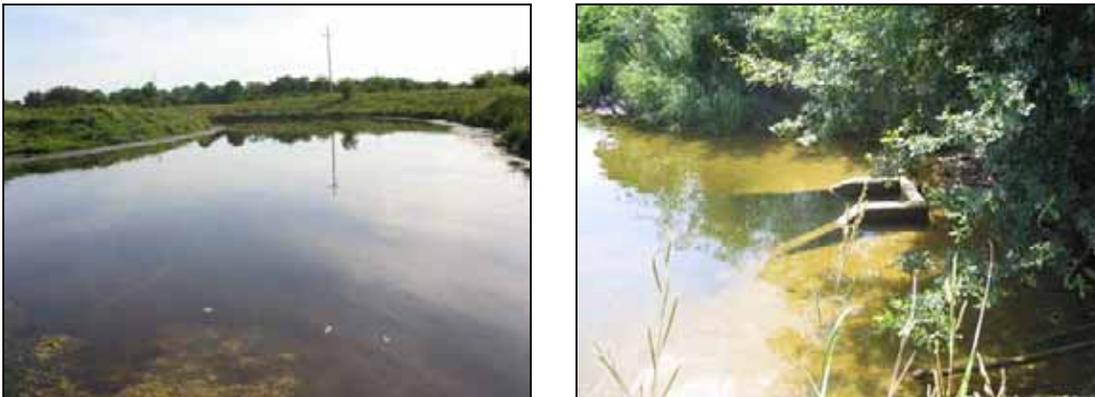
The site (~ 12ha) is located between the Annapolis Royal Marsh and Highway #1 in Annapolis Royal. The land is currently owned by the Town of Annapolis Royal, and is fallow; however the Town is seeking to sell the property as soon as possible. Directly downstream of the dyke is the Lloyd M. Bourinot Sail Centre, used seasonally as a training centre for sea cadets. The site is located upstream of the Annapolis Royal causeway and Nova Scotia Power's Annapolis Tidal Generating Station. The water levels in the French Basin are controlled by opening and closing sluice gates for power generation and therefore fluctuate less than normal tidal levels downstream of the barrage. Restoration of this site would test the feasibility of salt marsh remediation upstream of the power plant. The drainage structure located at the site is an old aboiteau; however the aboiteau opening is restricted or possibly plugged, resulting in large volumes of water pooling on the upstream side, as seen in Figure 6.

**Figure 6: Landward side of dyke showing water pooling behind dyke (left) and photo of drainage structure on downstream side of dyke (right)**

Replacing the small drainage structure with a larger culvert or small bridge would restore tidal flushing to the area. A forced sewer main, which runs underneath the dyke, would require additional caution if the site was restored. The freshwater wetland directly to the South of the property is bordered by a walking trail that is very popular among local citizens. Restoring the area to salt marsh would allow both the fresh and salt water marshes to be observed from the trail and would create a unique learning opportunity for local residents and students.

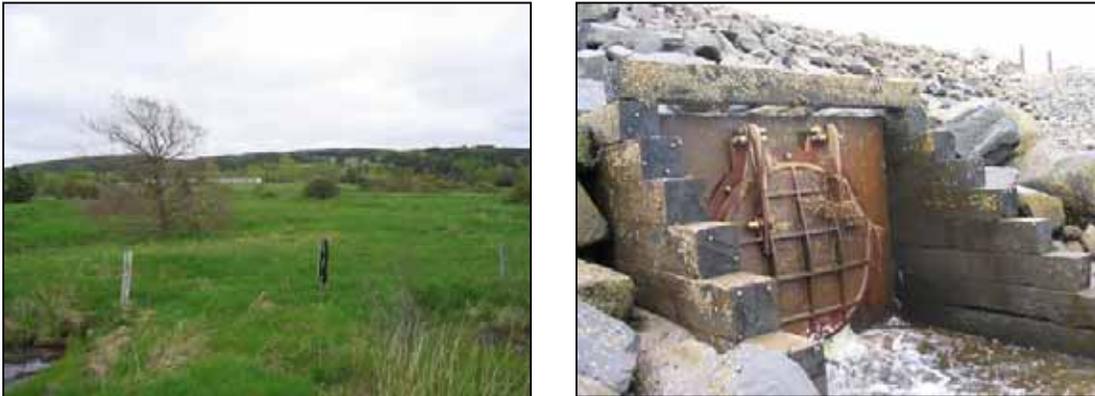
The site is a large area (~ 14ha) of fallow land along Highway #1 across from Dugway Road. There is evidence of an old cow pasture, however the area is presently fallow with several trees and shrubs present. The former DAR railbed is completely restricting flooding and an aboiteau is blocking a small tidal creek that runs through the property. The aboiteau has been breached on a number of occasions in the past with several repairs being needed (P.L. Reardon, personal communication, September 22, 2005). The aboiteau structure has been causing significant erosion on the downstream side, where a narrow stripe of salt marsh exists. An old deteriorating dyke separates the two sites (AC33R and AC34R), however it is not currently being maintained. A gradual increase in slope on the landward side of the site would likely protect land behind the property, including homes and a section of the Annapolis Royal Golf Course; however some new dyke may be needed to protect an adjacent hay field. The area is owned by C.H.R. Holdings Ltd, which consists of several members of a local family. Tidal range was not measured at this site, as the aboiteau is completely restricting tidal flow to the upstream side.

Figure 7: Landward view of restorable area (left) and downstream view of aboiteau (right)

Replacing the aboiteau with a large culvert or bridge would allow tidal flow into the creek and restore this large area to salt marsh. The installation of a small bridge at the site would reduce erosion on the upstream and downstream sides and would eliminate the need for frequent and costly repairs to the aboiteau. The land is not currently being used for agricultural purposes nor is there plans to cultivate it in the coming years. If the old dyke that presently separates the two sites (AC33/34R) was reinforced and maintained, no new flood protection structure would be needed to protect the adjacent hay fields. Alternatively, the old dyke could be removed and a new section built on the property boundary, flooding a larger area while still protecting adjacent land.
