Fish Passage Restoration and Habitat Enhancement

*Addressing habitat
fragmentation and
productivity in the Annapolis
River watershed*

Jamie McCamon
December 2015

Clean Annapolis River Project

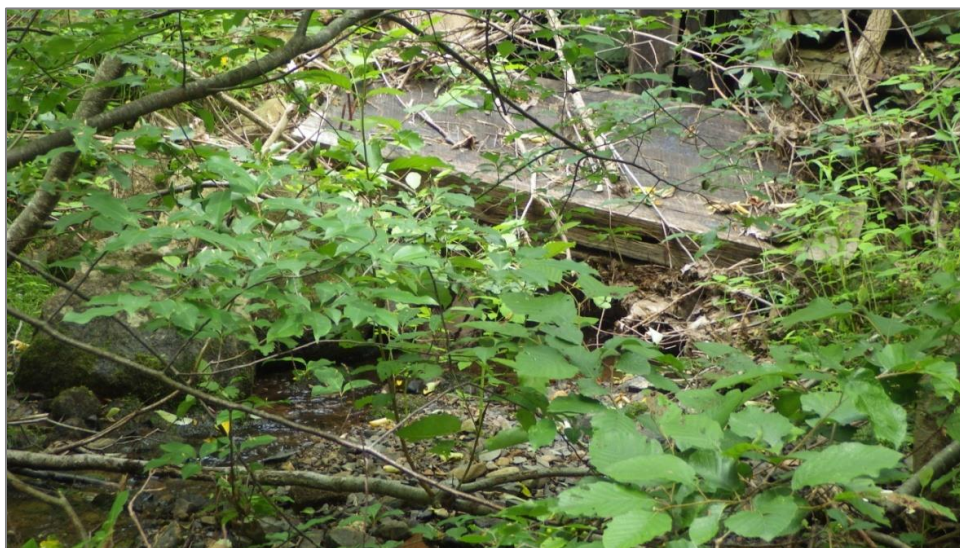
Comments: Located on a tributary of the Annapolis River called Pete's Brook, PET004 was a square box wooden culvert falling apart at the inflow. Debris was removed to restore fish passage however major structural work or replacement is still required to address impending culvert failure. Figures 13 through 15 show the inflow prior to and after debris removal.

Figure 13. PET004 Before debris removal.

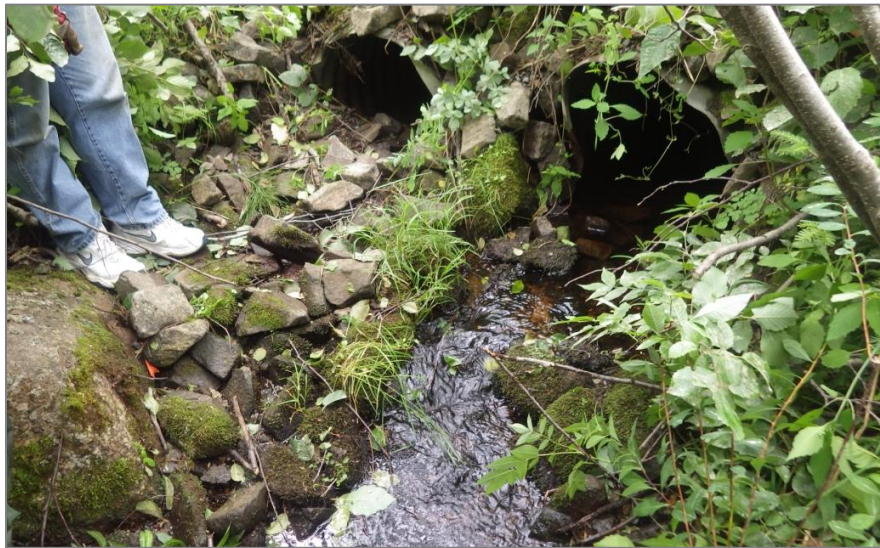
Comments: One of two culverts at RHR022, located on a tributary of the Round Hill River, a sub-watershed of the Annapolis River, was found to be plugged solid with rocks and debris. Shovels, a few pairs of hands, and some team work made this a working culvert conducive for fish passage. Figures 16 and 17 show before and after photos of the site.

Figure 16. RHR022 Before debris removal.

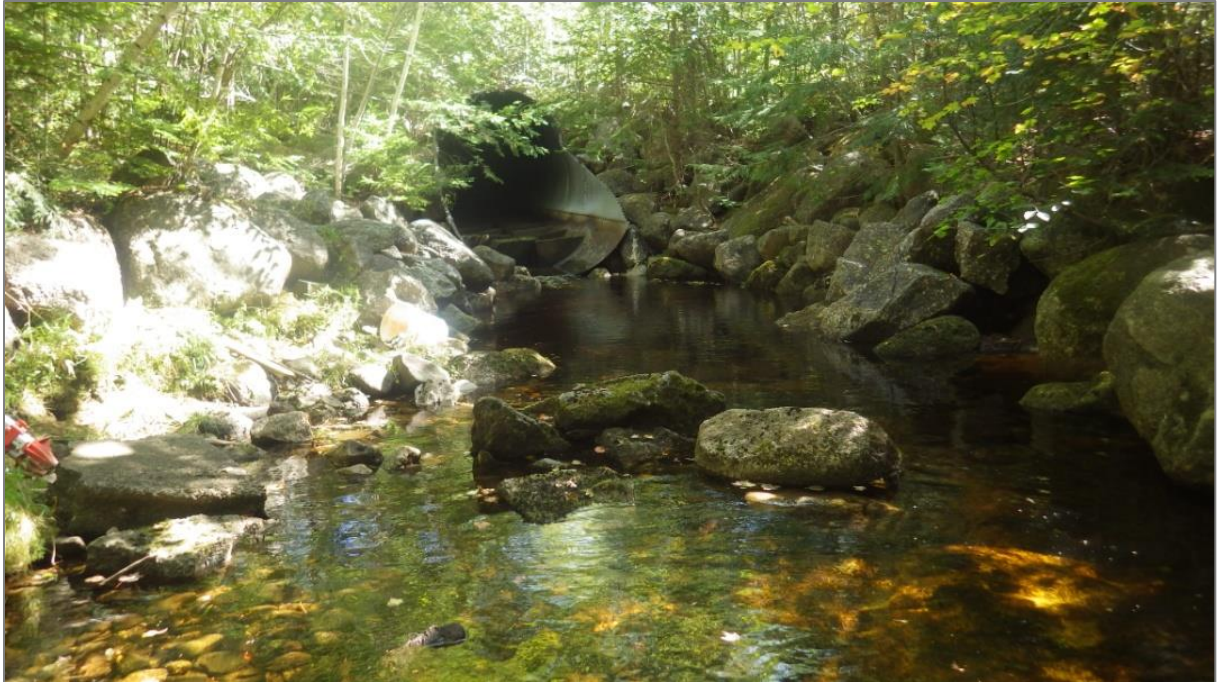
Comments: Button Brook is a stream that flows directly into the Annapolis River. BUT006 is a large round steel culvert with concrete baffles. An outflow drop of 11cm was easily remedied with a tailwater control in the form of a rock weir that was built using materials found on the site. Available rocks were fashioned into a rock weir and used some mud, grass and moss to seal the structure. A few broken baffles in the culvert require further repair work. Figures 25 to 28 show images of the restoration activities for this site.

Figure 25. BUT006 Before remediation.

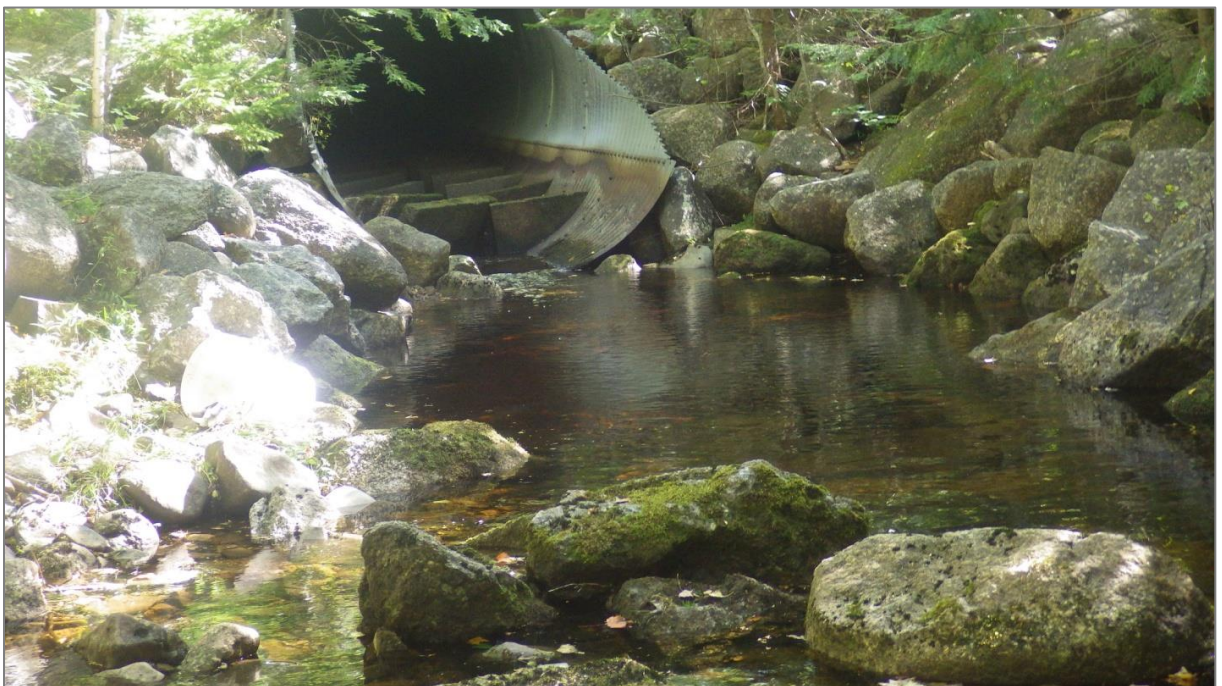
Figure 26. BUT006 After remediation.

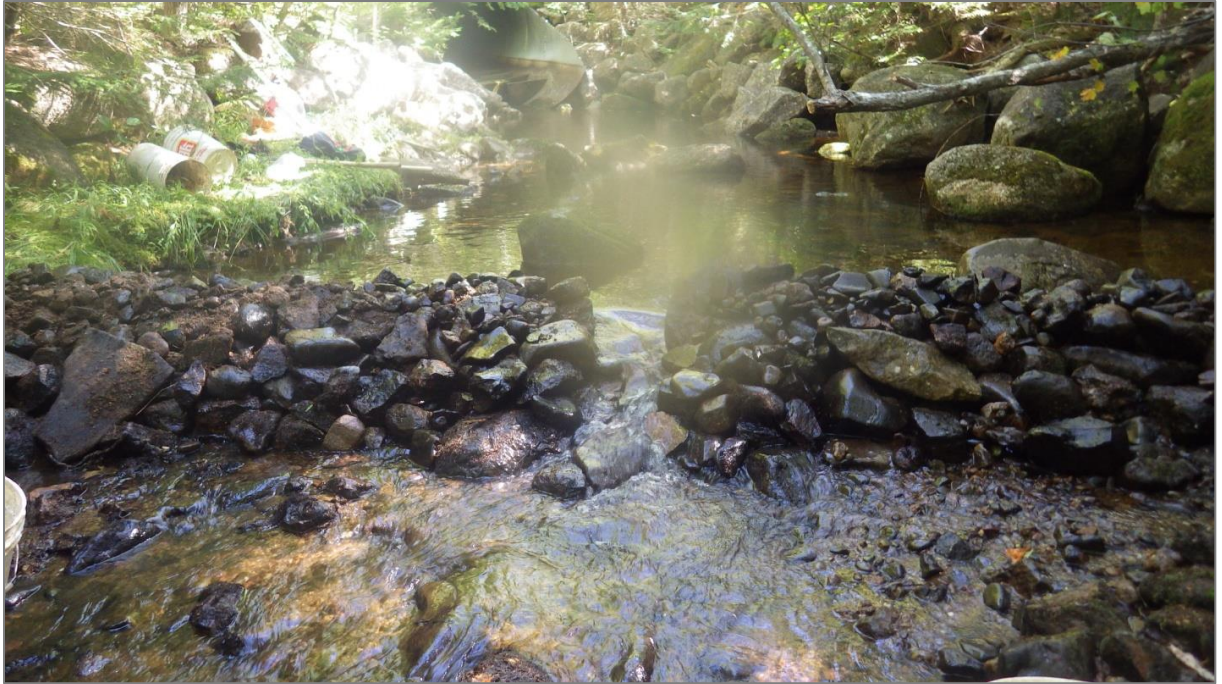
Figure 27. BUT006 Finished weir.

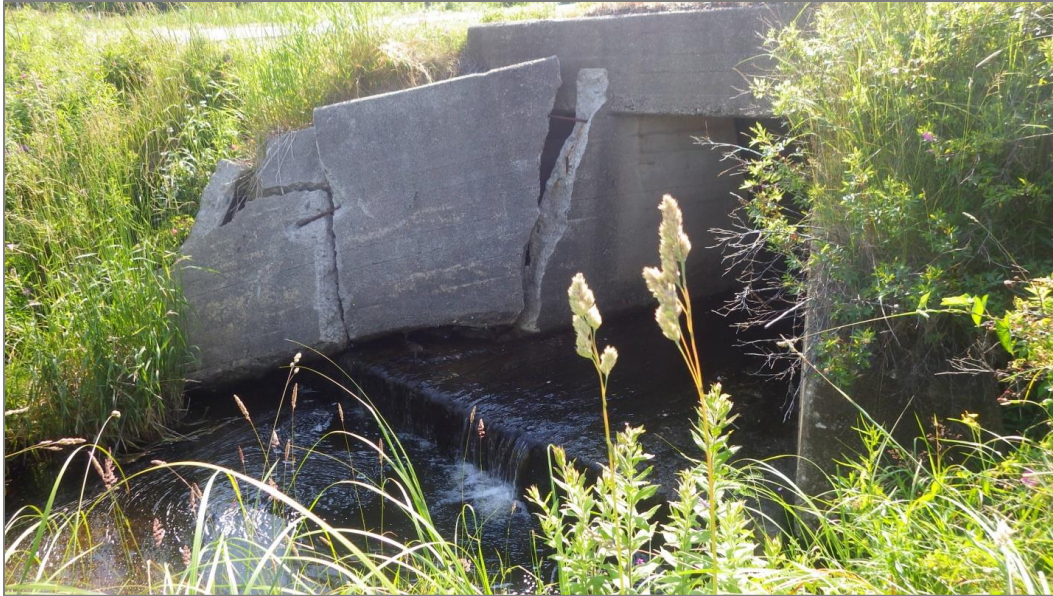
Comments: This culvert, on a tributary of the Annapolis River west of the causeway in Annapolis Royal, required a number of restoration activities. The site was located on Balcom Brook, and flowed directly into the Annapolis Basin. There was broken concrete divider in this culvert which was not addressed through remediation activities, and will required removal. Electric tools and a generator were required to complete the restoration work at this culvert, to install a culvert divider, baffles and low flow barrier. Stainless steel expansion bolts and galvanized steel lag bolts were needed to attach cedar posts to the cement culvert. Battery operated drills with extra batteries, hammers, wrenches, socket sets, and a chain saw were also used in installation activities. Due to the size of the outflow drop (over 60cm) and the downstream slope at this site, it was necessary to construct two tailwater control structures and also install a fish chute in order to restore fish passage through the culverts. On site materials were used where possible to aid in the construction of both rock weirs that were installed downstream of the culvert outflow. Figures 34 through 43 show the remediation activities that occurred on site.

Figure 34. BAL001 Broken concrete divider that requires removal.

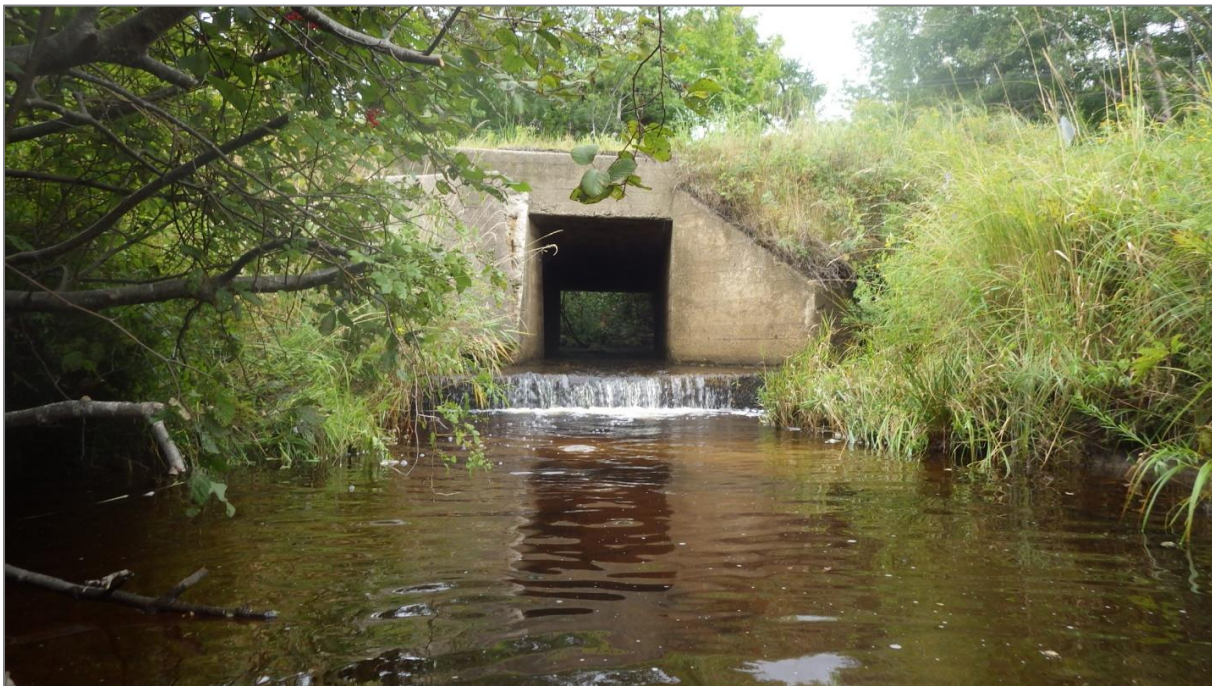
Figure 35. BAL001 Before remediation activities.

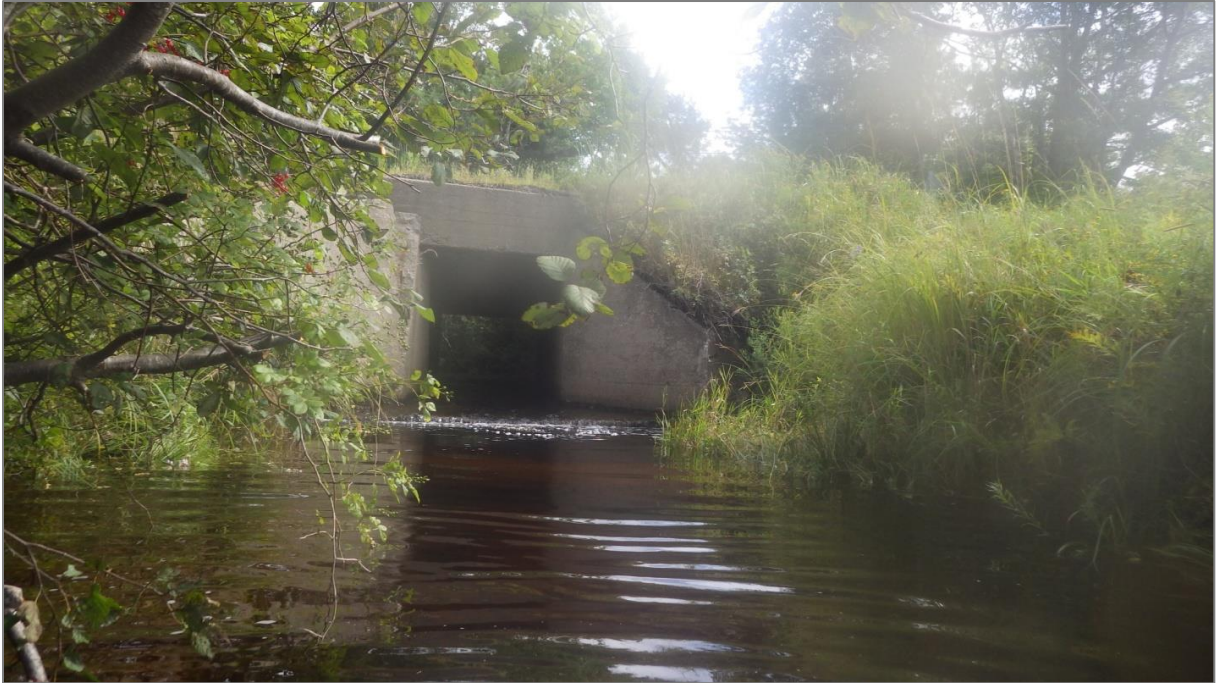
Figure 36. BAL001 After remediation activities.

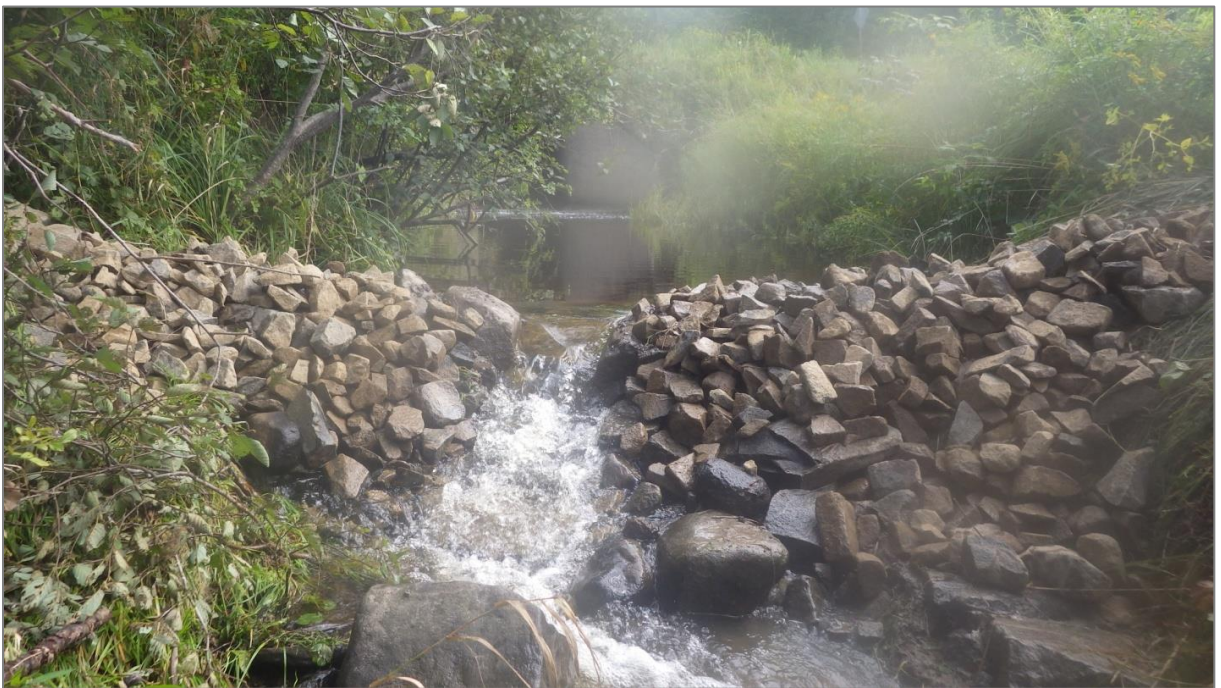
Figure 37. BAL001 First weir installed downstream of the culvert outflow.

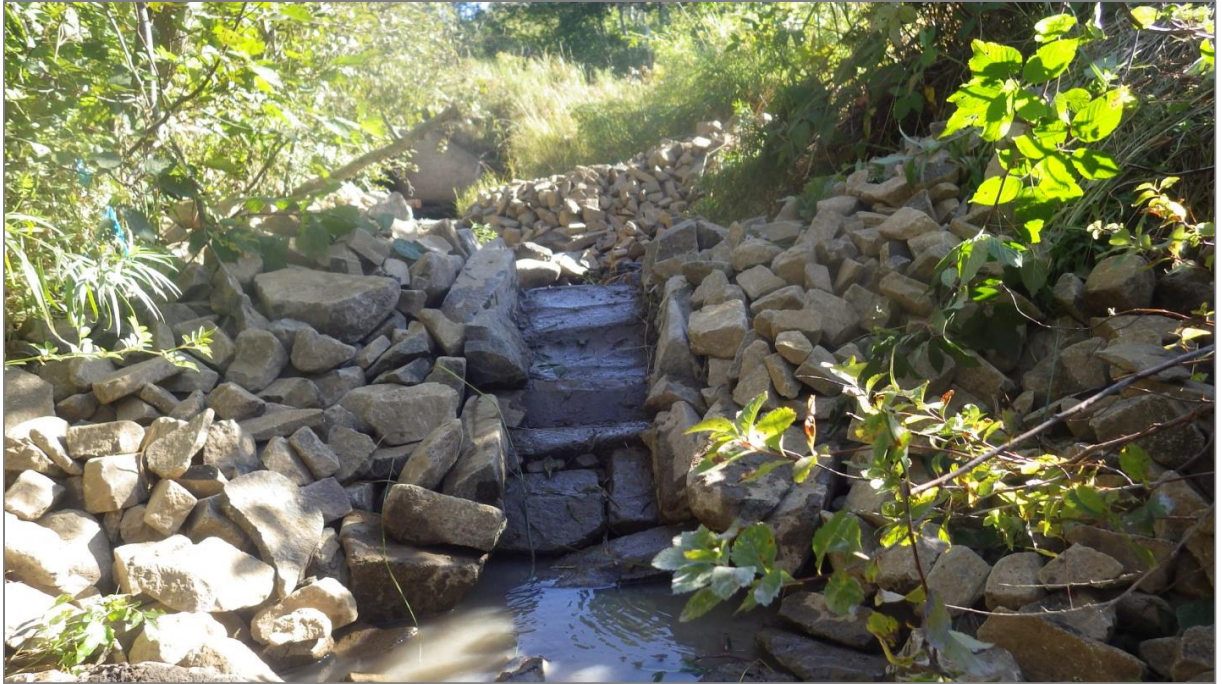
Figure 38. BAL001 Second weir, downstream of culvert outflow and first weir, after completion.

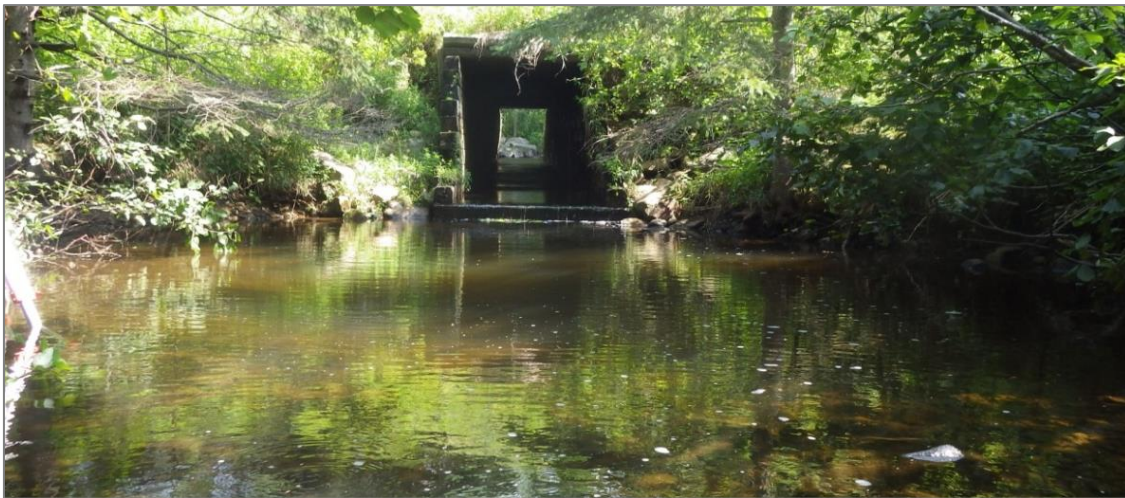
Comments: Most of the materials used to construct the rock weir were found on site, except for the larger footer stones. Clay, grass and fine gravel from on-site were used to seal the upstream side of the weir. Installation of a tailwater control structure restored fish passage through the culvert, opening up access to 1.6 km of upstream habitat (See Figures 44 through 48).

Figure 44. MOR008 Before tailwater control installation.

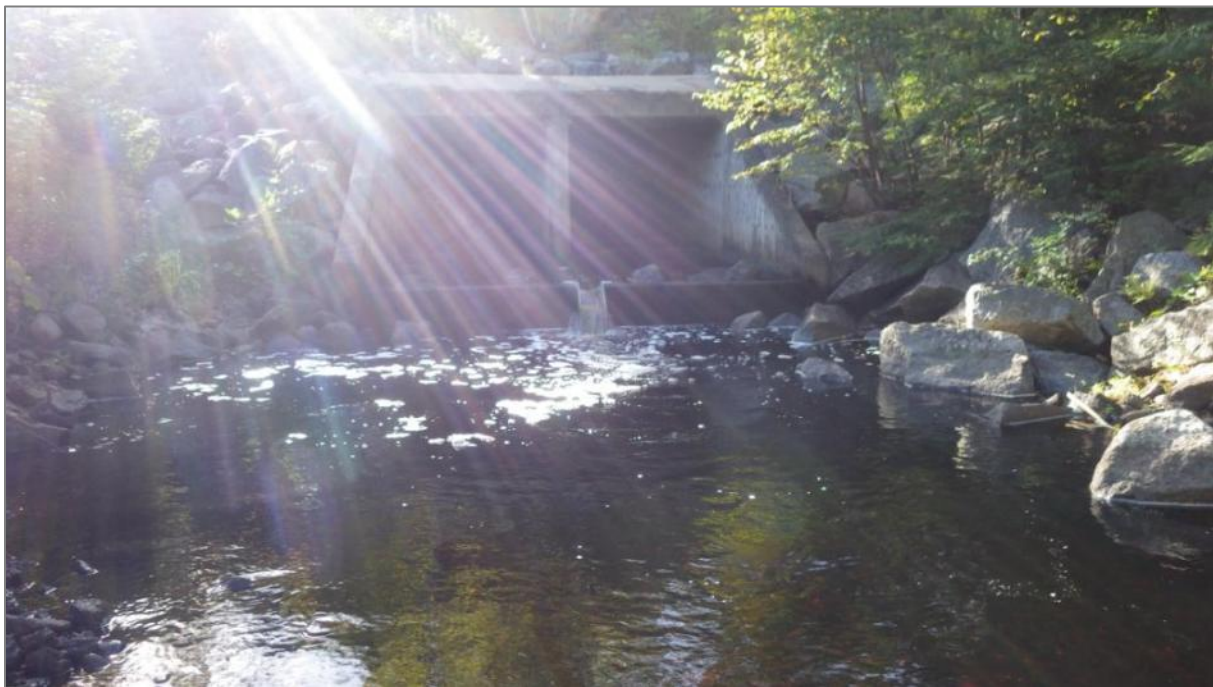
Figure 50. RHR013 Before weir reconstruction.

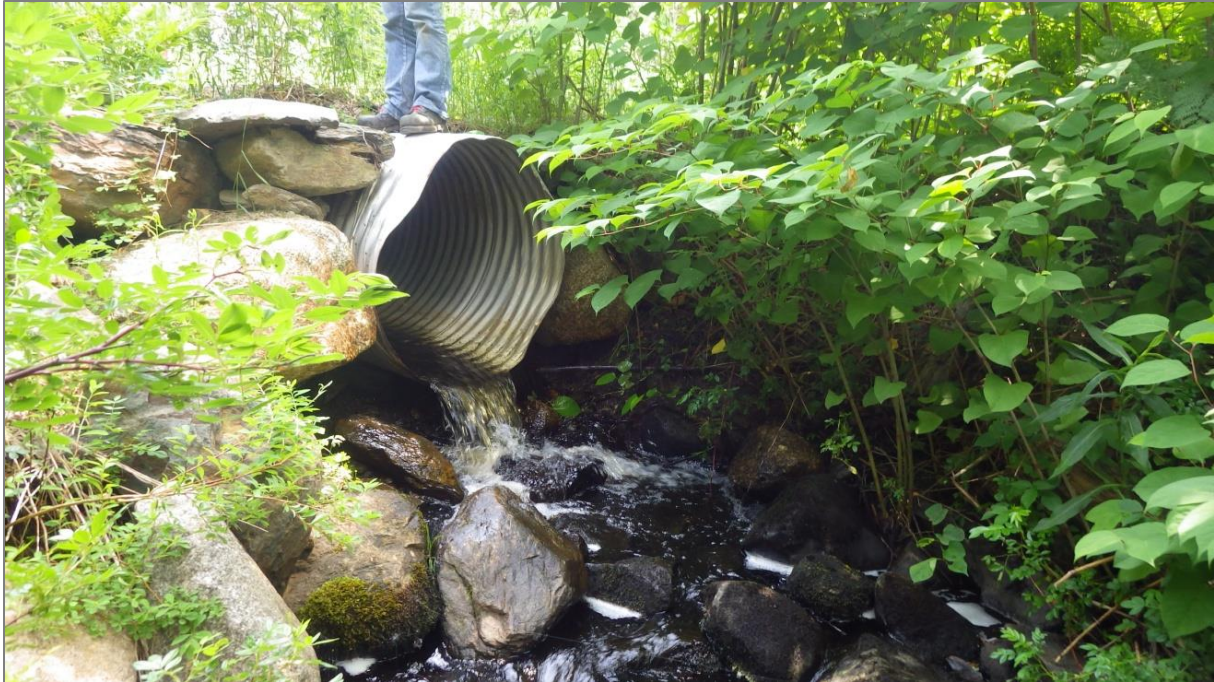
Comments: On a tributary of the Moose River, this culvert was just replaced last year and was re-installed with the same outflow drop as the old culvert. Quarry rocks were used alongside rocks onsite for the weir construction. The weir was sealed with clay, grass and sticks found onsite, and the outflow pool was lined with the clay to improve weir function. Even with the observed low flows in-stream at the time of construction, fish such as brook trout, suckers, and American eel were present on site. Figures 56 to 62 show some of the remediation activities that took place at the site.

Figure 56. EAS009 Before remediation activities.

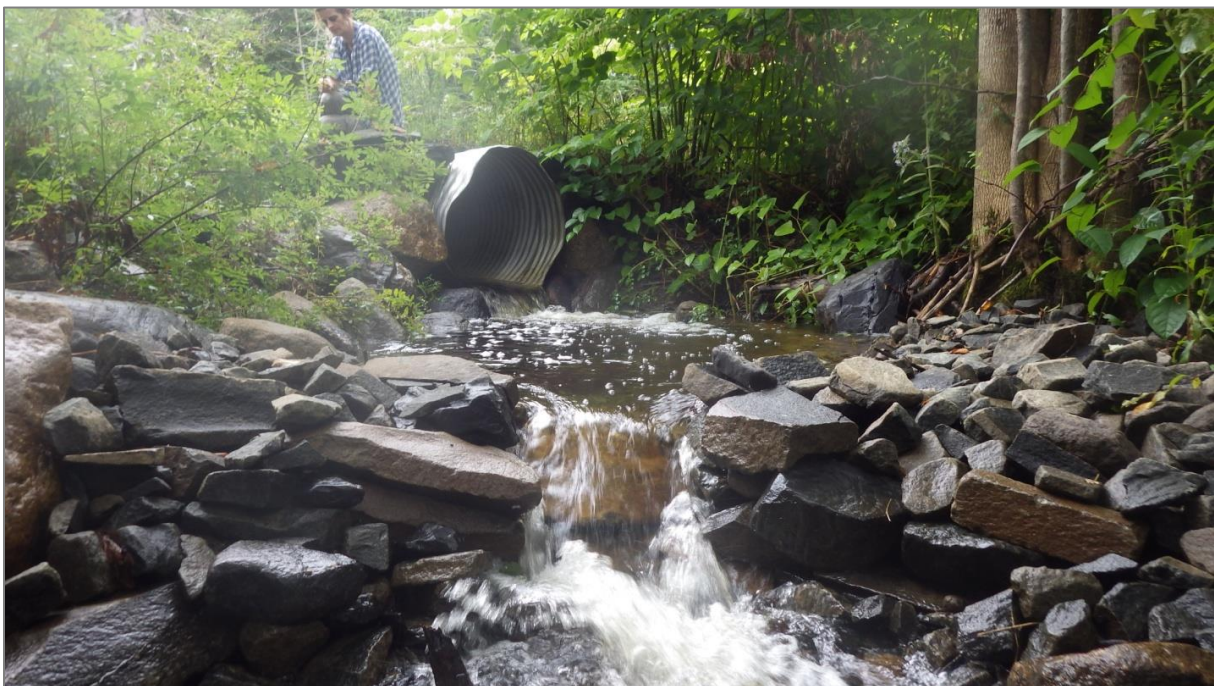
Figure 57. EAS009 After weir construction, prior to fish chute installation.

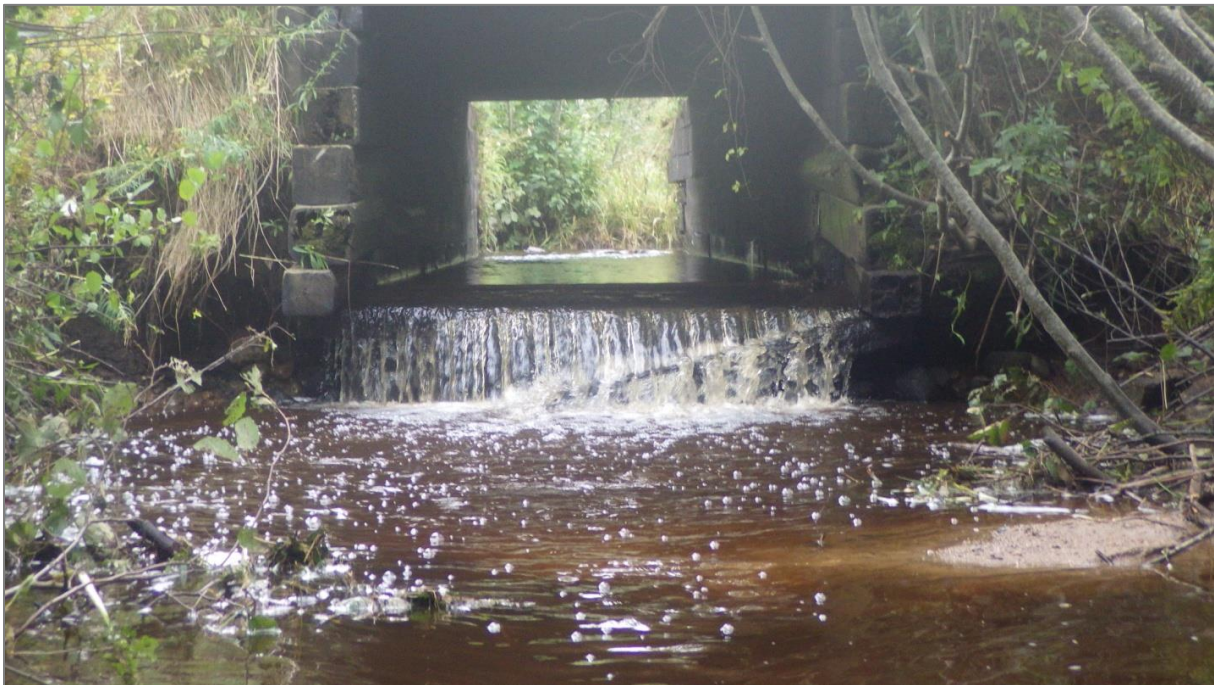
Comments: A broken wooden beam needed to be removed from the culvert outflow to allow for proper positioning of the fish chute. Due to the high sediment content in this stream, straw bales were used to alleviate the transport of sediment downstream during rock weir construction (see Figure 65). There were two beavers present during weir construction that were building a dam at the culvert inflow. A local landowner said the beavers were a regular nuisance and had permission from DNR to remove the dam whenever required. Once weir construction was complete CARP removed the dam. Figures 63 through 71 show the restoration activities that took place at BLK006.

Figure 63. BLK006 Before remediation activities. Note the large outflow drop and fallen timber.

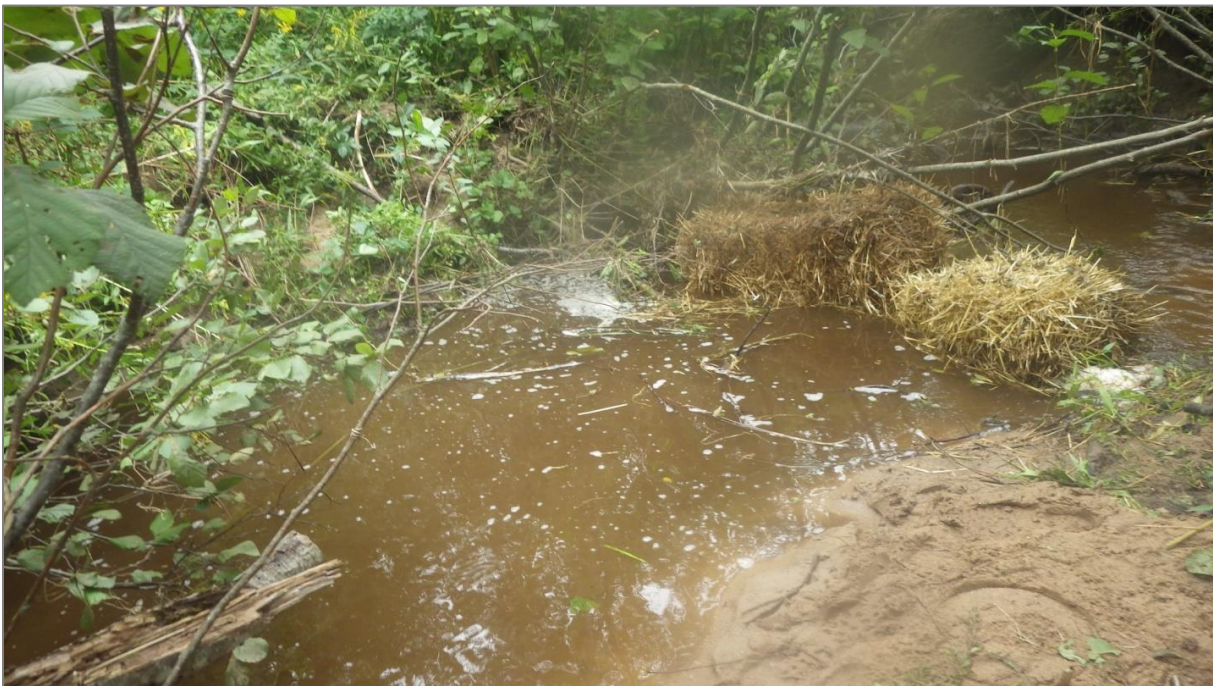
Figure 65. BLK006 Sediment trapping downstream of outflow.

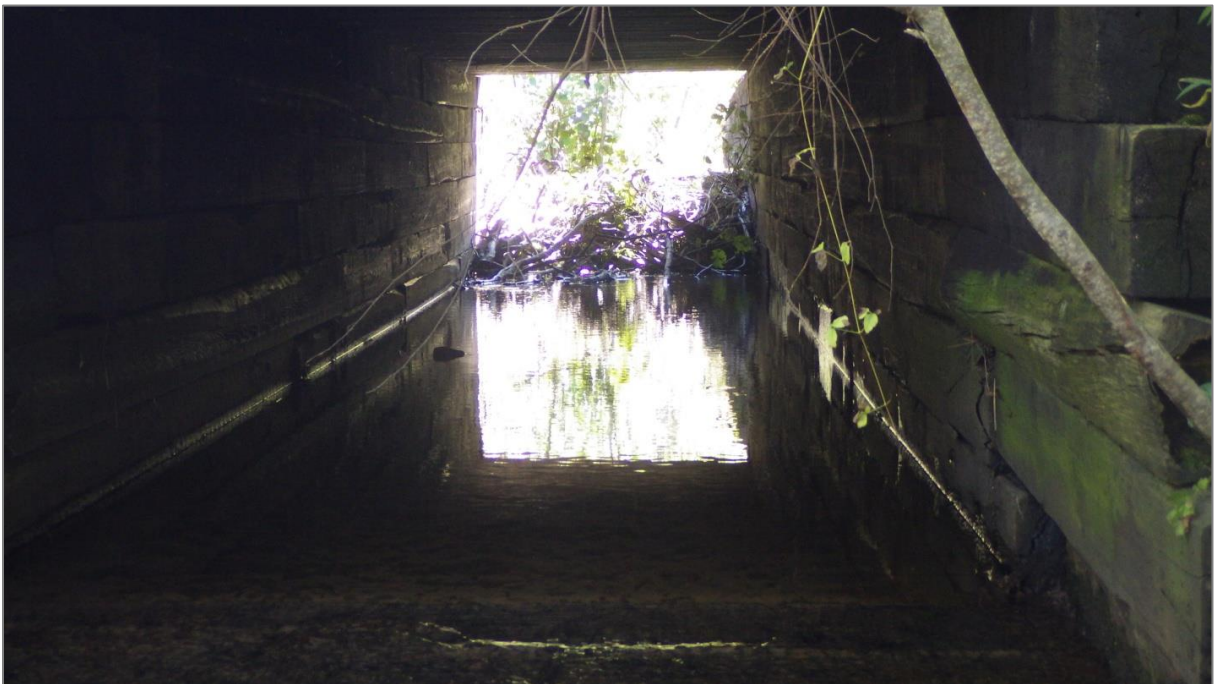
Figure 69. Beaver dam at inflow of BLK006.

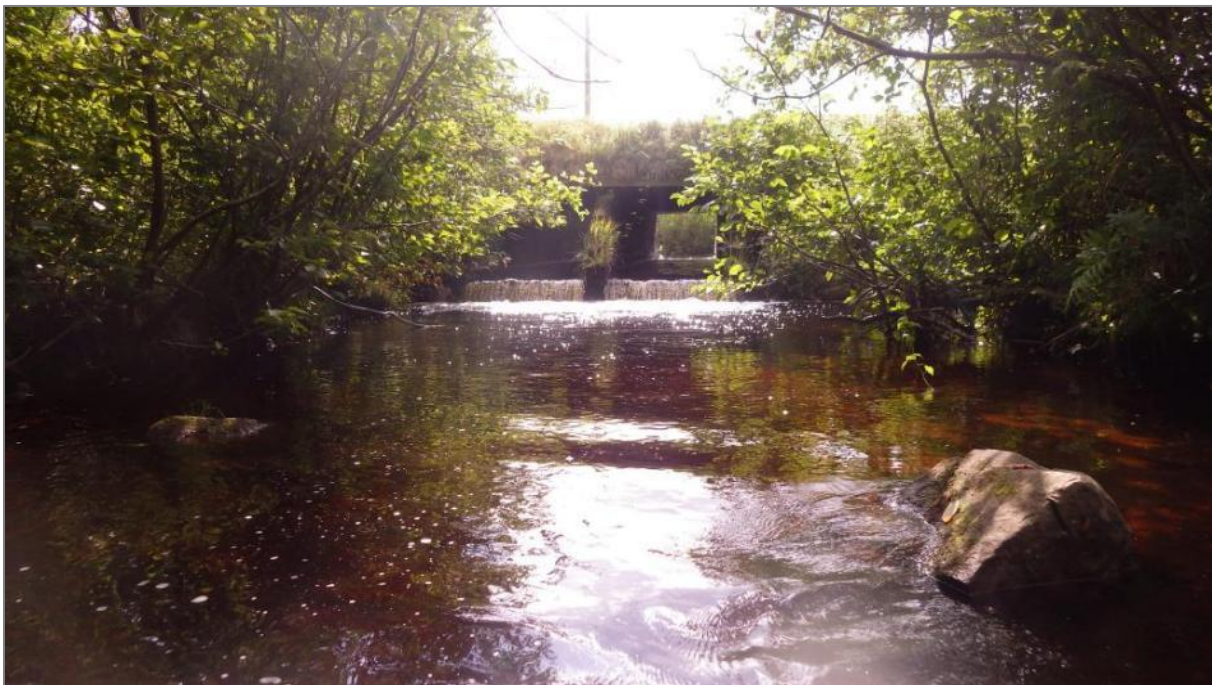
Comments: Baffles installed with the low flow barrier will alleviate low water levels during low flow periods and will give fish a resting spot during higher flows. A local landowner who supervised the installation reported that he observed the weir during a severe rain event and the weir was directing high flows towards the middle of the stream and away from the eroding right stream bank, just as planned when the weir was installed. Rocks that were not needed for weir construction were used to reinforce the right bank above and below the weir, and a section of streambank near the culvert that was eroding as well. Figures 72 to 79 show remediation activities that occurred on-site.

Figure 72. ROC004 Before remediation.

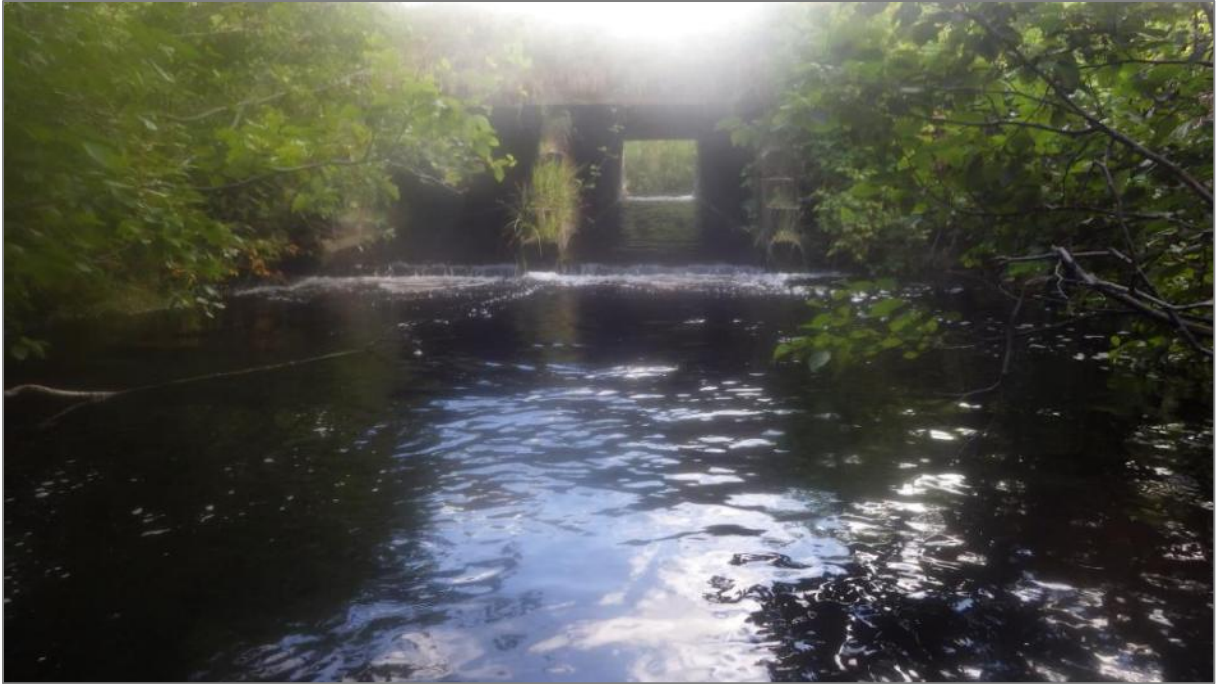
Figure 73. ROC004 After tailwater control weir construction.

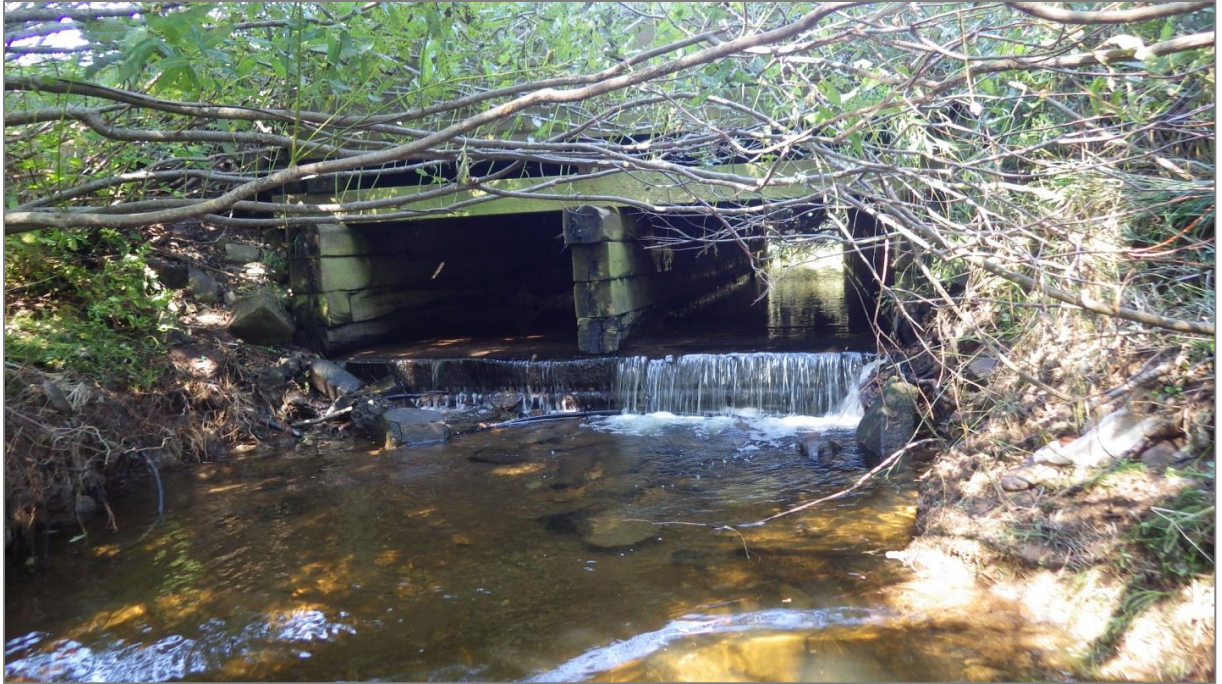
Comments: This restoration was completed with the help of volunteers from two different high school classes. Some channel clearing and streambank reinforcement was completed during the tailwater control weir construction to reduce erosion on the left bank downstream of the weir. A small quantity of moss mixed with mud from onsite were used to help seal the weir, but more matter will need to accumulate and plug the holes in the weir to improve its function during low flow conditions. A fish chute was installed at the outflow to help overcome the 45 cm drop, and a low flow barrier was installed in one of the culverts to improve water passage through the culvert during low flow conditions. Figures 80 to 86 show restoration activities that took place at NEB004.

Figure 80. NEB004 Before restoration work.

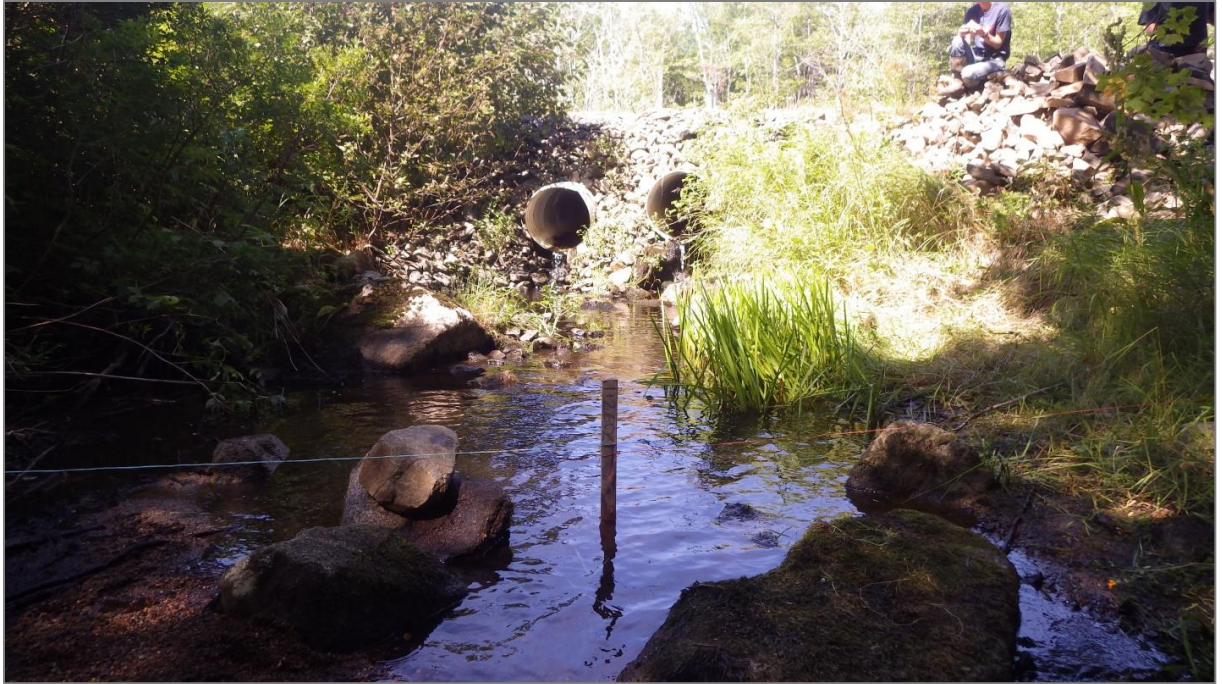
Comments: One of the two steel culverts at ALL017 had a low flow barrier installed, the other a manufactured fish chute. Fine gravel and some clay found onsite were used to plug holes in the weir. Constructed during a low flow period, this weir will need several high flow events to bring debris to seal the weir to improve its function during low flow conditions. Figures 87 through 91 show some before and after photos of culvert remediation work that took place.

Figure 87. ALL017 Before construction of tailwater control weir.

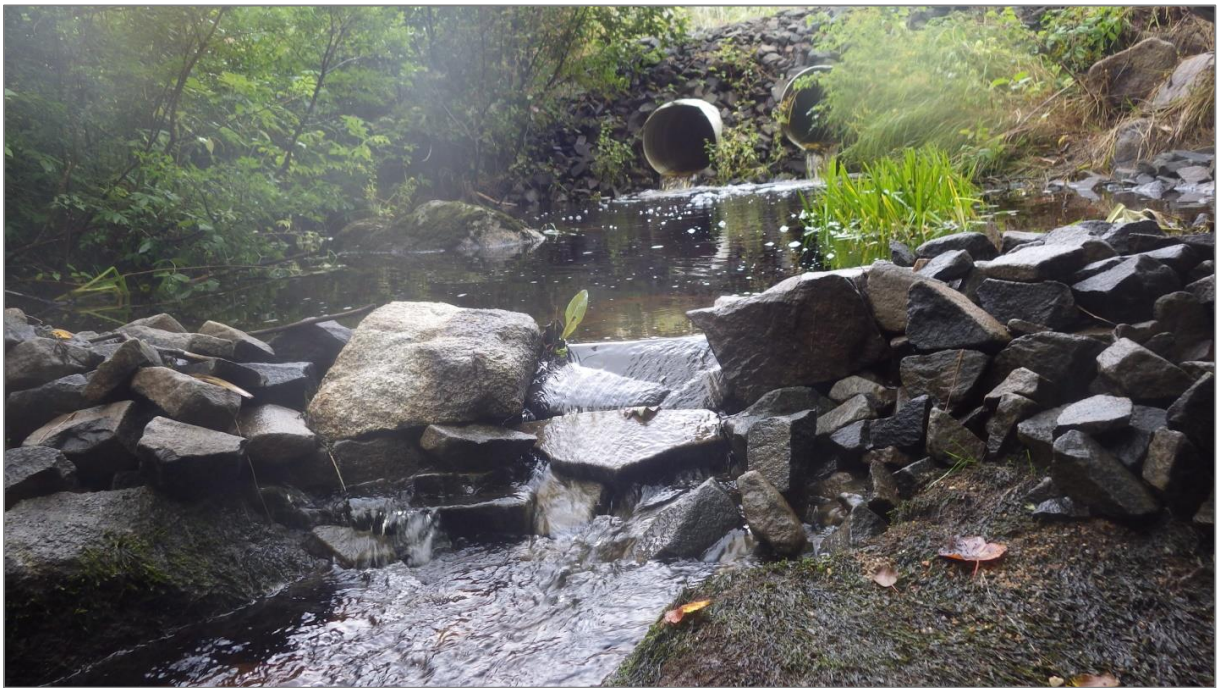
Figure 88. ALL017 After tailwater control weir construction.

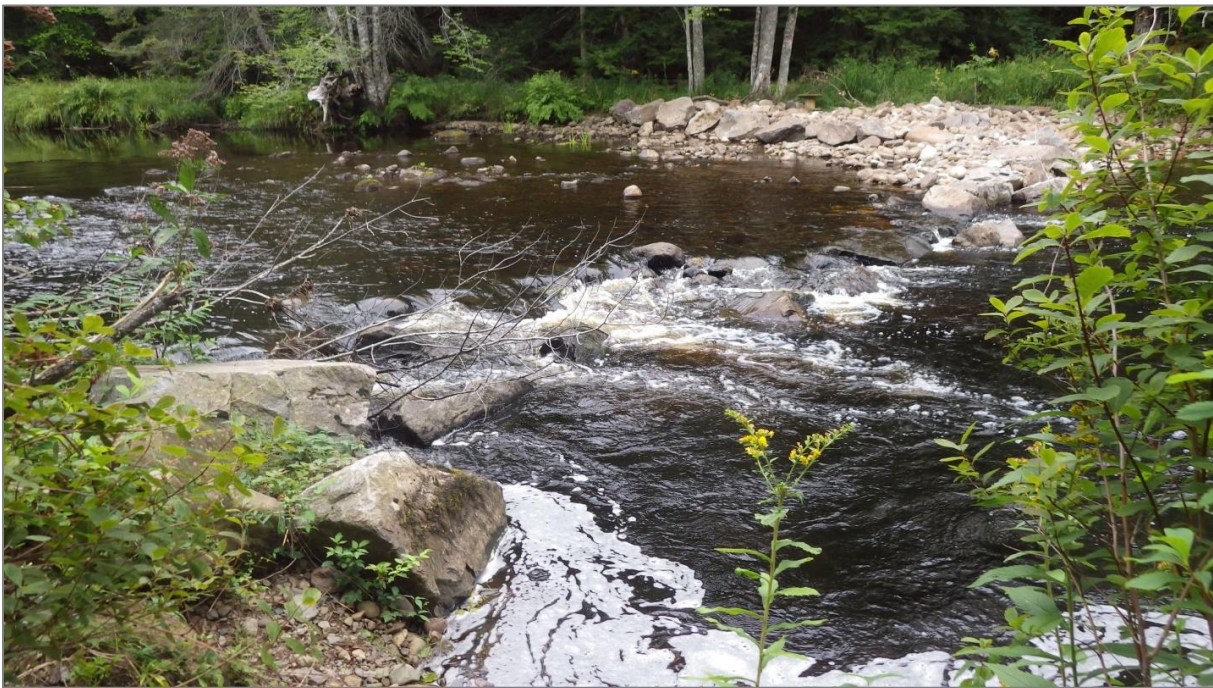
Figure 97. Weir "B" After adjustments were completed.

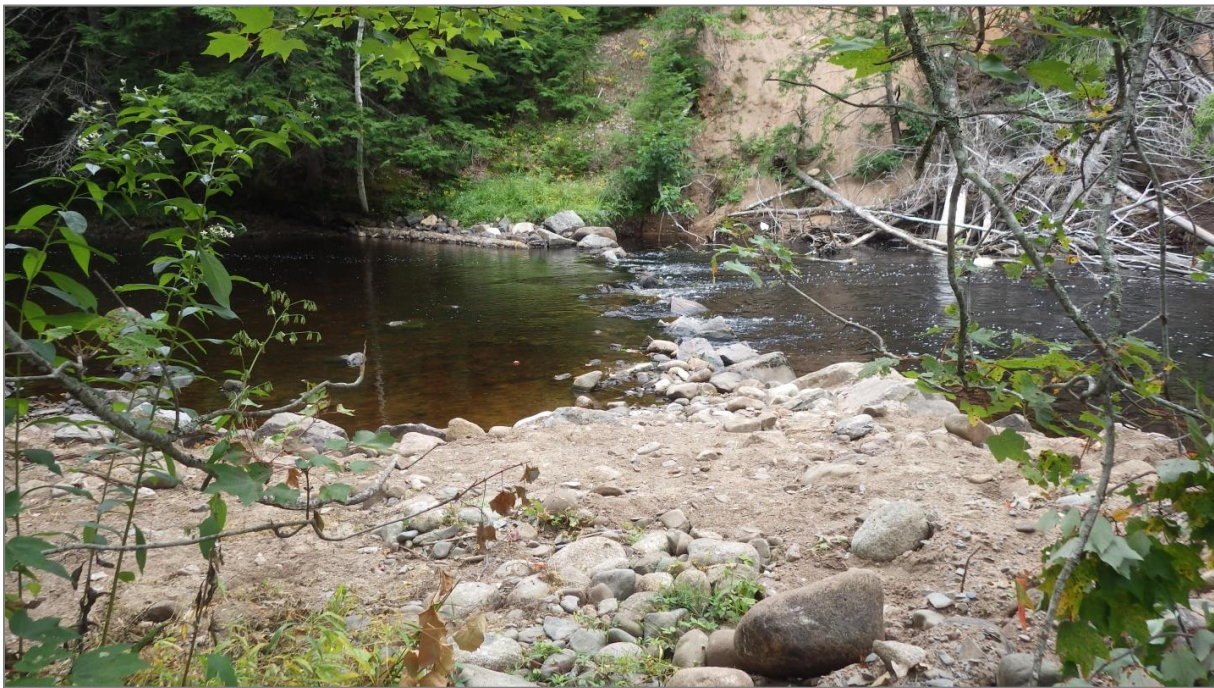
Figure 99. Weir "C" After completion of restoration activities.

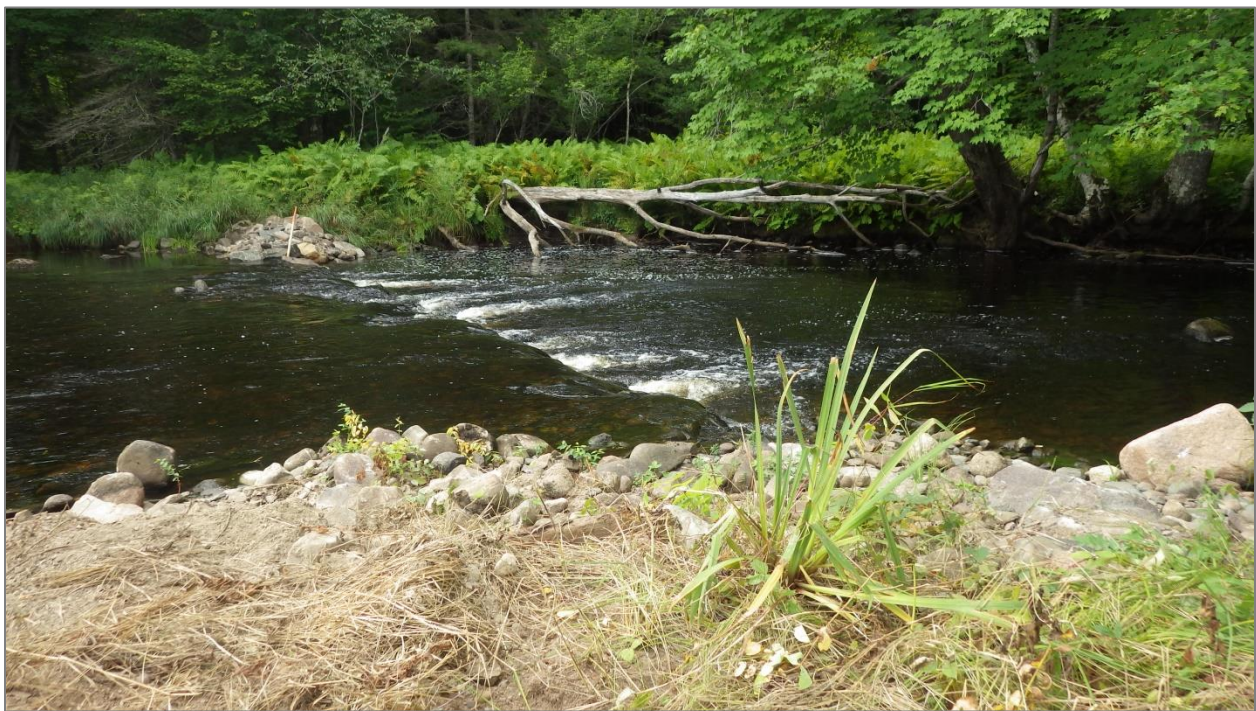
Figure 101. Weir "E" after re-construction of wing deflectors.

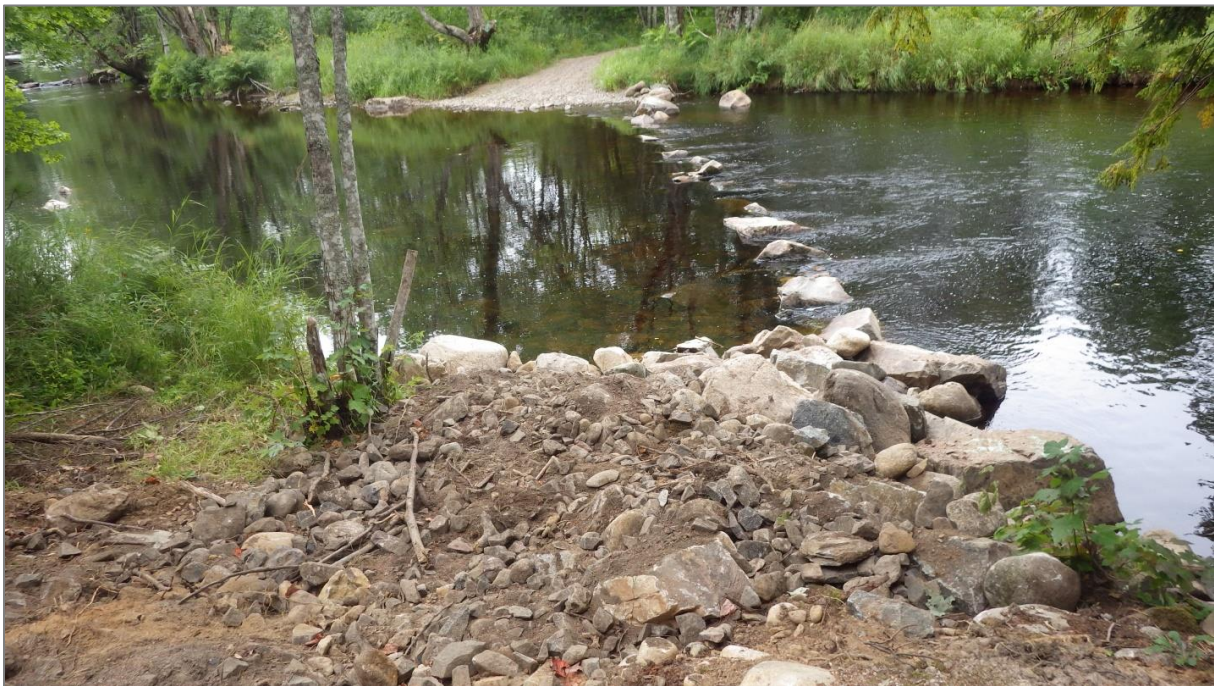
Figure 105. Weir "G" after the addition of the right wing deflector.
