Fish Passage Restoration and Habitat Enhancement

*Addressing habitat
fragmentation and
productivity in the Annapolis
River watershed*

Jamie McCamon
December 2015

Clean Annapolis River Project

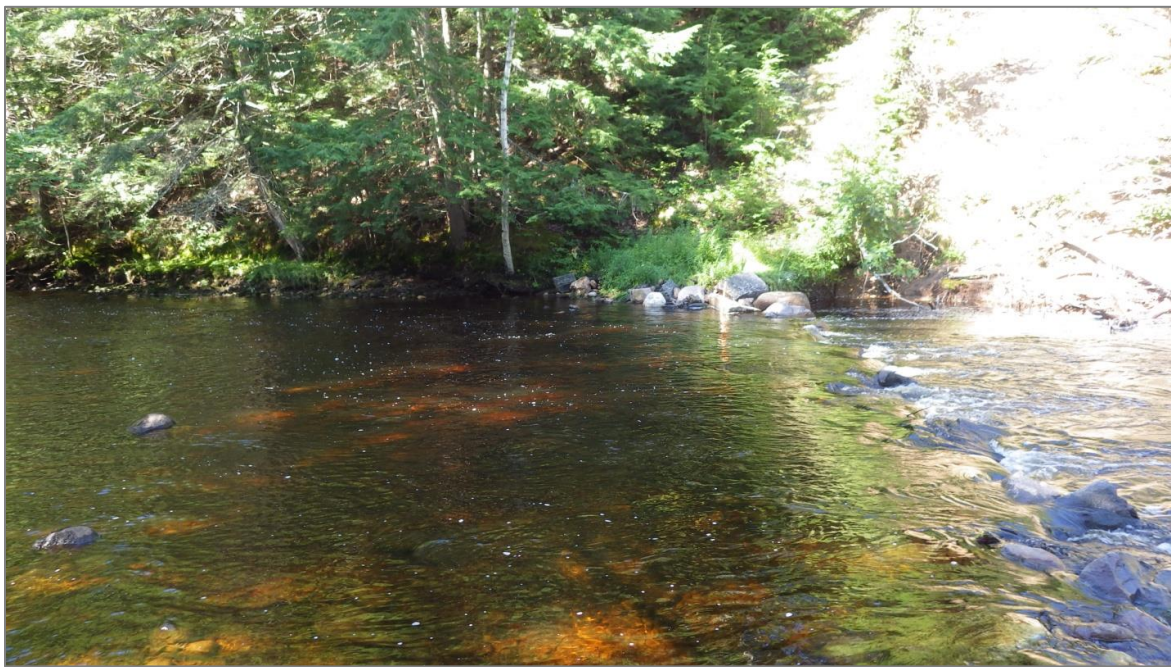
Figures 106 and 107 show before and after photos of the left bank of Weir C, prior to and after the installation of the left wing deflector. Figures 108 through 110 show some of the installation process that took place to secure the deflector and backfill it with rocks. This was a single log structure backfilled with rocks. A suitable tree found just upstream of the weir was cut down, trimmed, and cut to length for the deflector weir. The unused end of the tree was floated downstream and used in the digger log structure wing deflectors.

Figure 106. Before remediation activities.

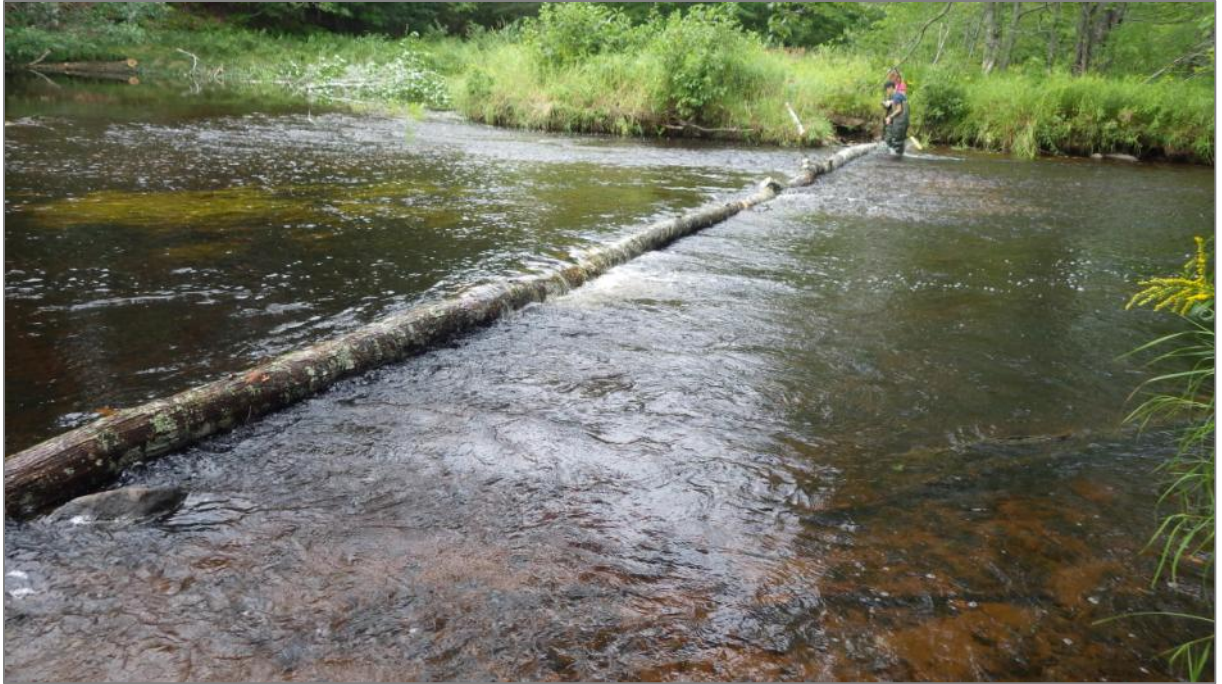
Figure 113. After, digger logs in place.

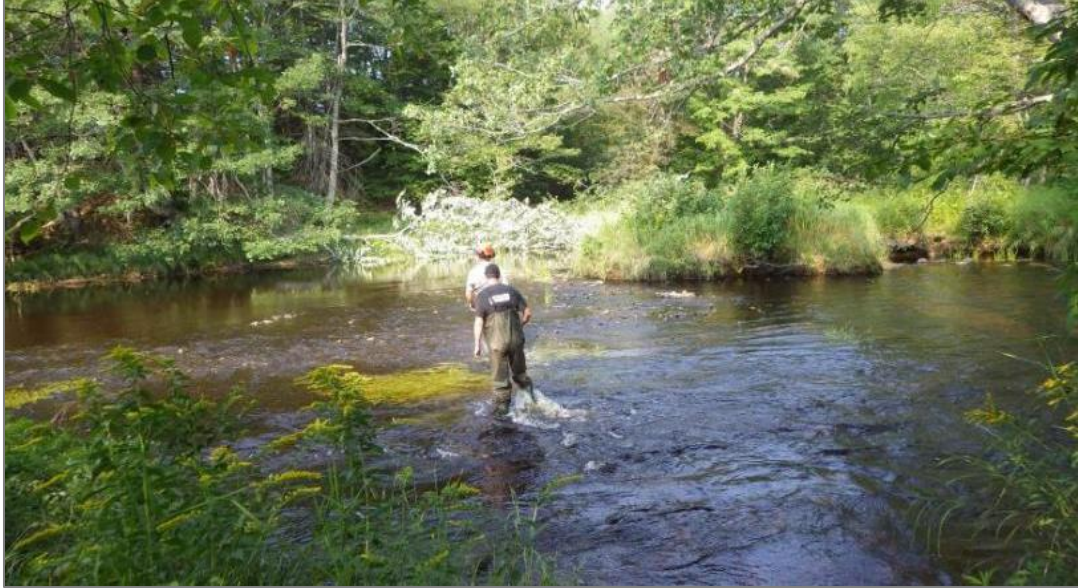
Left and right wing deflectors were installed along with the double digger logs. A full wing deflector was installed on the right bank (both upstream and downstream), while the left wing deflector had a structure installed on only the upstream side of the digger log. The one on the left bank, made with a pyramidal arrangement of three logs (two on bottom one on top), was backfilled with rocks found nearby on the river bottom. The right deflector upstream of the digger log was also pyramidal, backfilled with medium and large woody debris cut up from nearby dead trees and left over wood from the trees cut for the weirs and digger logs. The downstream deflector weir was made from one large log and backfilled with woody debris as well. Both the upstream and downstream parts of the right deflector had large branches from cut trees attached to them and which were staked into the riverbank to allow them to better absorb the energy from high flow events. Figures 118 to 125 show the digger log wing deflector installations.

Figure 118. Before digger log and wing deflector installation, upstream view.

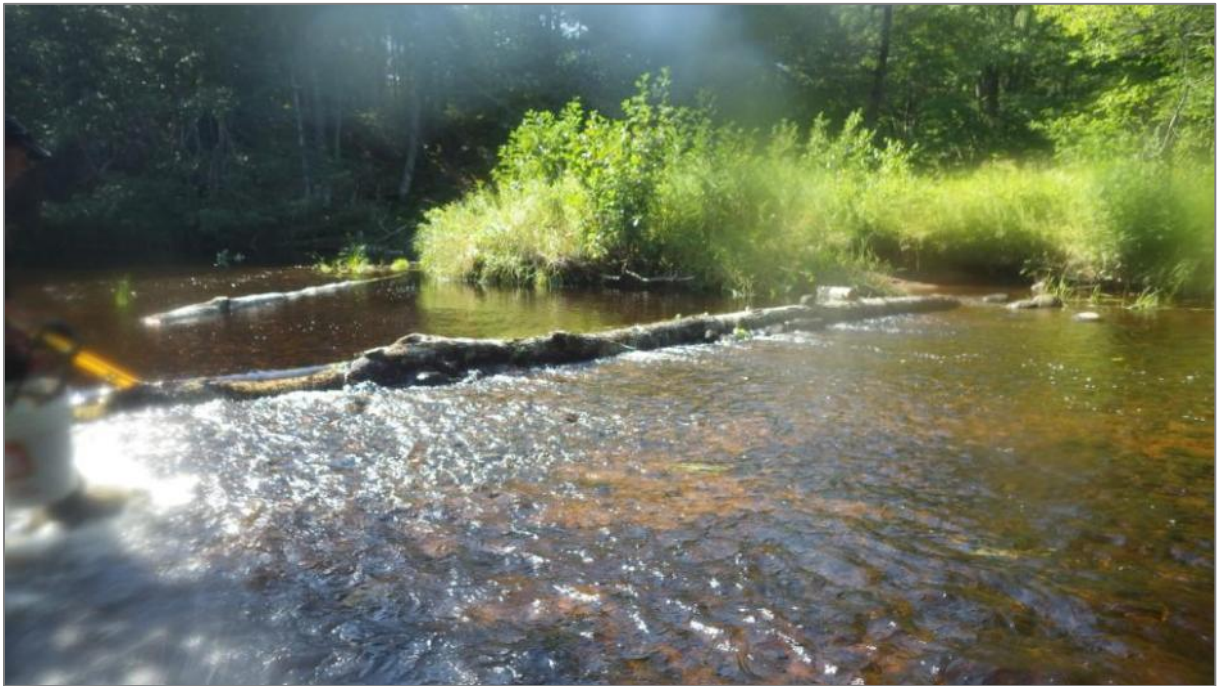
Figure 123. Left bank before installation of wing deflector.
