# Fish Passage Restoration and Habitat Enhancement

*A project to address fish habitat restoration and  
enhancement in the Annapolis River watershed*

Hayley Purcell Doyle, Fisheries Technician  
December 2018

**Clean Annapolis River Project**

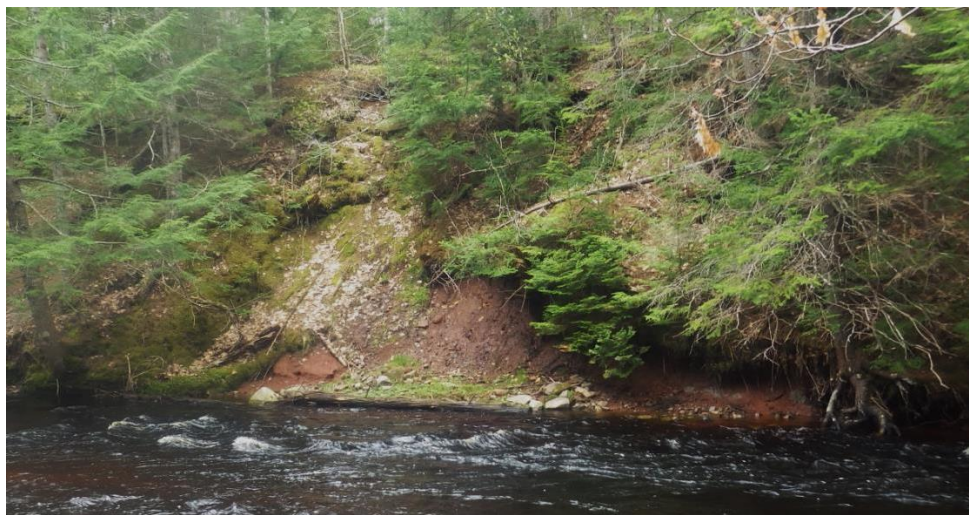
**Figure 1.** Eroding bank on the Fales River.

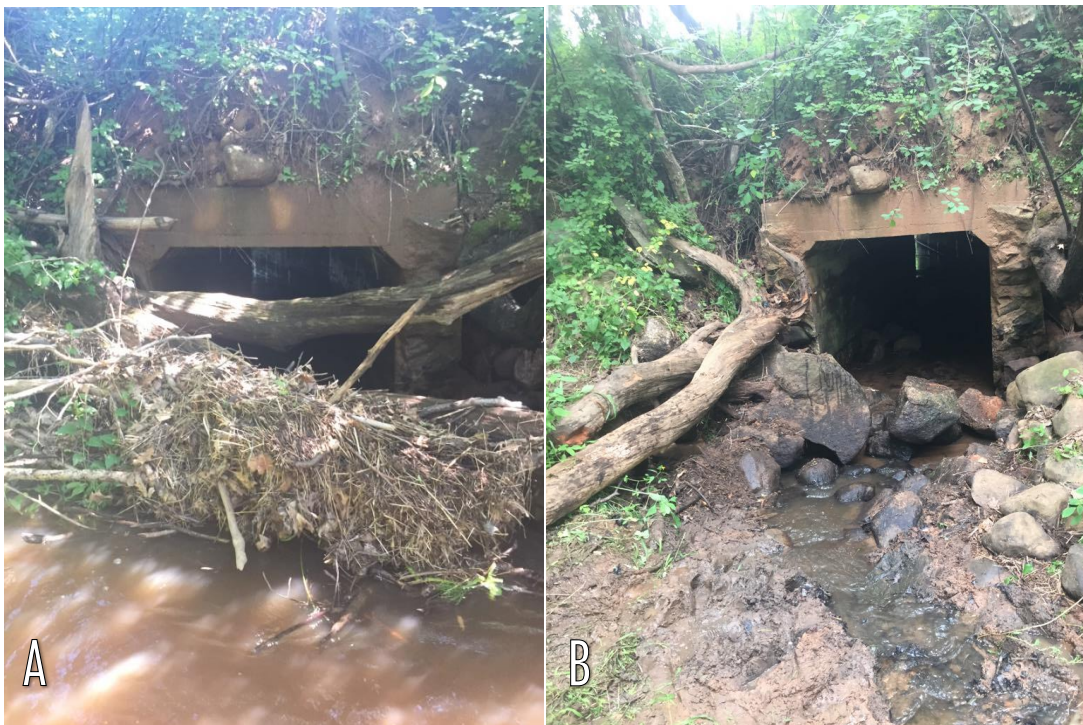
### **3.2.1 BAT001**

**Outflow Drop:** 19.0 cm

**Comments:** BAT001 is the first crossing of Bath Brook, a tributary to the Annapolis River with a main stem that runs 4.34 km long. Due to its location and close proximity to the main stem of the Annapolis River, this concrete, box culvert received an immediate debris removal. During its assessment in 2018, it was suspected that an inactive beaver dam and erosion of the bank surrounding the culvert was the source of the blockage (Figure 7). Staff removed the woody debris of the blockage to open up the inflow. Large boulders could not be removed for a full debris removal and therefore additional debris removals will be necessary over the following years.

**Figure 7.** BAT001 before (A) and after (B) debris removal.

**Remediation:** Debris removal

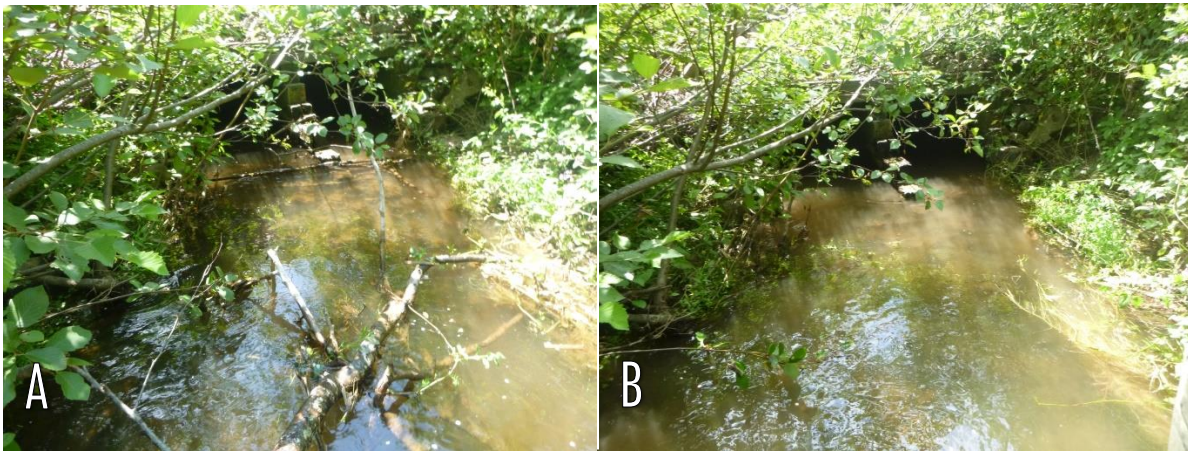
### 3.2.2 FRA001

**Comments:** FRA001 is the first crossing of the 5.06 km long Fraser Brook. This double, wooden box culvert was blocked across the inflow with woody debris (Figure 8). Upstream of the culvert also contained small logs that were removed to prevent future blockages. Similar to BAT001, this culvert was a high priority debris removal because of its location and close proximity to the main stem of the Annapolis River as well as its large upstream habitat gain. Although not severe, the removal of this debris blockage will ensure all sizes of migrating fish species, including Atlantic salmon and brook trout, can pass freely.

**Figure 8.** FRA001 before (A) and after (B) debris removal.

**Remediation:** Debris removal

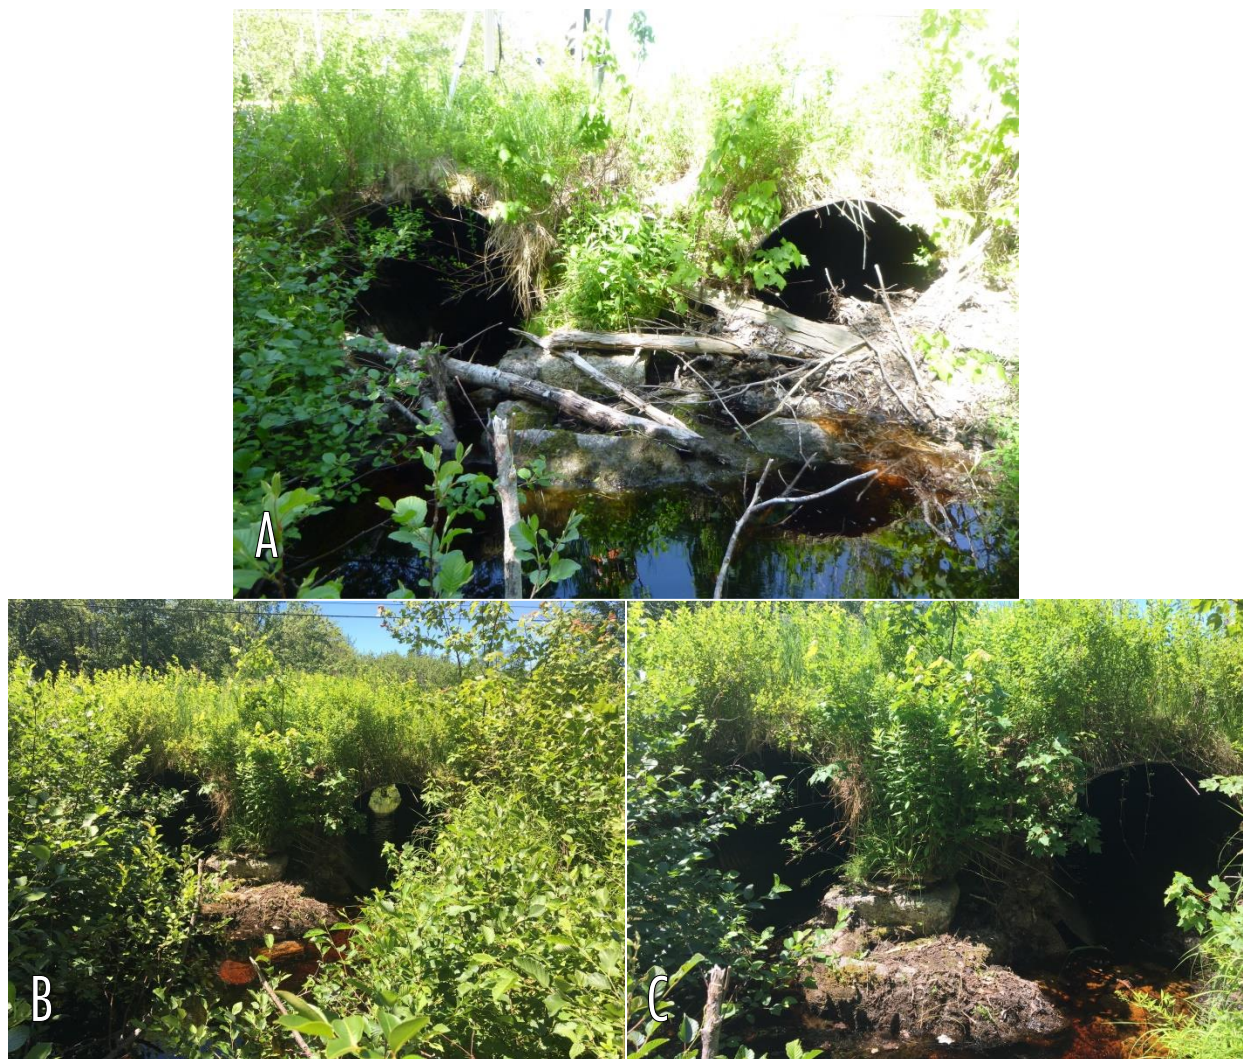
### 3.2.3 HRR004

**Comments:** HRR004 is the fourth upstream crossing of Harris Brook. This double, corrugated, metal pipe culvert had a significant debris blockage of rock and woody debris (Figure 9). Due to the significant upstream habitat gain of over 6 km, this culvert was a high priority for a debris removal. Although no fish were seen on site during the 2018 assessment and debris removal, a local property owner often fishes for an [unknown] trout species in the Harris Brook. Staff removed debris from the largely canopied culvert (Figure 9B) using a variety of equipment. The debris was disposed of off-site where it was not likely to fall back into the brook to allow the culvert to remain free for fish passage.

**Figure 9.** HRR004 before (A) and after (B)(C) debris removal

**Remediation:** Debris Removal

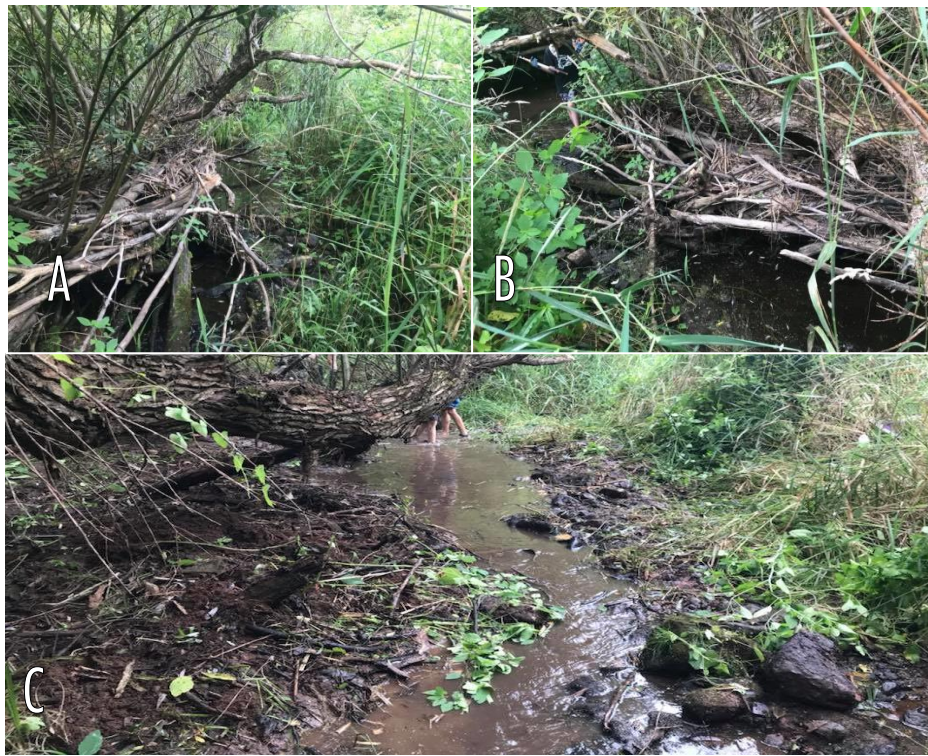
### 3.2.4 MCG009

**Comments:** MCG009 is a large, concrete culvert that was newly installed in 2012. Found along the McGee Brook, with a main stem that runs approximately 6.86 km long, this natural bottom culvert is located downstream of a large pond. There was no debris blockage directly at the inflow, but fallen trees and debris upstream was impeding fish passage to the 6.86 km of habitat beyond the culvert (Figure 10). Staff and volunteers removed the blockages allowing for free flowing water to reach the culvert and therefore increasing connectivity to the rest of the brook (Figure 11).

**Figure 10.** MCG009 before (A)(B) and after (C) debris removal.

**Remediation:** Debris removal

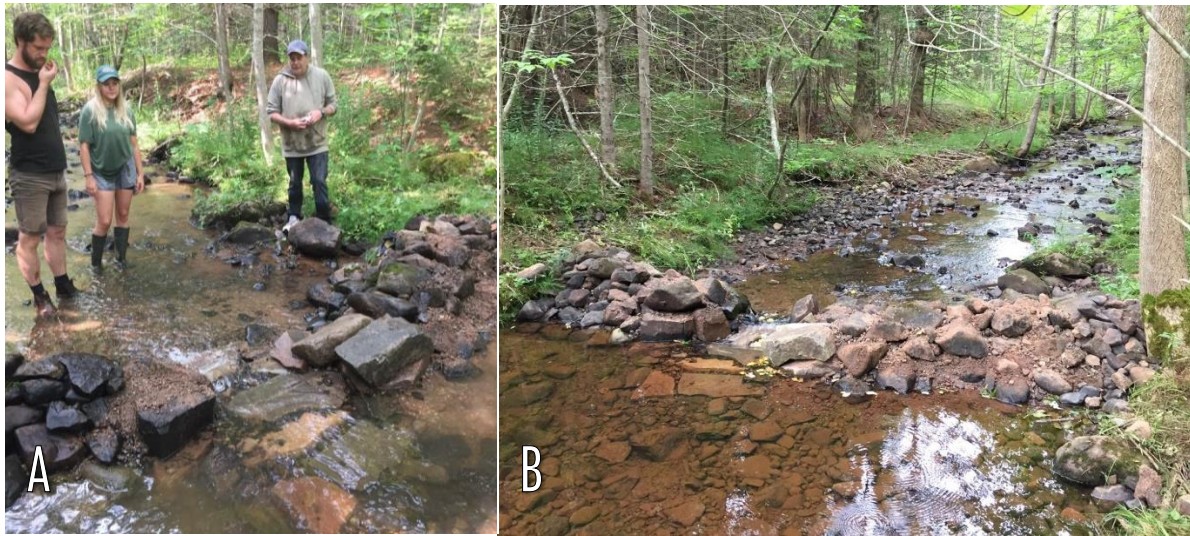
### **3.2.5 MOR008**

**Comments:** MOR008 is a wooden, box culvert on Morton Brook. Having received restoration activities in 2017, the fish chute that had been installed along with its attached baffles had blown-out through the winter. Staff remediated the fish chute and affixed it to the culvert using longer, galvanized lag screws. A second vortex rock weir was also constructed during the 2018 field season downstream from the first weir (Figure 12). This weir will help to raise the water levels through the culvert and improve upon the fish passage established in previous years. The structure was reinforced with large boulders and upstream sediments were used to help seal the weir during the construction phase. The addition of the second rock weir decreased the outflow drop to 3 cm from the original 24.4 cm before any restoration work. Upon completion of the 2018 field season, the MOR008 site has 3 functioning culvert restoration structures to assist with fish passage (Figure 13).

Figure 12. CARP staff constructing the MOR008 weir and the completed structure (B).

**Remediation:** Vortex rock weir, reinstallation of fish chute

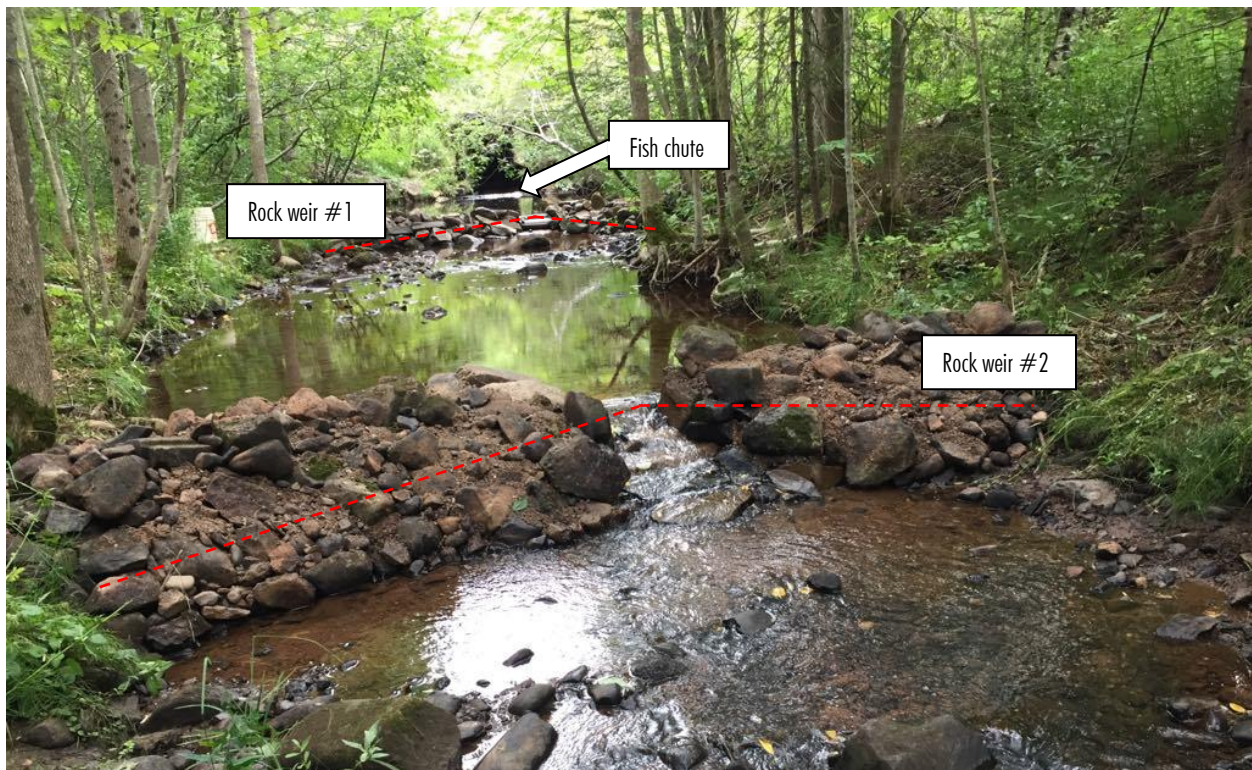
Figure 13. All current and working structures of the MOR008 site installed by CARP.

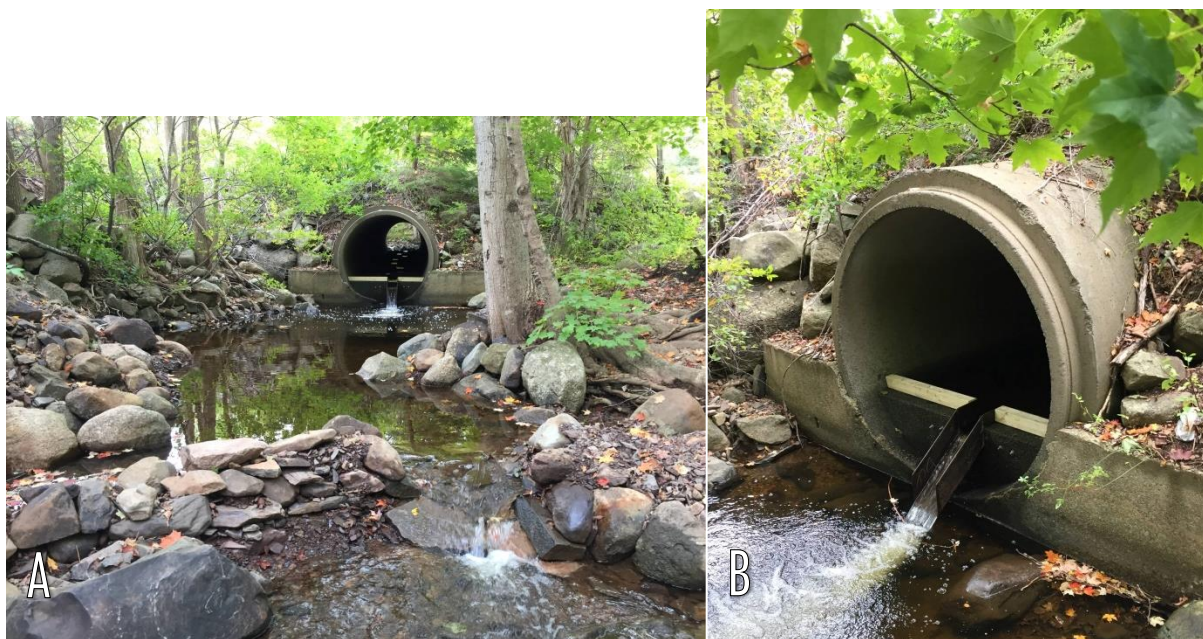
### 3.2.6 PET002

**Comments:** PET002 is a concrete, circular culvert with pre-fabricated concrete baffles located on Pete's Brook. The outflow pool houses many brook trout making this culvert a priority for remediation actions to assist these fish with migration. CARP staff installed two vortex rock weirs during the 2017 field season. Upon inspection in 2018, the first of the two weirs had completely blown out from the high flow events over the fall and winter seasons. A complete reconstruction of the rock weir was completed in the 2018 season using larger, heavier rock found on site (Figure 14A). The weir was also moved back approximately 1 m for better positioning to be bolstered to the bank and ensure no water was escaping around the weir. Large boulders were placed behind the walls of the weir for extra support. The fish chute that was acquired in 2017 was also installed (Figure 14B). It was affixed to the concrete using expanding bolts with additional 4x4 cedar posts installed on top of the concrete baffles for extra support. Upon completion of the 2018 field season, the MOR008 site has 3 functioning culvert restoration structures to assist with fish passage (Figure 15).

**Figure 14.** Reconstructed weir (A) and newly installed fish chute (B) at PET002.

**Remediation:** Installation of fish chute, remediation of vortex rock weir

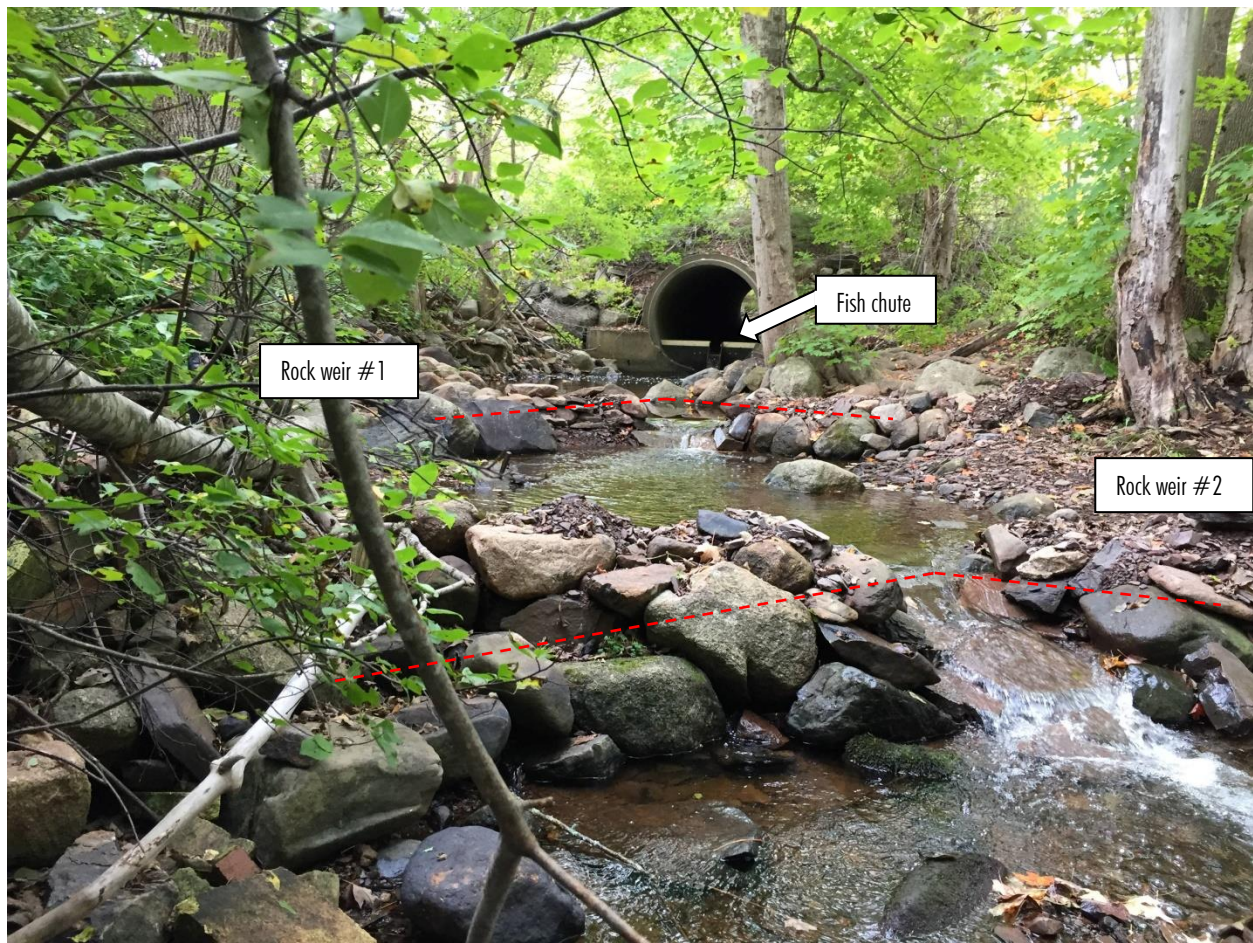
**Figure 15.** All current and working structures at the PET002 site installed by CARP.

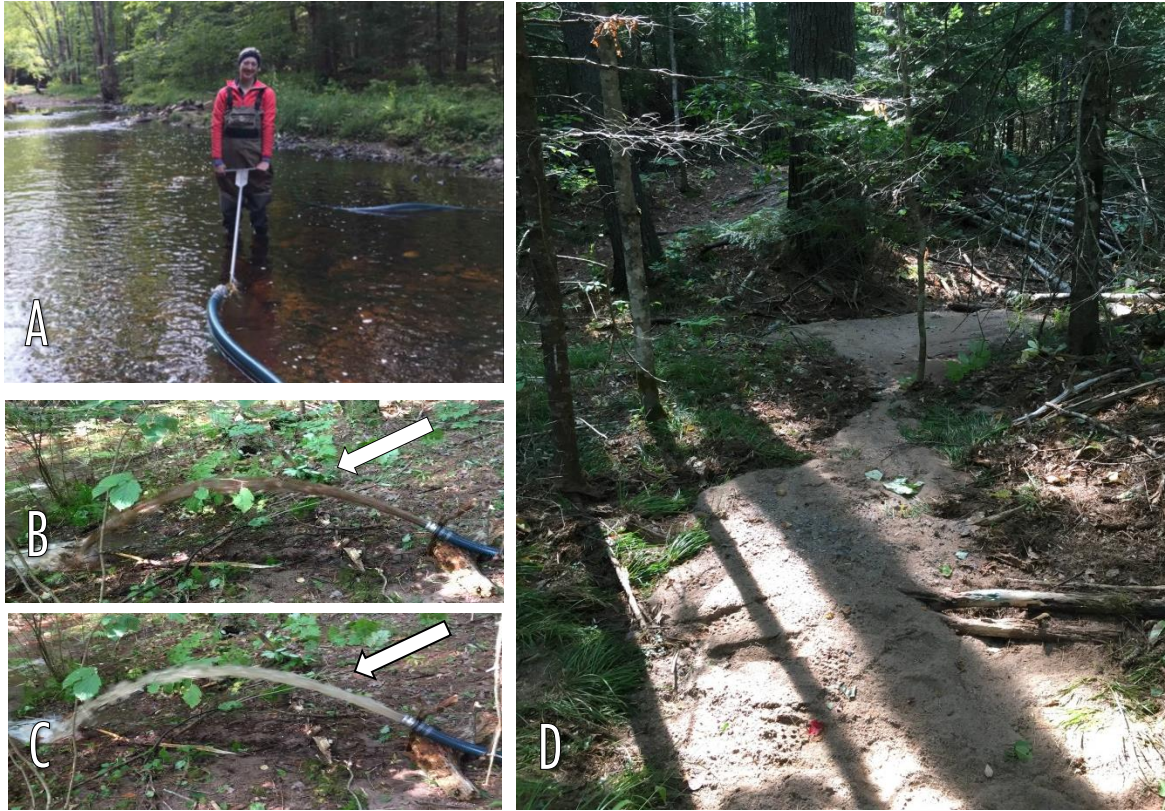
**Figure 17.** SandWandering activities performed on the Fales River resulting in the removal of a large amount of fine sediments

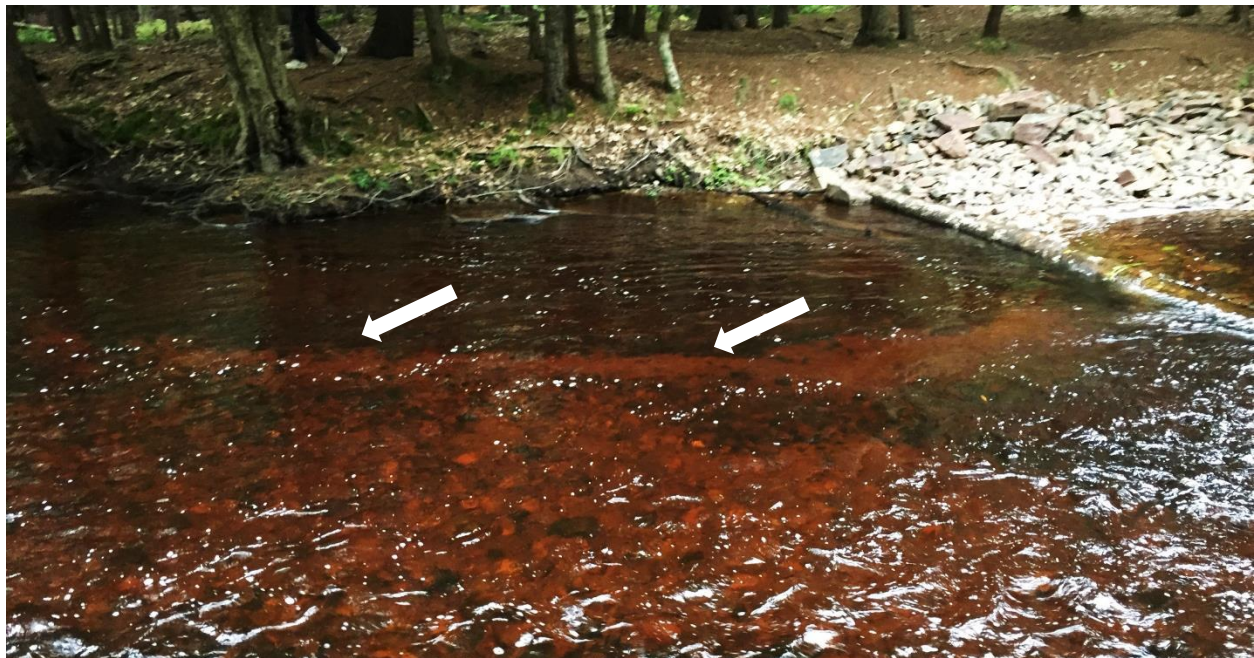
**Figure 18.** The visual success of SandWanding and the removal of fine sediments.

Immediate benefits of fine sediment removal were visually observed after the use of the SandWand (Figure 18). Once removed, the fine sediments were deposited off site. It is likely that the observed changes in criteria can be attributed to the SandWand treatment because comparable changes did not occur in the control site. By targeting restoration activities to key areas of habitat, conditions in available spawning areas have been improved for the use of salmonid species. However, the results only show a snapshot of impacts to the physical habitat, and whether the treatment will have long term benefits is unknown. The changes to embeddedness and sediment transport as a result of the fine sediment removal via SandWanding may be altered or regressed from seasonal high flows and therefore, the site will need to be reassessed during the following field season to document the long term impacts of restoration activities.
