Fish Passage Restoration and Habitat Enhancement

*Anadromous fish passage assessment and remediation
in the Annapolis and Cornwallis River Watersheds*

Rachel Walsh
March 2024

Clean Annapolis River Project

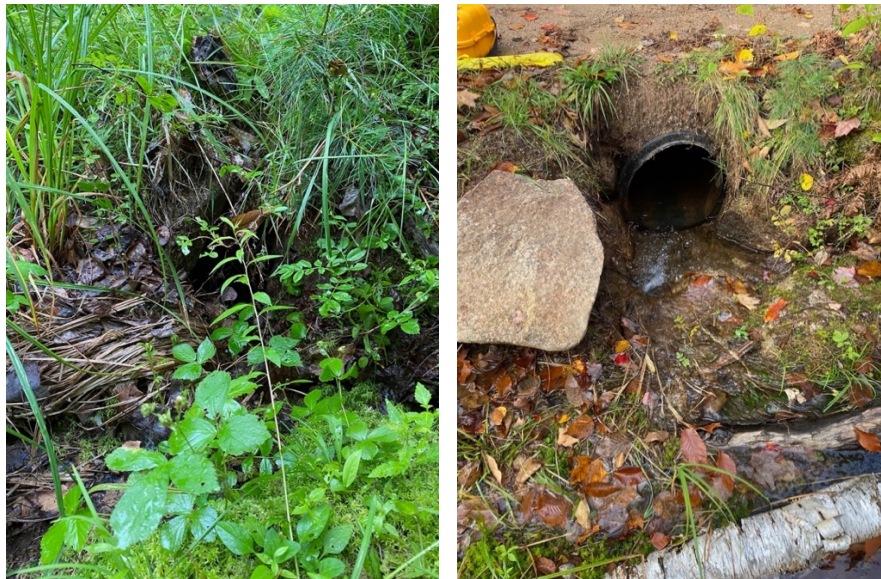
Comments: PAR006, situated along a tributary to Paradise Brook within the Roxbury Brook sub-watershed, was a corrugated plastic culvert. The culvert faced significant obstruction caused by debris and organic matter. As a result, a debris removal was conducted at both the inflow and outflow of the culvert in the summer of 2022.

Figure 6. Before (left) and after (right) the culvert inflow debris removal.

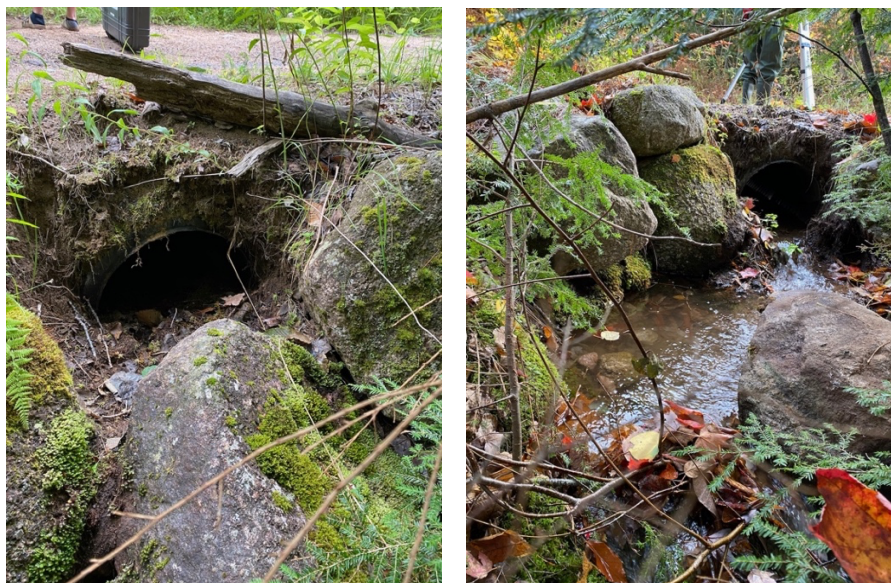
Figure 7. Before (left) and after (right) of the culvert outflow debris removal.

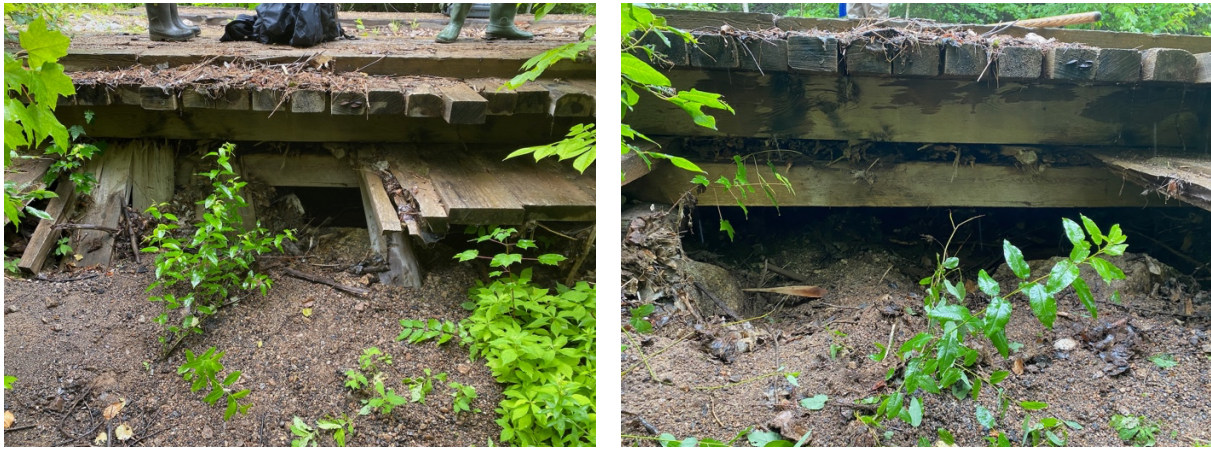
Comments: BIG002, positioned along Big Brook within the Roxbury Brook sub-watershed, was a bridge crossing. The bridge was constructed atop previously collapsed bridges, leading to the buildup of woody debris, leaf litter, and sediment at the structure's base. In the summer of 2022, a debris removal was carried out at BIG002. Subsequently, in October 2022, the site was revisited to confirm the absence of any new debris blockages.

Figure 8. BIG002 before (left) and after (right) debris removal.

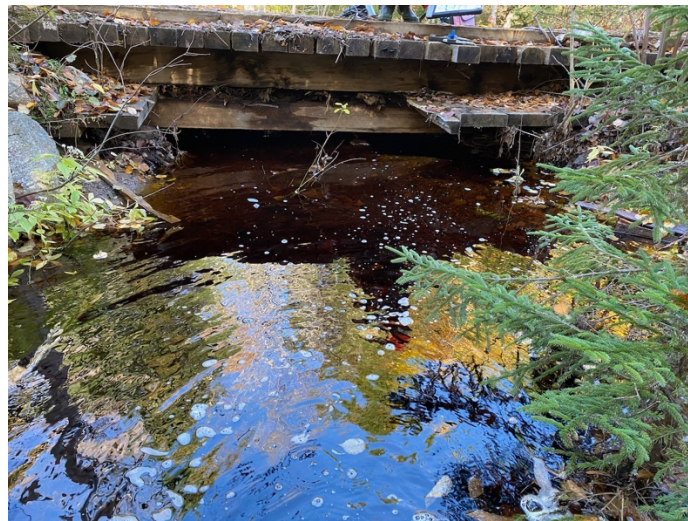
Figure 9. BIG002 upon revisiting the site in October 2022.

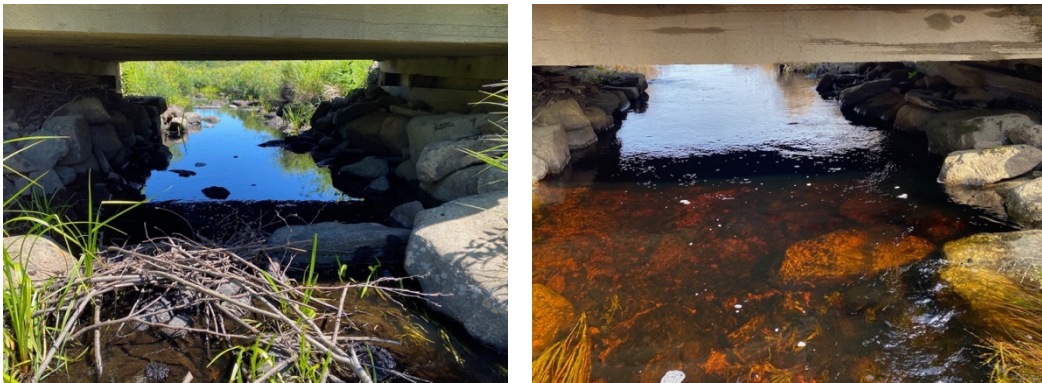
Comments: NEW001, located on Newcombe Brook within the Black River sub-watershed, functioned as a bridge crossing. Downstream of the structure, an accumulation of sticks and woody debris caused a blockage. This obstruction was cleared during the summer of 2022, restoring access to 3.5 km of upstream habitat. However, upon revisiting the site the following summer, an active beaver dam was noticed downstream of the bridge. Since the dam was active, it was left undisturbed.

Figure 10. NEW001 before (left) and after (right) debris removal.

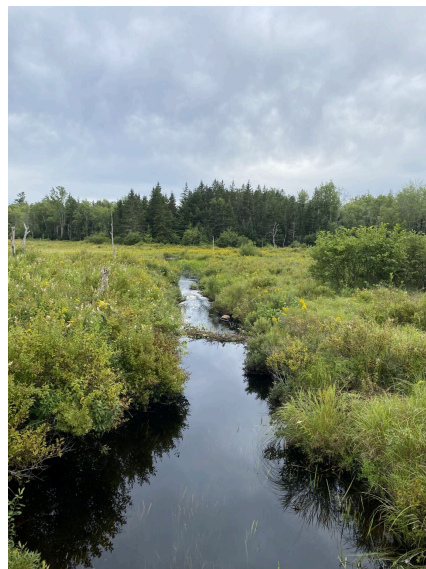
Figure 11. Active beaver dam downstream of NEW001.

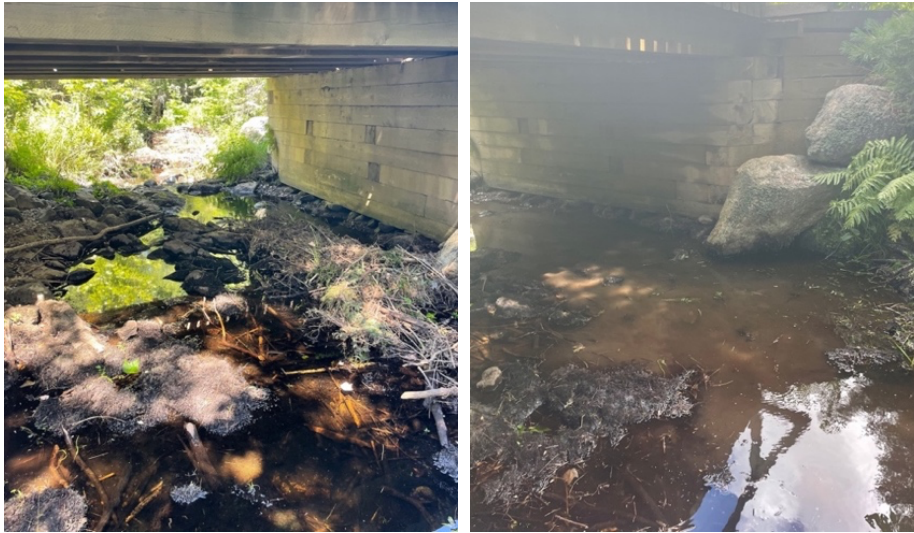
Comments: MAR001 was a bridge crossing located within the Cloud Lake Wilderness Area. Leaf litter, woody debris, and sediment had accumulated underneath the structure. Upon the removal of the debris, access to 0.92 km of upstream habitat was restored. Upon returning to the site the next summer, an active beaver dam was spotted upstream of the bridge. As the dam was still in use, no action was taken.

Figure 12. MAR001 before (left) and after (right) debris removal.

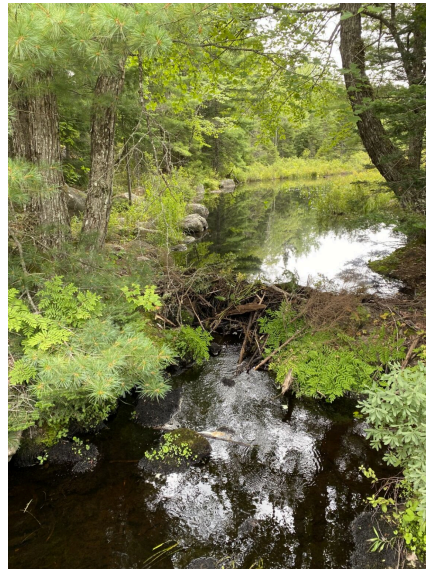
Figure 13. Active beaver dam downstream of MAR001.

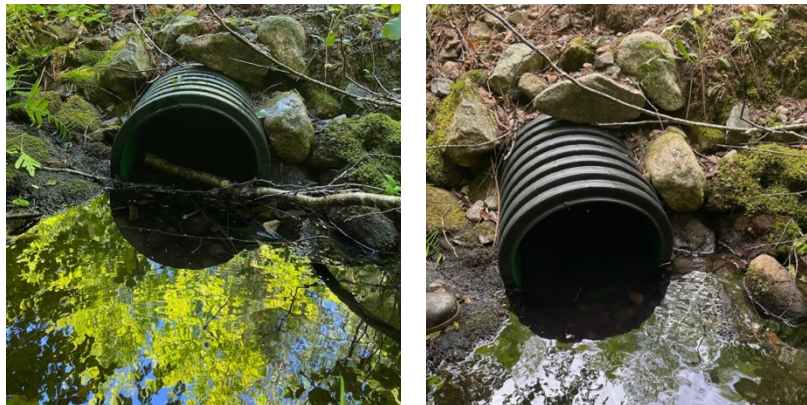
Comments: FAL013 was a corrugated plastic culvert located within the Fales River sub-watershed. Woody debris had accumulated at the inflow as well as inside of the culvert. The debris blockage was removed during the summer of 2022, restoring access to 1.6 km of upstream habitat.

Figure 14. FAL013 before (left) and after (right) debris removal.

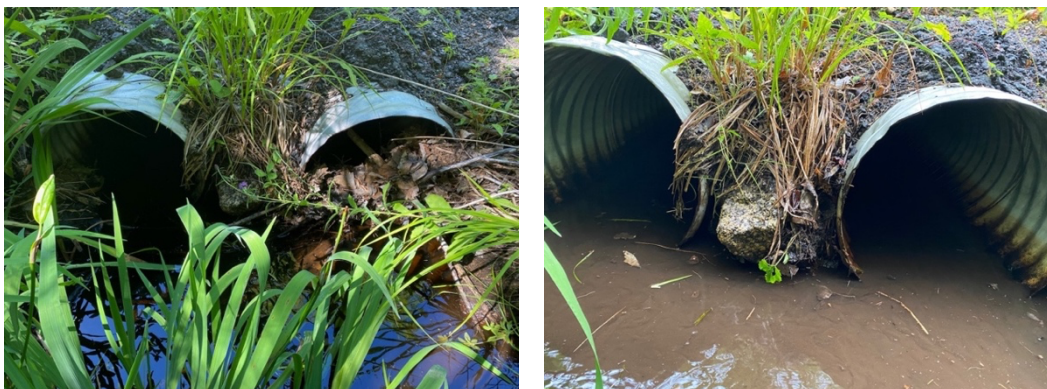
Comments: RHR064 consisted of two corrugated metal culverts positioned in the Round Hill River sub-watershed. The right side of the culverts' inflow was obstructed by a buildup of debris. Clearance of the debris enabled the restoration of access to 0.93 km of upstream habitat.

Figure 15. RHR064 before (left) and after (right) debris removal.

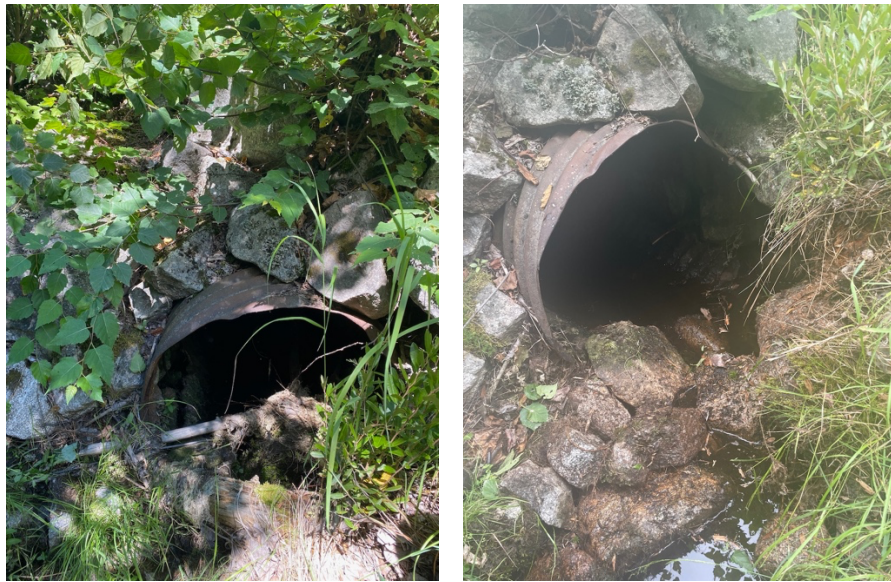
Comments: CLO001, positioned within the Cloud Lake Wilderness Area, served as a corrugated metal culvert crossing. The inflow of the culvert was obstructed by woody debris and leaf litter, hindering fish passage. Upon removal of the debris blockage, access to 5.1 km of upstream habitat was restored. A follow-up visit to the crossing in October 2022 confirmed the absence of any additional debris accumulation.

Figure 16. CLO001 before (left) and after (right) debris removal.

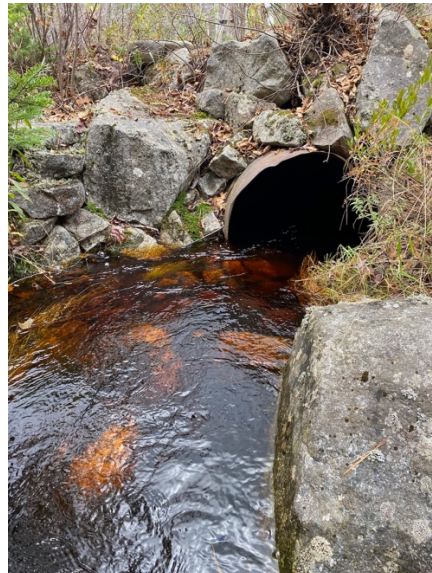
Figure 17. CLO001 upon revisiting the site in October 2022.

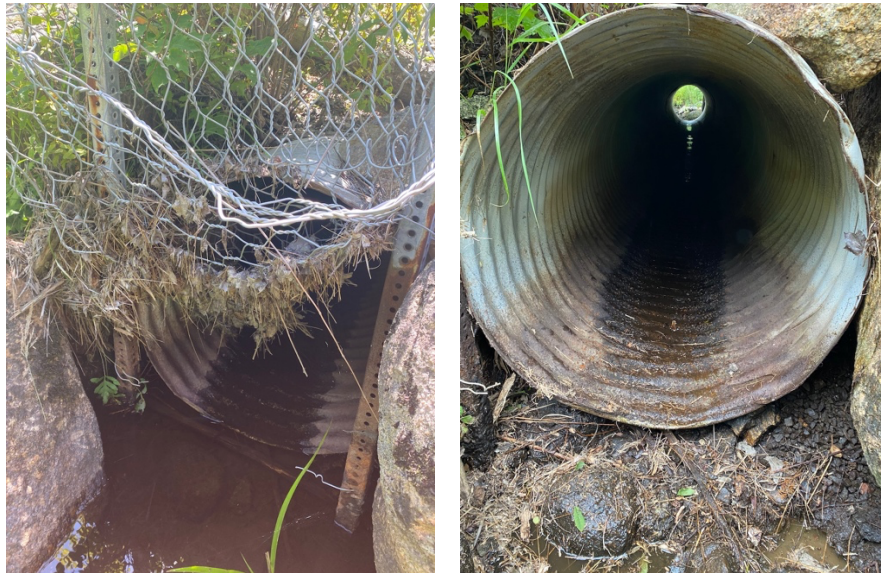
Comments: RHR061, situated in the Round Hill River sub-watershed, functioned as a culvert equipped with a metal grate designed to prevent debris from obstructing the culvert interior. However, the grate was prone to accumulating debris during periods of high-water flow (see Figure 19). To address this issue, both the grate and any remaining debris were removed during the summer of 2022.

Figure 18. RHR061 before (left) and after (right) debris removal.

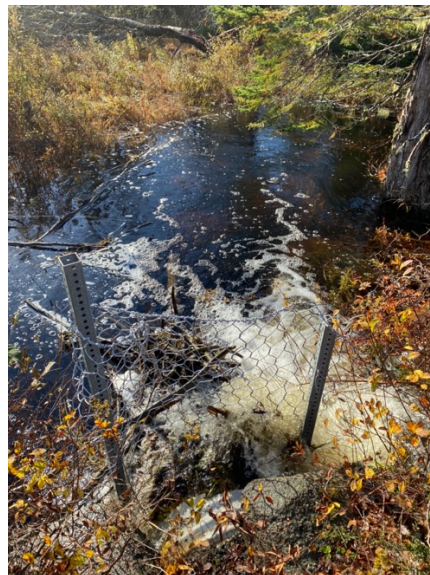
Figure 19. Culvert grate blocked with debris.

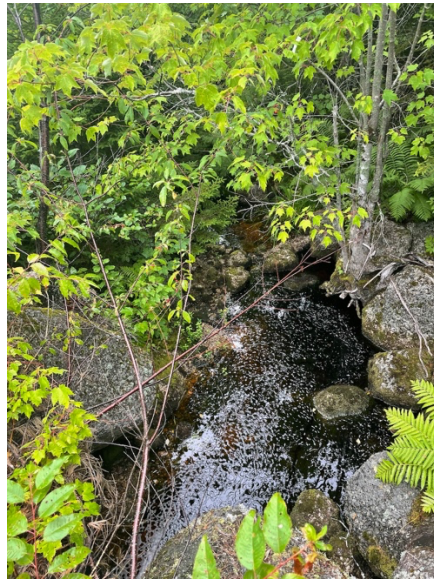
Comments: At JOU001, a tailwater control weir was built to elevate the water level in the culvert's outflow pool, aiming to decrease or eliminate an outflow drop of 19.5 cm. Following specific vortex rock weir formulas, the weir was meticulously constructed by manually relocating rocks collected from the site.

Figure 20. JOU001 before rock weir construction.

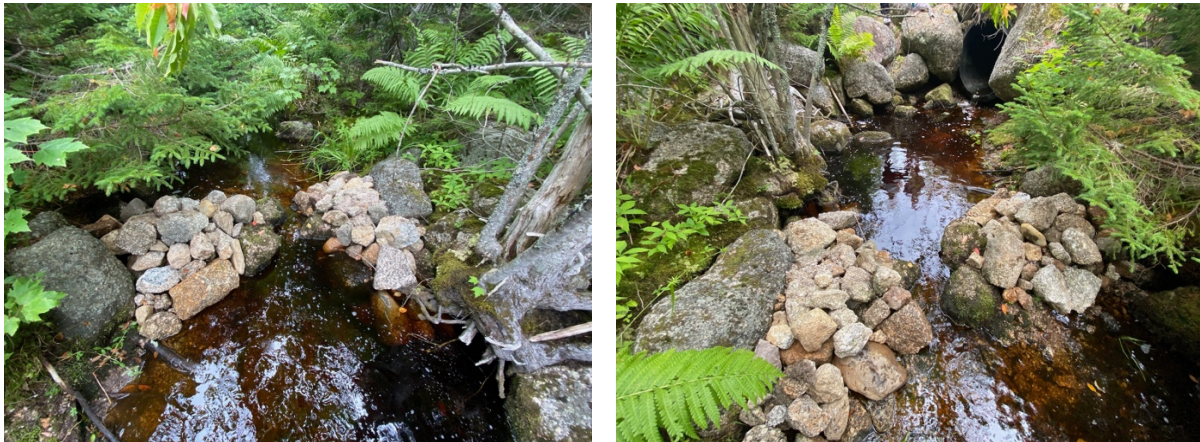
Figure 21. Rock weir built on Joudrey Brook.

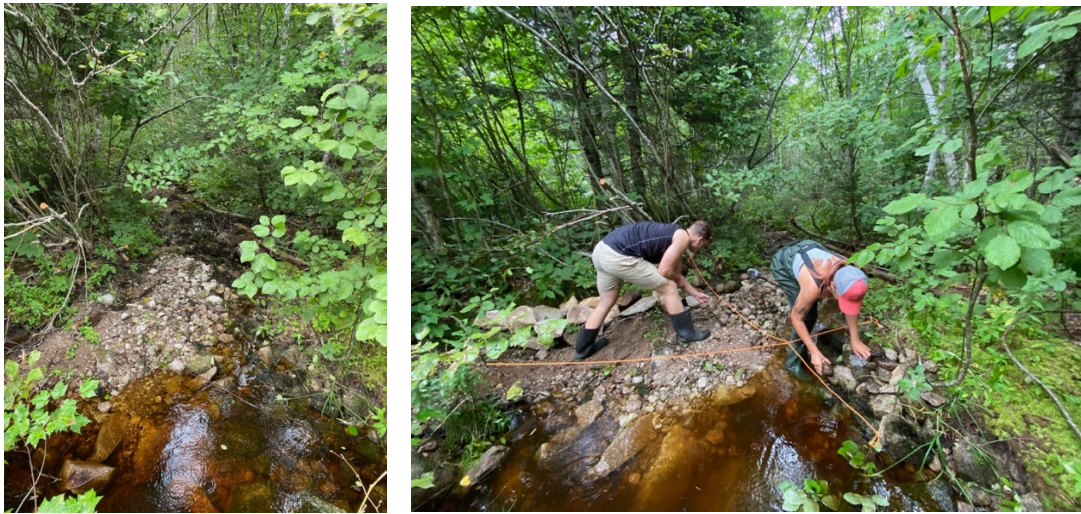
Comments: At EAL001, a tailwater control weir was built to elevate the water level in the culvert's outflow pool, aiming to decrease or eliminate an outflow drop of 13.5 cm. Following specific vortex rock weir formulas, the weir was meticulously constructed by manually relocating rocks collected from the site.

Figure 22. EAL001 before rock weir construction.

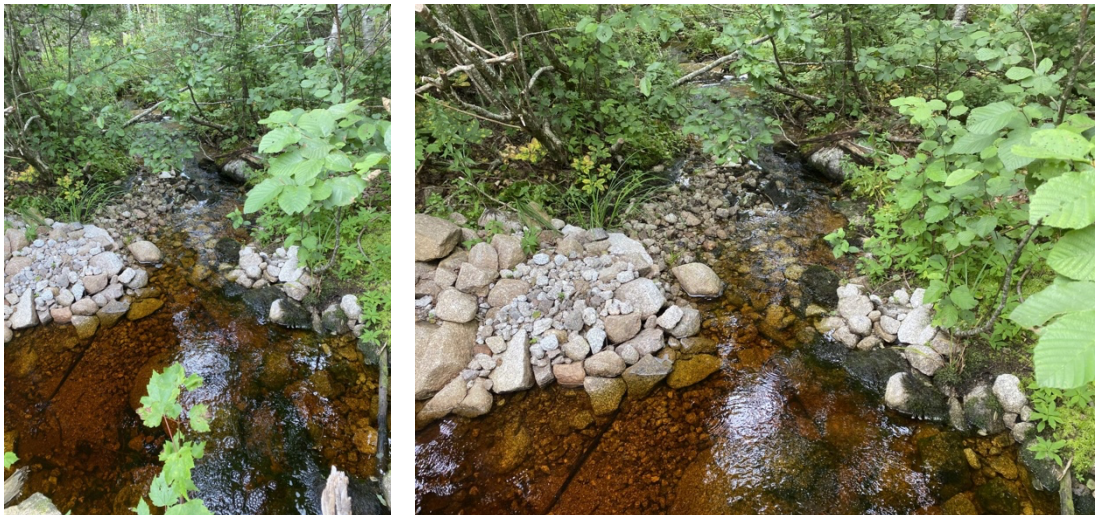
Figure 23. Rock weir built at EAL001.

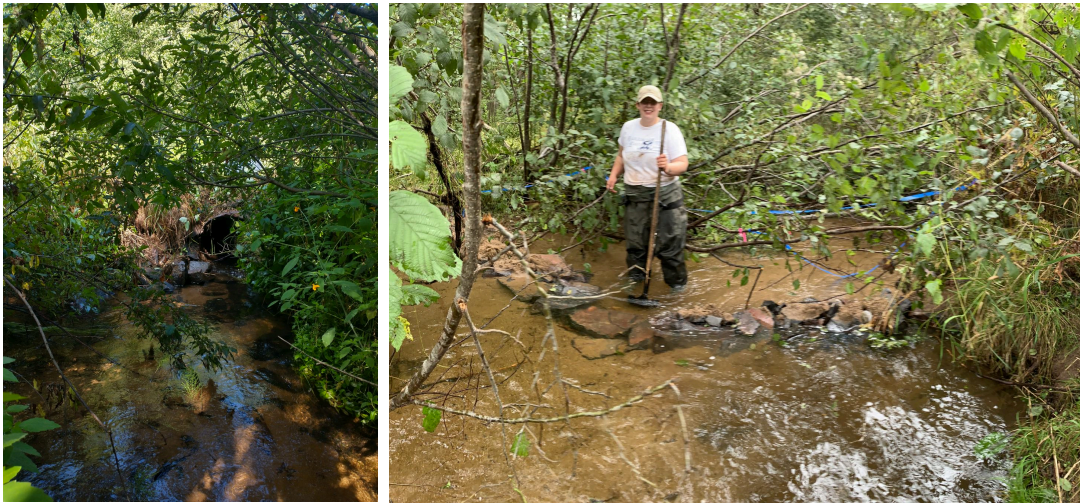
Comments: At RFB001, a tailwater control weir was constructed by JWA to elevate the water level in the culvert's outflow pool, aiming to decrease or even eliminate an outflow drop of 11 cm. Following specific vortex rock weir formulas, the weir was meticulously constructed by manually relocating rocks delivered to the site. However, upon revisiting RFB001 the following summer, it was observed that the weir did not remain intact and required additional rock to rebuild it properly.

Figure 24. RFB001 before (left) and during (right) rock weir installation.

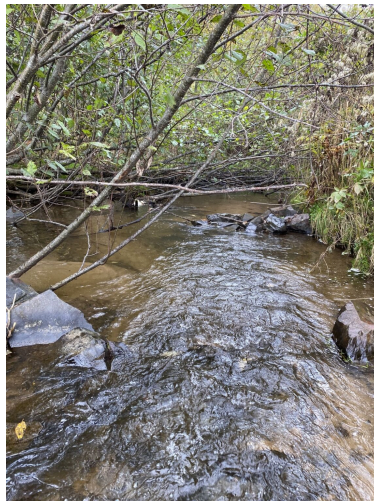
Figure 25. The rock weir at RFB001 no longer intact.

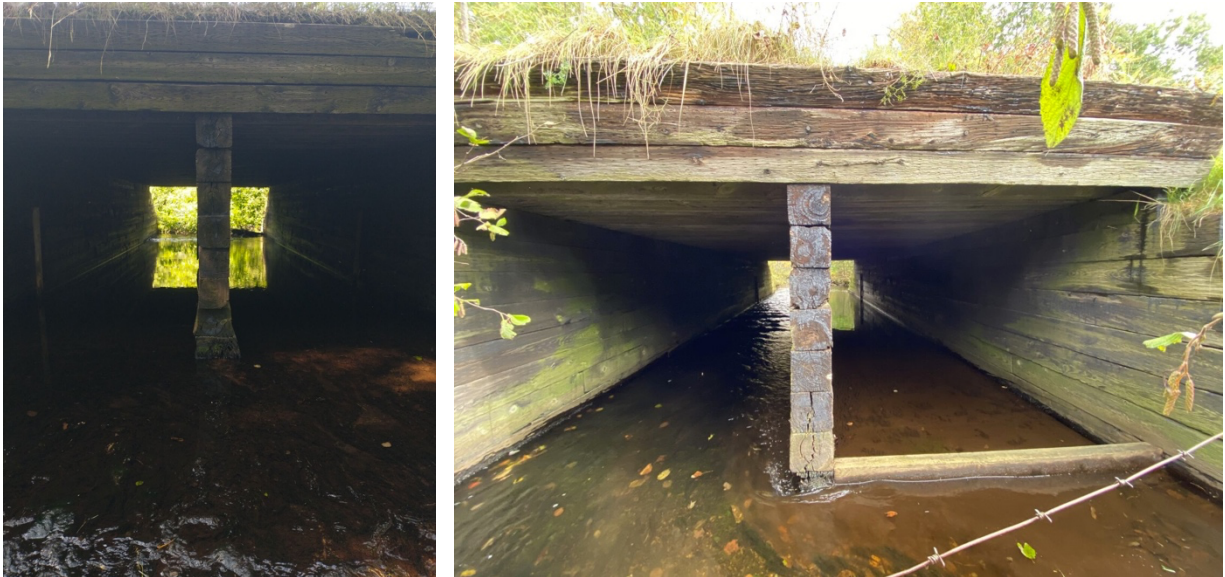
Comments: A low-flow barrier was installed by JWA at SHB005 to redirect water into one side of a double box culvert. The barrier was made out of untreated 4x4 lumber and installed using various hand tools.

Figure 26. SHB005 before (left) and after (right) the low-flow barrier installation.

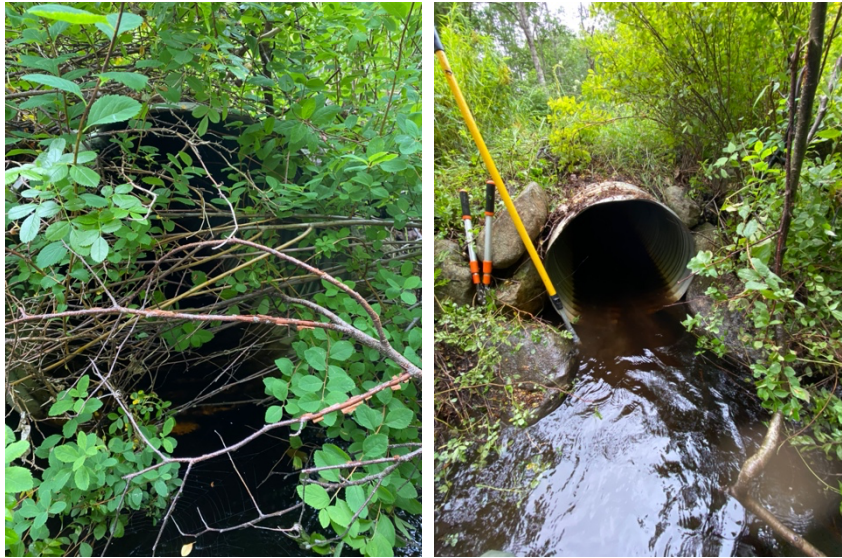
Comments: EAS009 was a corrugated metal culvert positioned along the East Moose River. In 2015, a fish chute and tailwater control structure were installed at this location. Maintenance work on the tailwater control structure and a debris removal were conducted in the summer of 2023, restoring access to 0.56 km of upstream habitat.

Figure 27. EAS009 before (left) and after (right) the culvert inflow debris removal.

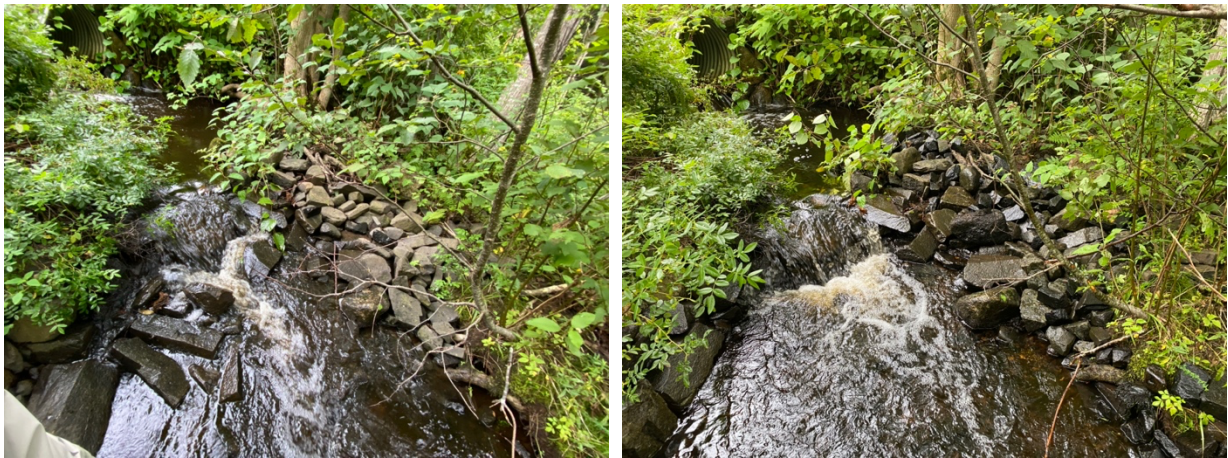
Figure 28. Before (left) and after (right) the tailwater control structure maintenance.

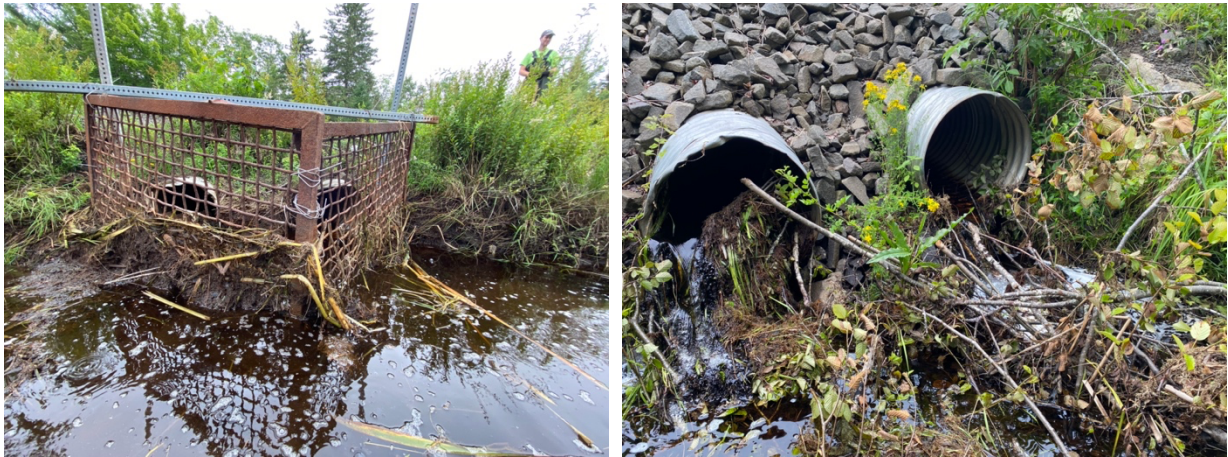
Comments: ALL017 consisted of a pair of corrugated metal culverts. In 2015, a fish chute and tailwater control structure were installed at the site. When the site was revisited in 2023, obstructions from debris were observed at the inflow and outflow of the culverts, resulting in flooding conditions upstream. A debris removal was undertaken to clear blockages from the culvert and accumulated debris downstream, restoring access to 0.26 km of upstream habitat.

Figure 29. ALL017 inflow (left) and outflow (right) blocked with debris.

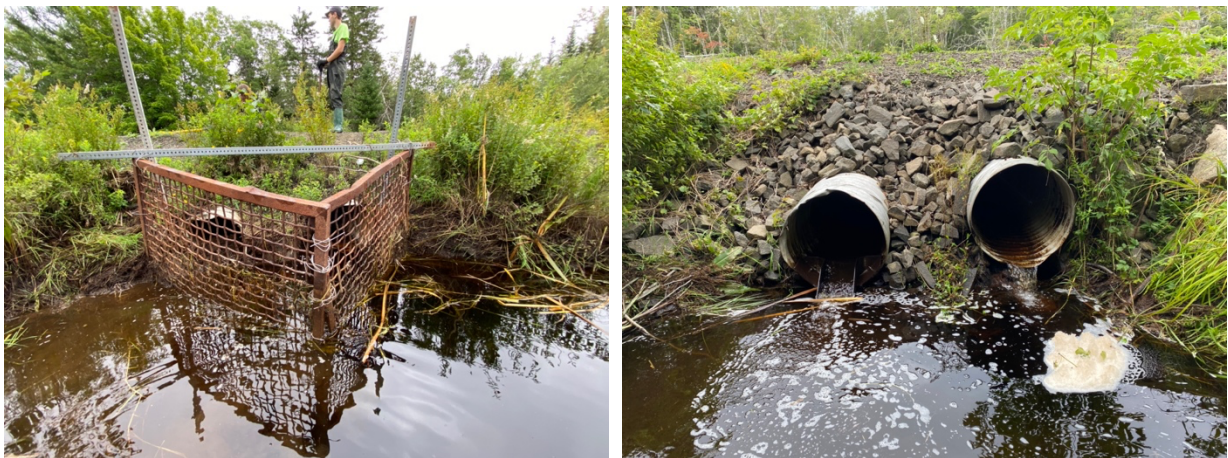
Figure 30. ALL017 inflow (left) and outflow (right) after the debris removal.

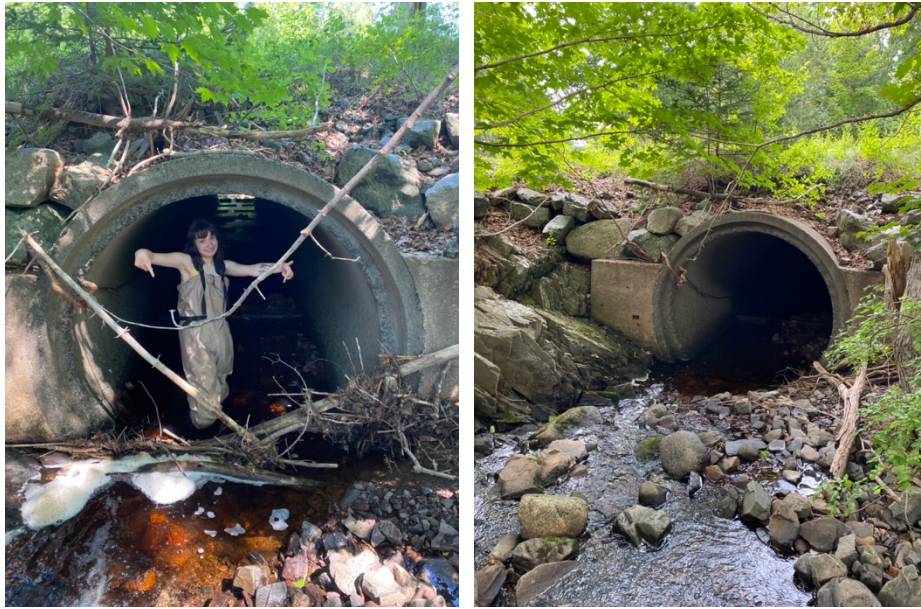
Comments: PET002 was a concrete culvert situated on Petes Brook. In 2018, CARP installed a fish chute and tailwater control structure at this location. Fortunately, those structures required no maintenance; however, there was an accumulation of sticks and woody debris observed at the culvert's inflow. A debris removal was conducted, restoring access to 2.22 km of upstream habitat.

Figure 31. PET002 before (left) and after (right) debris removal.

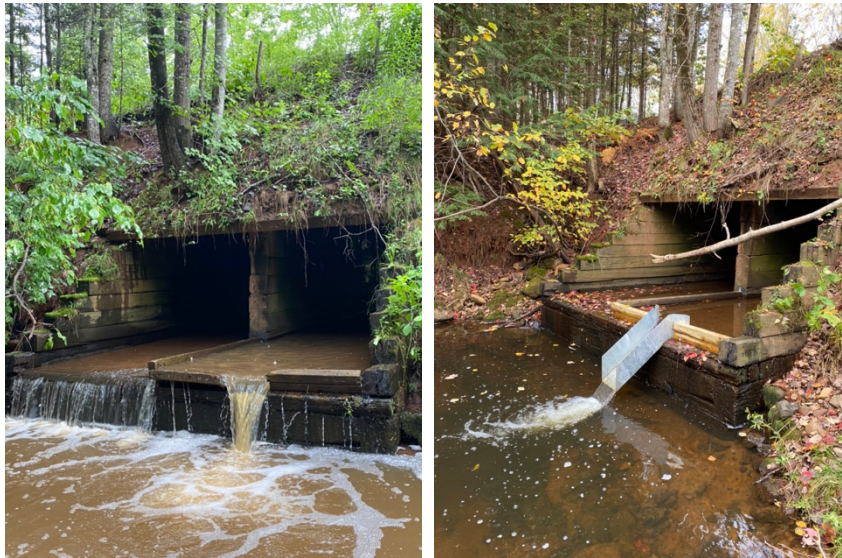
Comments: WAT004, located on Watton Brook, consisted of a double wooden box culvert. In 2016, several enhancements were made to the site, including the installation of baffles, a low-flow barrier, a fish chute, and a tailwater control structure. However, during the 2023 site revisit, it was discovered that the fish chute had detached from the culvert and couldn't be located. A replacement chute was ordered and successfully installed in September 2023 to rectify the culvert's excessive outflow drop of more than 50 cm.

Figure 32. WAT004 before (left) and after (right) the fish chute installation.

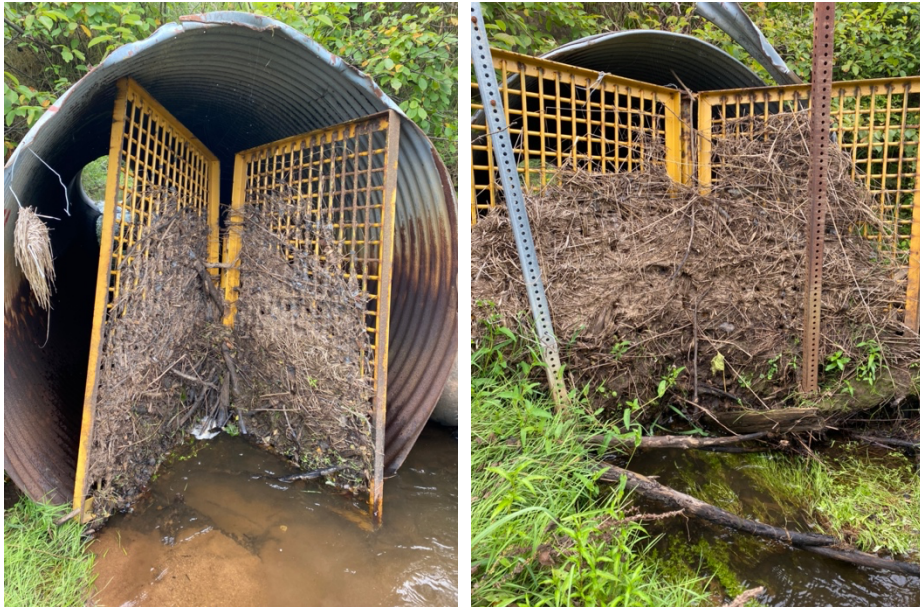
Comments: TRO010 was a pair of corrugated metal culverts located on Troop Brook. Woody debris and other organic matter had accumulated at the inflow gates of both culverts. The debris was removed during the summer of 2023, re-establishing access to 2.74 km of upstream habitat.

Figure 34. TRO010 inflow before the debris removal.

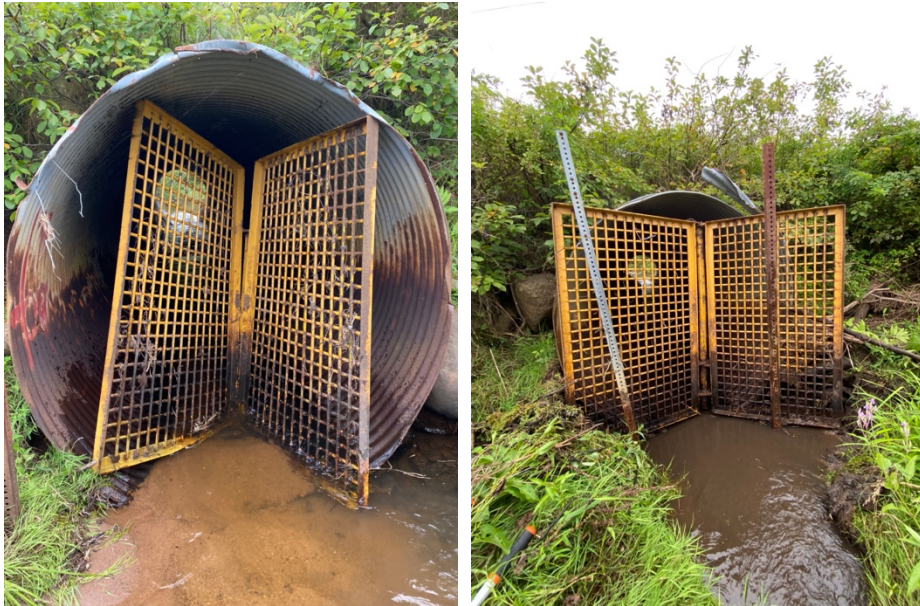
Figure 35. TRO010 inflow after the debris removal.

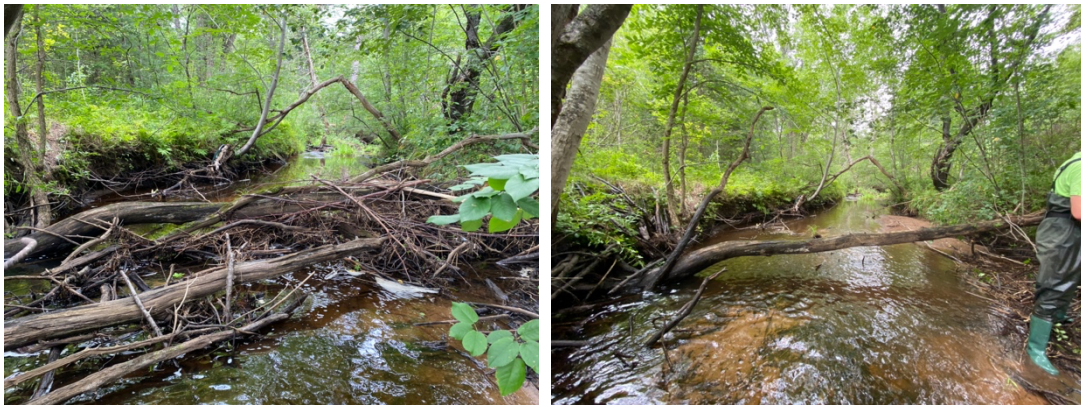
Comments: BLK004, located on the Black River, was a corrugated metal culvert. Downstream of the culvert, a significant accumulation of debris had formed, acting as a barrier to fish passage. The obstruction was successfully cleared, reopening access to 0.83 km of upstream habitat.

Figure 36. Downstream of BLK004 before (left) and after (right) debris removal.

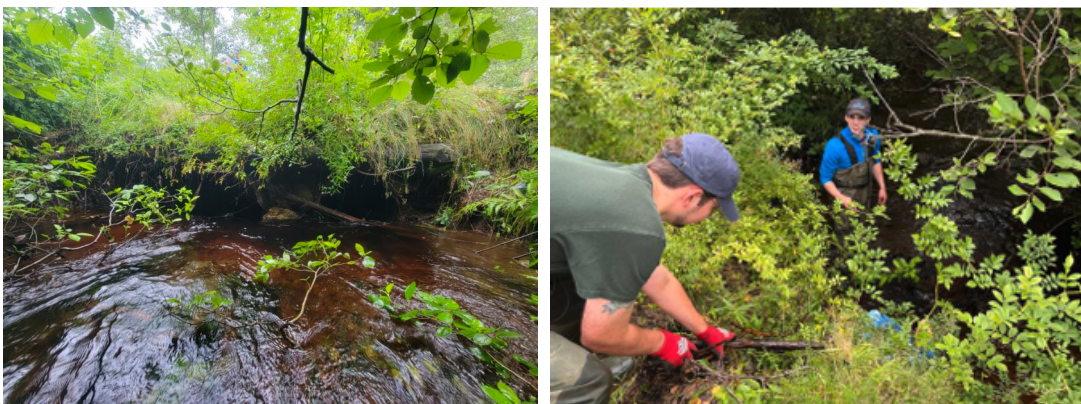
Comments: SHB006 was a set of 3 corrugated metal culverts along Sharpe Brook. Two out of the three culverts had severe accumulations of trash and woody debris, restricting water flow. A debris removal was conducted by the JWA field team, restoring access to 1.92 km of upstream habitat.

Figure 37. SHB006 before (left) and during (right) the debris removal.

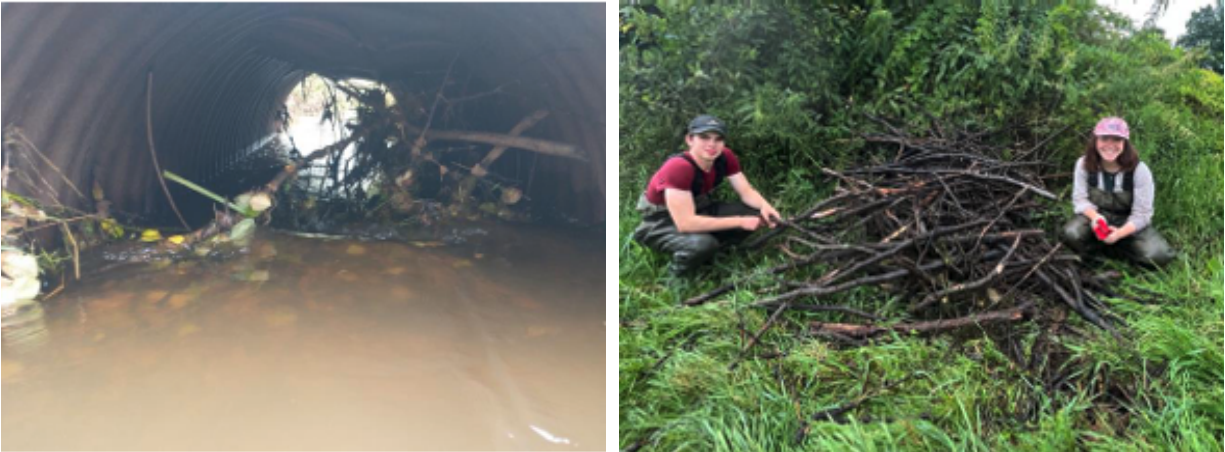
Comments: BWB003 was a set of 3 corrugated metal culverts underlying a concrete crossing on an agricultural property. An accumulation of woody debris was observed at the inflow of all culverts. A debris removal was conducted by the JWA field team, restoring access to 4.45 km of upstream habitat.

Figure 38. BWB003 before (left) the debris removal and JWA staff (right) with the debris removed from the site.

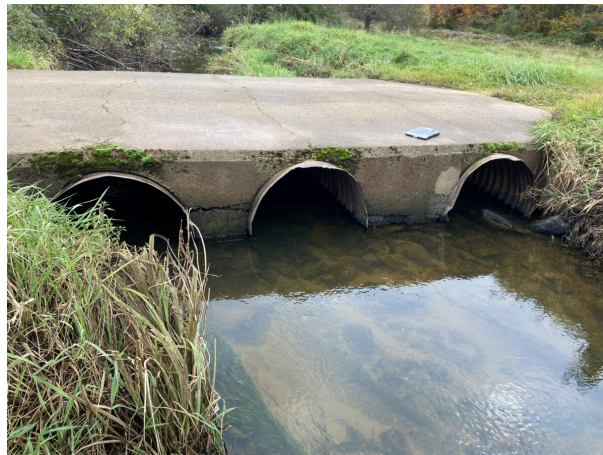
Figure 39. BWB003 after the debris removal.
