Assessing and Restoring
Aquatic Connectivity in the
Annapolis River Watershed

Prepared By Chelsae Postma
Ecological Restoration Technician
November 2011

Clean Annapolis River Project

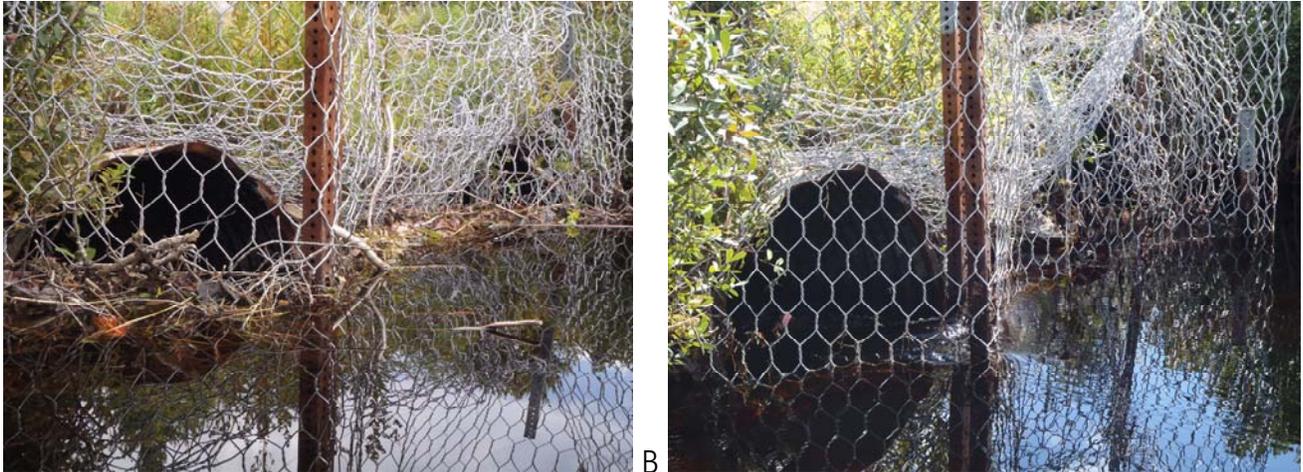
There is a debris cage located at the inflow of this culvert system that had collected a large quantity of material from the lake (Figure 4). Most of the debris was beaver sticks, root clumps, and decaying vegetation that was caught by the cage. The debris was approximately 3 ft high creating a partial dam with a high velocity drop making both a physical and velocity barrier. Figure 5 shows the water discharging from the outflow of the culvert before and after the remediation.

A B
Figure 4. Debris cage at Ballie Lake inflow before (A) and after (B) debris removal.

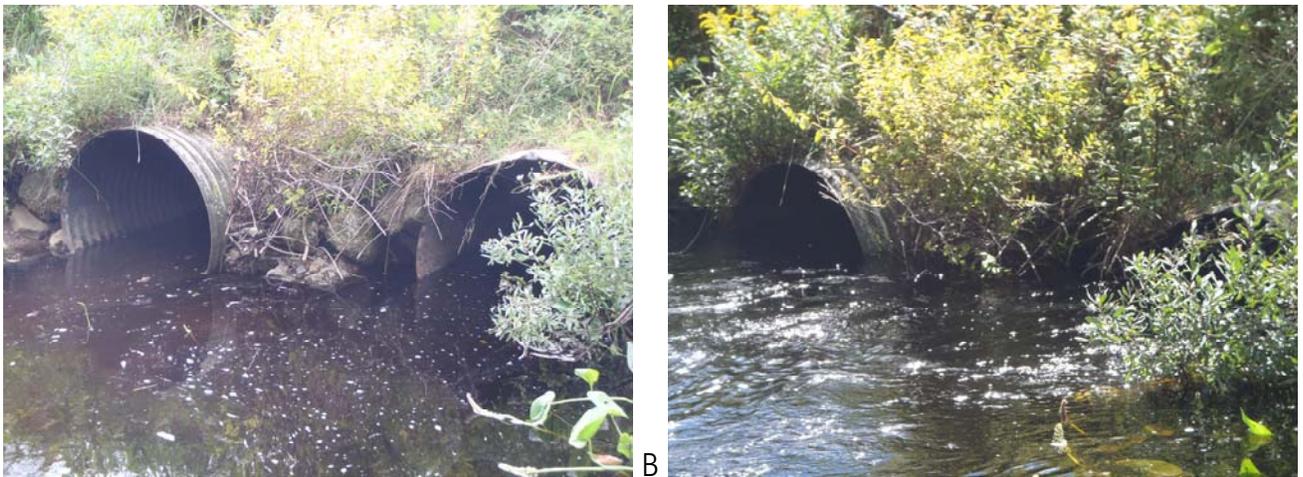
A B
Figure 5. Baillie Lake culvert outflow before (A) and after (B) debris removal from inflow.

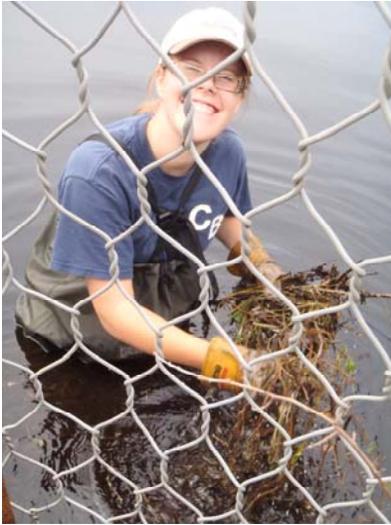
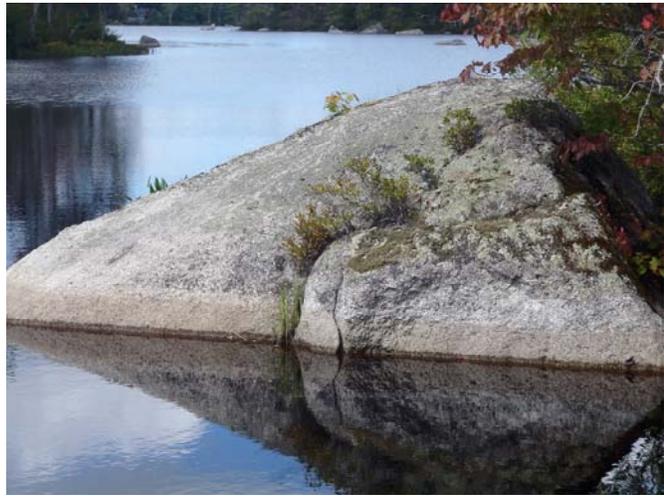
The restriction the barrier presented on lake flow was evident by the water level drop observed when CARP staff returned the following day (Figure 6). Due to the debris cage, it is likely that material will continue to collect at the inflow of BAI001. It is recommended that the owners of the roadway remove the cage or check yearly for obstruction.

Figure 6. CARP staff removing debris from inflow debris cage (A). Water level drop indicated on rock of Ballie Lake one day after debris removal (B).

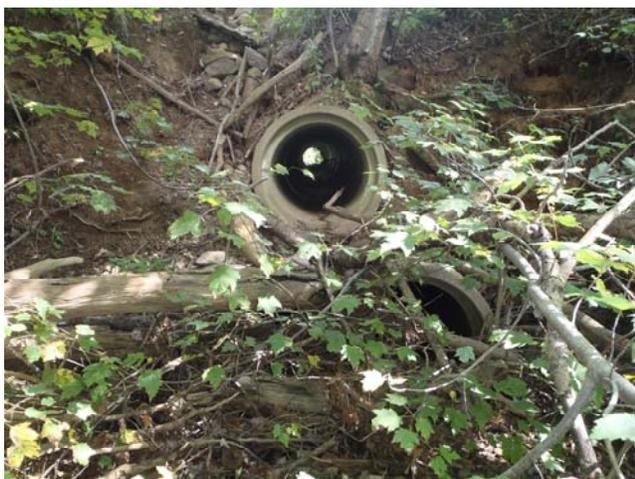
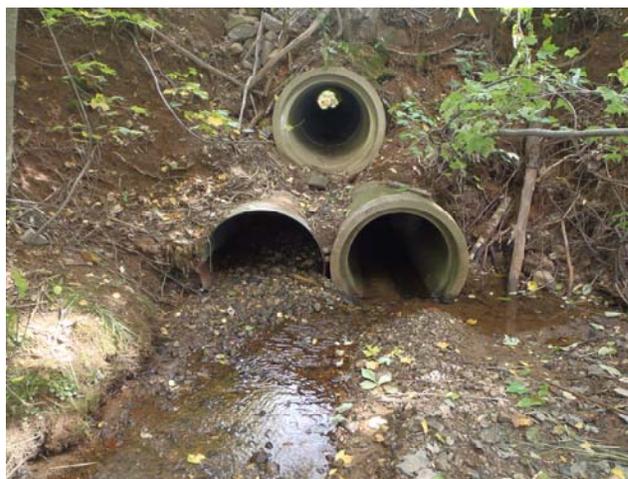
BER005 is located on a privately owned road and consists of two cement culverts and a steel culvert that form a double base with a cement culvert situated on top, perhaps to act as an overflow culvert. It appeared that trees had fallen into the brook at the inflow of the culverts, trapping other debris (Figure 8). The right bank was quite eroded which may have been the result of the rerouted water hitting the bank as it could not flow through the culverts. It is recommended that the owners assess the bank stability, as much of the lower support is lost.

A B
Figure 8. BER005 inflow before (A) and after (B) debris removal.

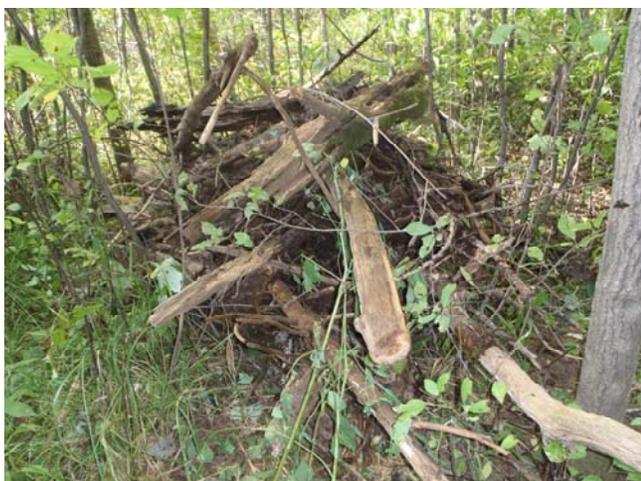
The debris was piled away from the brook in a location most likely to be safe from run off (Figure 9)

Figure 9. Debris pile from inflow after restoration of BER005.

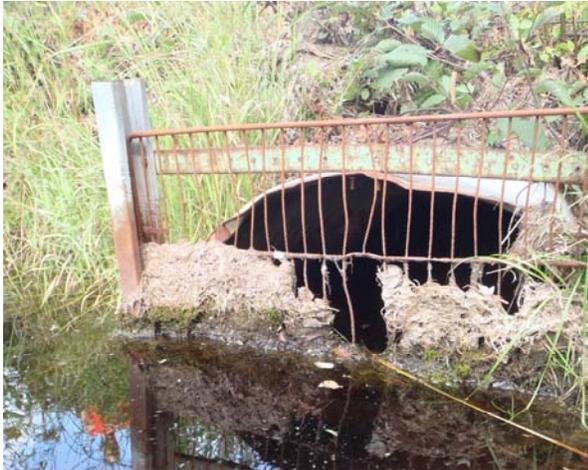
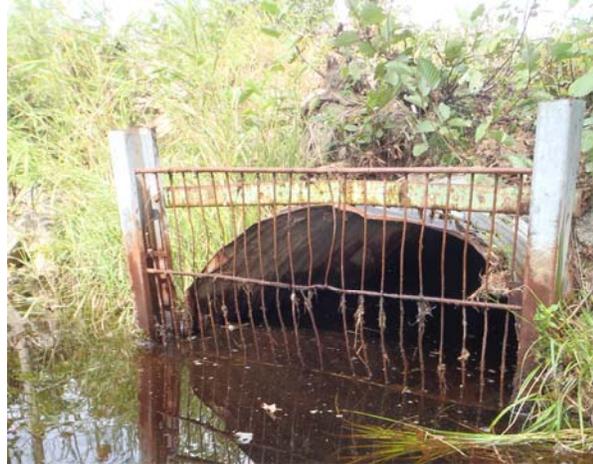
A debris cage is located at the inflow of this culvert. It consists of a grill that can be lifted up and out of the side supports and cleaned. There was evidence of previous cleanings. Much of the material blocking fish passage was grasses and aquatic plants that had collected on the debris cage creating a mat-like barrier. CARP staff removed this material as well as material at the base of the cage that may have washed into the culvert when the grill was removed (Figures 11 and 12).

A B
Figure 11. GRD010 inflow before (A) and after (B) debris removal.

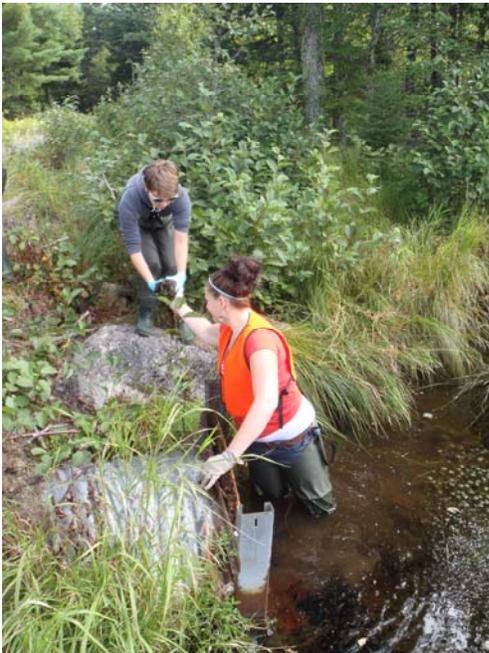
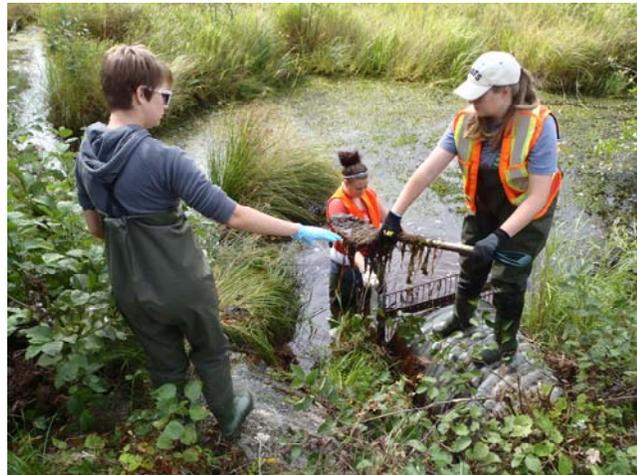
A B
Figure 12. A and B-CARP staff removing debris from inflow debris cage.

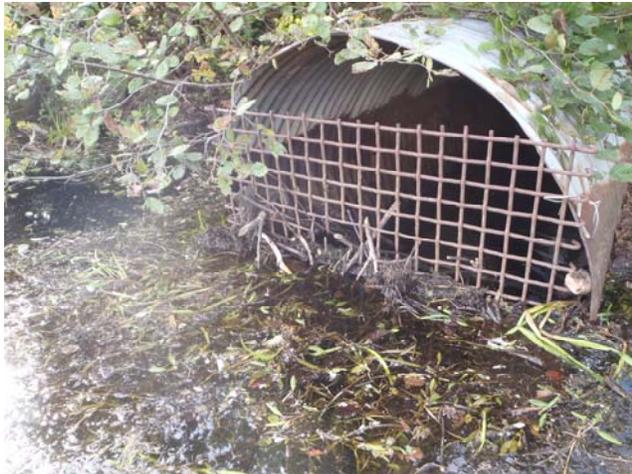
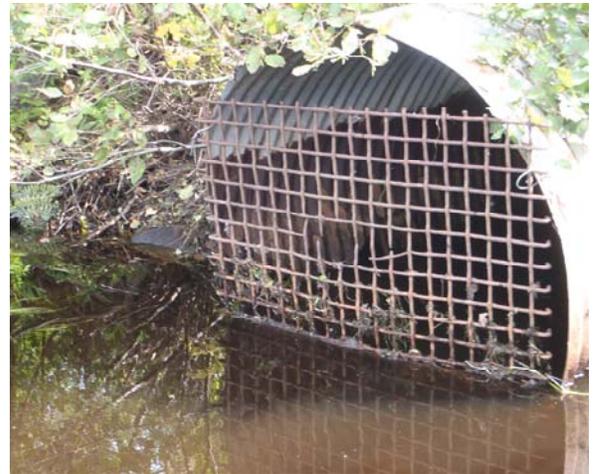
A debris cage is located at both the inflow and outflow of the steel, circular culvert. Large sticks and woody debris had collected at the base of the debris cage not allowing small vegetative material to pass (Figure 14). This blockage dammed a significant amount of the stream. After CARP staff removed this debris (Figure 15), there was a noticeable drop in the water level upstream of the culvert (Figure 16).

A B
Figure 14. HEN001 inflow before (A) and after (B) debris removal.

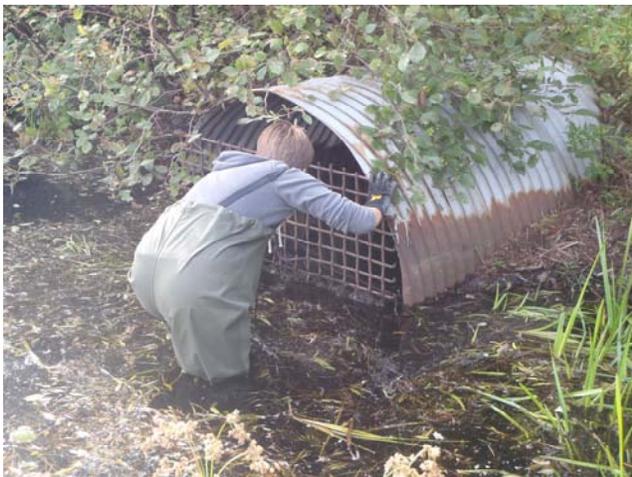
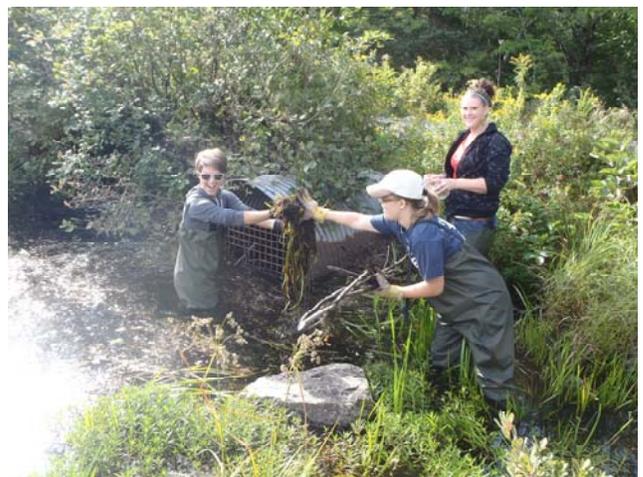
A B
Figure 15. A and B-CARP staff removing debris from inflow debris cage at HEN001.

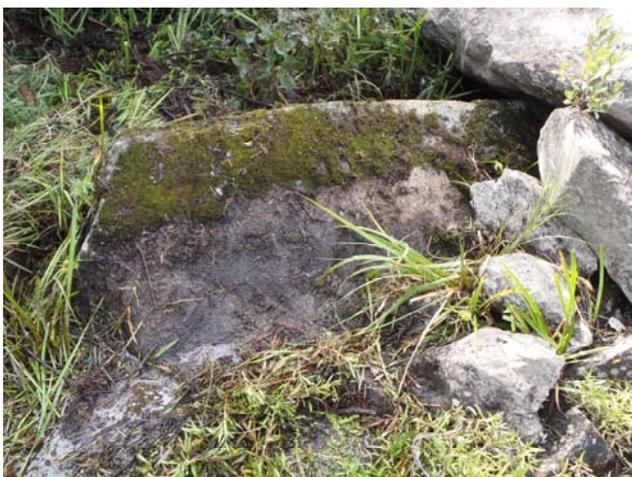
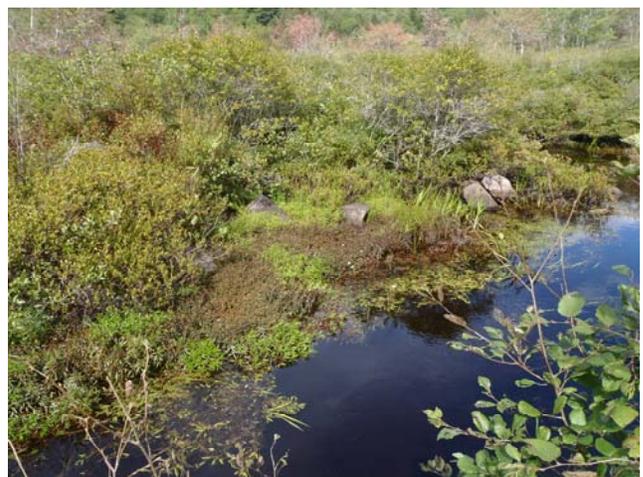
A B
Figure 16. Water level drop upstream of HEN001 after a few hours noted by A- moss on rock. B- the brown colour of newly exposed vegetation

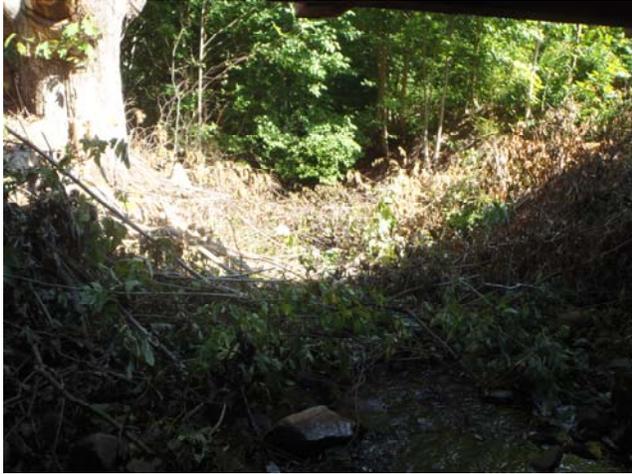
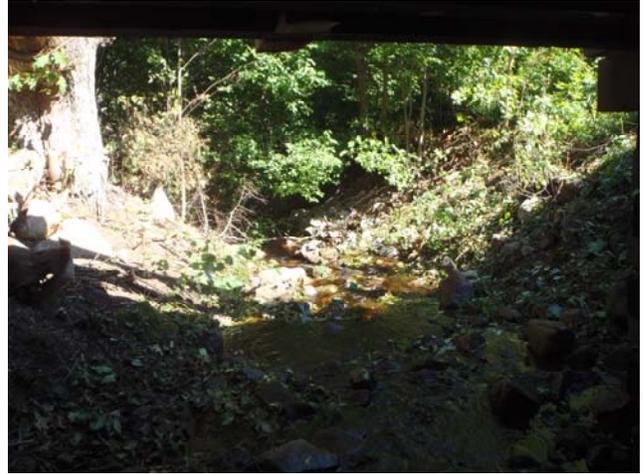
Millers Brook is a 10.3 km watercourse that flows directly into the Annapolis River near Lawrencetown from the South Mountain (Figure 17). There are twelve road crossings along the length of this brook; four are assessed as passable, five are located on trails and have not been visited, and two have not been previously marked on GIS. The only marked barrier is MIL012 which is a barrier bridge. Small trees and branches along the road and brook had recently been cut and left in the brook, creating an obstacle for migrating fish (Figures 18 and 19). CARP Staff removed the woody debris to allow a clear route for fish to swim.

A B
Figure 18. MIL012 outflow (brook level view) before (A) and after (B) debris removal

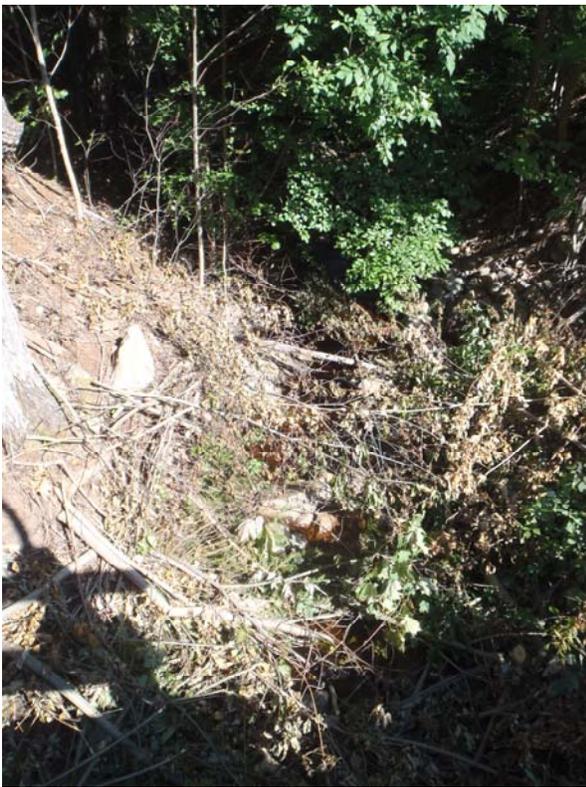
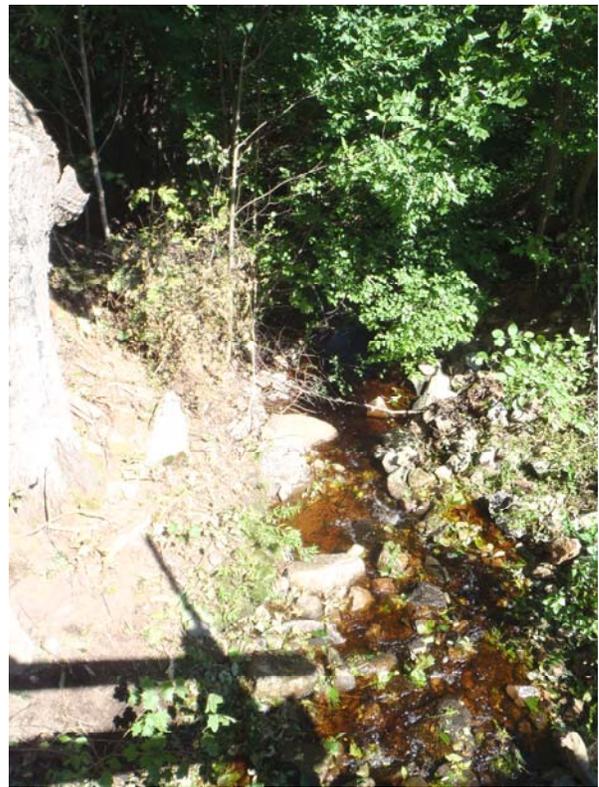
A B
Figure 19. MIL012 outflow (top view) before (A) and after (B) debris removal

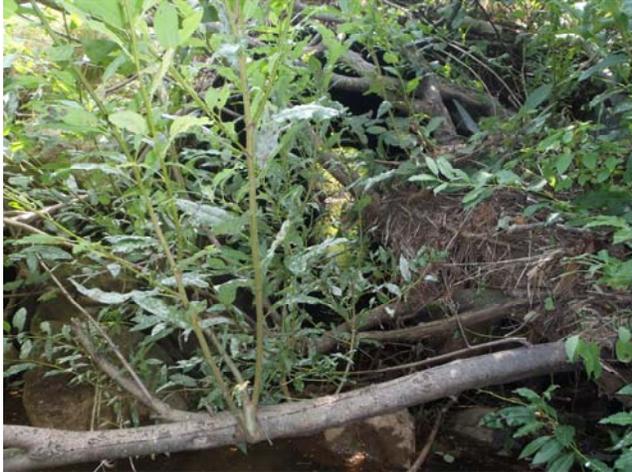
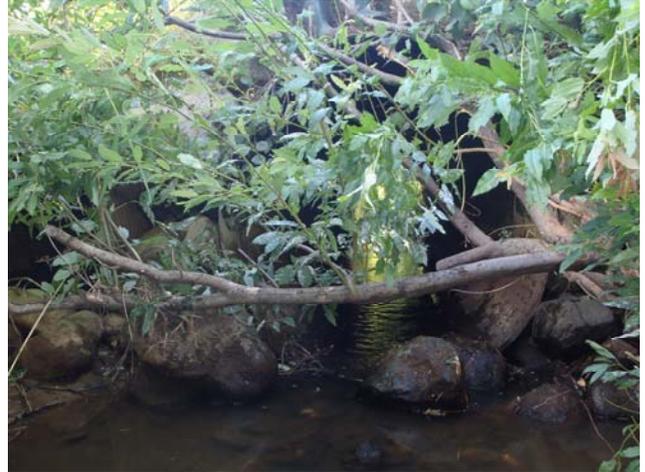
Two debris removals were accomplished at this site. The first was the removal of an abandoned beaver dam from branches overhanging the inflow of the main culvert. The material was removed from the tree to prevent it from continuing to fall into the inflow and blocking the culvert (Figure 21). The second removal was to restore flow through the main culvert. Material from the beaver dam that had floated downstream was caught at the culvert's entrance (Figure 22). CARP staff removed this debris to ensure continuous water flow through the culvert.

A B
Figure 21. NEB001 tree with remnants of an old beaver dam before (A) and after (B) debris removal.

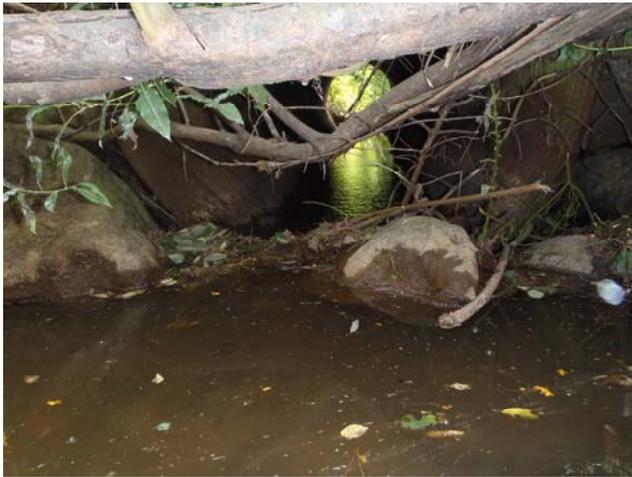
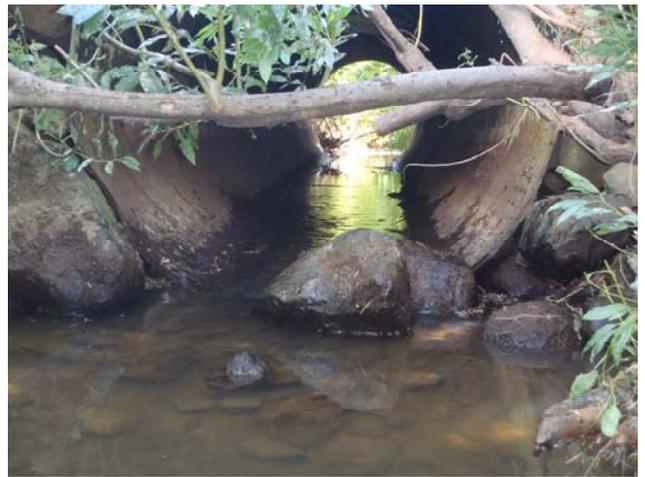
A B
Figure 22. NEB001 inflow before (A) and after (B) debris removal.

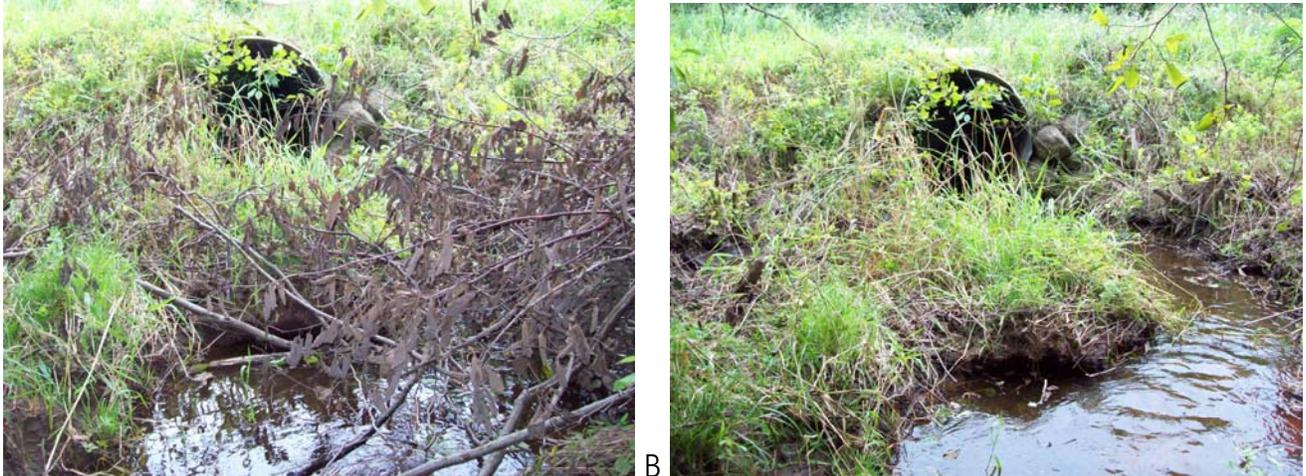
RHR010 is a steel culvert located on Mill Road where a tributary of the Roundhill River intersects Mill Road (Figure 23). This watercourse is about 660 m in length and the culvert restricted access to 360 m of upstream wetland, pond and watercourse habitat. This is the only culvert on this particular tributary. Small trees from the surrounding ditch were cut and left in the ditch, partially blocking access upstream of RHR010 (Figure 24). CARP staff cleared this debris as well as woody material caught on a low hanging branch downstream of the culvert.

A B
Figure 24. RHR010 upstream before (A) and after (B) debris removal.

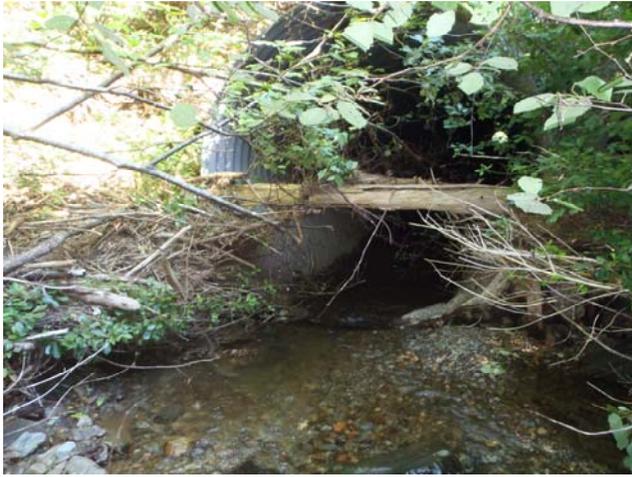
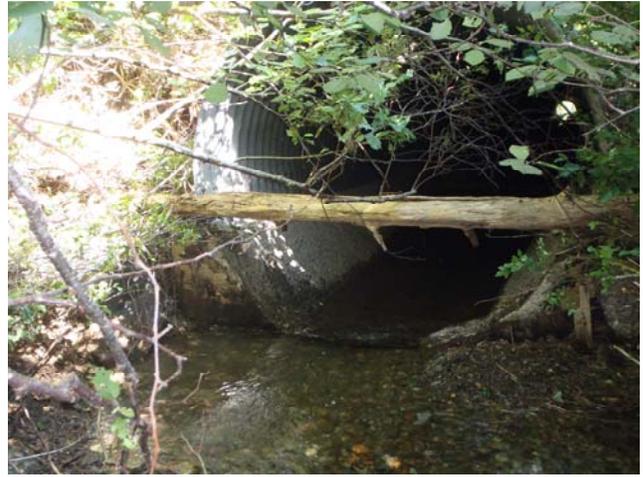
the woody debris at the inflow of the culvert. The main problem was the remnants of an abandoned beaver dam that was falling into the brook from the left bank (Figure 26 and 27). There was also a large tree trunk across the culvert which was too large to be removed by hand by CARP staff. There are ten road crossings on this watercourse, five of which were unmarked on GIS maps and therefore not assessed. Out of the other five, two were passable and three were barriers. One of these barriers was ROA014, the other two are located in the upper portion of separate branches and limit approximately 2.2 km of upstream habitat.

A B
Figure 26. ROA014 upstream before (A) and after (B) debris removal.

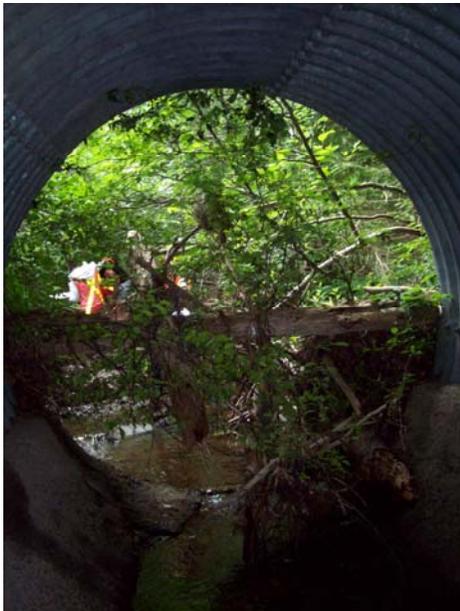
Figure 27. ROA014 inflow viewed from inside culvert.

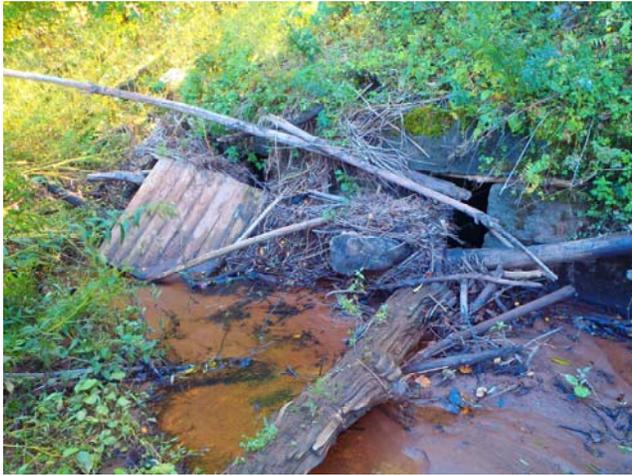
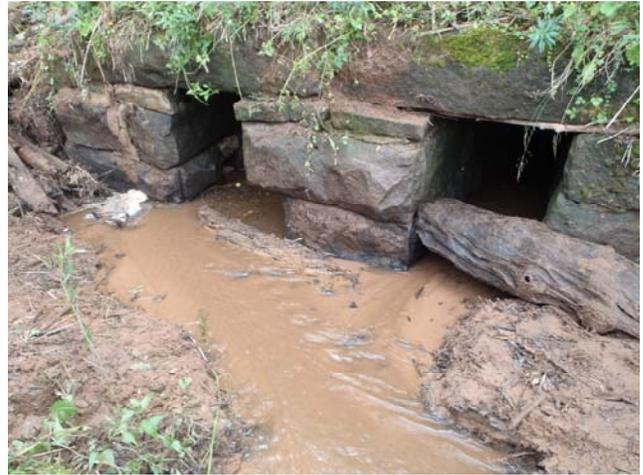
The remediation at Watton Brook will require a multi-year initiative. A very large amount of material had accumulated at the inflow of this double culvert system (Figure 29). In part, it was caused by an abandoned beaver dam. However, there was evidence of illegal dumping into the brook (eg: horse stall doors). In addition, large logs and other woody debris had collected at the inflow, trapping smaller material. Due to the extent of built up sediment from prolonged blockage, staff only removed part of the barrier (Figure 30).

A B
Figure 29. WAT006 upstream before (A) and after (B) debris removal.

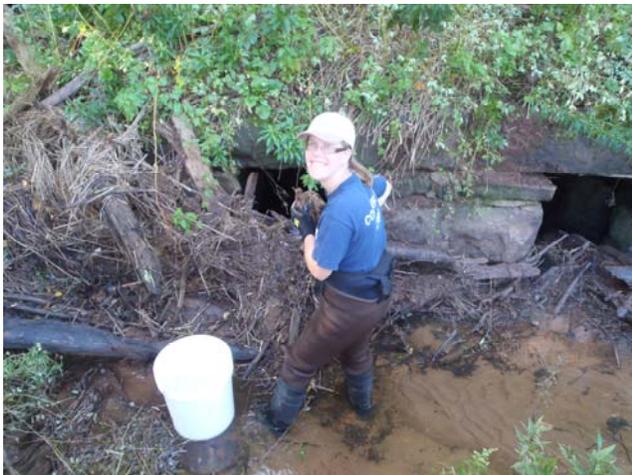
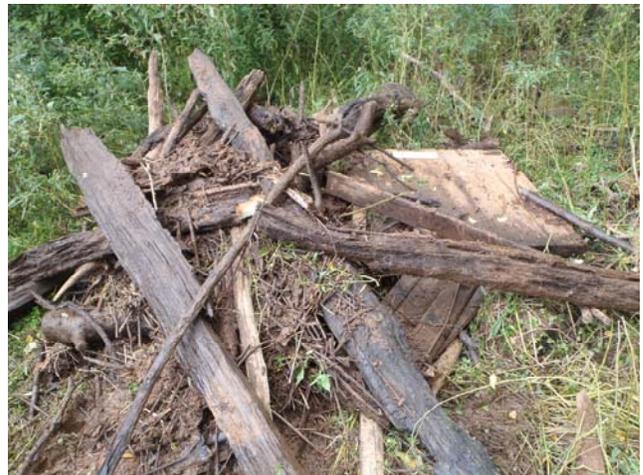
A B
Figure 30. WAT006 staff clearing the debris (A) and debris pile (B).

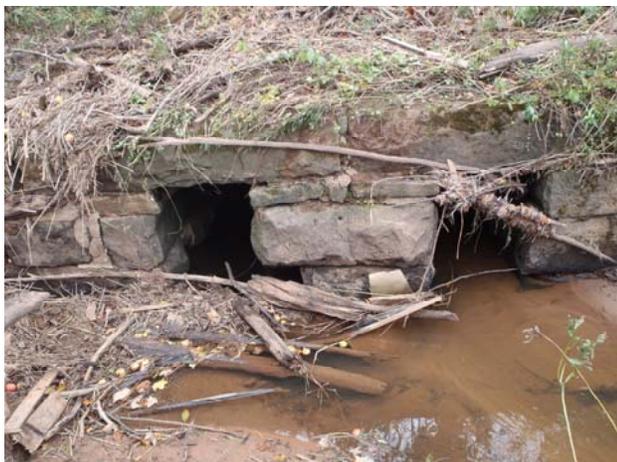
The site was re-visited approximately one month after the debris removal (Figure 31). Passage was possible through the right culvert, though the beaver dam material from the left bank had eroded into the brook, again blocking the left culvert inflow. It is recommended that the remainder of the beaver dam, as well as the material dumped on the bank above the culvert, be removed in 2012.

Figure 31. WAT006 one month after remediation efforts.

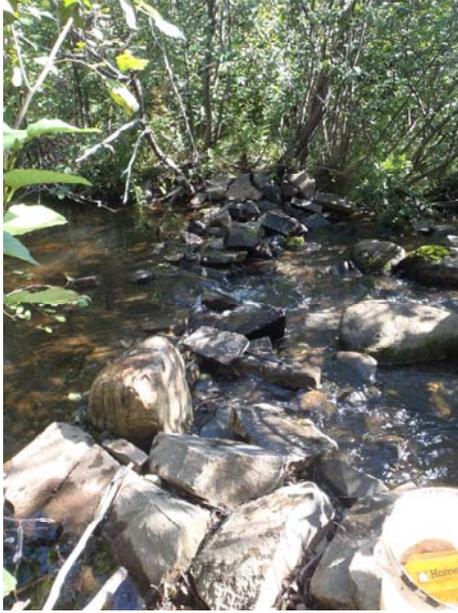
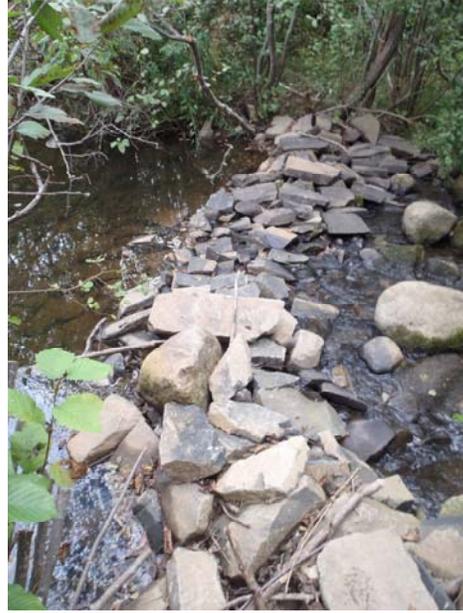
The tailwater control weir installed in 2010 was functioning well; however, some of its rock had been dislodged in the previous year. It also needed to be slightly higher to further backwater the culverts. CARP staff added rock to Weir A to help stabilize the structure and ensure continued function (Figures 34 and 35). During maintenance, the low flow notch was built slightly higher in hopes of backwatering the culvert at least half its length. The design of this tailwater control weir can be found in the 2010 report, *Broken Brooks: Repairing Past Wrongs* (Taylor, 2010).

A B
Figure 34. Weir A before (A) and after (B) retrofit.

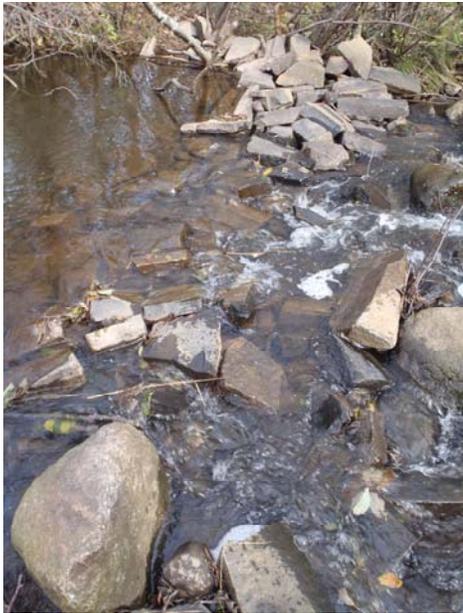
Figure 35. Weir A after extreme rain storm.

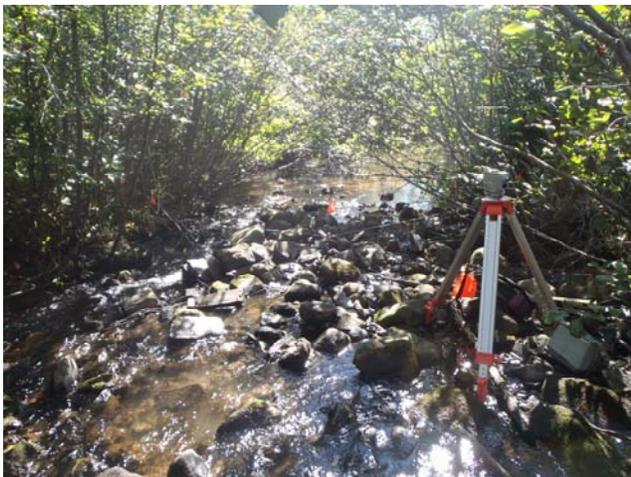
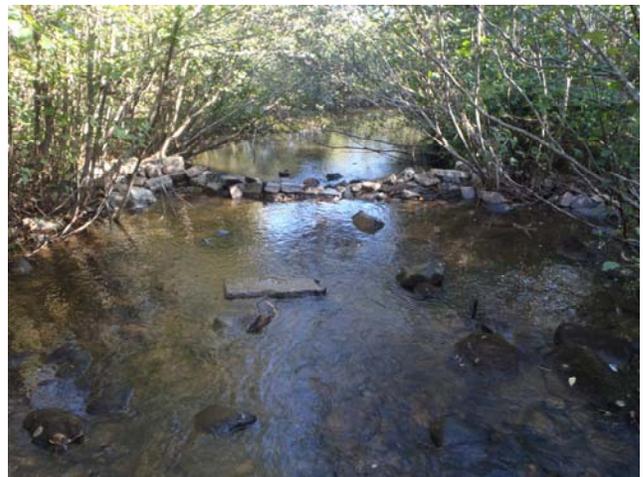
The location of Weir B at TRO010 was mapped out and built in September (Figure 36).

A B
Figure 36. Weir B before (A) and after (B) rock weir installation.

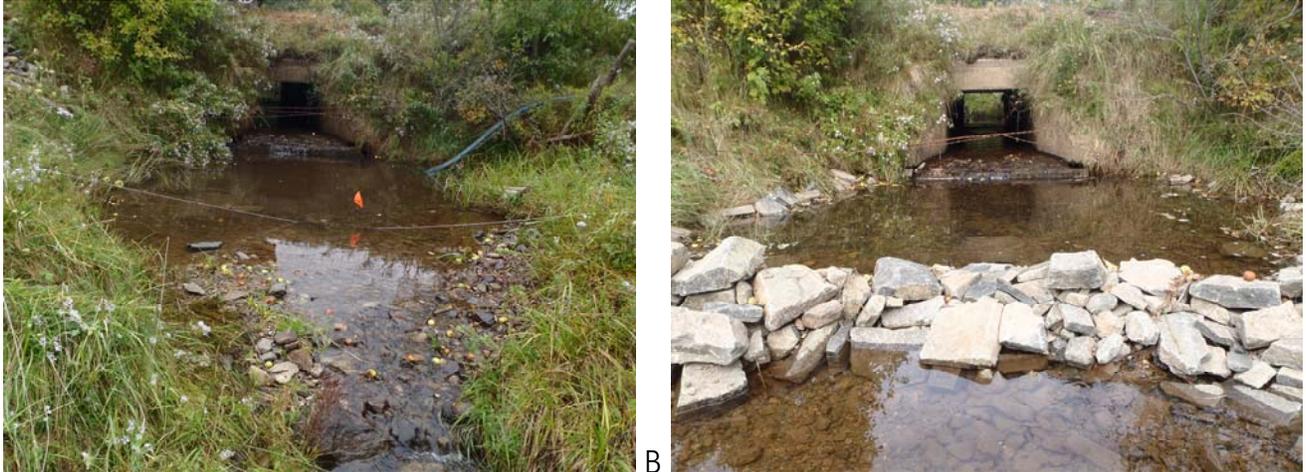
A B
Figure 38. MCE015 before (A) and after (B) Tailwater control weir installation.

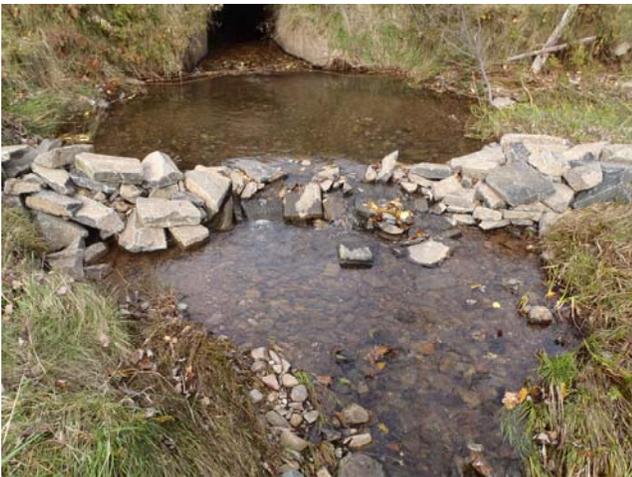
Approximately one month later, the rock weir appeared to be functioning (Figure 39). There was still a small outflow drop, possibly due to the plunge pool being too large, but the outflow drop was still significantly reduced (Figure 40). It is recommended that the site be revisited in 2012 as a follow-up.

Figure 39. MCE015 one month after installation.

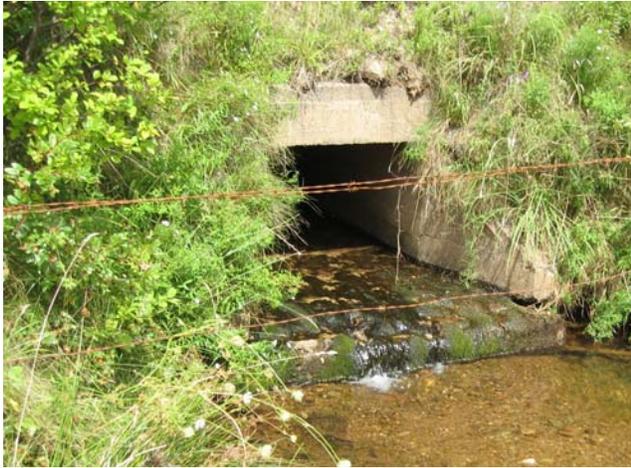
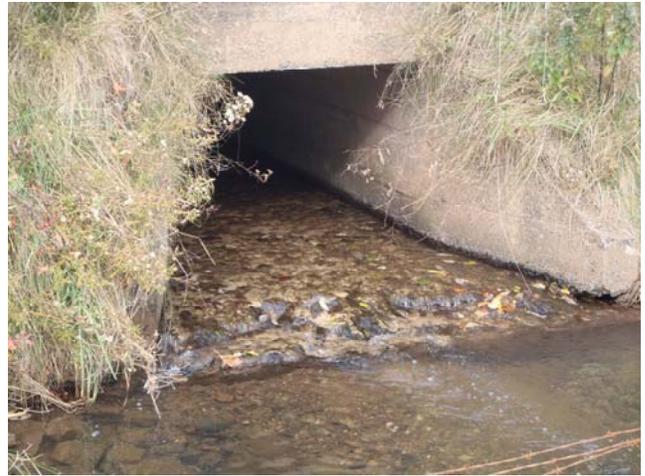
A B
Figure 40. MCE015 Outflow before (A) and after (B) Tailwater control weir installation. NOTE:
Photo A was taken in summer 2010 and photo B was taken October 2011, one month
after weir installation.
