# Fish Passage Restoration and Habitat Enhancement

*A project to address fish habitat fragmentation and degradation in the Annapolis River Watershed*

Rachel Walsh  
December 2023

## **Clean Annapolis River Project**

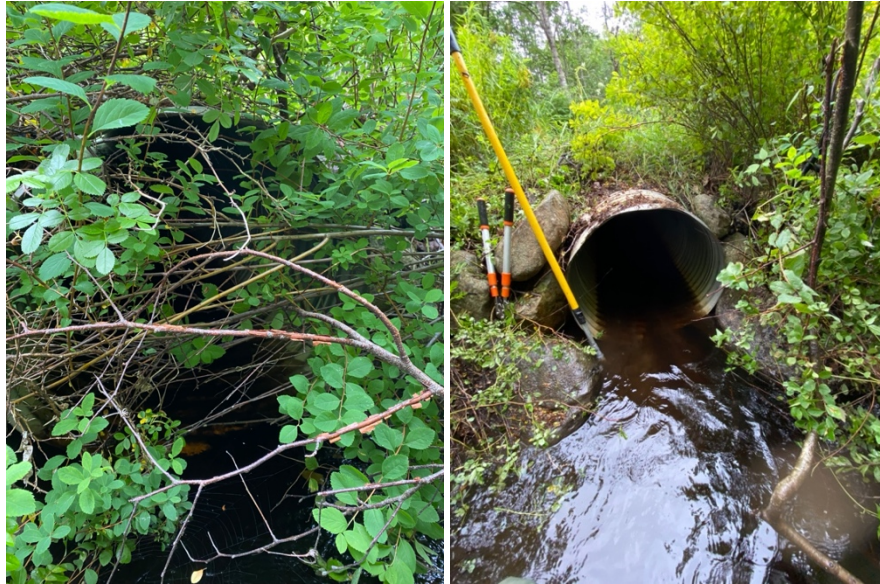
*Comments:* EAS009 was a corrugated metal culvert positioned along the East Moose River. In 2015, a fish chute and tailwater control structure were installed at this location. Maintenance work on the tailwater control structure and a debris removal were conducted in the summer of 2023, restoring access to 0.56 km of upstream habitat.

Figure 6. EAS009 before (left) and after (right) the culvert inflow debris removal.

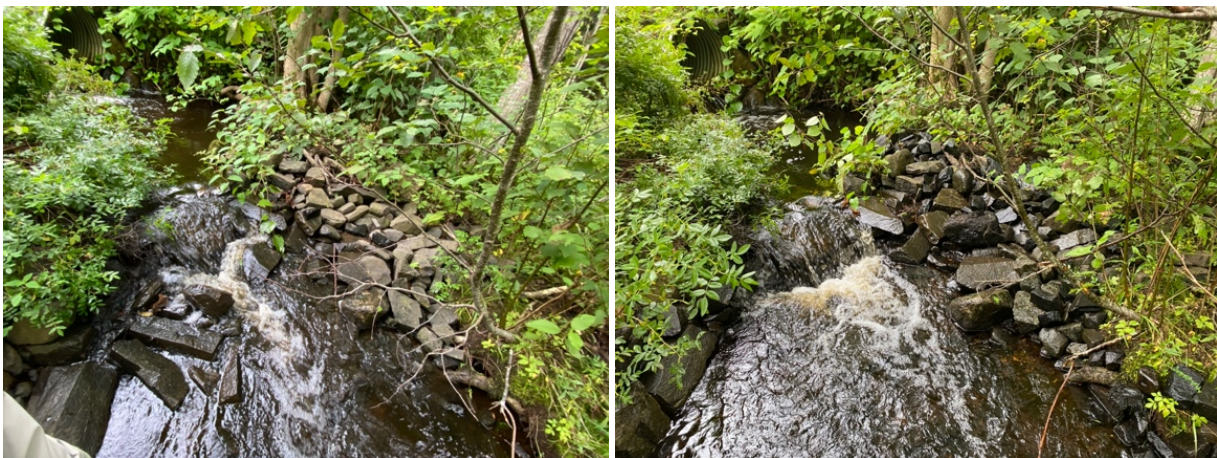
Figure 7. Before (left) and after (right) the tailwater control structure maintenance.

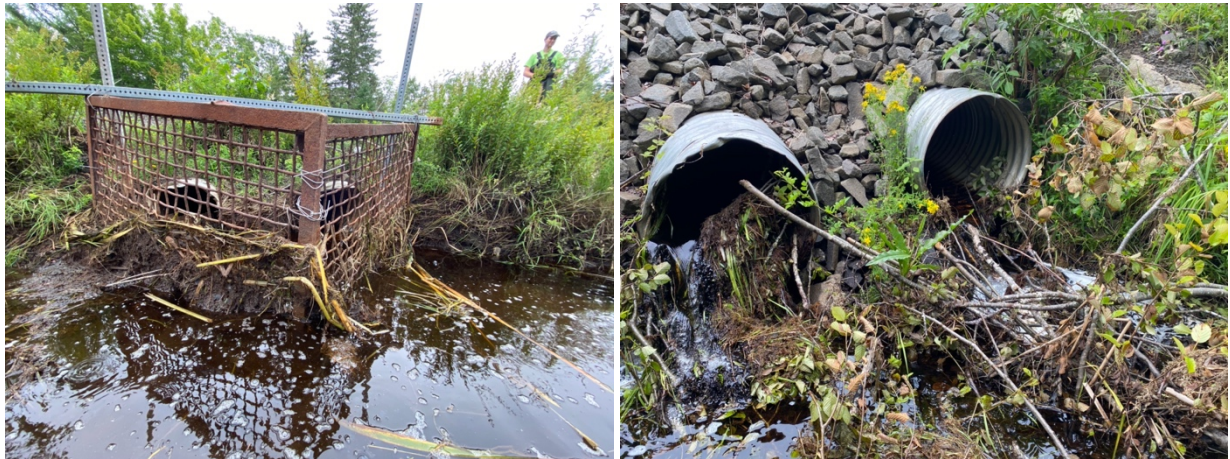
*Comments:* ALL017 consisted of a pair of corrugated metal culverts. In 2015, a fish chute and tailwater control structure were installed at the site. When the site was revisited in 2023, obstructions from debris were observed both at the inflow and outflow of the culverts, resulting in flooding conditions upstream. A debris removal was undertaken to clear blockages from the culvert and accumulated debris downstream, restoring access to 0.26 km of upstream habitat.

Figure 8. ALL017 inflow (left) and outflow (right) blocked with debris.

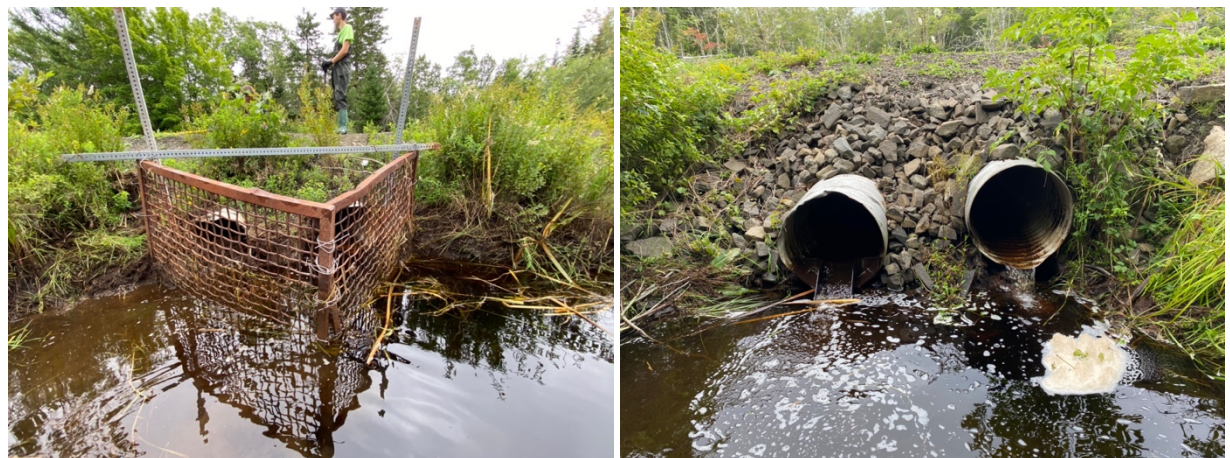
Figure 9. ALL017 inflow (left) and outflow (right) after the debris removal.

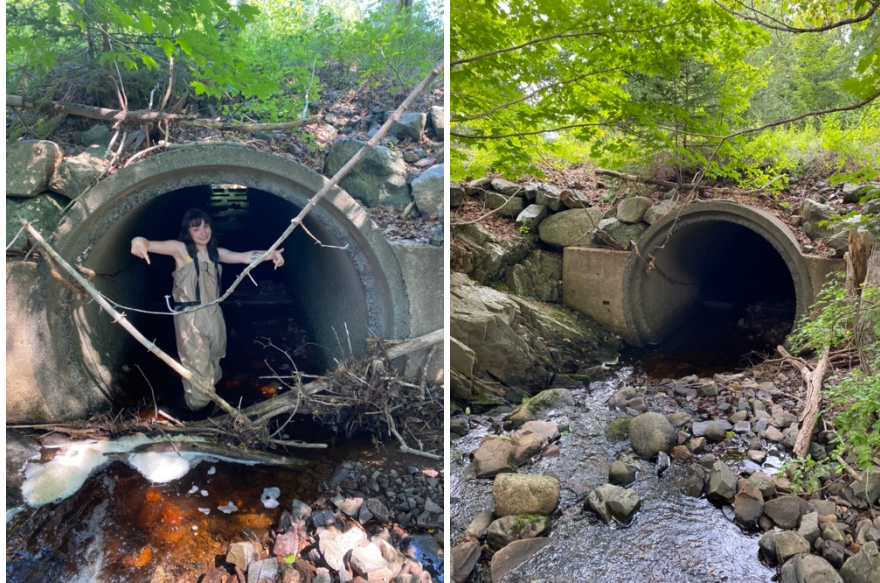
*Comments:* PET002 was a concrete culvert situated on Petes Brook. In 2018, CARP installed a fish chute and tailwater control structure at this location. Fortunately, those structures required no maintenance; however, there was an accumulation of sticks and woody debris observed at the culvert's inflow. A debris removal was conducted, restoring access to 2.22 km of upstream habitat.

Figure 10. PET002 before (left) and after (right) debris removal.

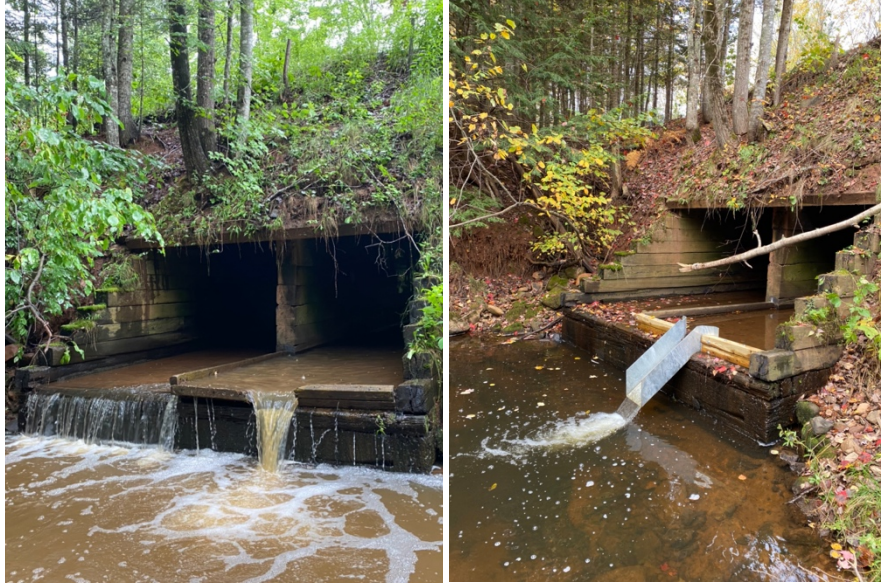
*Comments:* WAT004, located on Watton Brook, consisted of a double wooden box culvert. In 2016, several enhancements were made to the site, including the installation of baffles, a low-flow barrier, a fish chute, and a tailwater control structure. However, during the 2023 site revisit, it was discovered that the fish chute had detached from the culvert and couldn't be located. A replacement chute was ordered and successfully installed in September 2023 to rectify the culvert's excessive outflow drop of more than 50 cm.

Figure 11. WAT004 before (left) and after (right) the fish chute installation.

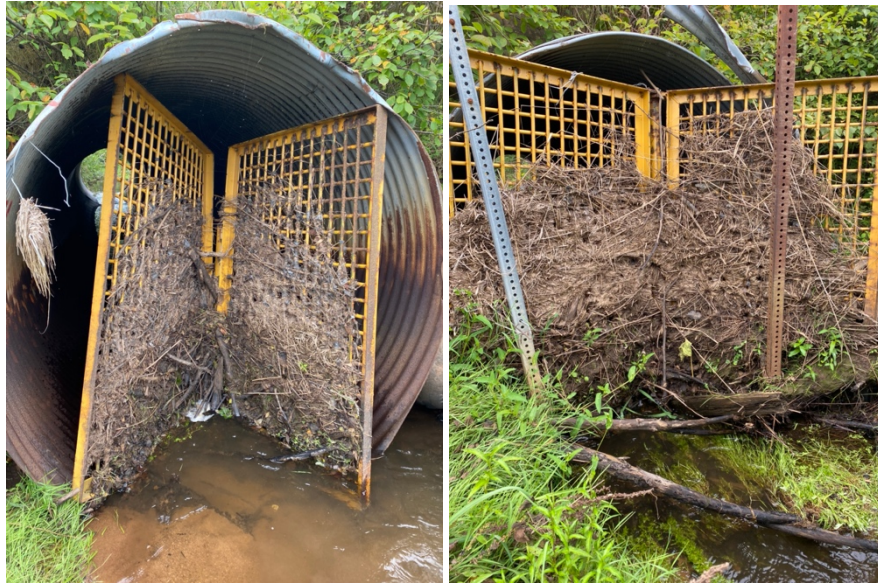
*Comments:* TRO010 was a pair of corrugated metal culverts located on Troop Brook. Woody debris and other organic matter had accumulated at the inflow grates of both culverts. The debris was removed during the summer of 2023, re-establishing access to 2.74 km of upstream habitat.

Figure 13. TRO010 inflow before the debris removal.

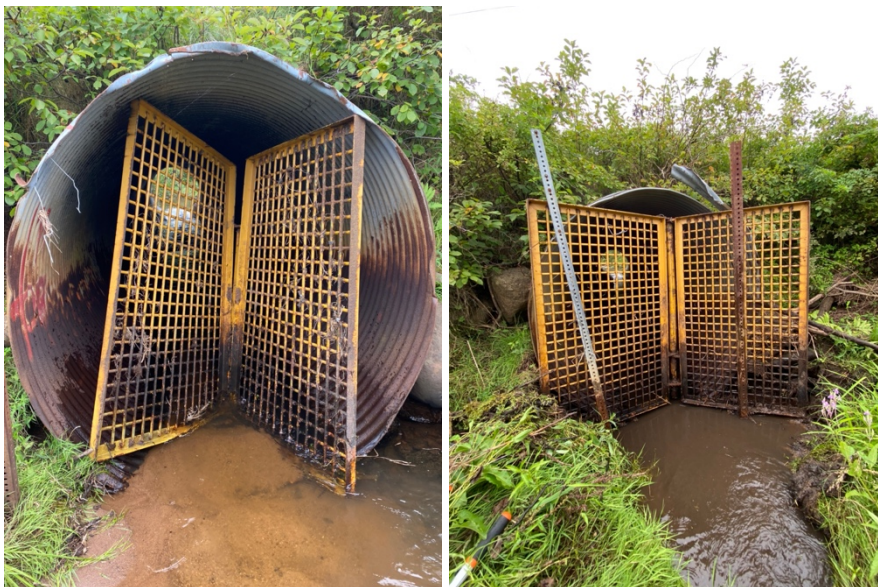
Figure 14. TRO010 inflow after the debris removal.

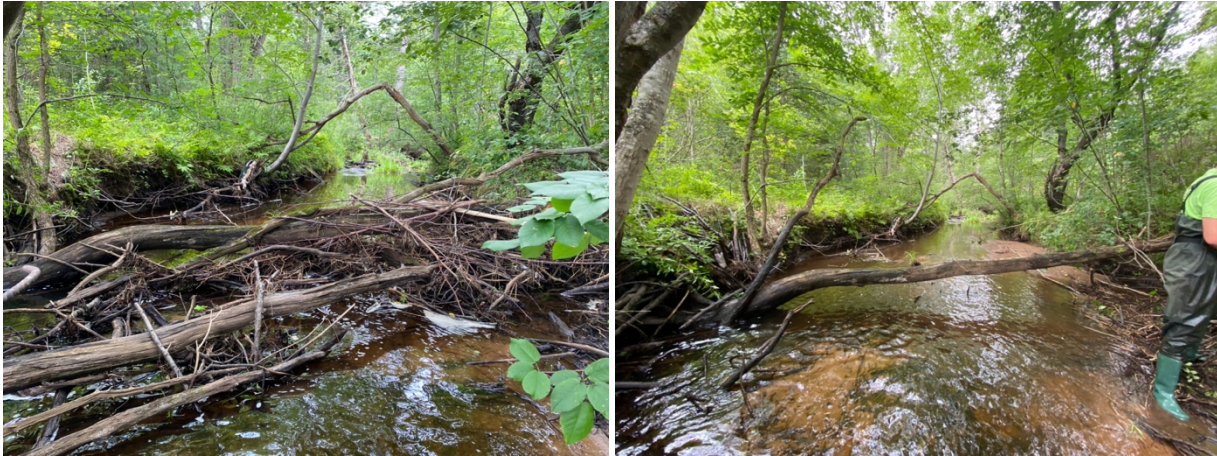
*Comments:* BLK004, located on the Black River, was a corrugated metal culvert. Downstream of the culvert, a significant accumulation of debris had formed, acting as a barrier to fish passage. The obstruction was successfully cleared, reopening access to 0.83 km of upstream habitat.

Figure 15. Downstream of BLK004 before (left) and after (right) debris removal.

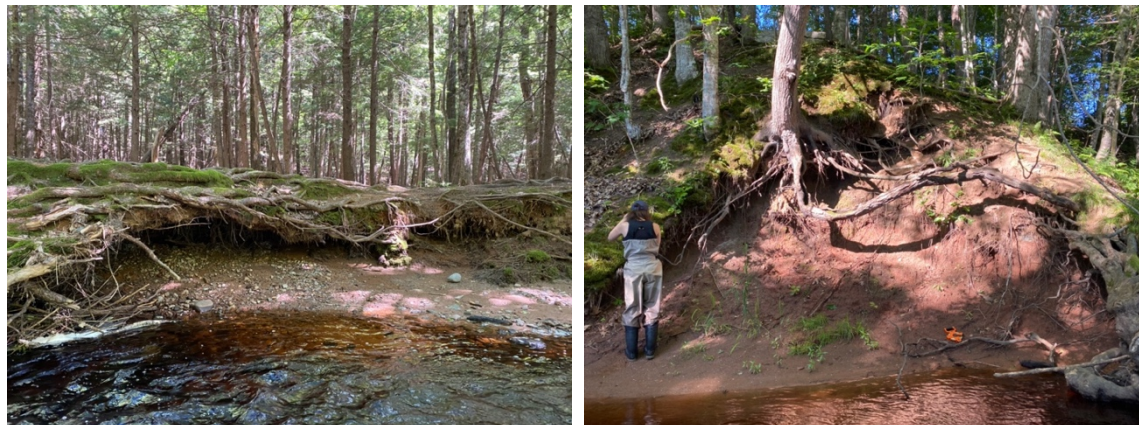
Streambank erosion surveys took place over a 3 km stretch of the Fales River on August 2 and 3, 2023. Within this stretch, 26 locations exhibiting significant erosion were pinpointed. In the context of this survey, an erosion site was defined as either having deep undercut banks or steep banks with exposed soil. Detailed erosion survey results can be found in Appendix 6.13.

Figure 19. Examples of erosion identified on the Fales River.
