# Fish Passage Restoration and Habitat Enhancement

*A project to address fish habitat fragmentation and degradation in the Annapolis River watershed*

Hayley Doyle  
Fisheries Technician  
December 2019

## Clean Annapolis River Project

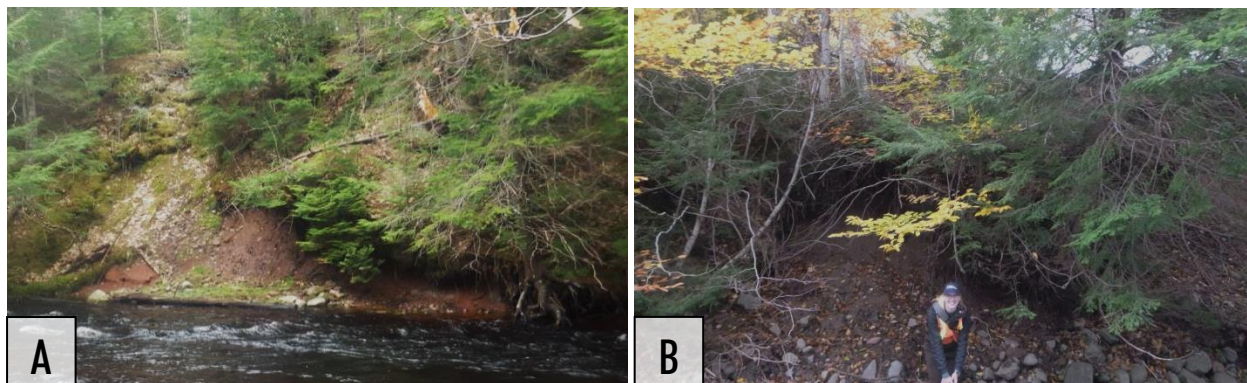
**Figure 1.** Eroding banks on the Fales River (A) and the Round Hill River (B).

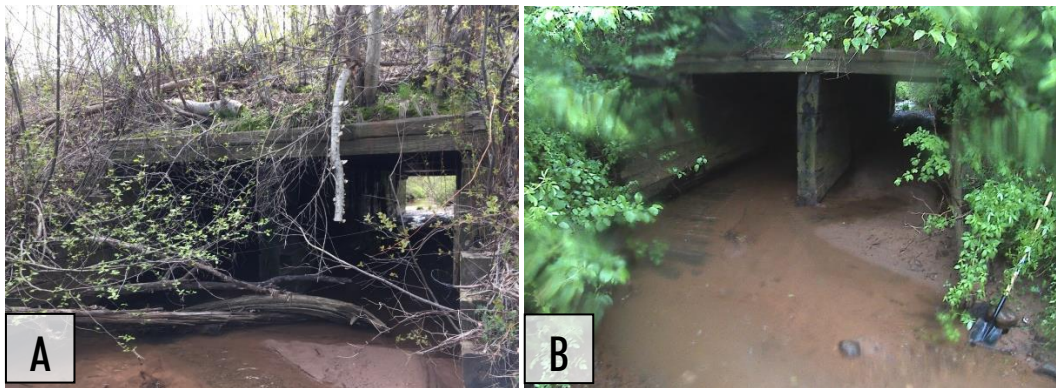
*Comments:* Little Brook is one of the first tributaries connected to Walker Brook; a large and important tributary that connects directly to the Annapolis River. LIB003 was assessed for the first time in 2019 and is the first watercourse crossing on Little Brook with an upstream habitat gain of 2.3 km. Due to the severity of debris blocking the culvert's inflow, the culvert's minimal slope and outflow drop and its location within the Annapolis River watershed, this double, wooden culvert was a priority culvert for restoration efforts. The 1<sup>st</sup> Kingston Scouting Cubs volunteered alongside CARP staff to remove the large woody debris from the inflow of the culvert using shovels, rakes, loppers, and hand saws. The debris was disposed of off-site where it was not likely to fall back into the brook to allow the culvert to remain free for fish passage.

**Figure 8.** LIB003 debris removal before (A) and after (B).

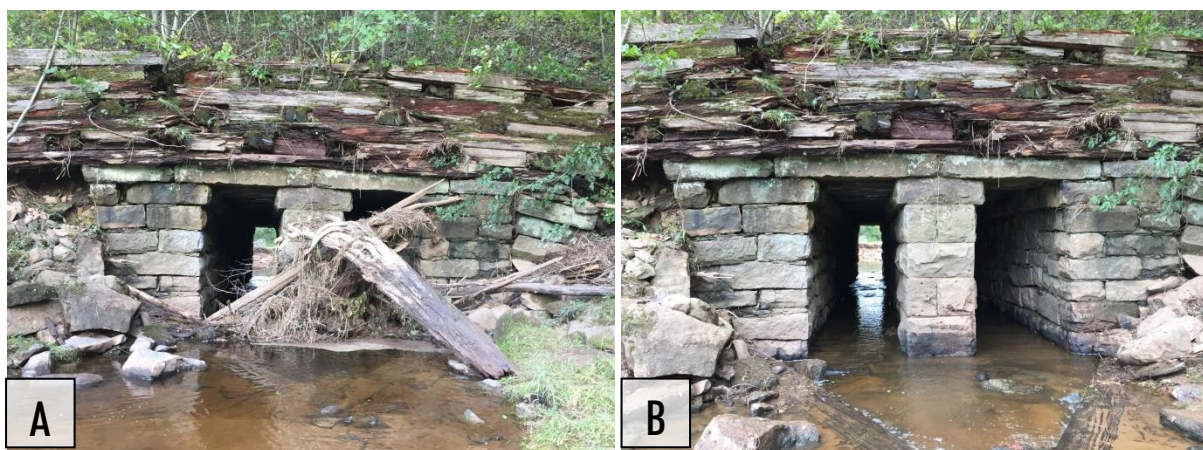
*Comments:* OHB001 was first assessed in 2017 where the assessment could not be completed due to the degree of debris blockage at the inflow of the culvert. This double, stone and wood culvert received its first debris removal in 2017 by CARP staff. Upon revisiting this culvert during the 2019 season, after hurricane Dorian swept through Nova Scotia, it was apparent that the debris blockage had returned and a full culvert assessment still could not be completed. Large, heavy tree trunks and logs were stuck at the inflow of the culvert with large amounts of smaller sticks and leafy matter built up around the culvert inflow allowing almost no water to flow through either of the two culverts under the Annapolis County Rail Trail. The large upstream habitat gain of over 6 km above this watercourse crossing as well as its close proximity to the Annapolis River made this debris removal maintenance a priority for the 2019 field season. Volunteer students and teachers from the Lawrencetown Education Centre helped to remove the heavy debris blockage from OHB001 allowing for the water to move freely and allow for fish passage once again.

**Figure 10.** OHB001 debris removal before (A) and after (B).

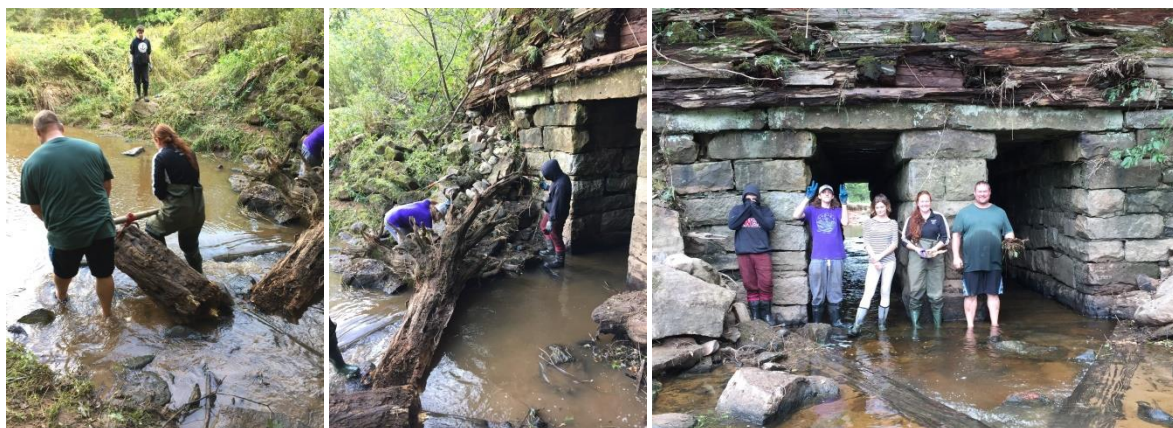
**Figure 11.** Volunteer staff and students from the Lawrencetown Education Center helping to remove large woody debris from the inflow of the culvert that washed up as a result of hurricane Dorian.

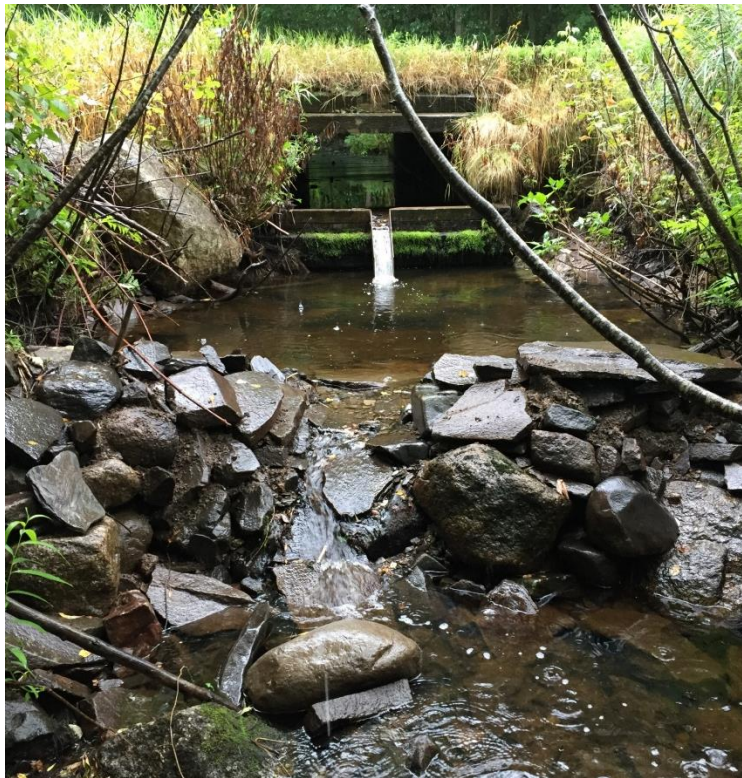
*Comments:* ROC011 was first assessed in 2010 and received its first restoration efforts by CARP staff in 2017, where a fish chute was installed at the outflow of the culvert and a tailwater control structure was constructed. Upon revisiting this culvert in 2019, the rock weir's overflow appeared to have been blown out, causing more of a hindrance for fish swimming up from downstream and appeared to have trapped a few small fish in the outflow pool. During the 2019 field season, the overflow of the rock weir was disassembled and reconstructed by CARP staff. Large, flat rocks found on site were used for the maintenance restoration efforts to create a flat, easy-sloping overflow while the rock weir walls remained sturdy and continued to hold back water for the outflow pool.

**Figure 12.** ROC011 rock weir reconstructed to fix the structure's overflow to allow for fish passage once again.

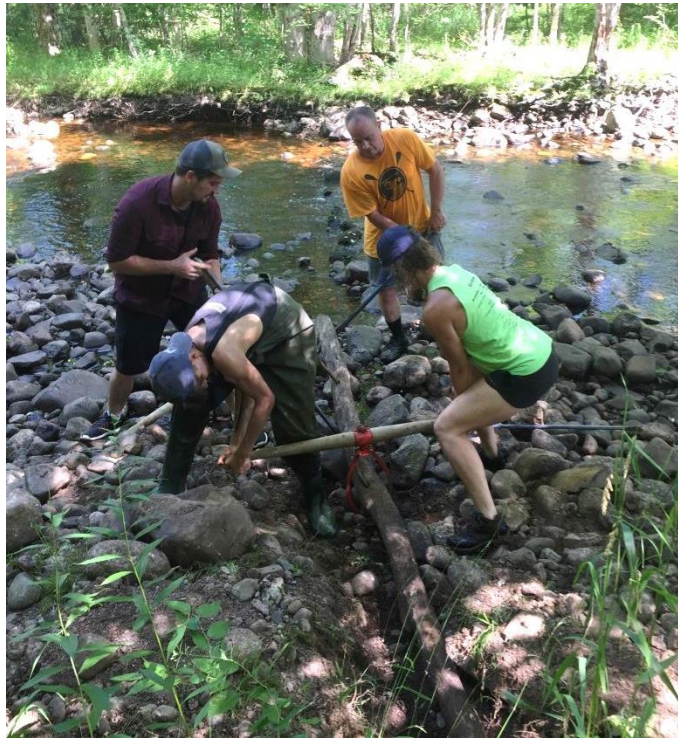
**Figure 16.** CARP staff and volunteers removing a broken and undersized digger log from the Round Hill River.

A total of six undersized and degrading digger logs were removed from a section of the Round Hill River. Some of the logs installed in the late 1990's fell into the newly determined layout of the stream or were providing another beneficial purpose to the river and therefore were left in place. However, the digger logs removed during the 2019 field season had done little digging since their installation and many were completely or partially buried in the substrate. Refer to Appendix 6.10 for the locations of the digger logs removed from the Round Hill River in 2019.

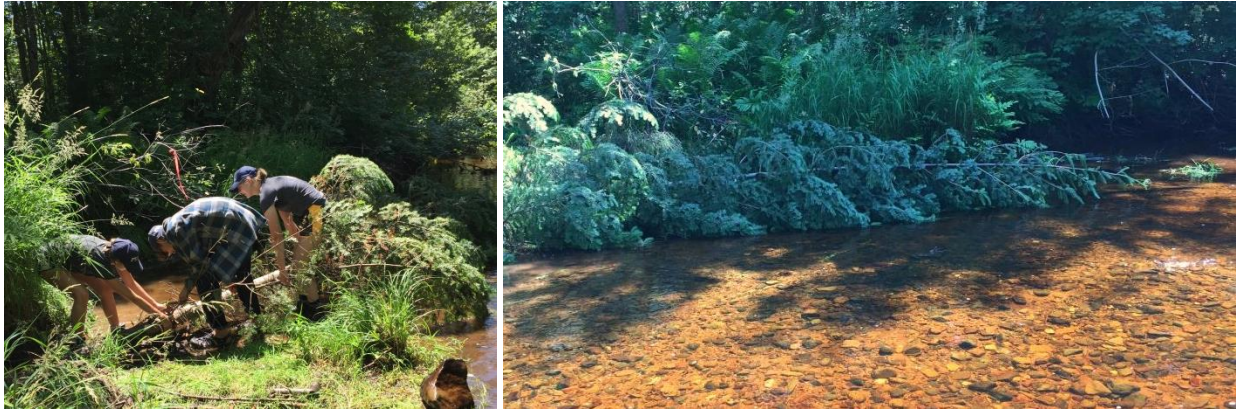
**Figure 17.** Single, tree deflector installed by CARP staff on the Fales River.

In 2019, the Fales River received one in-stream restoration structure to enhance spawning, rearing and migration habitat. The single tree deflector will help to redirect the stream flow away from the eroding bank in addition to acting as a sediment trap for free flowing, fine sediments (Figure 17). This structure brought the stream bankfull width from an over-widened 14 m to the calculated design width of 11.36 m. The tree deflector installed in the Fales River restored a linear length of 68 m and an area of 775 m<sup>2</sup> of in-stream habitat. This in-stream structure will aid in stabilizing the stream bank consequently reducing erosion at the site.

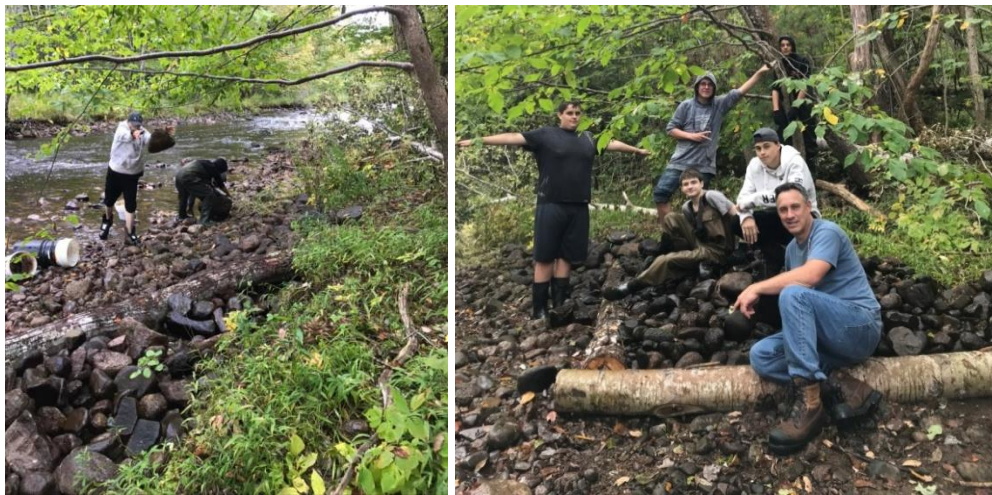
**Figure 18.** West Kings District High School staff and students helping to fill the single log deflector with cobble and boulder on the Round Hill River.

The Round Hill River received a single, log deflector during the 2019 field season (Figure 18). The deflector was installed to help concentrate flow as well as narrow and deepen the channel of an area of stream over-widened by approximately 2 m. The cobble and boulder rock from within the stream that was used to fill the frame of the deflector assisted in stabilizing the bank in addition to accentuating the natural pool downstream from the new structure. This single log deflector installed on the Round Hill River restored a linear length of approximately 65 m and an area of 706 m<sup>2</sup>.
