Clementsport Dam Removal and Restoration

Project Report: 2011 Season

Produced for the Clean Annapolis River Project
By Lindsey Freeman and Andy Sharpe
November 2011

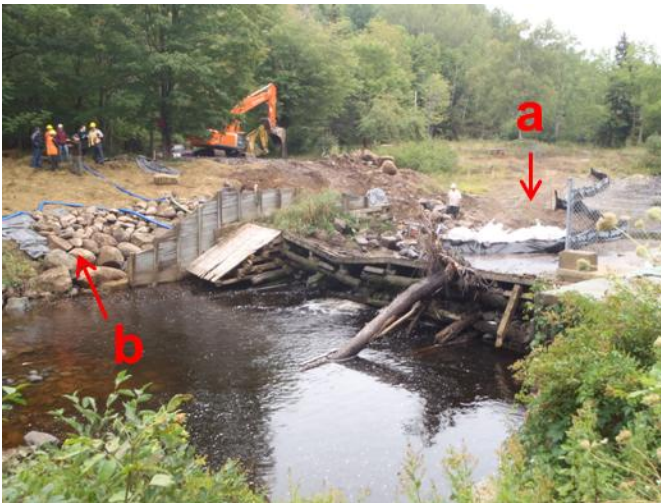
Figure 2 | Silt and erosion control measures established at the dam removal site. Silt fences are denoted by a) and b) shows some bank protection measures put in place.

To expedite the removal process and minimize impacts to the Moose River, construction equipment and materials were amassed at the site prior to removal. Sedimentation and erosion were minimized using approved control measures around the construction site such as silt fences, cofferdams, pumps, erosion control blankets, stone and filter gravel, and hay (see Figure 2). Diversion channels were also created to redirect the river during construction activities to minimize disturbance to fish (see Figure 3). Fish rescue was also undertaken as required throughout the project's completion.

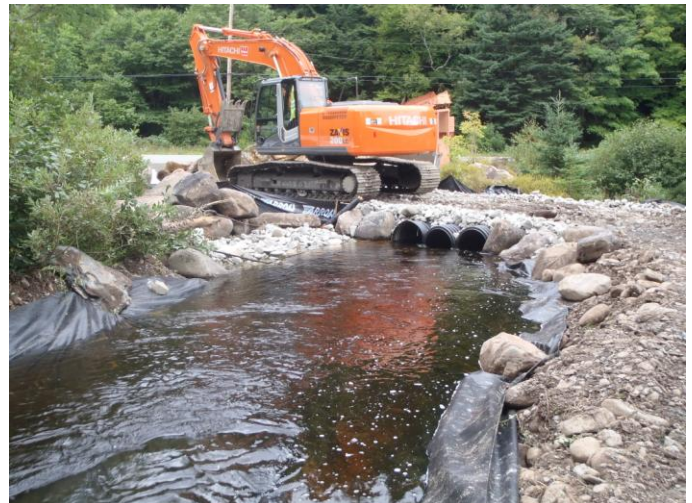
Figure 3 | Diversion channel during dam removal.

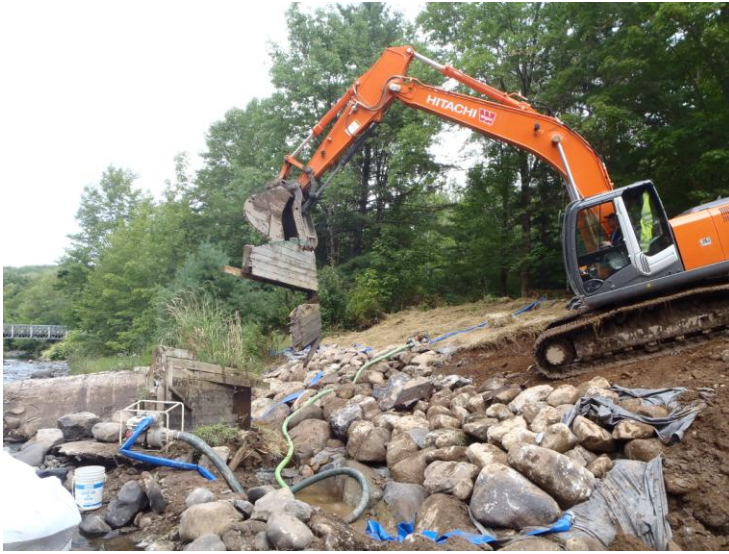
Figure 4 | Removal of fish ladder.

The removal of the Clementsport dam was conducted in a series of steps between September 5 and 13th, 2011. The dam itself consisted of several parts, namely a fish ladder adjacent to the eastern shore, a wooden crib serving as the core structure of the dam, and a concrete abutment on the western shore that housed water withdrawal equipment. Prior to the dam removal, the earthen embankment on the eastern shore was cut back to create a 3:1 slope, and erosion control measures were put in place. After site preparation was complete, the fish ladder was removed, followed by the wooden crib structure. The concrete abutment was demolished later, after a majority of the floodplain restoration work had been completed. All debris was trucked off site, and disposed of in accordance with provincial regulations. Figures 4 through 6 illustrate the steps of the dam removal, beginning with the removal of the fish ladder (Figure 4), the wooden crib (Figure 5), and the demolition of the concrete abutment (Figure 6).

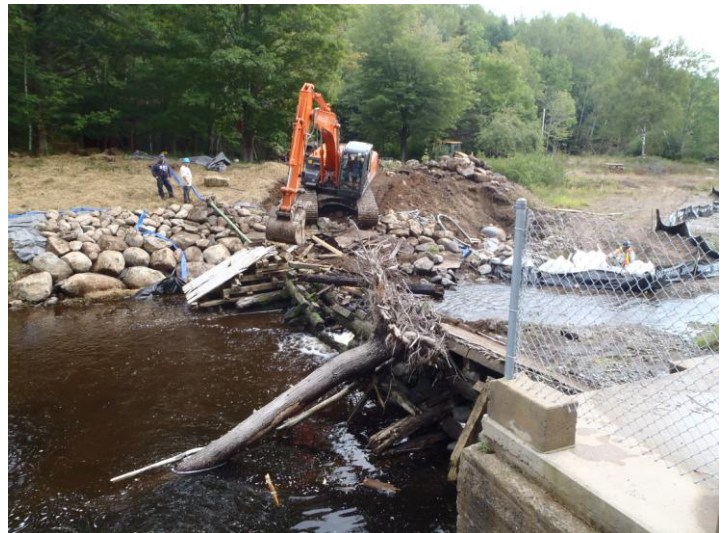
Figure 5 | Removal of wooden crib structure.

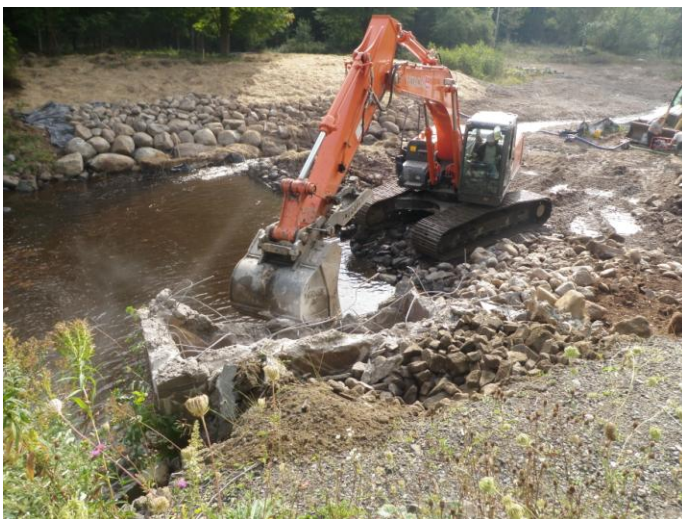
Figure 6 | Demolition of concrete abutment.

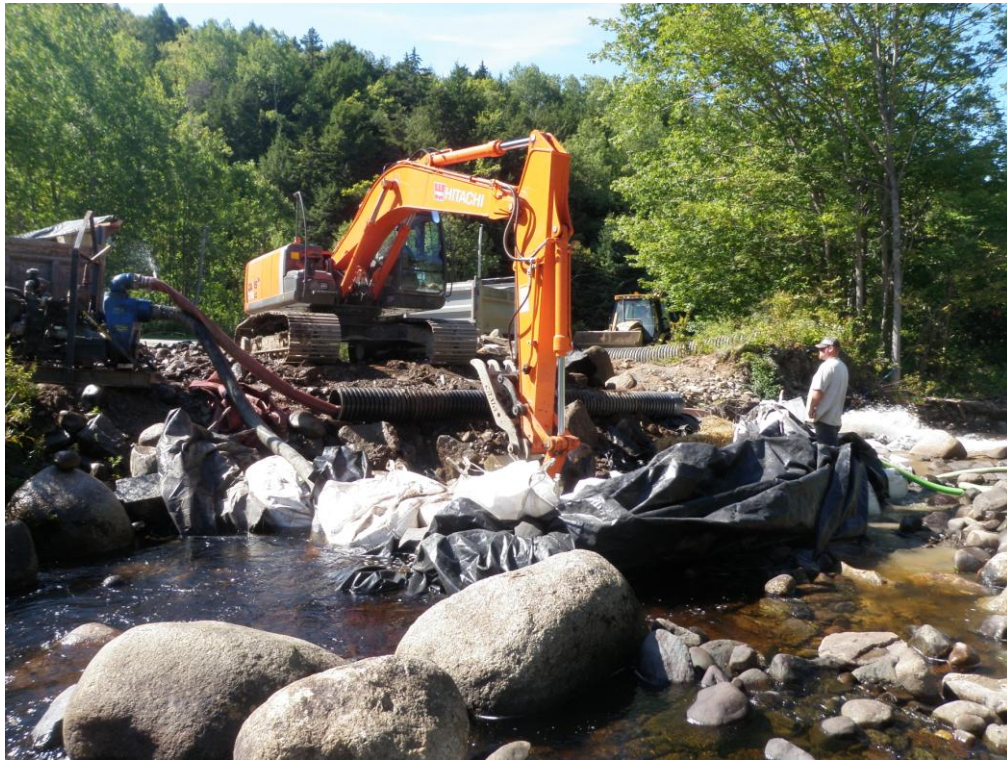
Figure 8 | Stabilizing an eroding bank upstream of the impoundment area.

The restoration of the Moose River floodplain consisted of both reconstruction and re-vegetation efforts. A diagram outlining the primary activities is presented in Figure 7. Firstly, the riverbed upstream of the former impoundment area was lowered and re-graded to widen the floodplain and remove some of the accumulated cobble debris. Three riffles were constructed in the same general area to slow the velocity of the river. In the former impoundment area, three rock weirs were built to trap sediments over time and allow the accretion of sediments alongside the Clementsport Road. Bank stabilization work was completed adjacent to Clementsport Road to cover soils exposed from the concrete abutment removal and to reinforce the existing bank structure. The fine sediments that had accumulated by the dam in the former impoundment area were also removed in order to restore the substrate to a coarser arrangement common to the Moose River system. Upstream of the riffles, a grade control structure was installed and an eroding bank was stabilized with stone and filter gravel. Figure 8 illustrates the dewatering and excavation that was completed prior to the addition of stone and filter gravel for bank protection.
