# Ecological Monitoring of the Clementsport Dam Removal Project

*Results of pre and post-restoration monitoring undertaken at  
the Clementsport Dam Removal Site on the Moose River,  
Clementsport NS*

Levi Cliche, Lindsey Freeman  
and Robert Mayhew  
August 19, 2013

## **Clean Annapolis River Project**

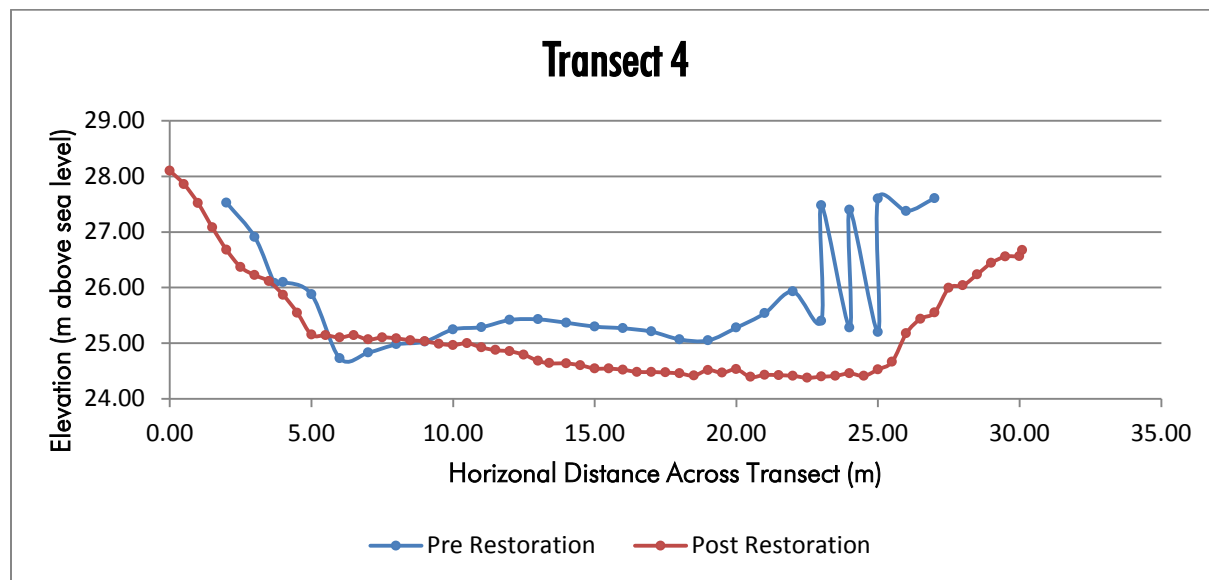
Figure 4: Cross-Sectional Profile at Transect 4

Transect 4 is located immediately upstream of the former dam, and traverses the site of the fish ladder that existed in conjunction with the dam. The location of the fish ladder can be seen in the extreme fluctuations in elevation between 20 and 25 meters across the pre restoration transect. The change in grade between 25 and 30 meters is due to the regrading of the eastern bank. The decrease in bottom elevation between 10 and approximately 22 meters post restoration is likely due to the removal of accumulated sediments from behind the dam prior to removal, and the development of a new channel can be seen by the pre and post restoration elevation changes from 10 to 25 meters across the transect.

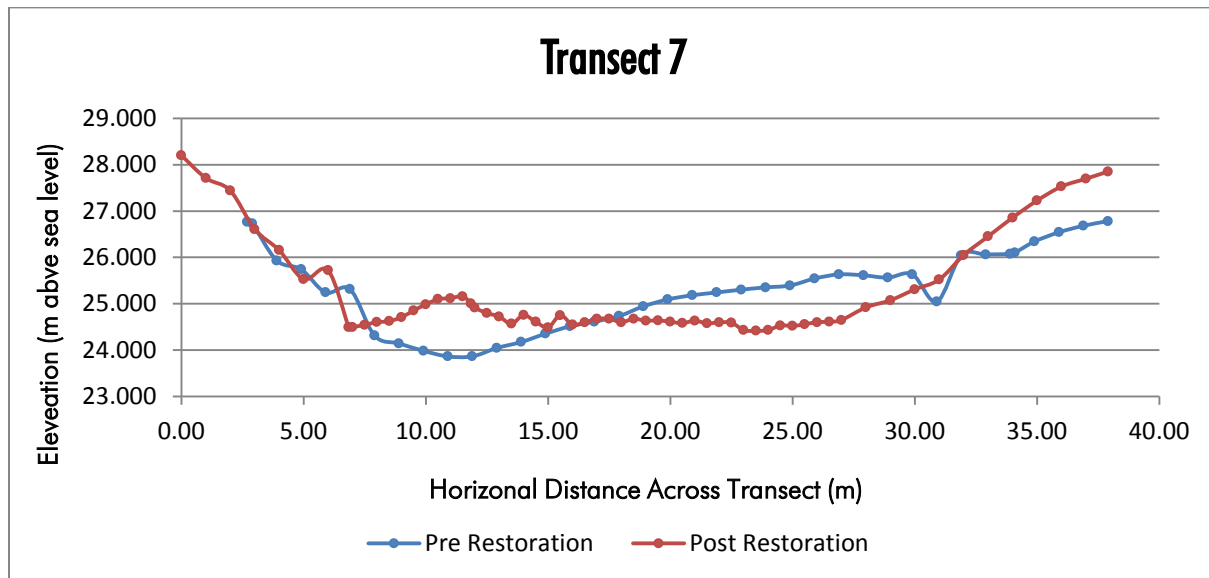
Figure 5: Cross-Sectional Profile at Transect 7

Transect 7 is located 25 meters upstream of the former dam, within the impoundment area. Some change in profile can be observed across this transect. Most notably, the bottom elevation seems to have flattened out between 7.5 and 30 meters. This may change in time as the

channel through the former impoundment continues to establish itself, but at the moment may have implications for fish passage, as the channel is wide and shallow, and may not prove passable in summer water level conditions.

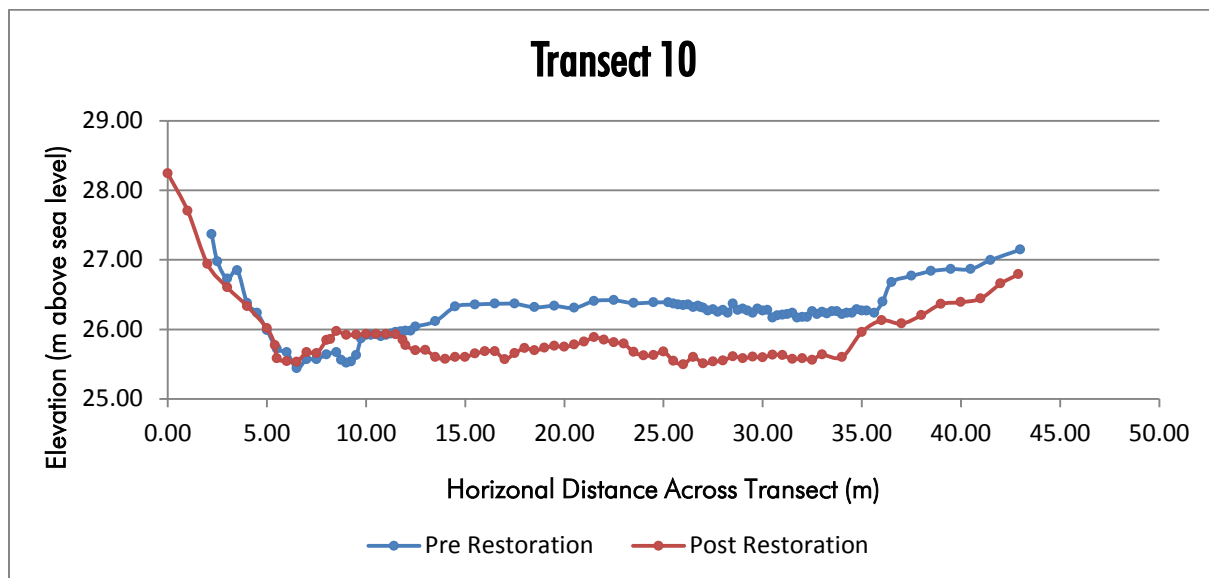
Figure 6: Cross-Sectional Profile at Transect 10

Transect 10 is located 55 meters upstream of the former dam, within the section of channel that underwent re-grading (see figure 2). The overall change in elevation observed post-restoration is likely attributable to the re-grading work. It should be noted that the thalweg elevation seen between 5 and 10 meters demonstrates little change post-restoration.

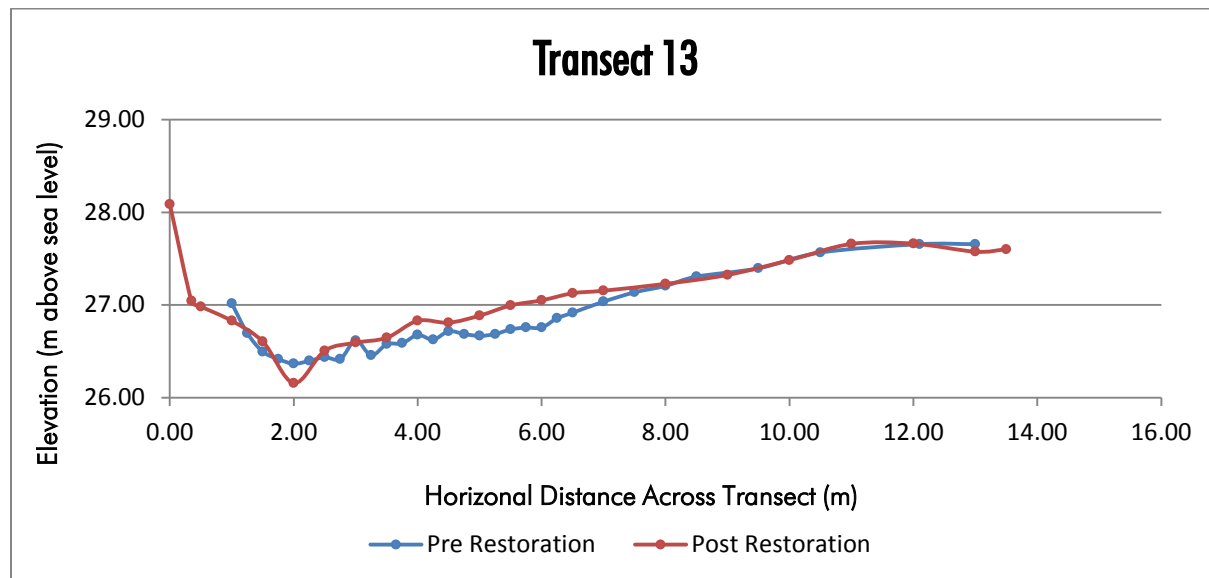
Figure 7: Cross-Sectional Profile at Transect 4

Transect 13 is located 120 meters upstream of the former dam, outside of the restoration area. Little change is seen in the cross-sectional profile at this site.

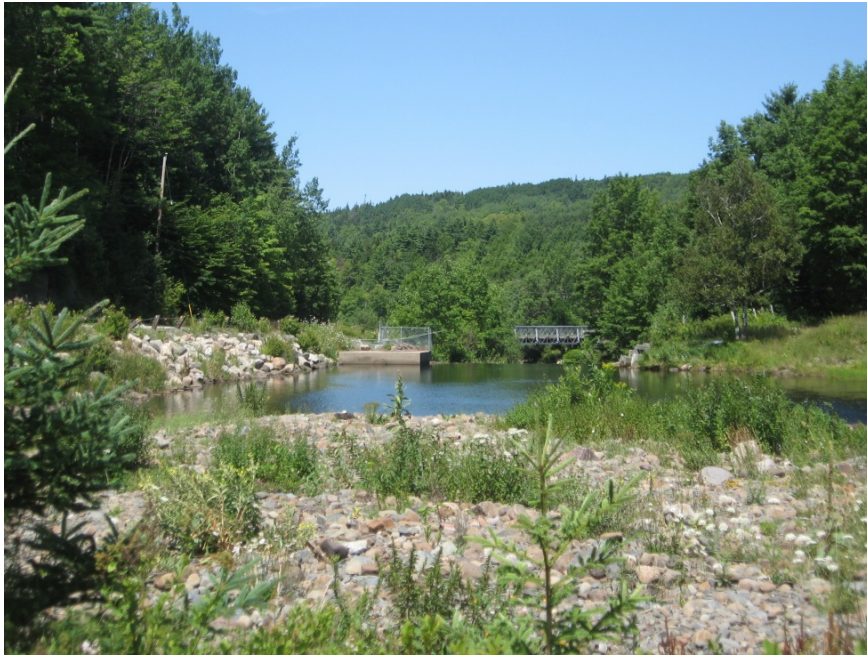
Figure 9: Station 1 Pre-Restoration August 9, 2009

The presence and extent of the headpond prior to the dam removal are seen in Figure 9. A shift to lotic conditions and the establishment of a channel are observable in Figures 10 through 12. It should be noted that in Figure 10, which shows the channel immediately after the dam removal and channel work, the wetted channel is prominently to the right within the former impoundment, flowing through a series of constructed riffles as intended in the restoration design (refer to section 1.2). Weirs installed along the left side of the former impoundment were intended to direct flow to the right and trap and build sediment to further establish the channel. It can be observed in Figures 11 and 12 that the wetted channel has shifted to the left of the former impoundment, and is flowing over the weirs. A small proportion of the flow through the site still runs through the constructed riffles, but it appears that the primary channel is being established along the left side of the former impoundment.

Changes in riparian vegetation are quite apparent in this series of photos. The presence of scattered shrubs and herbaceous vegetation can be seen in Figure 9 prior to the disturbance caused by the dam removal and channel work. Little change is noted between Figures 10 and 11. Figure 12 shows a dramatic change in vegetative cover. Shrubs and herbaceous vegetation appear to be colonizing the exposed soils in the former impoundment quite aggressively.

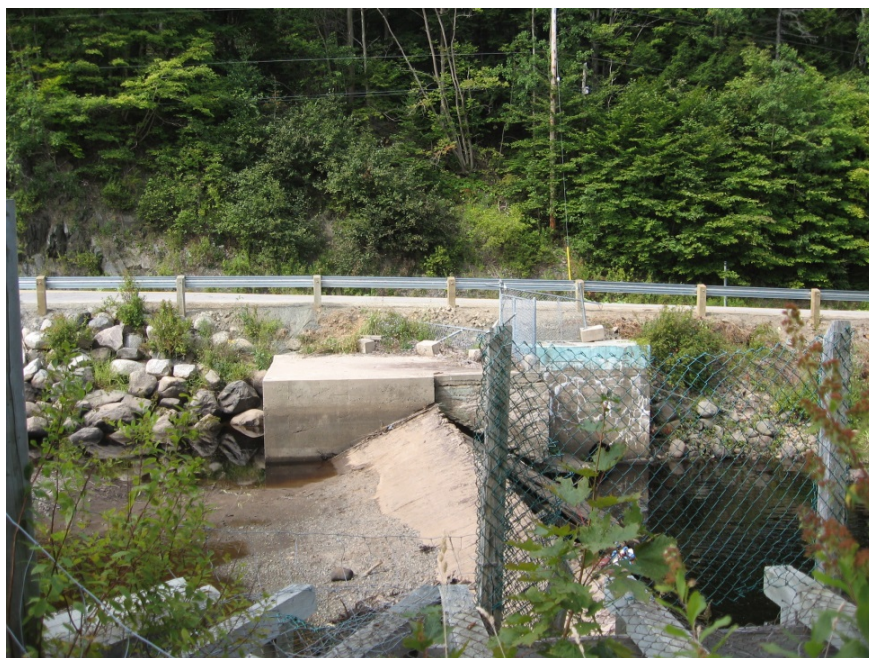
**Figure 13:** Station 2 Pre-Restoration September 11, 2009

Figure 13 shows the dam and accumulated sediments in the headpond at low flow. Figure 14 shows the site immediately after the dam and the majority of the accumulated sediments were removed. The prevalence of fine substrate material behind the former dam is apparent in Figure 14, as is the presence of a pool at the former tailwater. Figure 15 shows the establishment of the channel at station 2, and a shift in substrate to a cobble/boulder composition that is more consistent with the substrate found in reaches outside of the former impoundment. Figure 15 also shows that the plunge pool below the dam has been filled in.

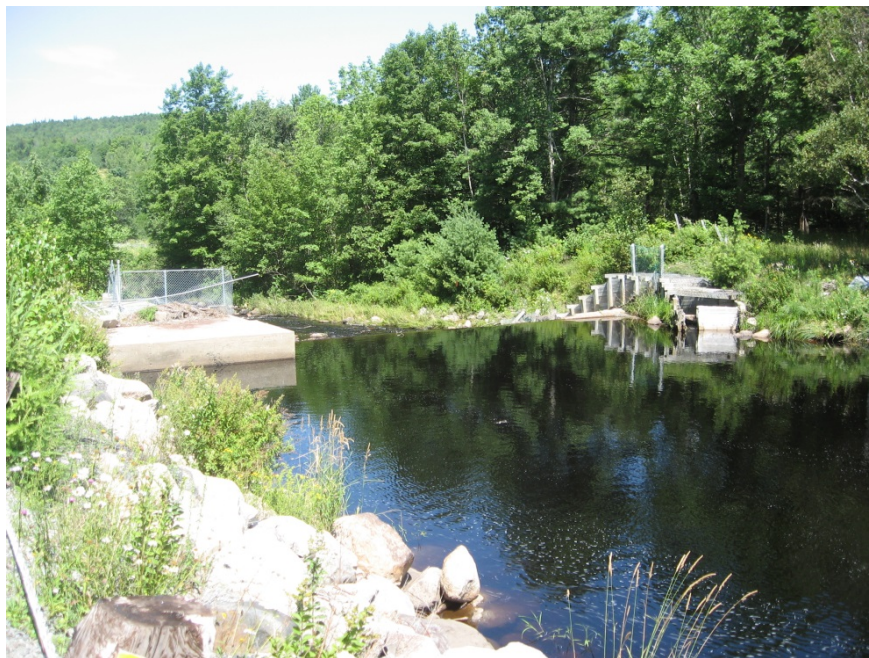
**Figure 16:** Station 3 Pre-Restoration August 6, 2009

Figure 16 shows the dam and the presence of the headpond. Figure 17 shows the site immediately after the dam was removed and the prevalence of fine substrate material behind the former dam, as well as the presence of a pool at the former tailwater. Figure 18 shows the establishment of the channel at Station 2, and a shift in substrate to a cobble/boulder composition that is more consistent with the substrate found in reaches outside of the former impoundment.

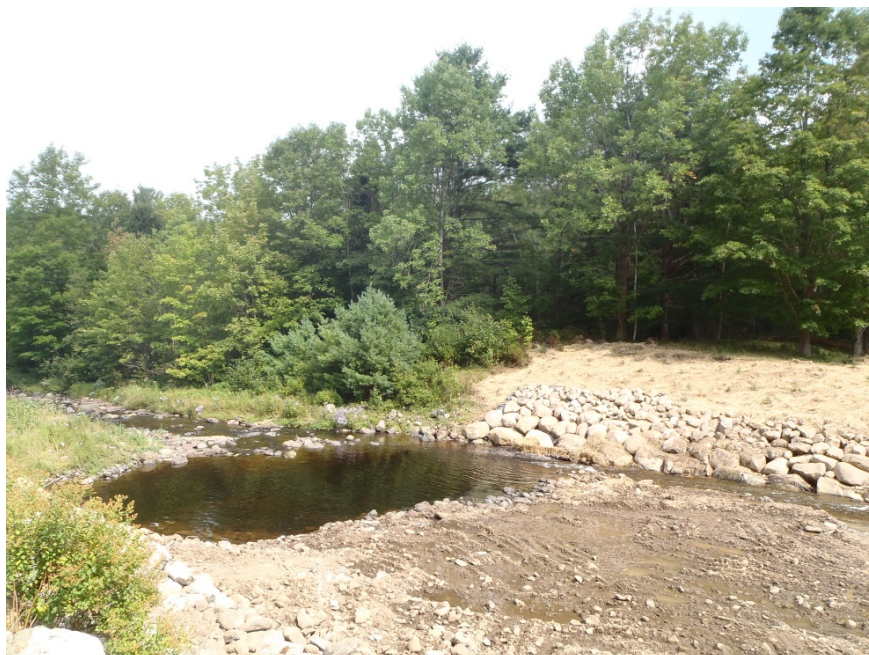
Figure 17: Station 3 Post-Restoration September 14, 2011

The presence of hay mulch and planted white spruce along the re-graded eastern bank can be seen in Figure 17. Figure 18 shows grasses colonizing the eastern bank, and sprouting willow and dogwood stakes immediately behind the location of the former dam on the west bank. Figure 19 shows further colonization of exposed soil by vegetation.

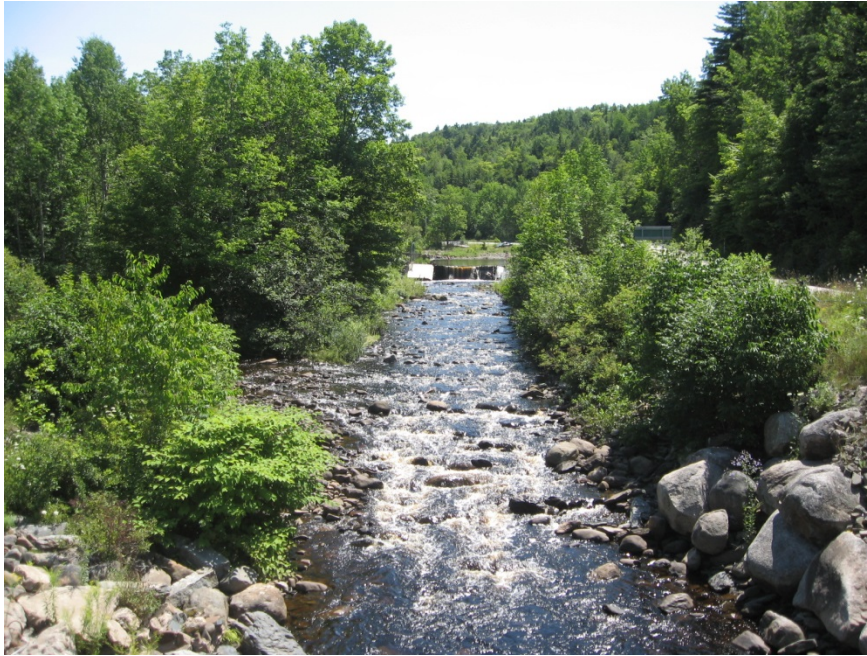
**Figure 24:** Station 5 Pre-Restoration August 6, 2009

The series of photos at Station 5 depict an upstream view of the channel between Guinea Road bridge and the former dam. The dam is visible in Figure 24, and absent in Figures 25 through 27. The channel characteristics appear consistent throughout the life of the project at this site, indicating little change in the downstream channel due to the removal of the dam.

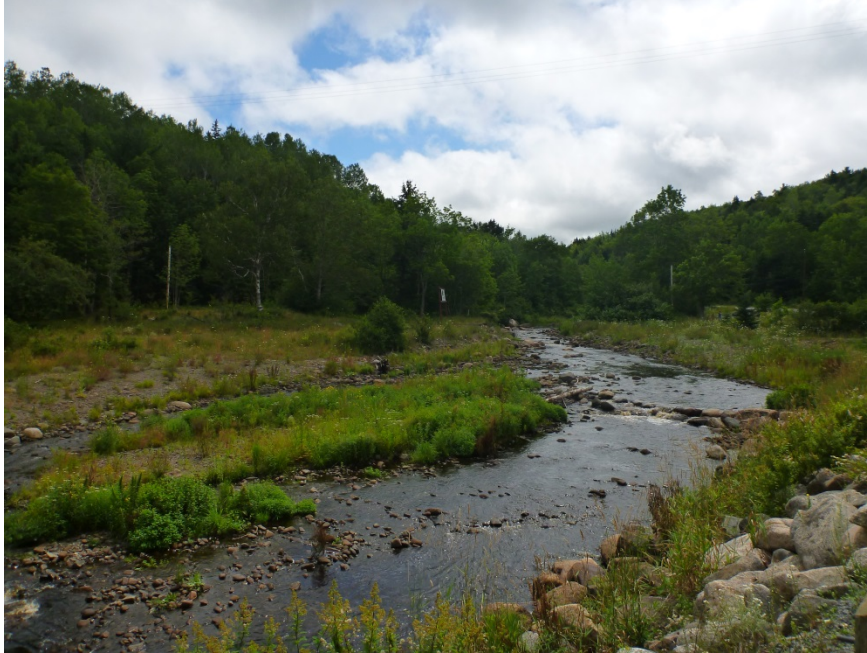
**Figure 31:** Station 6 Post-Restoration July 29, 2013

As with Station 1, little change is noted in riparian vegetation until 2013 (Figure 31) whereupon extensive colonization of exposed soils is observed.

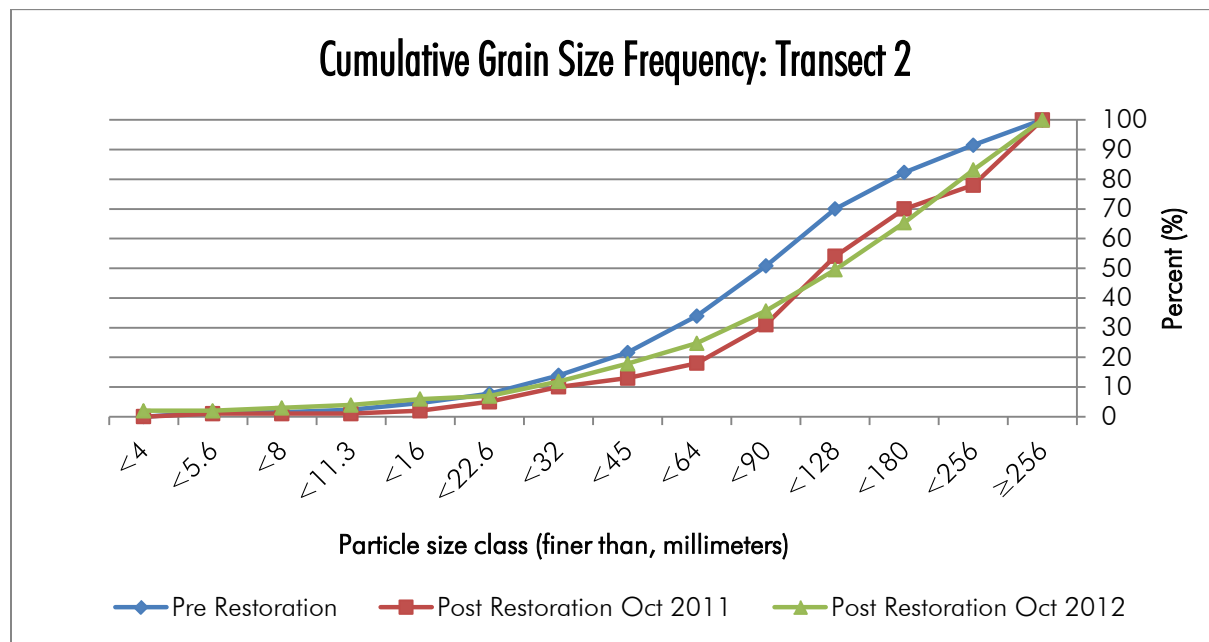
Figure 41: Cumulative Grain Size Frequencies: Transect 2

Transect 2 is located 50 meters downstream of the former dam. Little change in grain size is exhibited at this site, likely due to the fact that it was not within the restoration area, and that little to no finer materials from the impoundment settled at this location. The gradient below the impoundment is relatively steep, likely preventing settlement of fine materials.

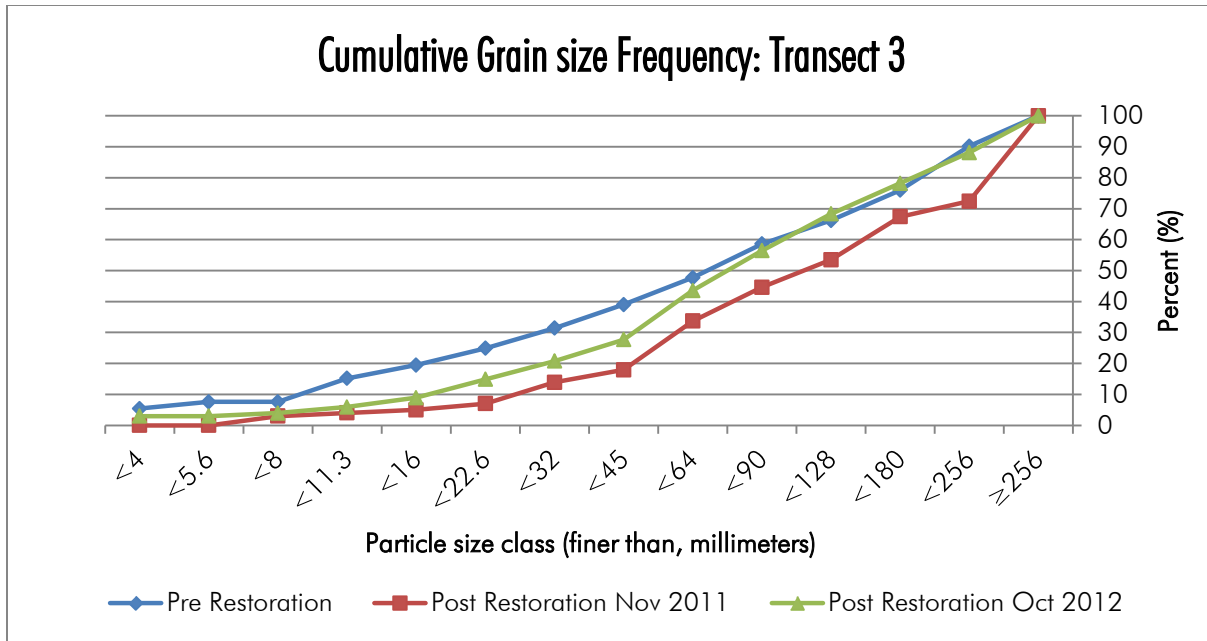
**Figure 42:** Cumulative Grain Size Frequencies: Transect 3

Transect 3 is located 10 meters downstream of the former dam. Little change in grain size is exhibited at this site, likely due to the fact that it was not within the restoration area, and that little to no finer materials from the impoundment settled at this location. The gradient below the impoundment is relatively steep (refer to Section 3.1.2: Longitudinal Profile), likely preventing settlement of fine materials.

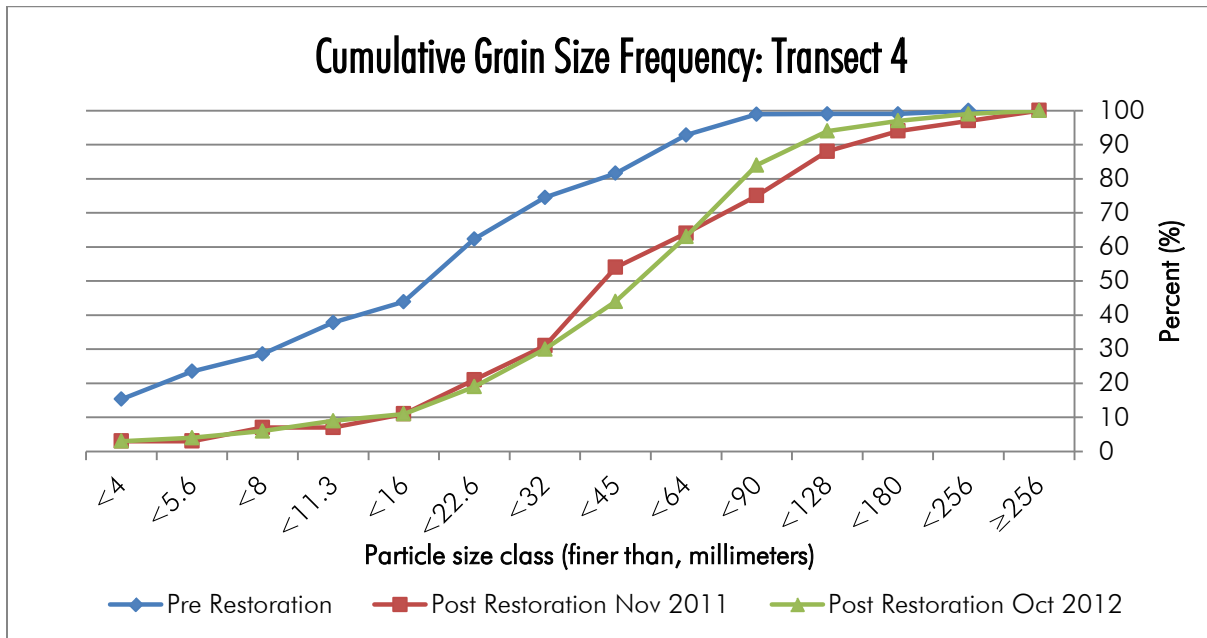
**Figure 43:** Cumulative Grain Size Frequencies: Transect 4

Transect 4 is immediately upstream of the former dam. Prior to removal of the dam, accumulated sediments were removed from the impoundment. In addition, much of the remaining finer material was liberated after the dam was removed. This likely explains the significant decrease in the proportion of grain grain sizes in all categories under 11.3 millimeters post-restoration.

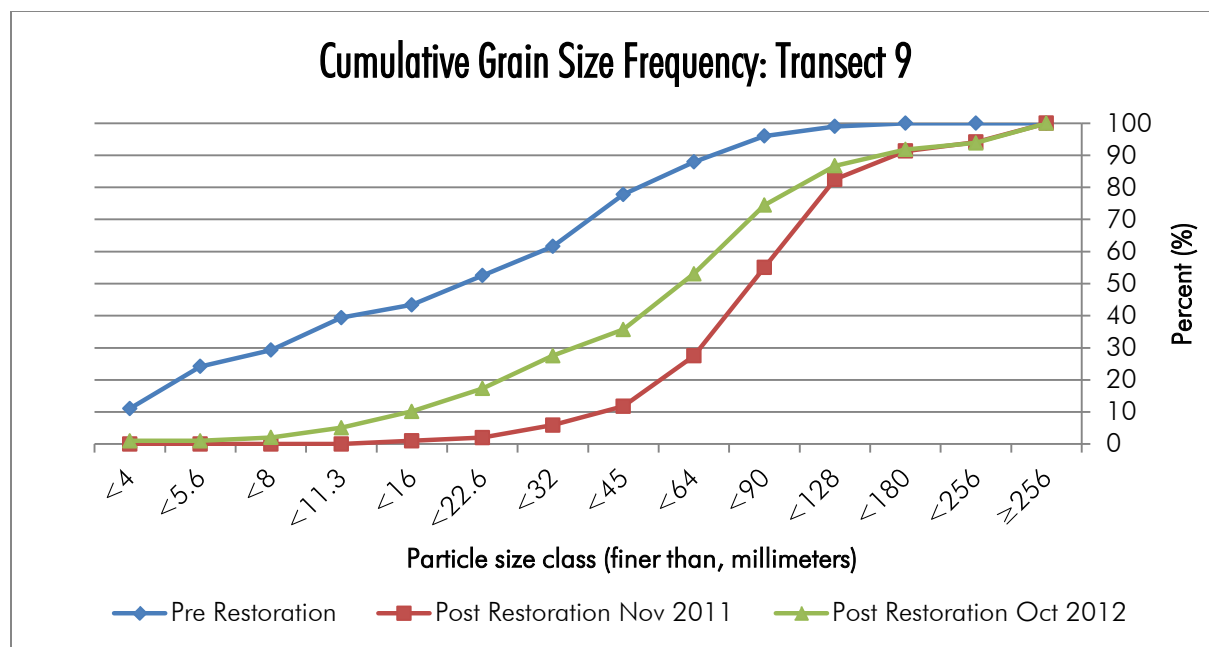
Figure 44: Cumulative Grain Size Frequencies: Transect 9

Transect 9 is located 40 meters upstream of the former dam, within the former impoundment. A notable decrease in the proportion of material <8 millimeters is apparent, and likely due to increased flow from the dam removal carrying finer material downstream.

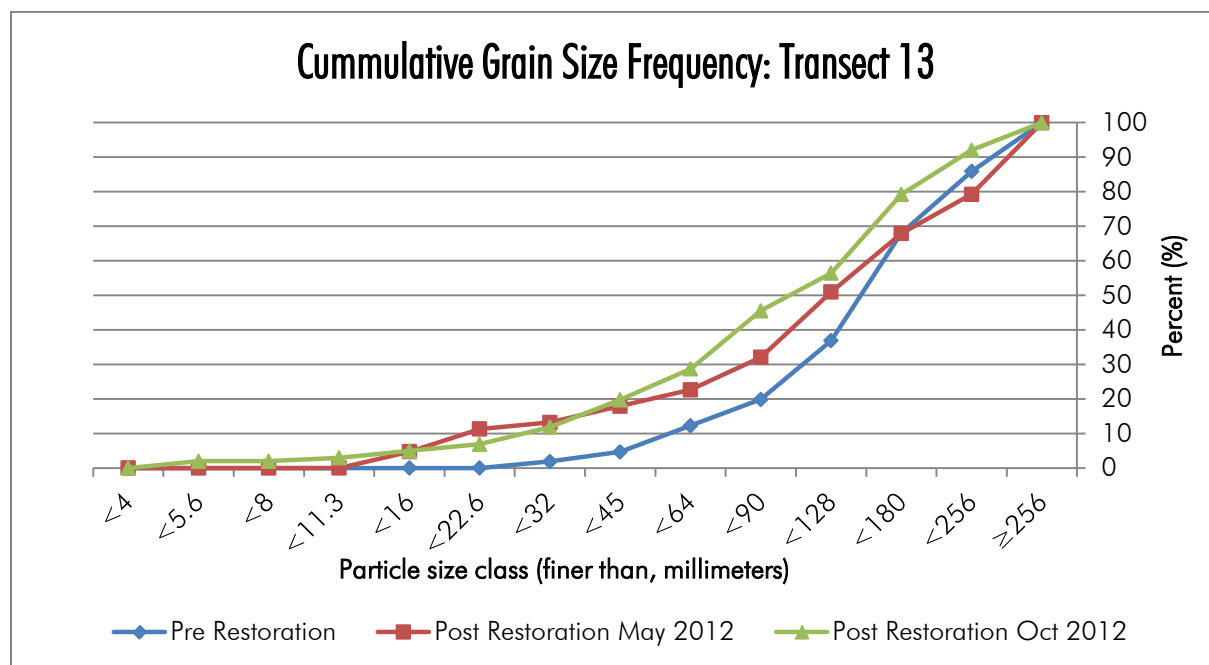
Figure 45: Cumulative Grain Size Frequencies: Transect 13

Transect 13 is located 120 meters upstream of the former dam, in the location where the grade control structure was installed. Very little change in grain size distribution is noted at this site, likely due to the fact that the gradient at the location changed little from the construction of the grade control (refer to Section 3.1.2: Longitudinal Profile), and that it is at the upstream margin of the restoration area.

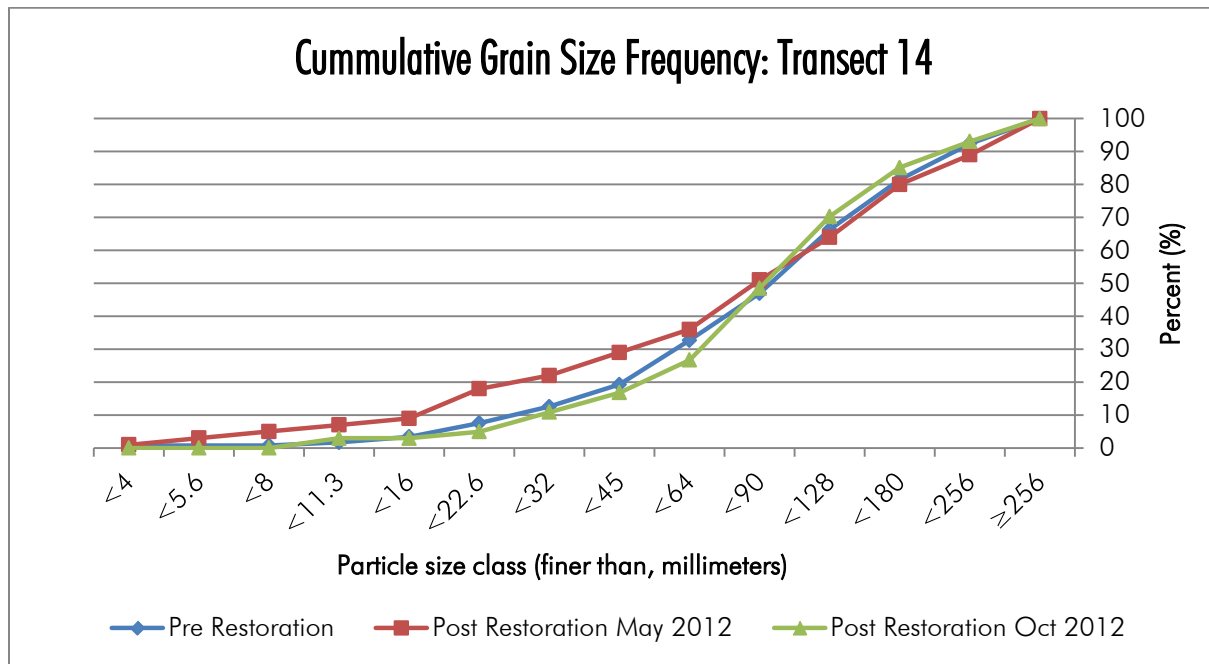
Figure 46: Cumulative Grain Size Frequencies: Transect 14

Transect 14 is located 180 meters upstream of the former dam. Very little change is noted in grain size distribution. This site is well upstream of the restoration, and outside of the influence of the former dam.
