# Fish Passage Restoration and Habitat Enhancement

*Atlantic salmon habitat restoration on the Fales River*

Rachel Walsh  
December 2024

## ***Clean Annapolis River Project***

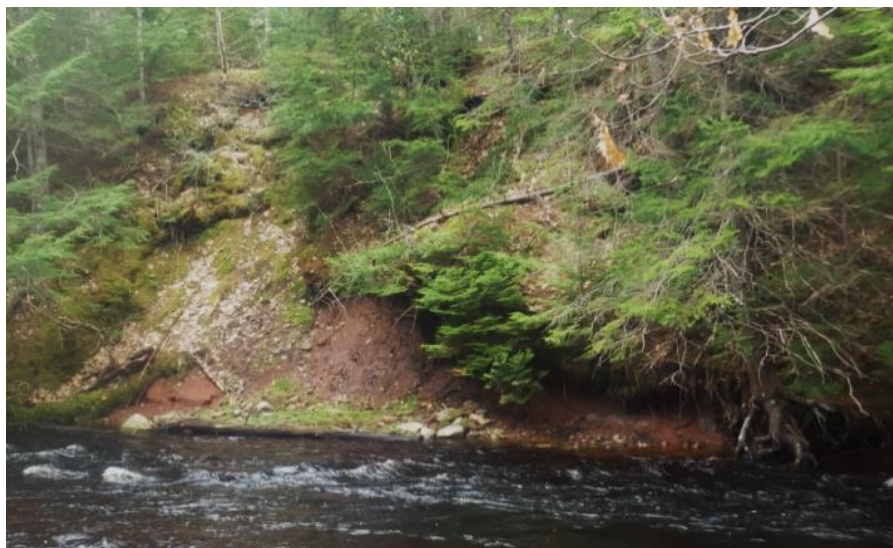
Figure 1. Eroding bank on the Fales River.

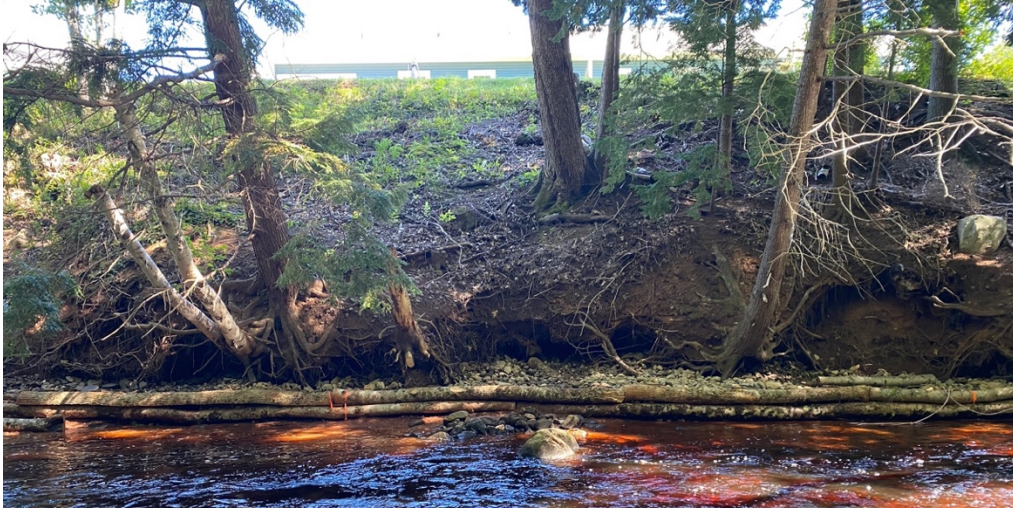
A log crib was installed to support an eroding bank on the Fales River. The logs of the crib were stacked two high and pushed up against the bank, and rock was used to fill the space behind the log wall. Due to the large size of the crib and the amount of rock needed to fill it in, a dump truck load of ~20 cm diameter basalt was delivered to the restoration site. Wheelbarrows and a paddleboard were used to float the rock down the river to efficiently fill in the structure. The completed log crib stabilized a 16-meter section of eroding bank, with a height of 0.45 meters.

**Figure 8.** Log crib installed to protect an eroding bank along the Fales River.

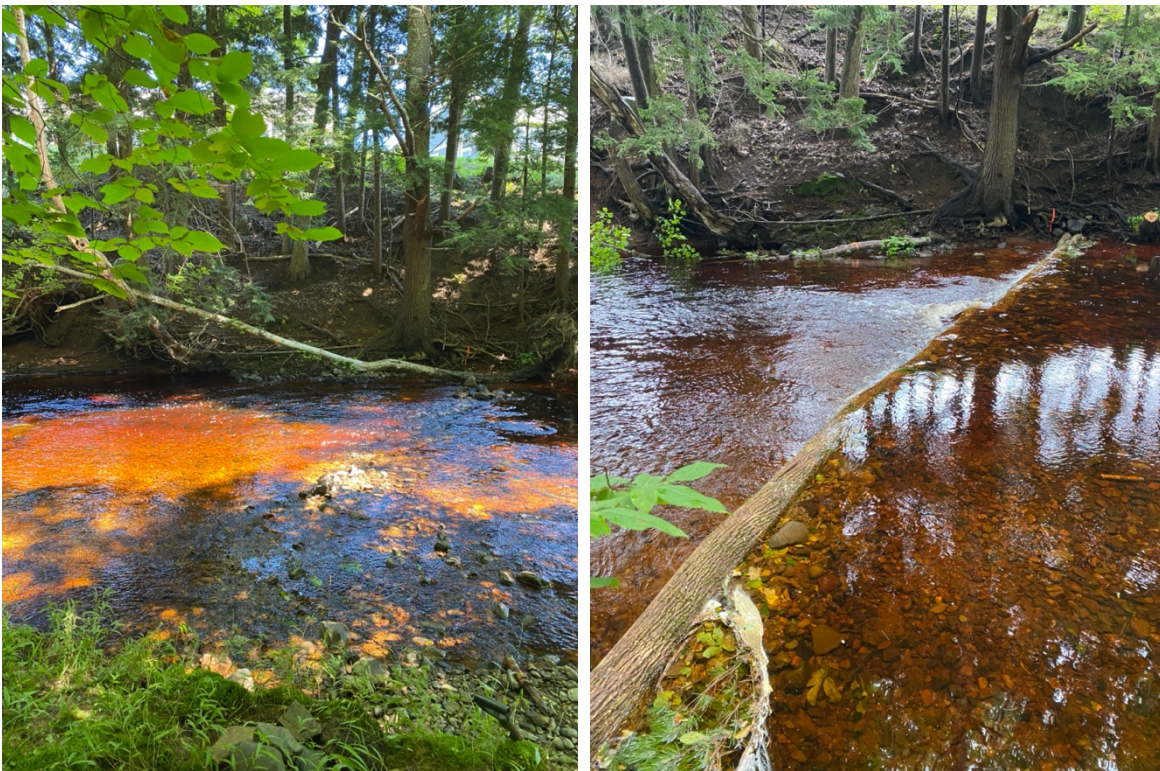
A double digger log was installed to enhance salmonid spawning, rearing and migration habitats while addressing fine sediment accumulation within the streambed. This structure was designed to support the riffle-pool-run sequence of the river by stabilizing the bottom of a riffle and creating a downstream pool. The double digger log spanned 14 m and consisted of two logs angled to meet at the low point on the right bank, focusing flows on the pool side of the stream. The in-stream area restored by the digger log totals 958.4 m<sup>2</sup>.

**Figure 9.** Before (left) and after (right) digger log installation on the Fales River.

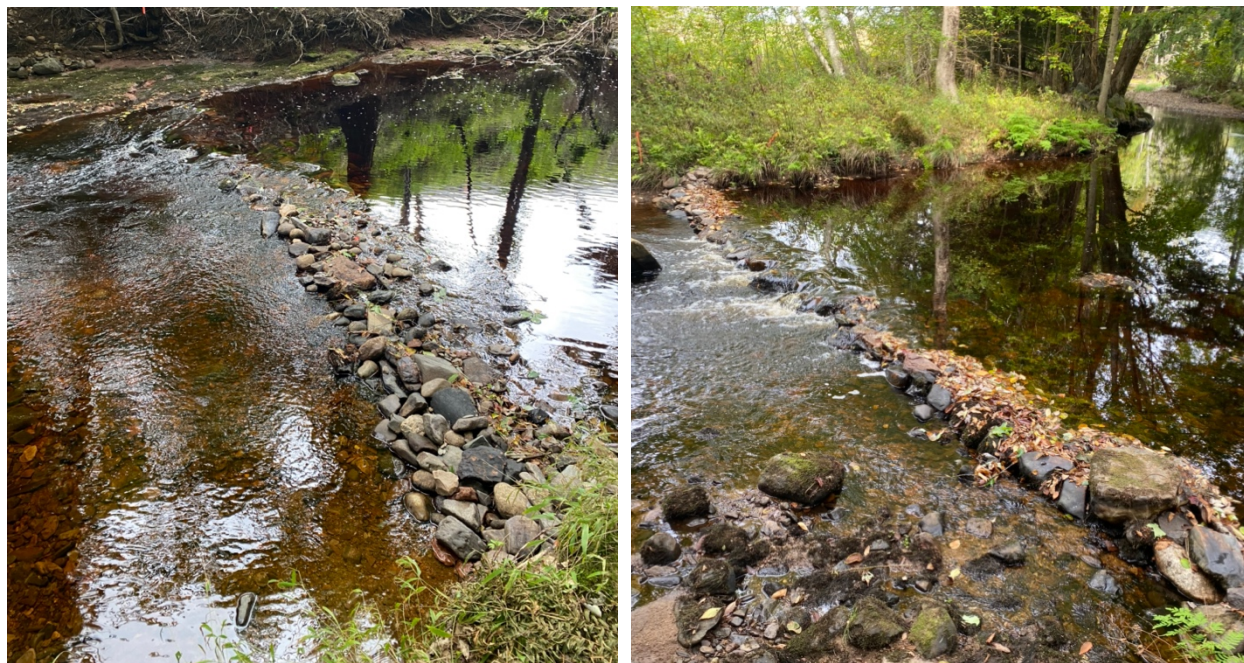
Two rock sills were constructed at the heads of pools to enhance upstream riffle sections and downstream pool habitats. The downstream sill was built to a height of 30 cm, while the upstream sill reached 20 cm. Both structures spanned the width of the river and included 2 m rock ramps on their upstream sides. The two sills combined restored an in-stream area of 1,643 m<sup>2</sup>.

Figure 10. Two rock sills installed along the Fales River.
