Summary of Pre-Restoration Monitoring Clementsport Dam, Moose River, Nova Scotia

Prepared by Marla Bojarski

Clean Annapolis River Project
P.O. Box 395, 151 Victoria Street, Annapolis Royal, NS, B0S 1A0
902 532 7533; carp@annapolisriver.ca; www.annapolisriver.ca

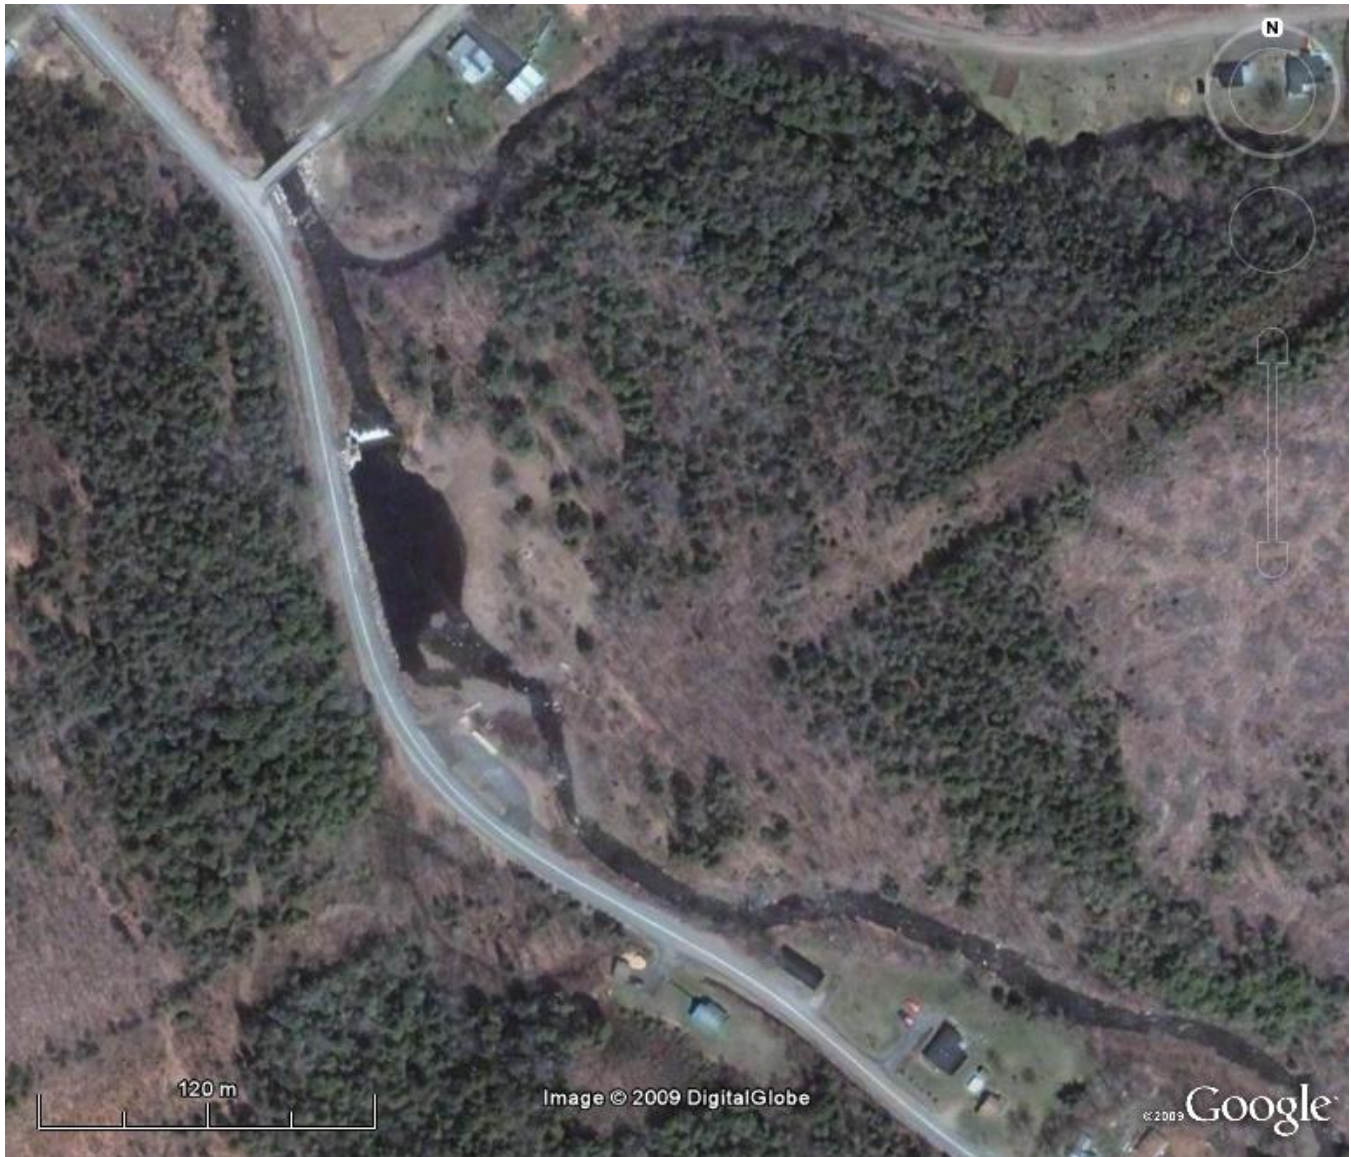
Figure 2. An aerial photo of the Clementsport dam and impoundment. Direction of water flow is from south to north. The road to the west is Clementsport Road.

Up until 2007, partial fish passage over the Clementsport dam existed at high water levels, with parr and adult salmon being reported above the dam. It has been reported that fish congregating in the pool at the foot of the dam have been subjected to poaching. Figure 2 presents an image of Moose River at the Clementsport dam.

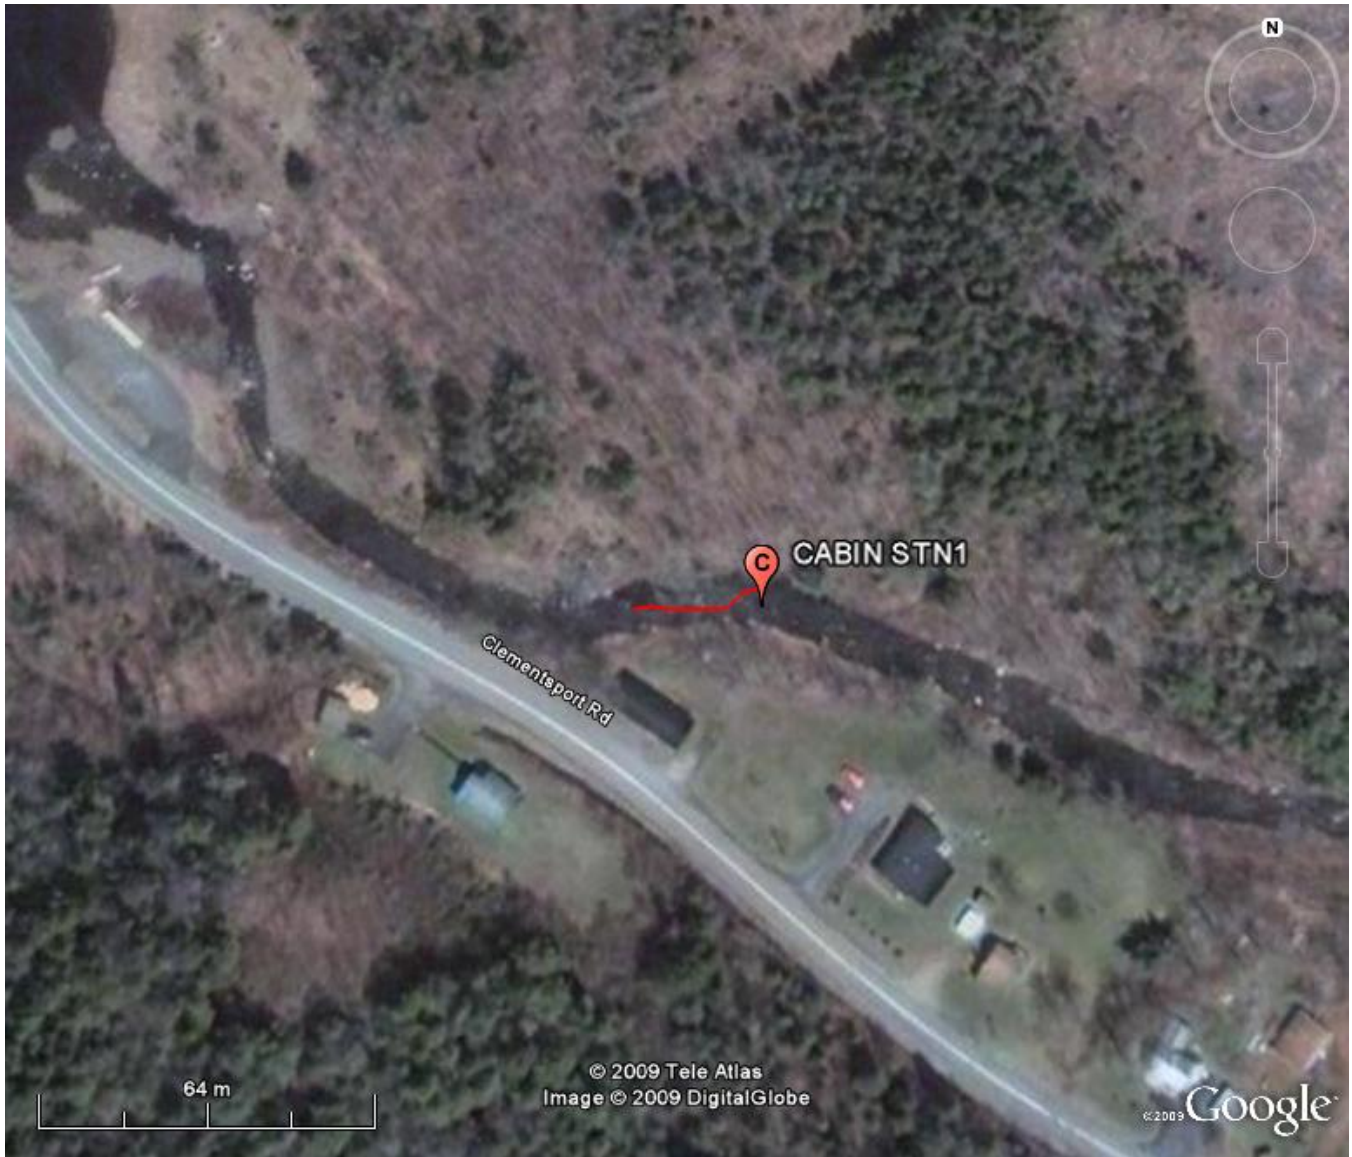
Figure 7. Shows location of CABIN station one, located upriver of impoundment, as well as the approximate path taken for sample collection. The kicknet and movement of the collector was against the river current and was therefore towards the east.

A GPS point was recorded for each sampling station (Appendix A). The CABIN procedure employs a timed kicknet collection with a 500 μ m mesh size. Maps 6, 7 and 8 shows the locations and approximate paths of the samples collected. Note that the direction of the path was always against the current of the river. If there were large boulders or other obstructions in the way, the net was held downstream while the object was brushed by hand, and the current carried any macroinvertebrates into the net. The collector moved upstream in a zigzag pattern across the streambed for 3 minutes. The sample was then preserved in an 85% ethanol solution. Habitat information for each site was collected.

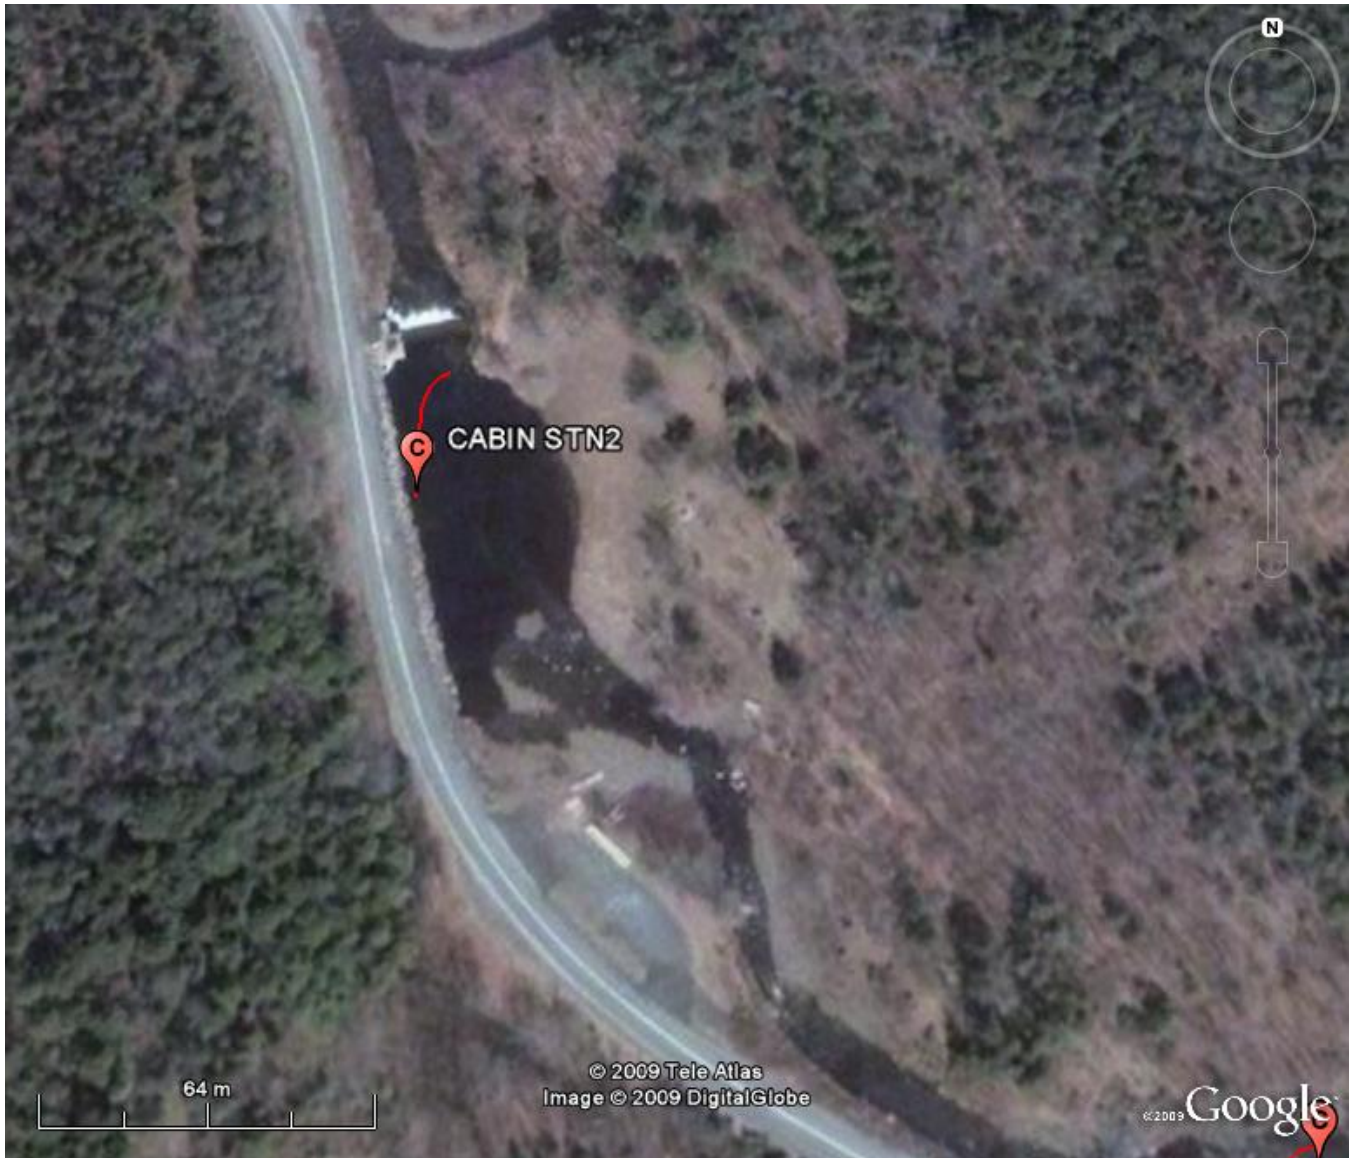
Figure 8. Shows the location of CABIN station two, in the impoundment and the approximate path taken for sample collection. The direction of movement by the collector was against the river current, and therefore was towards the south.

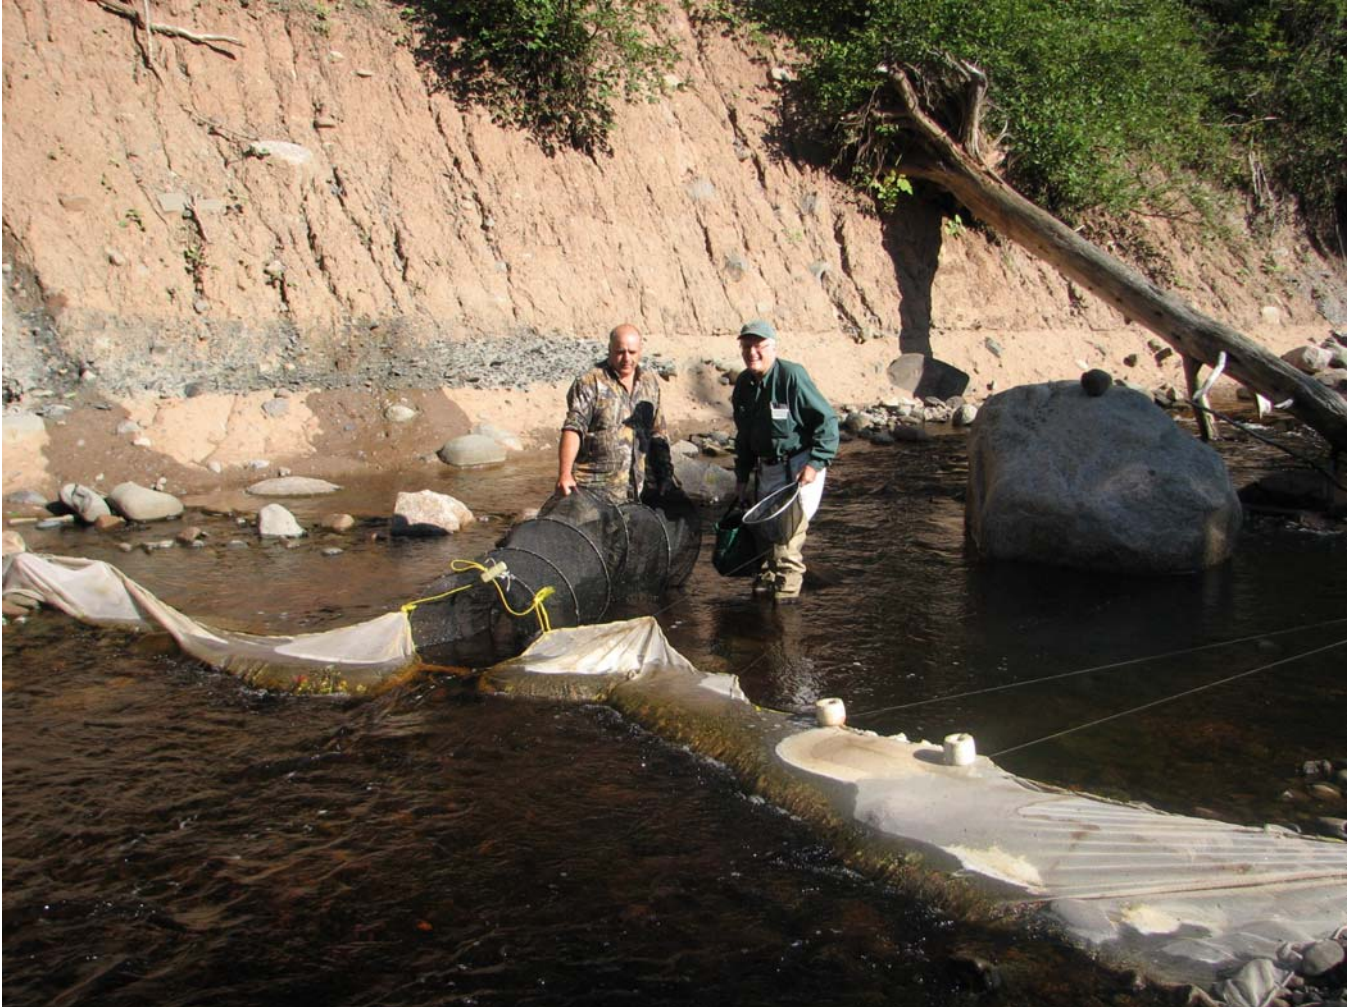
Figure 10. Fyke net in place 400 meters from the Annapolis Basin positioned to capture fish moving upstream. Roy Bertaux (left) and Reg Baird (right) were the local experts conducting the survey. Image by Barb Baird.

Equipment included placing one fyke below the Clementsport dam approximately 400 meters from salt water (the Annapolis Basin). The net was deployed September 7th and was checked every 24 hours. Fish were measured, identified to the species level and returned to the river. The net was retrieved on October 4th, 2009. Figure 10 shows the fyke net in place. Results from this exercise confirmed the presence of Atlantic salmon (*Salmo salar*) (Figure 11), Brook trout (*Salvelinus fontinalis*) (Figure 12), and American eel (*Anguilla rostrata*) (Figure 13).

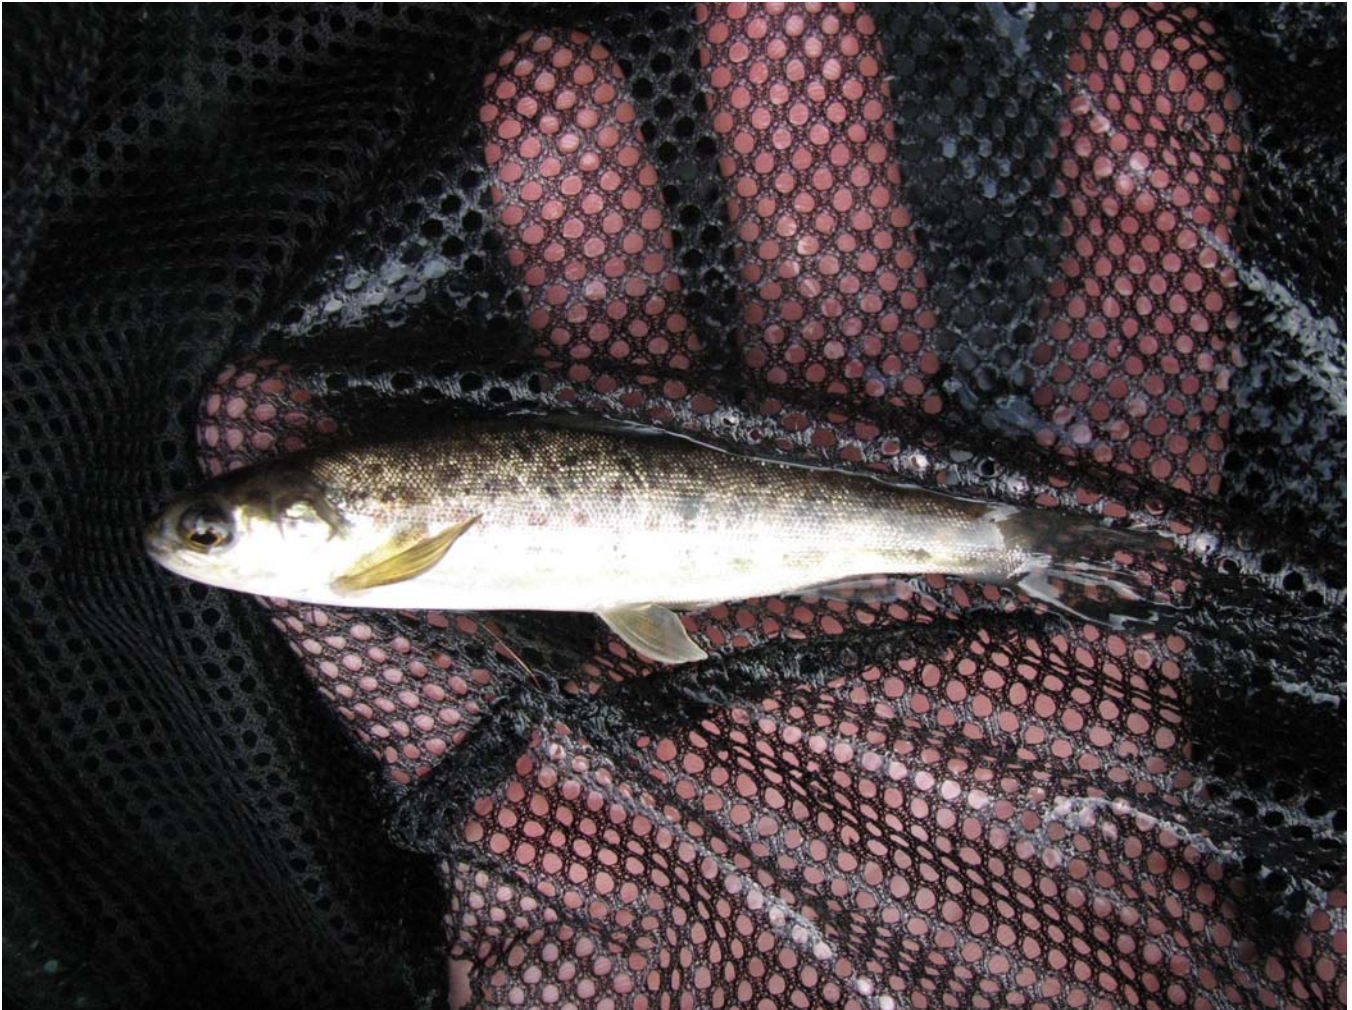
Figure 11. Photo taken of Atlantic salmon parr (*Salmo salar*) down stream in Moos River. The angle of the fyke net used was such that it caught fish moving upstream. Image by Barb Baird.

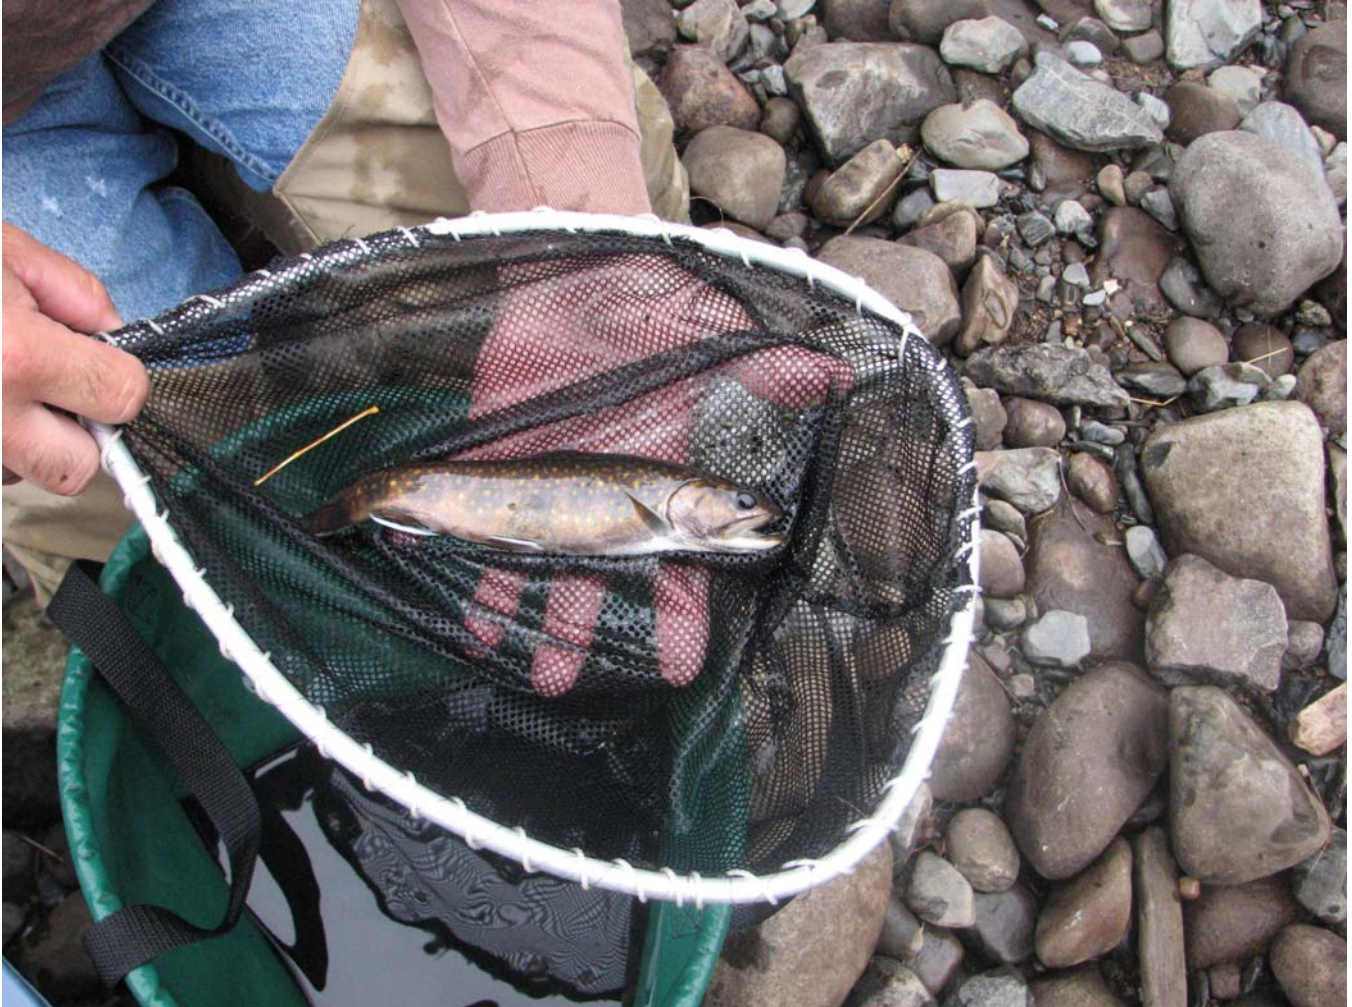
Figure 12. Photo of Brook trout (*Salvelinus fontinalis*) caught moving upstream in the Moose River. Image by Barb Baird.

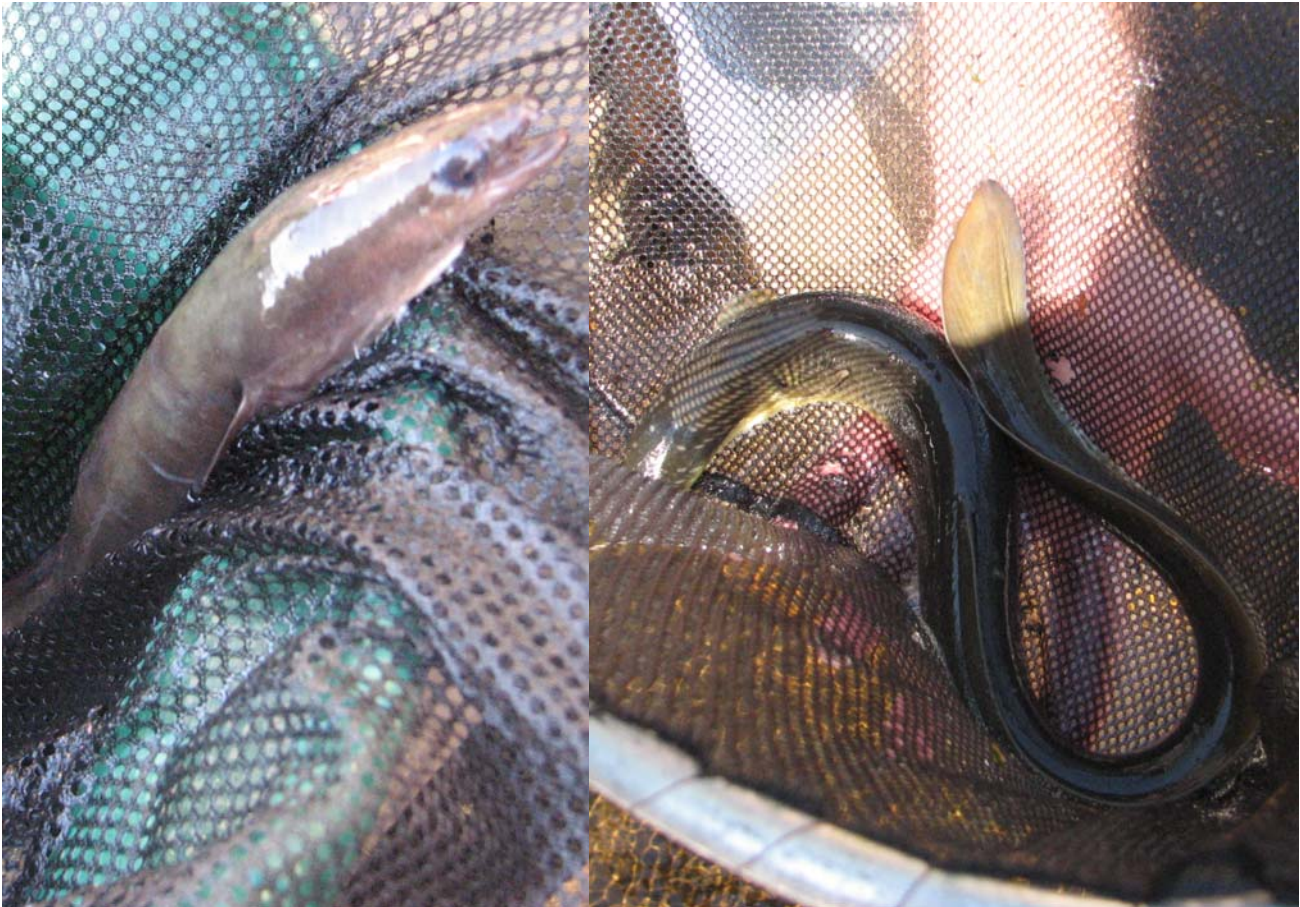
Figure 13. Photos of American eel (*Anguilla rostrata*). The same specimen is shown, the photo on the left is a view of the head, while the photo on the right shows the majority of the body with the head obscured. This specimen was found just above one wing of the fyke net. Image by Barb Baird.
