The Working by Water Project was a project developed by Clean Annapolis River Project in the fall of 2002 to limit the sources of land-based pollution to the Annapolis River watershed. The project began in January of 2003, upon receipt of funding from Eco Action. The focus of the project was directed mainly at agricultural land uses adjacent to waterways, including pastureland and cropland located on river frontage, or through which tributaries to the Annapolis River run. A few non-agricultural sites where sedimentation due to erosion was occurring were also included in the project. Activities undertaken to achieve the project's goals focused mainly on establishment, enhancement and protection of riparian buffer zones, and on limiting livestock access to waterways.

This report will summarise Clean Annapolis River Project's Working by Water project that was developed in the fall of 2002, and implemented in the spring of 2003. It will provide detail on the reasoning for the project and its development, its realisation, and the results obtained from its implementation.

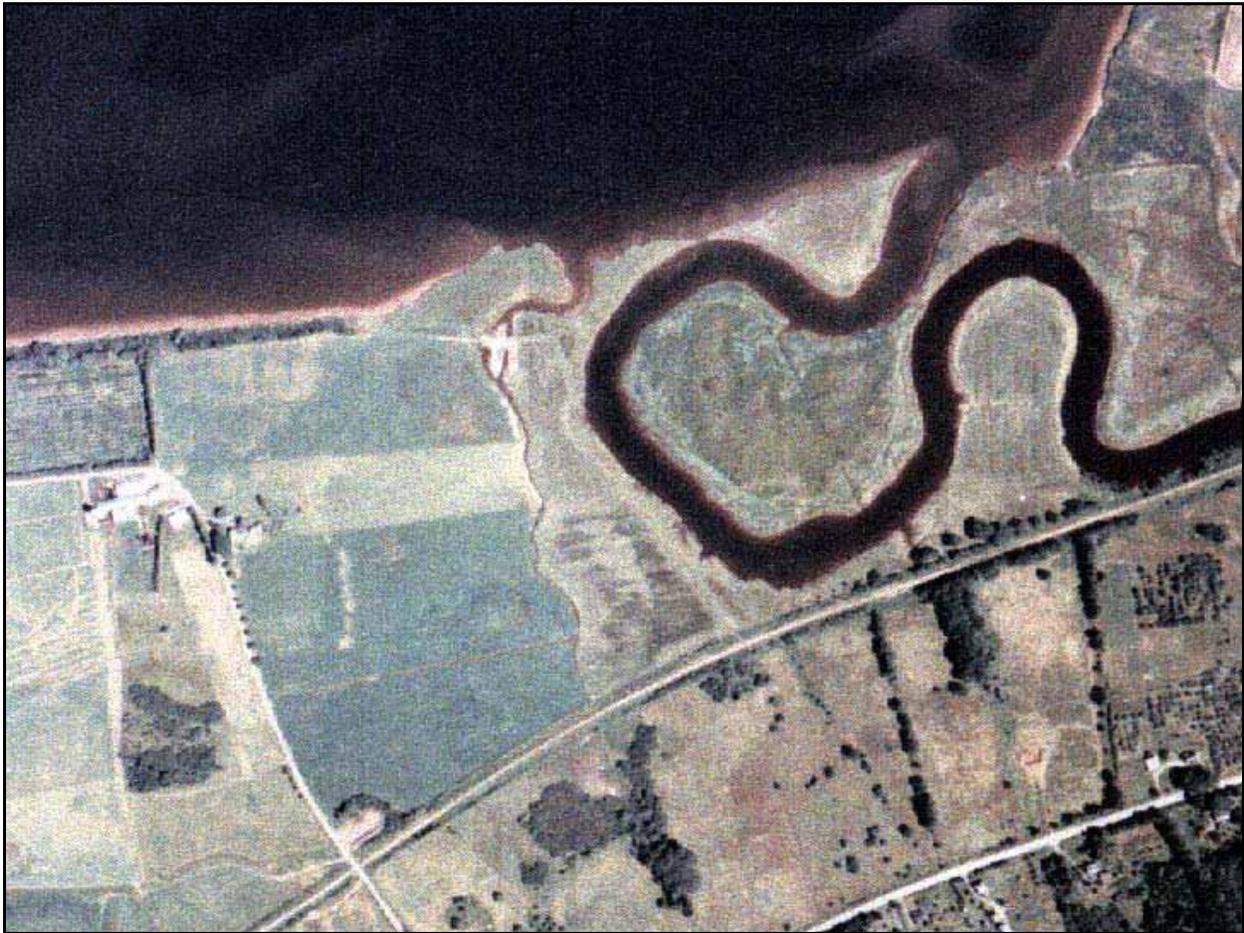
Bishop Family Farm (Round Hill)

- 1- Pine trees and willow shrubs planted, and electric fence installed
- 2- Pine trees and willow shrubs planted
- 3- Ditches planted with willow shrubs
- 4- Farm
- 5- Live sills

The Bishop Family Farm is a large dairy and beef operation located off Highway 201 in Round Hill. There is much pastureland associated with this operation along the banks of both the Annapolis and Round Hill Rivers. The bank of the Annapolis River at one location on this site was found to be eroding rapidly. This bank is very high and steep, and is composed mostly of sand and clay. There is a flat area at the foot of the steep bank where there is vegetation growing between the slope and the river at most times of the year. However, when the water level is high enough, the flow comes in contact with this steep bank, washing material away from the foot of the slope and causing further erosion. This is also a concern because of the sedimentation this is causing to the Annapolis River. In order to remedy this situation, the plan consisted of building live sills covering a portion of this slope in hopes that the method would succeed in lessening the grade, stabilizing the soils, and establishing vegetation there. This experimental solution would act as a guide for future activities intended to stabilize the significant area over which the described process of erosion is occurring.

Much of the pastureland at this site is along the Round Hill River, in the area just upstream of its confluence with the Annapolis River. Livestock were found to have direct access to the Round Hill River, as well as several small waterways flowing into the river. The first plan developed with the Bishop Family Farm included fencing to restrict cattle access to a large portion of the Round Hill River, and planting pines and willows between the fence line and the water's edge in order to establish and maintain a healthy riparian buffer zone between the pastureland and the river. This was later removed from the plan, as funding did not appear sufficient to allow for this portion of the site plan. As the project progressed, it appeared that it would be possible to fence and plant the area previously slated for these activities, as well as to maybe extend the previously planned fence to include a larger area of pasture than was anticipated when the plan was developed.

After the amendments to the site plan described above had taken place, the implementation of the plan was completed as expected. A Watercourse Alteration Permit for bank stabilisation was obtained from the Department of Environment and Labour. Fifteen live sills were constructed on the steep, eroded bank described above, and three bundles of shrub willow stakes were buried in the bank in hopes that they would sprout in the spring. At the top of the eroding slope, two rows of willow stakes were pounded into the ground as an experimental planting. On the portion of pastureland included in the site plan, red pines were planted in a furrow ploughed by the landowner at a distance of 5m from the water along 600m of the Round Hill River. Shrub willows were planted between the row of pines and the river along this 600m stretch, as well as along both sides of 100m of ditch running through the pasture to the Round Hill River.

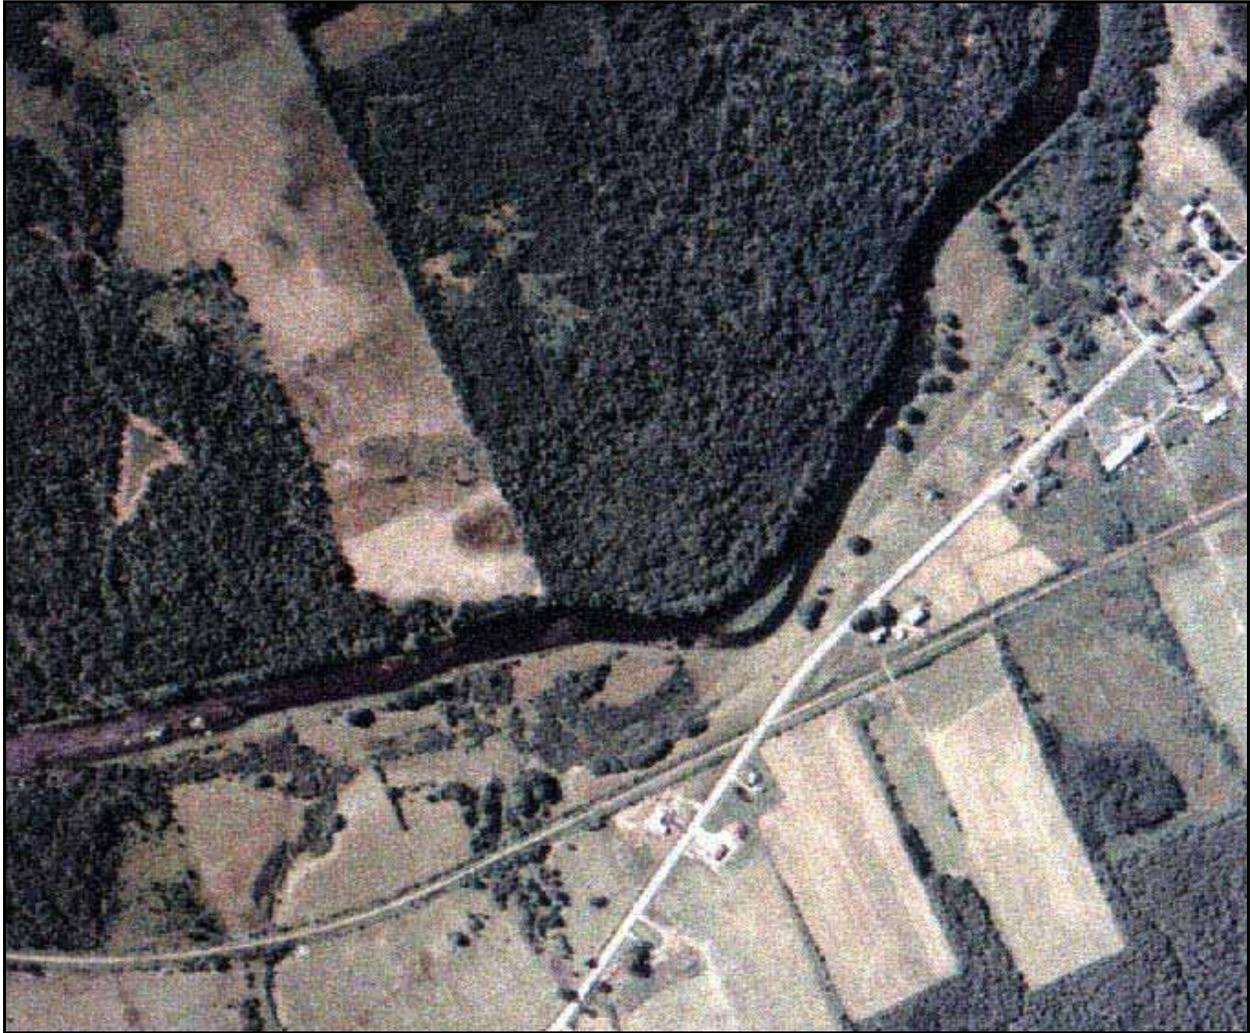
Lilly Property (Lawrencetown)

- 1- Pine trees and willow shrubs planted, and electric fence installed
- 2- Alternative watering systems
- 3- Water crossings
- 4- Farm

Annapolis River were inadequate, and in some locations were lacking completely. This led to the development of a site plan focusing mainly on restriction of livestock access to the waterways, with the priority being the Annapolis River itself. The river was to be fenced out completely, as well as two of the waterways if time and resources permitted. Recycled plastic fence posts were to be used for fencing. These posts, fabricated with waste silage wrap generated on farms, were chosen for their durability, UV resistance, their inert nature, and for the fact that their production from recycled materials places less demand on natural resources. Crossings were to be constructed on the two brooks crossing the pasture, and gates were to be erected on each crossing to allow the brooks to be used as dividing lines between sections of pasture. Due to the fact that the cattle would no longer have access to fresh water for drinking, it was deemed necessary to install two watering systems to provide a source of water for the herd. Trees were to be planted along the entire riverfront on the Lilly property in order to help establish a healthy riparian buffer between the livestock grazing area and the Annapolis River.

This site was the most intensive site within the project. The plan that was developed was to encompass all of the methods that were chosen to accomplish the project's goals excepting live sill construction. The result was to be a site on which all livestock access to the waterways was eliminated, and where the entire waterfront of the Annapolis River had undergone riparian zone restoration/enhancement activities (i.e. tree planting). Due to many factors including unforeseen difficulties in fencing some sites, weather, and time constraints, a portion of the fencing was not completed during the 2003 field season. The entire riverfront of the Annapolis River at this site was fenced at a distance of 10m from the water, but there still remains some fencing to be done on the brooks flowing through the pastures. The landowner still intends to continue implementing the plan independent of the project as time permits.

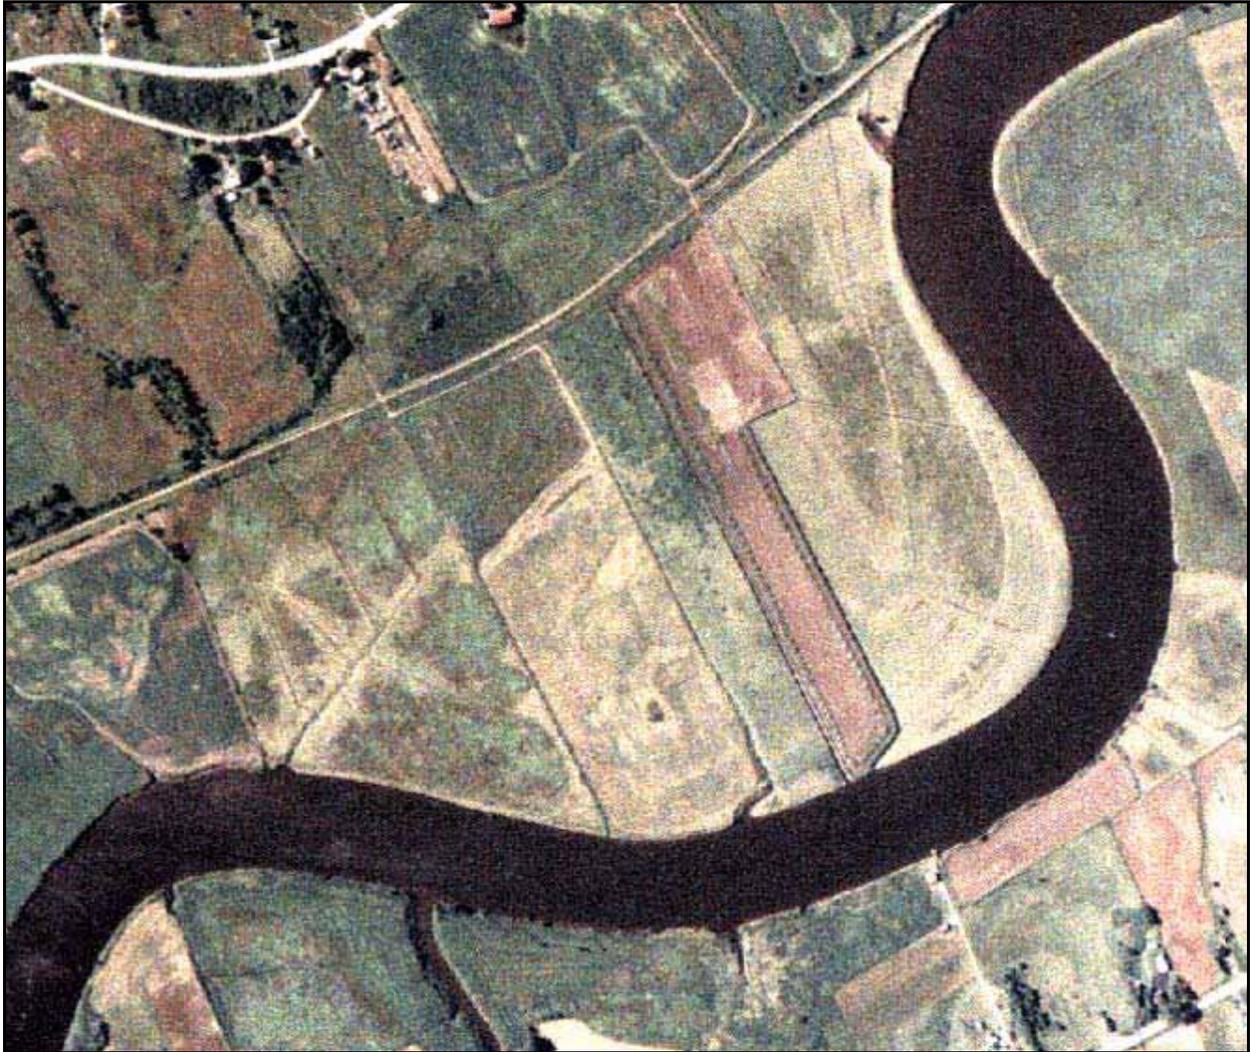
Centrelea Properties (Centrelea)

- 1- Burton Messinger Property: Pine trees planted
- 2- Scott Ritchie Property: Pine trees planted along the riverfront and ditches
- 3- John Walker/William Piggot Property: Pine trees planted
- 4- Timothy Rice Property: Pine trees and willow shrubs planted
- 5- Helen Messinger Property: Pine trees and willow shrubs planted
- 6- Timothy and Thomas Rice Property: Pine trees and willow shrubs planted

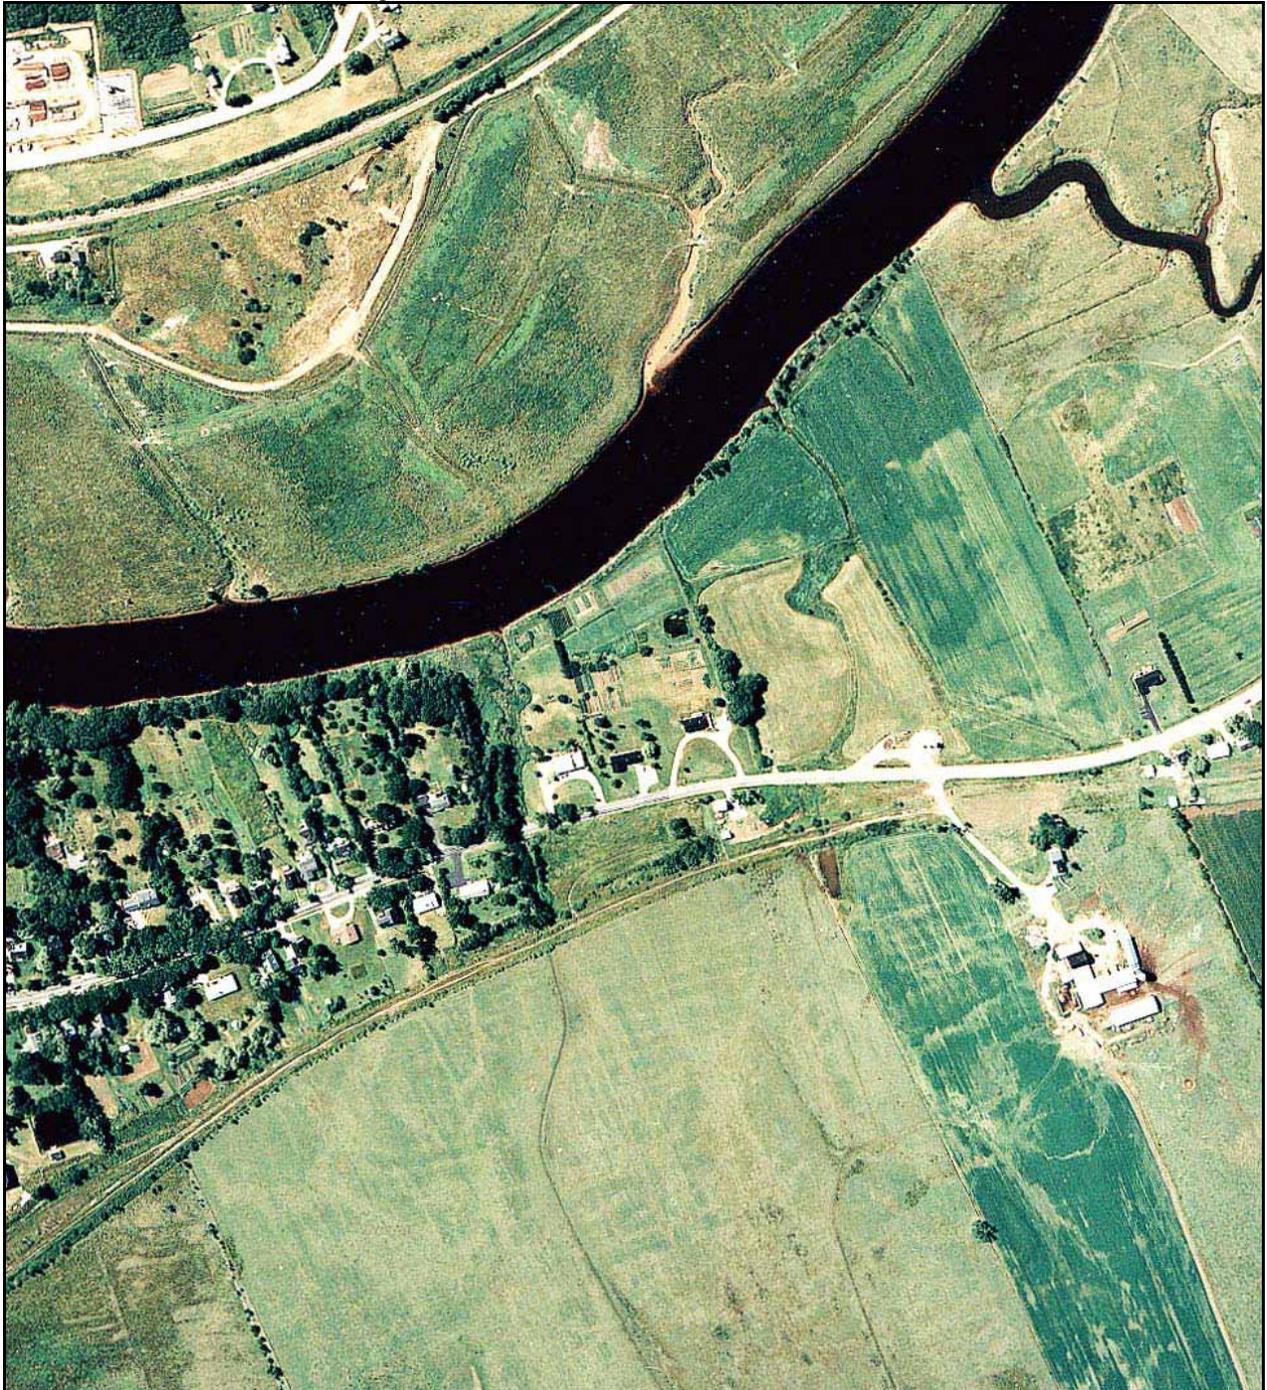
Ward Property (Bridgetown)

Photo of western side of Bridgetown

(Fash Brook) that separates the cornfield from the alfalfa field. Near Fash Brook's confluence with the Annapolis River there was found to be some severe erosion taking place on both sides of the brook's banks. This was adding much sediment to the brook. In order to remedy this situation, a plan was developed to use willow staking to stabilize the banks on both sides, and to establish vegetation on the exposed soils.

This site plan was very straightforward, and its implementation was accomplished without complications or adjustment for the most part. A Watercourse Alteration Permit for bank stabilisation was obtained from the Department of Environment and Labour. The only necessary change from the original plan came about when the installation of live sills was undertaken. The banks at this site were very steep, augmenting the risk that disturbing the soils there could cause sedimentation of the brook. It was decided that willow stakes would simply be pounded into the bank without digging terraces for the construction of sills. This would eliminate the risk of sedimentation, and still allow the willows to become established on the bank, providing greater stability and creating a vegetative buffer.

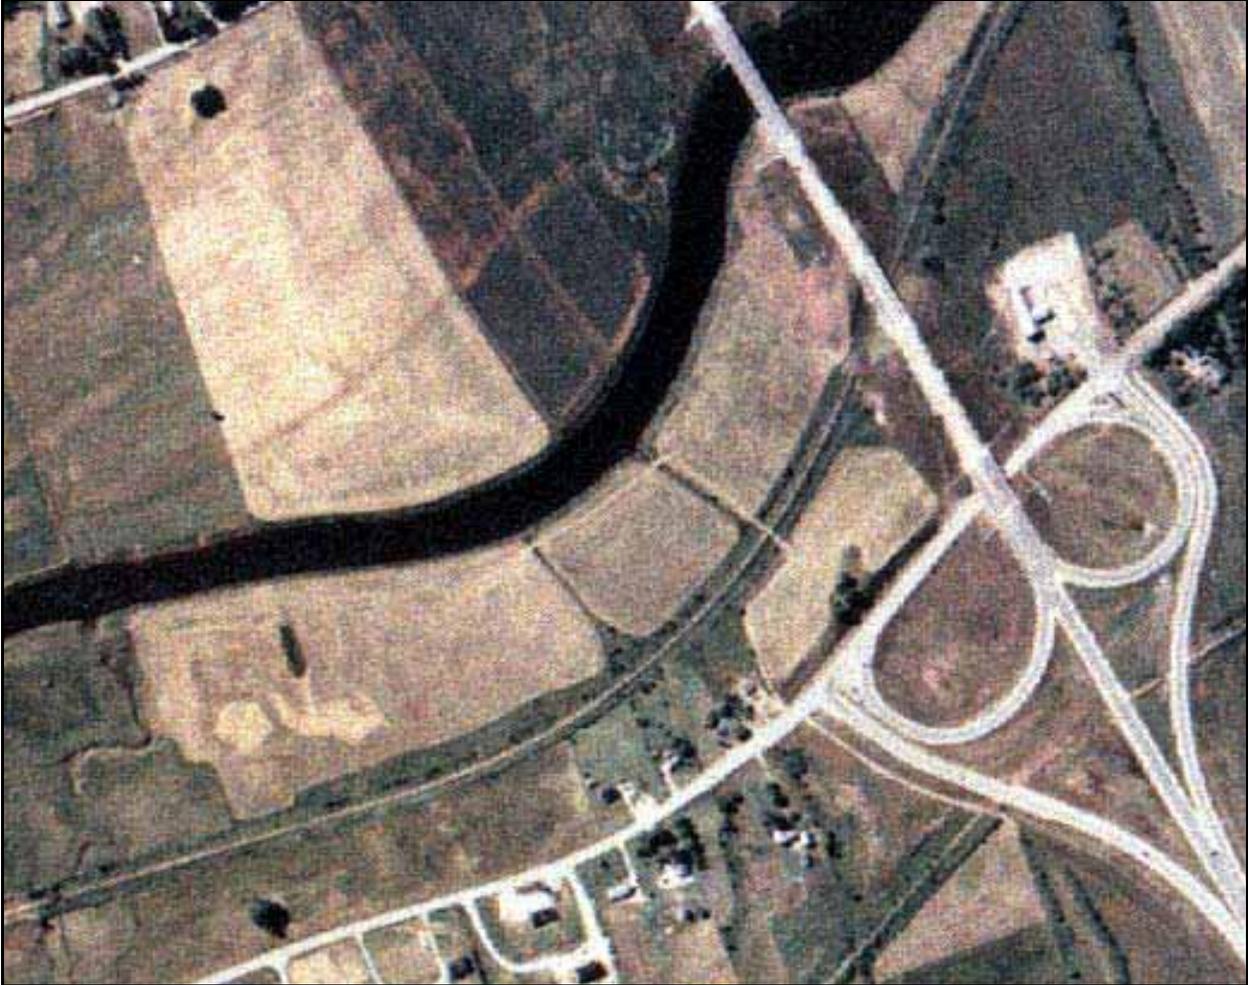
Ward Property (Bridgetown)

Photo of eastern side of Bridgetown

- 1- Pine trees and willow shrubs planted
- 2- Willow staking
- 3- Farm

Hometosta Farm is a beef and dairy operation located in Bridgetown on Highway 1. The areas examined for inclusion in the project were two series of forage crop fields, one on the eastern side of the town of Bridgetown, and one on the Western side. The site on the east of Bridgetown was a series of three cornfields located on the north bank of the Annapolis River. The riparian buffer zone between the fields and the river was narrow and steep, and consisted mostly of grasses. The plan developed for this site was to plant a row of pines at the edge of the cornfield, and to bolster the existing riparian buffer zone with willows. This was to be done in order to expand and improve the existing buffer, and to help control erosion of the riverbank.

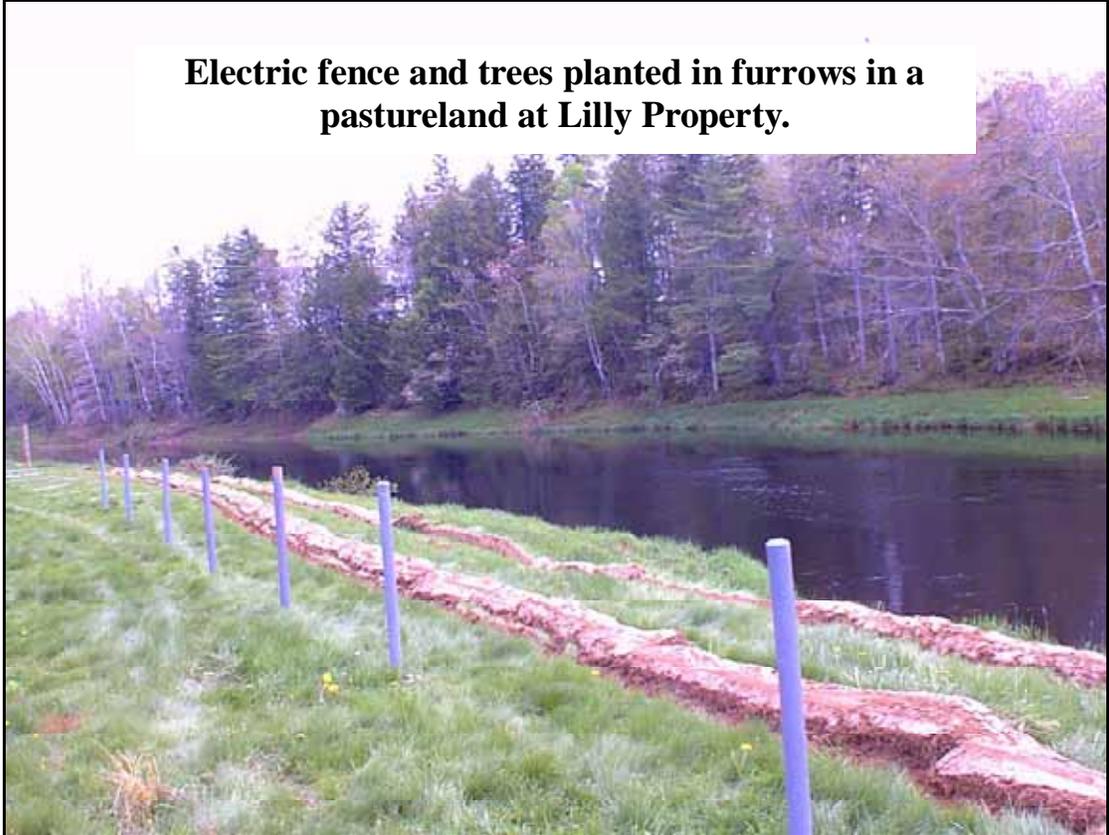
Electric fence and trees planted in furrows in a pastureland at Lilly Property.

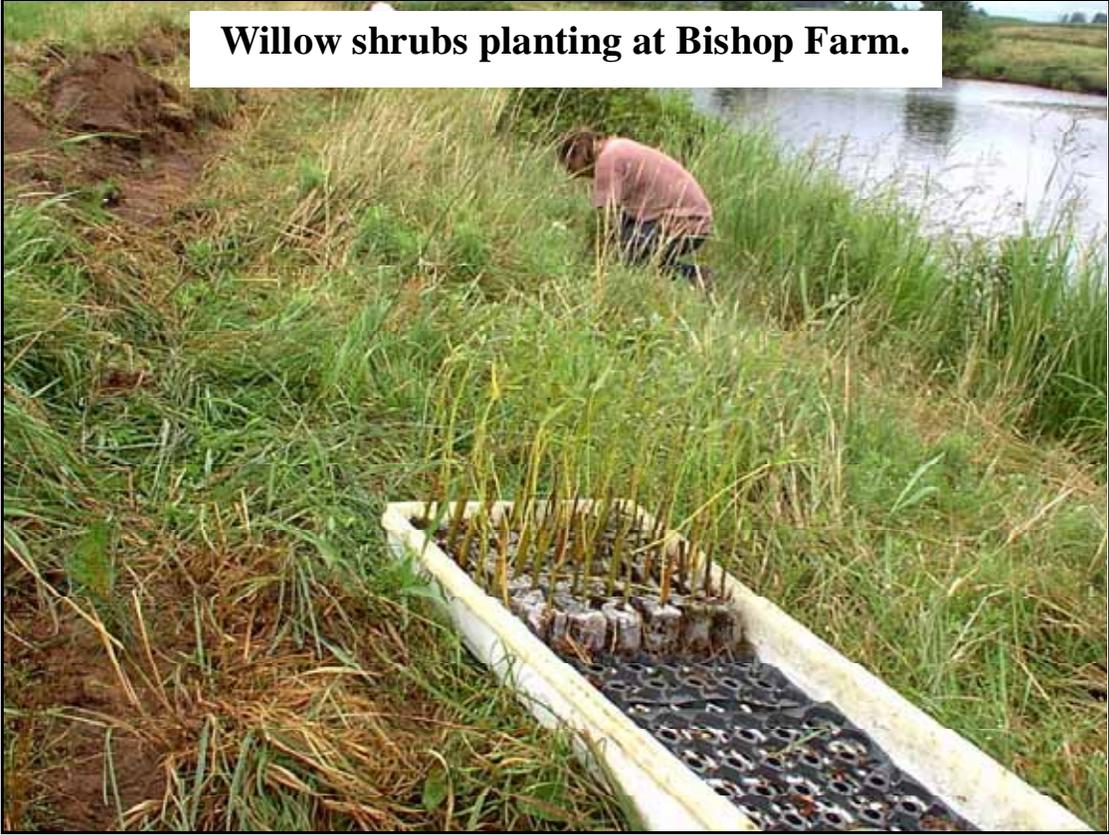
Willow shrubs planting at Bishop Farm.

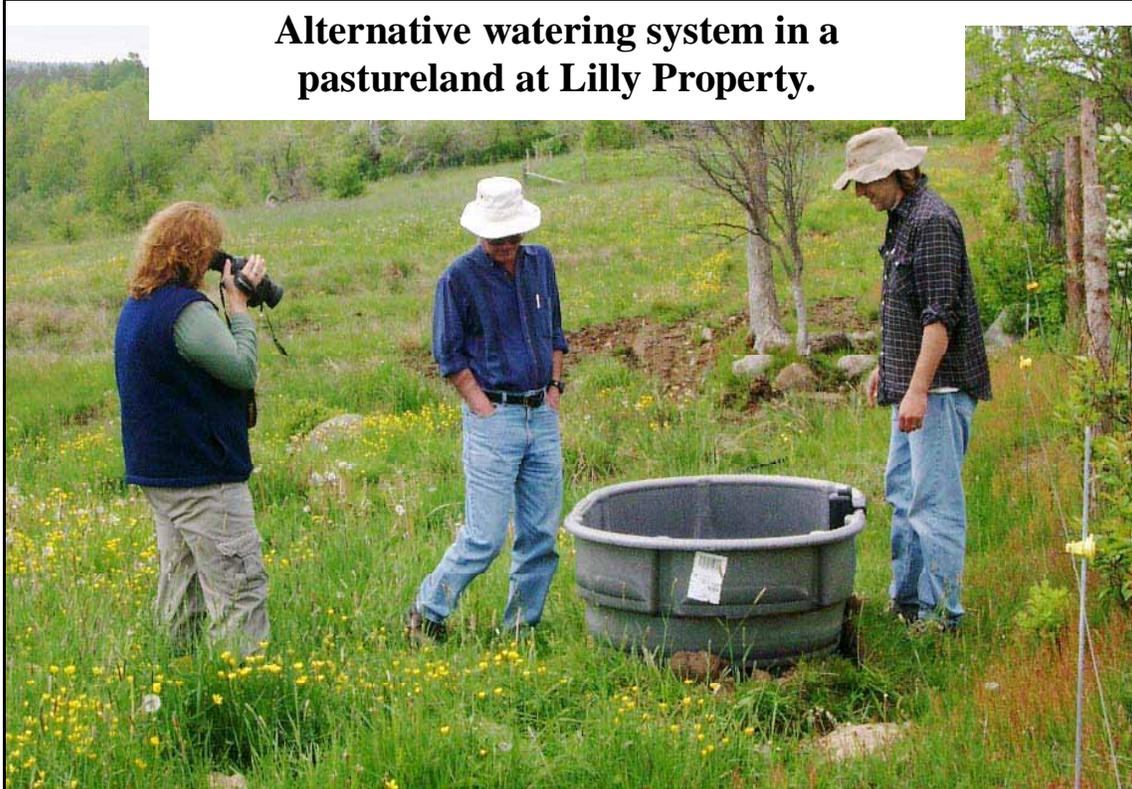
Alternative watering system in a pastureland at Lilly Property.

Alternate watering systems: Alternate watering systems were to be used in situations where restricting livestock from a waterway would result in cutting them off from their only source of available drinking water. These were to consist of watering troughs connected to a source of clean water via a length of water hose, and fitted with a float valve to control water levels in the trough.

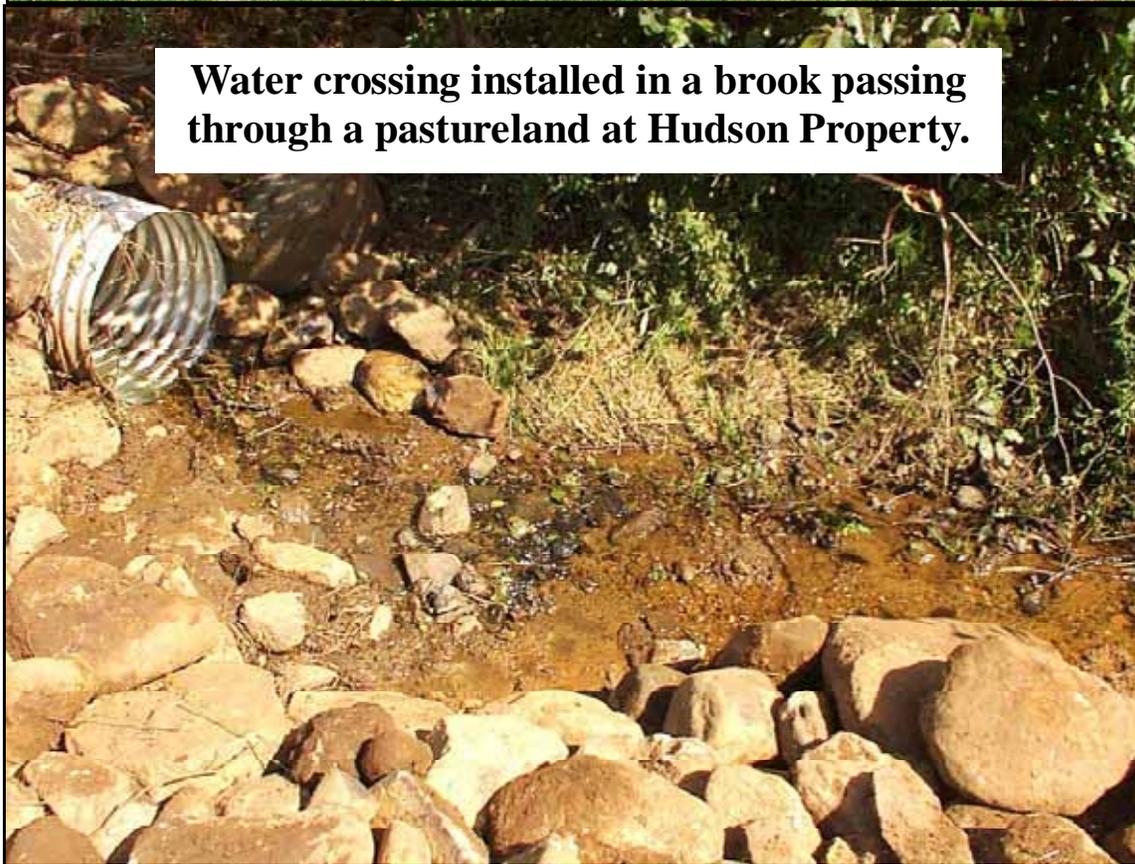
Water crossing installed in a brook passing through a pastureland at Hudson Property.

Hudson Farm is a beef operation located in Port Wade, along the Annapolis Basin. The focus for this site was on pastureland through which a small brook was flowing. Cattle crossed the brook at two separate sites to get to other grazing areas and to and from the barn. This constant traffic of cattle through these two points on the brook was causing degradation of the banks, sedimentation of the waterway, and was a direct source of contamination of the brook. The installation of two crossings, one at each of the locations where the cows were already crossing, was planned in order to remedy the situation.

This site plan was completed as anticipated. The two culverts were installed upon acquisition of permission from the Department of Environment and Labour.

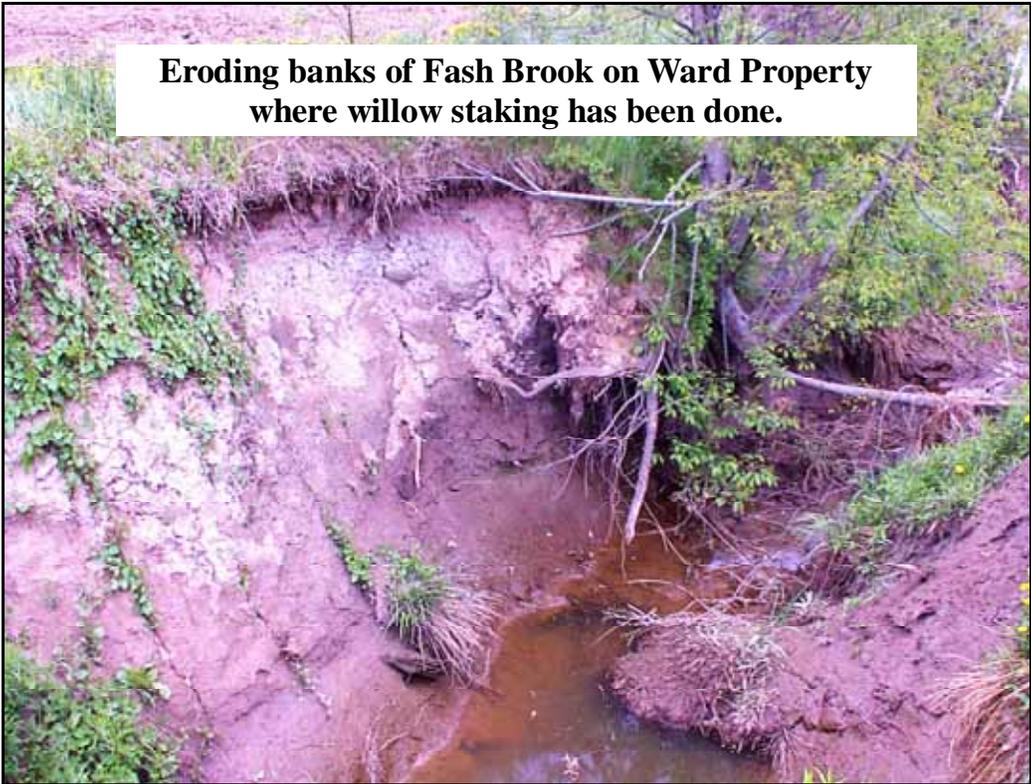
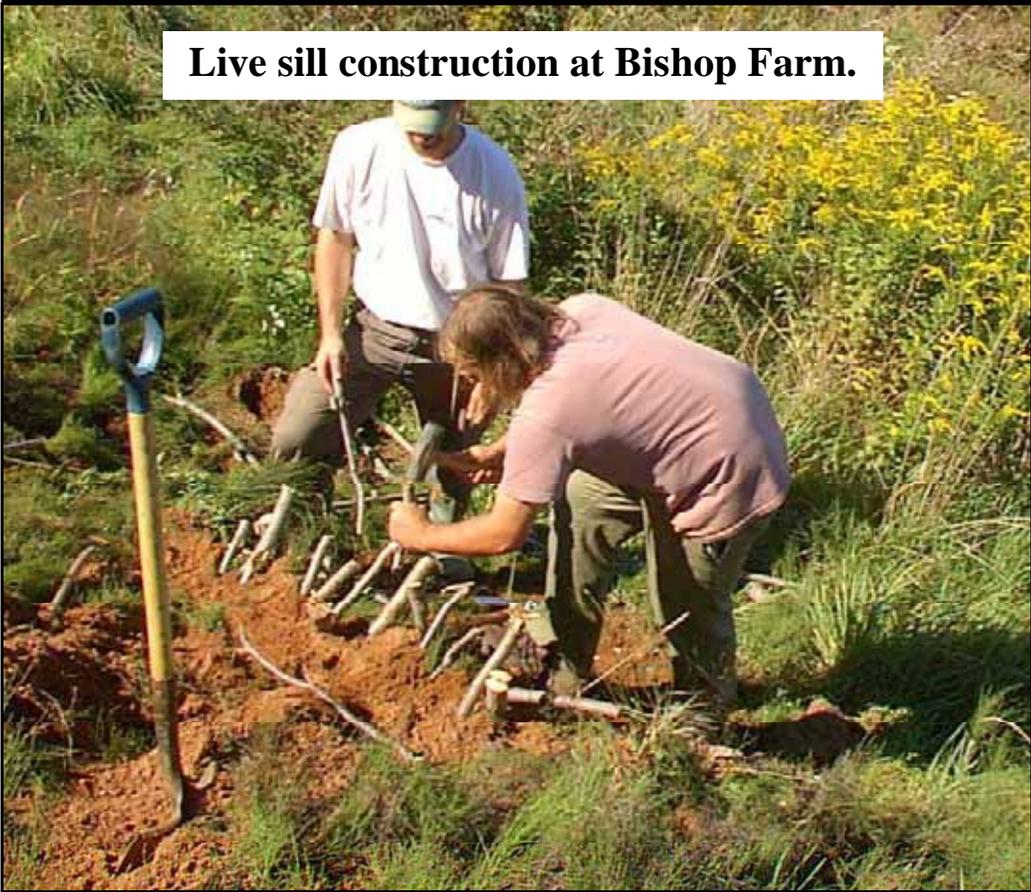
Eroding banks of Fash Brook on Ward Property where willow staking has been done.
