Fish Passage Restoration and Habitat Enhancement

*Fish habitat enhancement in the Round Hill
River sub-watershed*

Rachel Walsh
December 2020

Clean Annapolis River Project

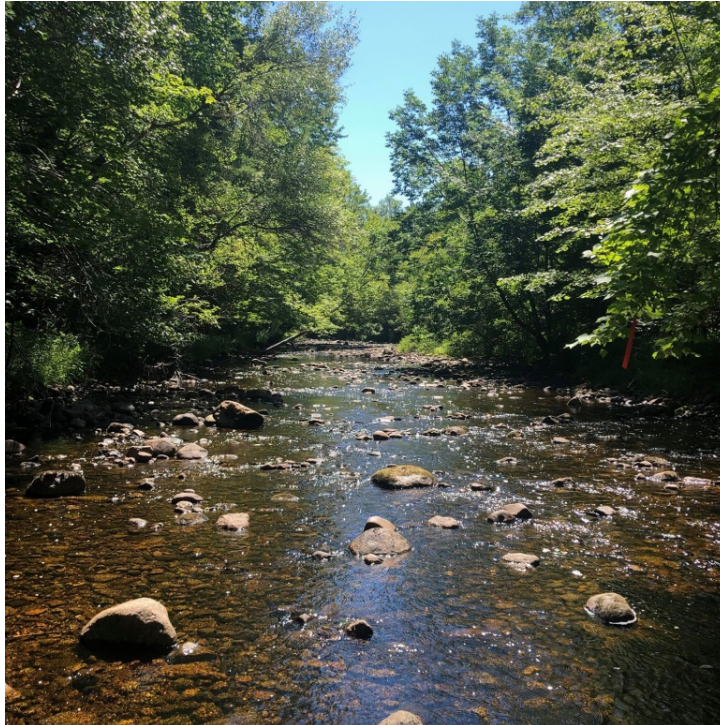
Figure 1. A straightened and over widened section of the Round Hill River

The sites for restoration as well as the structures installed were selected through the guidance of Nova Scotia Salmon Association's (NSSA) Adopt A Stream Biologists. The sites were selected based on the width, gradient, and meandering pattern of the river. A straight and over widened section of the Round Hill River was

selected to receive in-stream restoration with the hopes to concentrate flow, narrow and deepen the channel, as well as re-establish its meandering pattern.

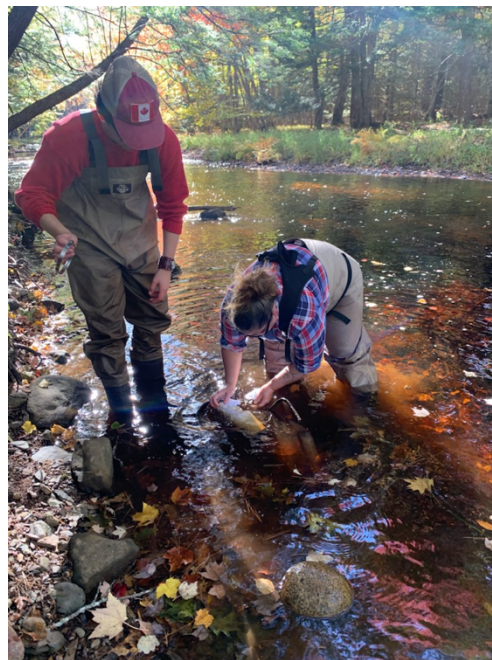
Figure 4. CARP staff Brandi Veinot and volunteer John Hill installing a sediment trap

Sediment traps were installed in locations along the river where samples showed the most fine sediment accumulation. The traps were made by cutting 10 cm diameter PVC pipe into 15 cm lengths. Nylon mesh netting was fitted over the pipe and held in place by a hose clamp. Rebar was used to secure the traps into the riverbed to assure they stayed in place for the length of the collection. The contents of the sediment traps were dried and weighed to determine the amount of sediment present.

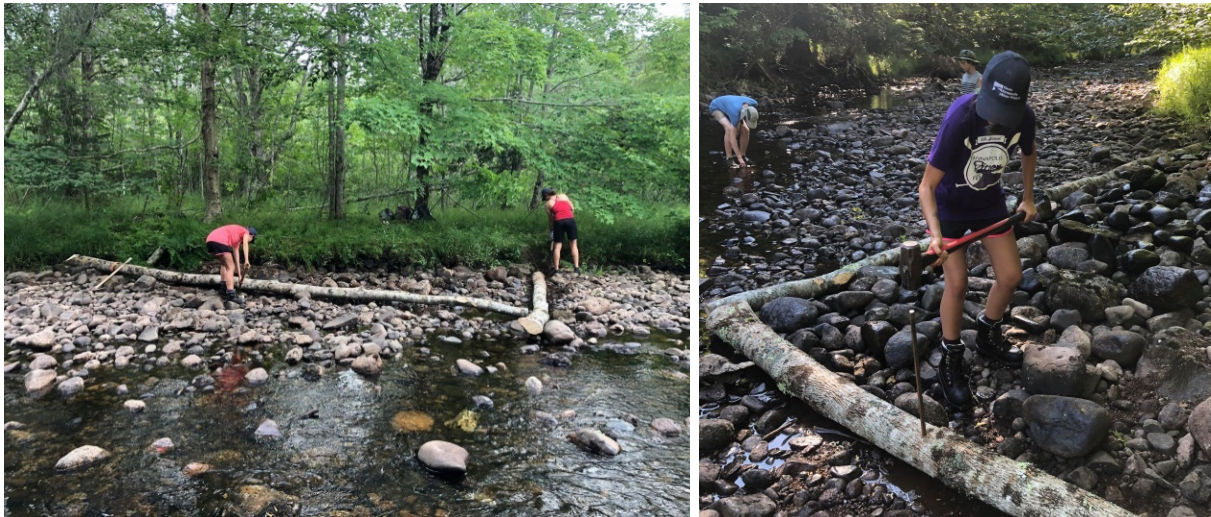
Figure 6. CARP summer interns, Marina McBride and Abigail Bonnington, installing a log deflector

A series of 4 log deflectors were installed in the Round Hill River system in the 2020 field season (Figure 6). The deflectors were installed on alternating banks; the first being on the left, slightly upstream of a natural right pool.

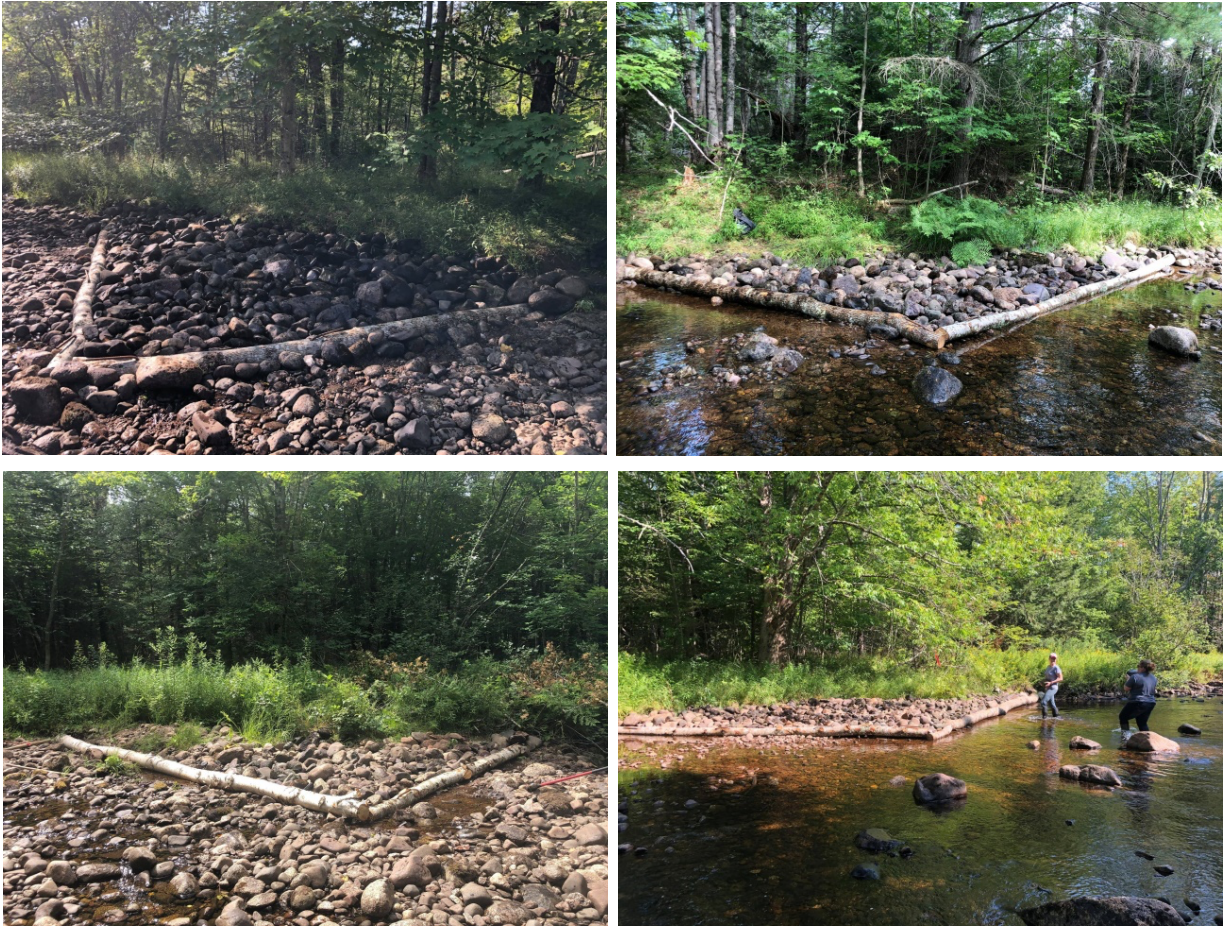
Figure 7. Four log deflectors installed by CARP staff on the Round Hill River

The deflectors were installed to help concentrate flow as well as narrow and deepen the channel of an area of stream over-widened by approximately 3 m. The cobble and boulder rock from within the stream that was used to fill the frame of the deflector assisted in stabilizing the bank in addition to accentuating the natural pool downstream from the new structure. These 4 log deflectors installed on the Round Hill River restored a linear length of approximately 240 m and an area of 2604 m².

Continue restoration work on the Round Hill River including additional installations of in-stream enhancement structures. The 2020 deflectors should be revisited, and future actions should be identified for structures further upstream.

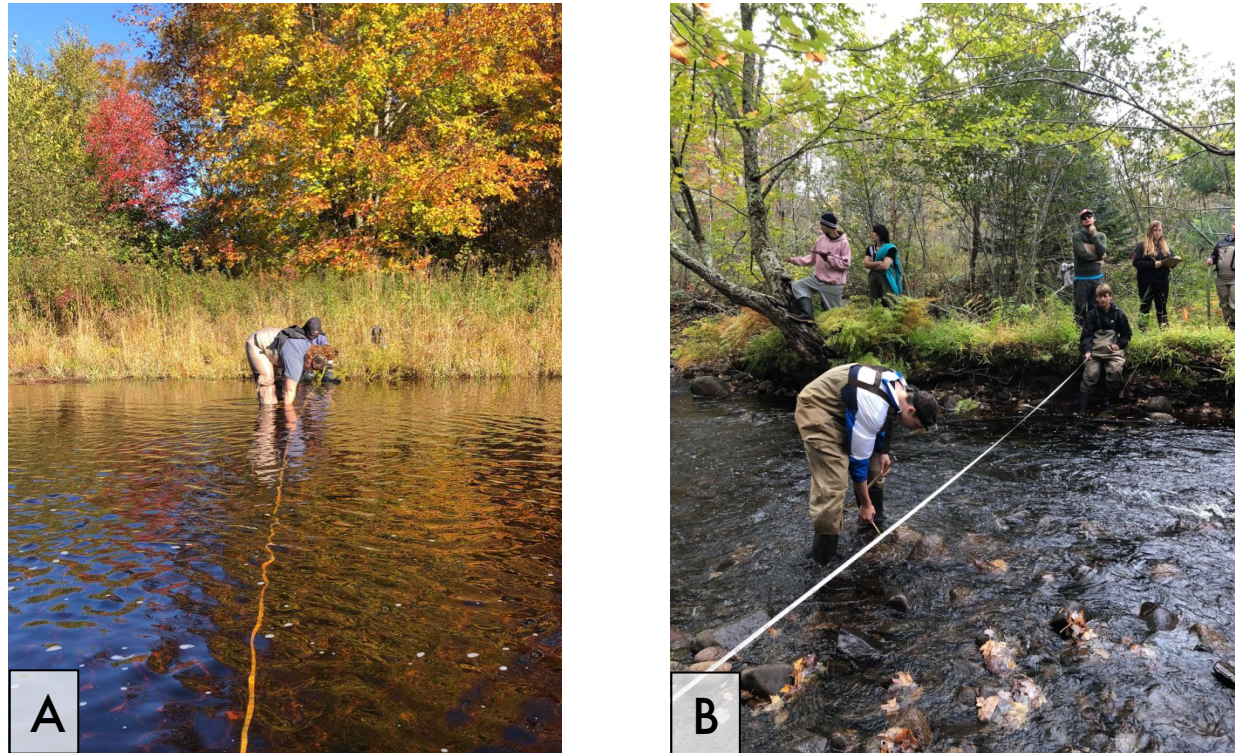
Figure 8. Volunteers and CARP staff completing HSI measurements on the Fales River (A) and the Round Hill River (B)

Through assessing representative variables and values of salmonid habitat features, Habitat Suitability Index assessments were completed in the Fales River and Round Hill River sub-watersheds to evaluate the quality of freshwater fish habitat. The sites were located in areas of recent restoration work, as well as locations where work hasn't taken place in recent years or at all.

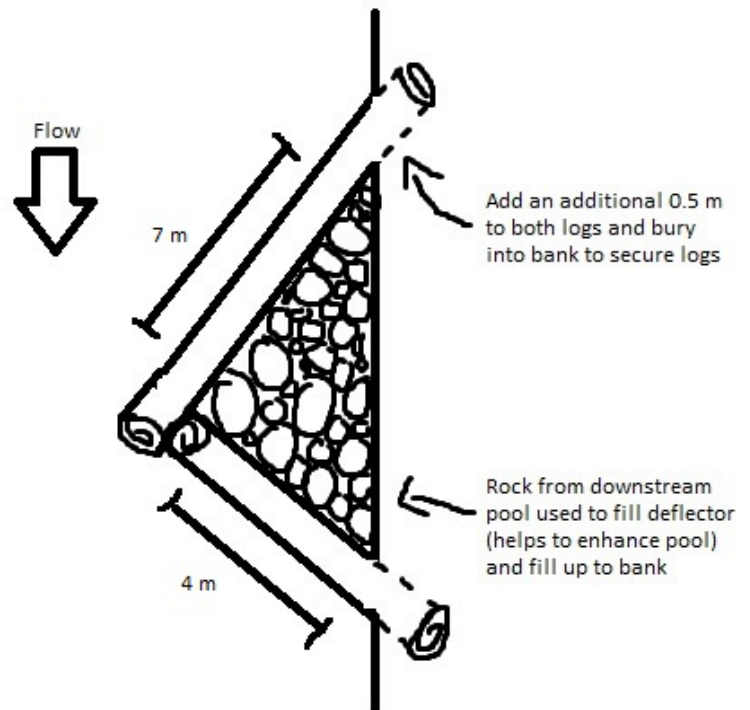
Structure: Log deflector

Site: Round Hill River, Round Hill NS

Location: 309835, 4960206

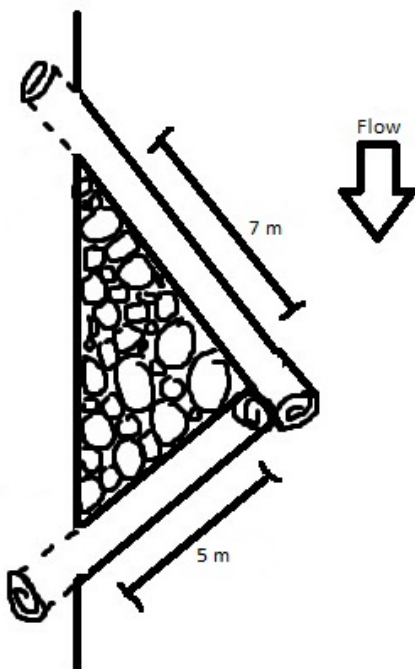
Structure: Log deflector

Site: Round Hill River, Round Hill NS

Location: 309872, 4960162

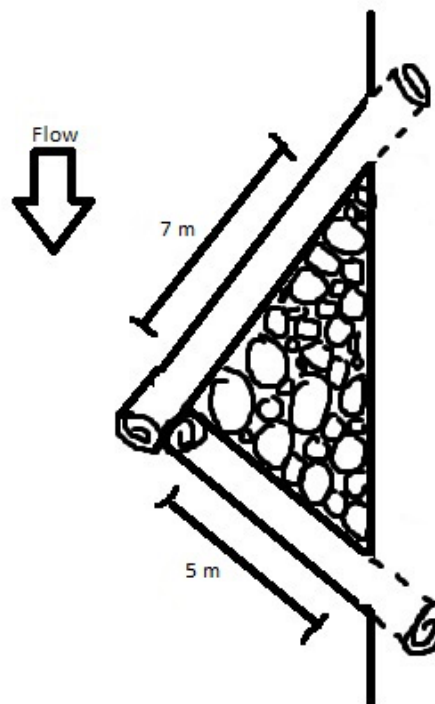
Structure: Log deflector

Site: Round Hill River, Round Hill NS

Location: 309912, 4960111

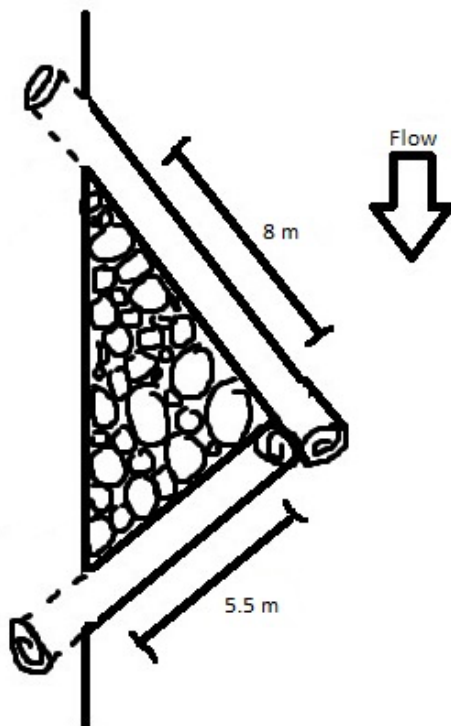
Structure: Log deflector

Site: Round Hill River, Round Hill NS

Location: 309940, 4960063
