# Annapolis Watershed Salt Marsh Evaluation: Surveying Tidal Barriers Along the Annapolis Basin

Denise Sullivan  
Clean Annapolis River Project  
November 2005

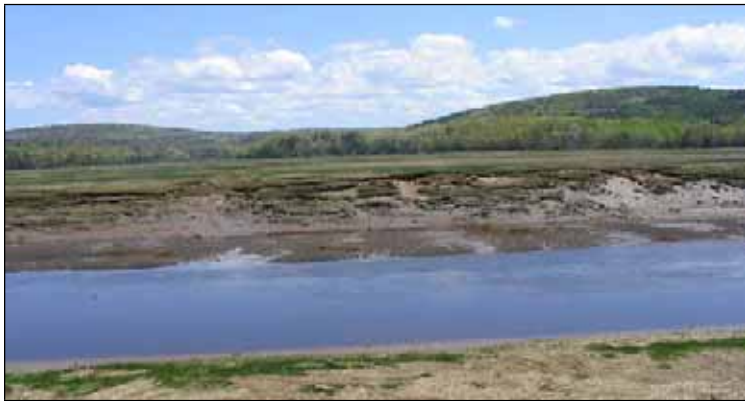
1. Allain's River Marsh, Annapolis Royal – This salt marsh is the last remaining salt marsh of any considerable size in the Annapolis Basin. Large areas of the marsh were previously dyked and used for agricultural purposes; however large areas also remain relatively untouched. The entire marsh is approximately 83 hectares and is in close proximity to both priority sites. In fact, the site at Highway 1 Allain's Creek was historically part of the Allain's River marsh system. Years of development, road and railroad building have fragmented the marsh, however, both areas would still be subject to similar physical, chemical, and biological variables.

**Figure 8: Reference marsh at Allain's River, Annapolis Royal**

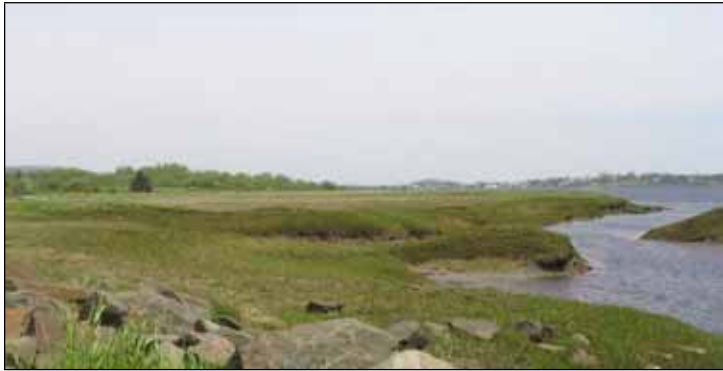
2. Dentabella Marsh (eastern end), Granville Beach – Most of Dentabella Marsh is presently agricultural dykeland, however there is a 4-5 hectare section of marsh on the far eastern side, which is below the dyke and is currently unrestricted salt marsh. This portion of marsh could serve as a reference to other sites on Dentabella Marsh, such as AC42D, chosen as one of six potential restoration sites.

**Figure 9: Reference marsh on the eastern end of Dentabella Marsh, Granville Beach**

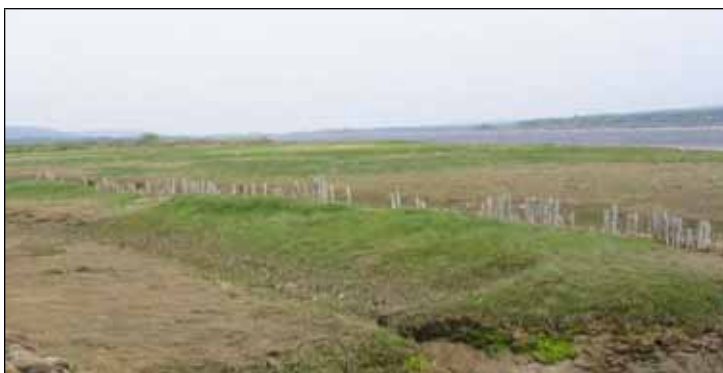
3. Stoney Beach Road — The site is approximately 5-6 hectares of unrestricted salt marsh at the end of Stoney Beach Road, in Granville Beach. It lies directly between the two large dyked marshes, Queen Anne Marsh and Dentabella Marsh. The site could serve as a reference in future restoration projects on the eastern tip of Queen Anne Marsh (ie: AC34D) and/or on the western tip of Dentabella Marsh (ie: AC41D).

**Figure 10: Reference marsh at Stoney Beach Road, showing remnants of an old dyke in forefront**

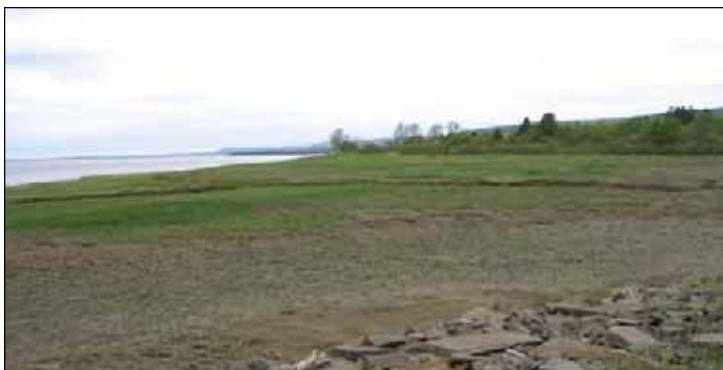
4. Queen Anne Marsh (western end), Port Royal — Approximately 4-5 hectares on the western tip of Queen Anne Marsh remains unrestricted below a dyke. The site is relatively undisturbed and would be subject to many of the same variables as the site at AC46D, another of the six potential restoration sites.

**Figure 11: Reference marsh on the western end of Queen Anne Marsh, Port Royal**

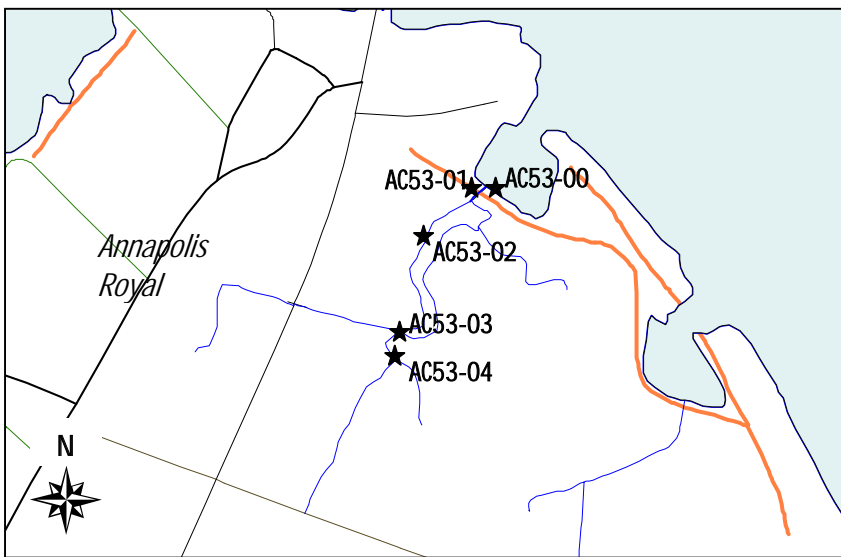
The site at French Basin Marsh was visited five times from October 21 to November 21, 2005 for collection of preliminary water quality data. The sites were visited four times during high tide levels from October to November and once at a low tide level in November. The five sampling locations are shown in Figure 12. The site receives little flushing or drainage due to a malfunctioning aboiteau beneath the dyke. The water pools behind the dyke, and the bottom sediment is a black, foul smelling, anoxic mud. Large amounts of thick algae cover the banks of the brook as well as the aboiteau structure. A muskrat was seen swimming in the brook on several occasions. The preliminary water quality data at high and low tide is presented in Tables 6 and 7, respectively.

**Figure 12: Sampling locations along creek at French Basin Marsh (Scale 1: 8 621)**

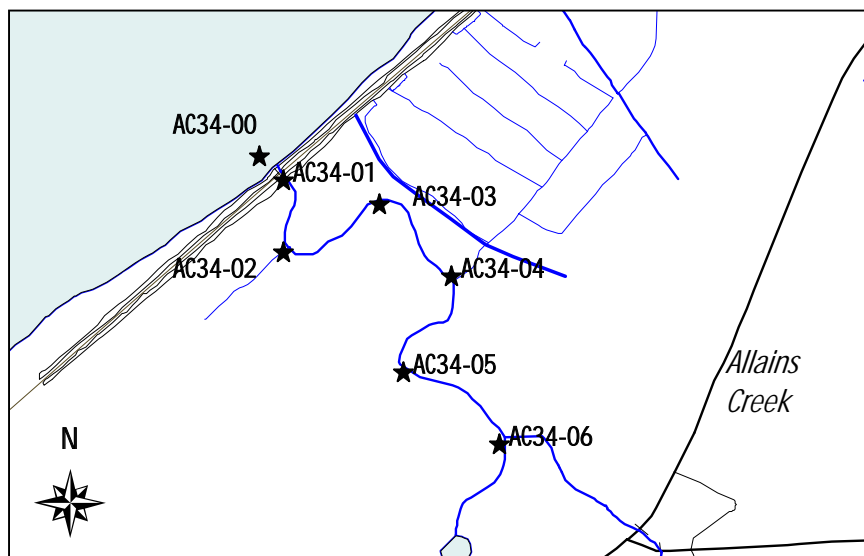
The site at Highway #1, Allain's Creek was visited during high tide on October 21, 2005 for collection of preliminary water quality data. When the landowner withdrew late in project, monitoring at the site was stopped. The six sites that were visited are shown in Figure 13. The data collected is shown in Table 8.

**Figure 13: Sampling locations along creek at Highway #1, Allain's Creek (Scale 1: 8 209)**
