# Broken Brooks 2012

*Salmonidae Outreach,  
Accessibility and Restoration*

By Kristen Wagner  
Fish Habitat Technician  
January 2013

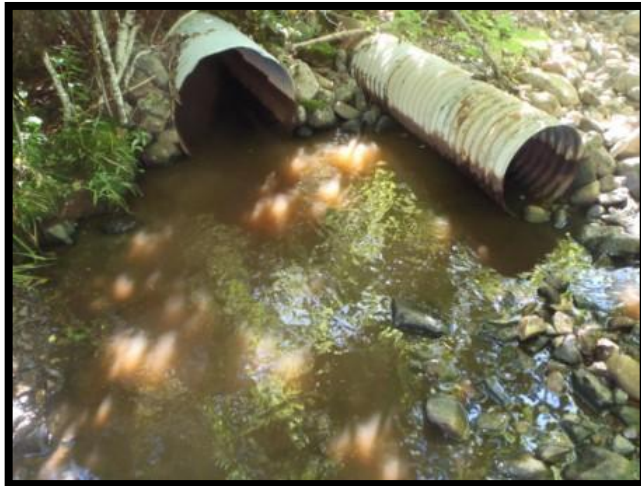
MED001 is a circular corrugated metal culvert located on Meadow Brook, which is a tributary that drains into Black River just downstream of Allen Lake Road near Bloomington (Figure 18). The culvert is severely deteriorated, and has a partially rusted out bottom at the inflow. At one point in time MED001 may have been a system of two culverts, but presently, the second culvert is only evident on the outflow side (Figure 19). CARP staff searched for the inflow, but there was evidence that it had at least partially been removed (Figure 20). MED001 restricts 2.20 km of upstream habitat that opens up into a lake.

Figure 19. Two culverts at the outflow side of MED001.

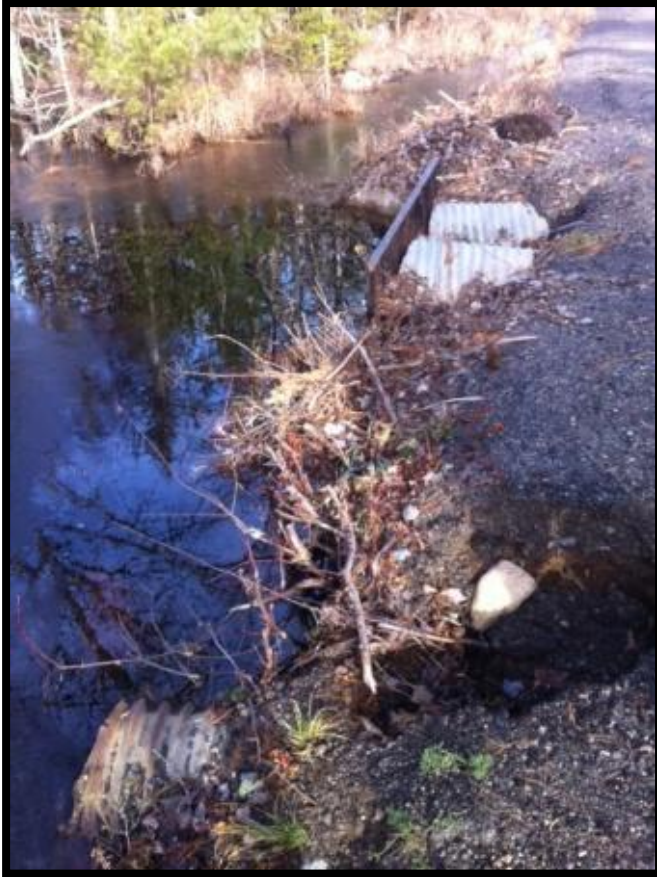
NIC030 is a system of 3 circular corrugated metal culverts that run underneath Old Liverpool Road near Albany Cross (Figure 33). Two of the culverts are directly beside each other, with one large grate covering the inflow of both culverts, and the third culvert is approximately 4 m away (Figure 34). This system of culverts lies upstream of McGill Lake, and it restricts 2.98 km of upstream habitat as well as access to small bodies of water and wetland areas.

The inflow grate over the two culverts was covered with dead vegetation (Figure 35) and there was a beaver dam just inside of the inflow mouth of the third culvert. The grate was cleared and the beaver dam was removed (Figure 36).

Figure 34. Three culvert system at NIC030.

It is recommended that the inflow grate be completely removed, or receive regular (yearly) maintenance.
