Clementsport Dam Removal and Restoration

Project Report: 2011 Season

Produced for the Clean Annapolis River Project
By Lindsey Freeman and Andy Sharpe
November 2011

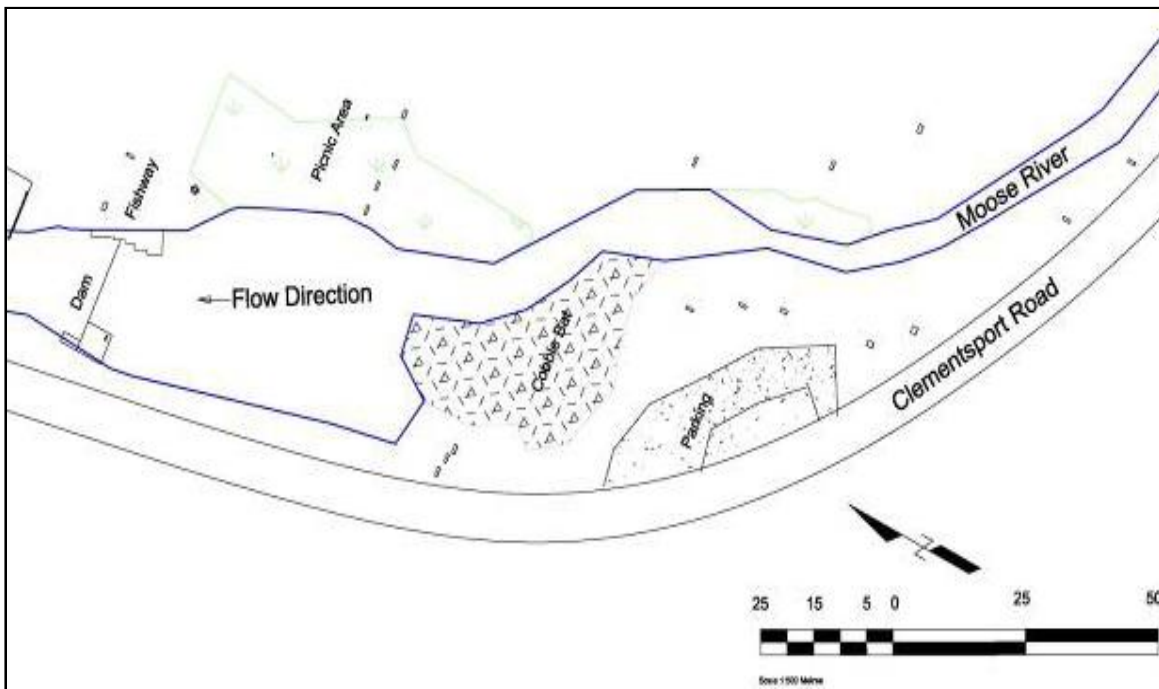
Figure 1 | Clementsport Dam site layout prior to dam removal and floodplain restoration.

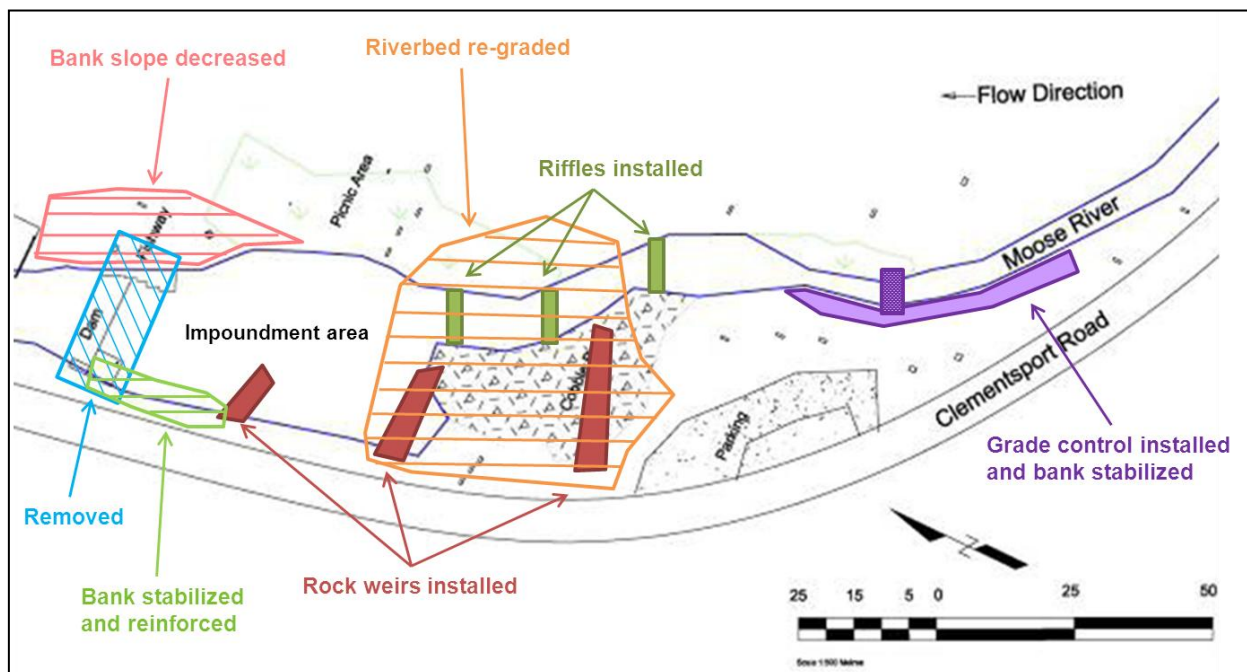
Figure 7 | Overview of floodplain restoration work completed at the Clementsport Dam site.

The restoration of the Moose River floodplain consisted of both reconstruction and re-vegetation efforts. A diagram outlining the primary activities is presented in Figure 7. Firstly, the riverbed upstream of the former impoundment area was lowered and re-graded to widen the floodplain and remove some of the accumulated cobble debris. Three riffles were constructed in the same general area to slow the velocity of the river. In the former impoundment area, three rock weirs were built to trap sediments over time and allow the accretion of sediments alongside the Clementsport Road. Bank stabilization work was completed adjacent to Clementsport Road to cover soils exposed from the concrete abutment removal and to reinforce the existing bank structure. The fine sediments that had accumulated by the dam in the former impoundment area were also removed in order to restore the substrate to a coarser arrangement common to the Moose River system. Upstream of the riffles, a grade control structure was installed and an eroding bank was stabilized with stone and filter gravel. Figure 8 illustrates the dewatering and excavation that was completed prior to the addition of stone and filter gravel for bank protection.

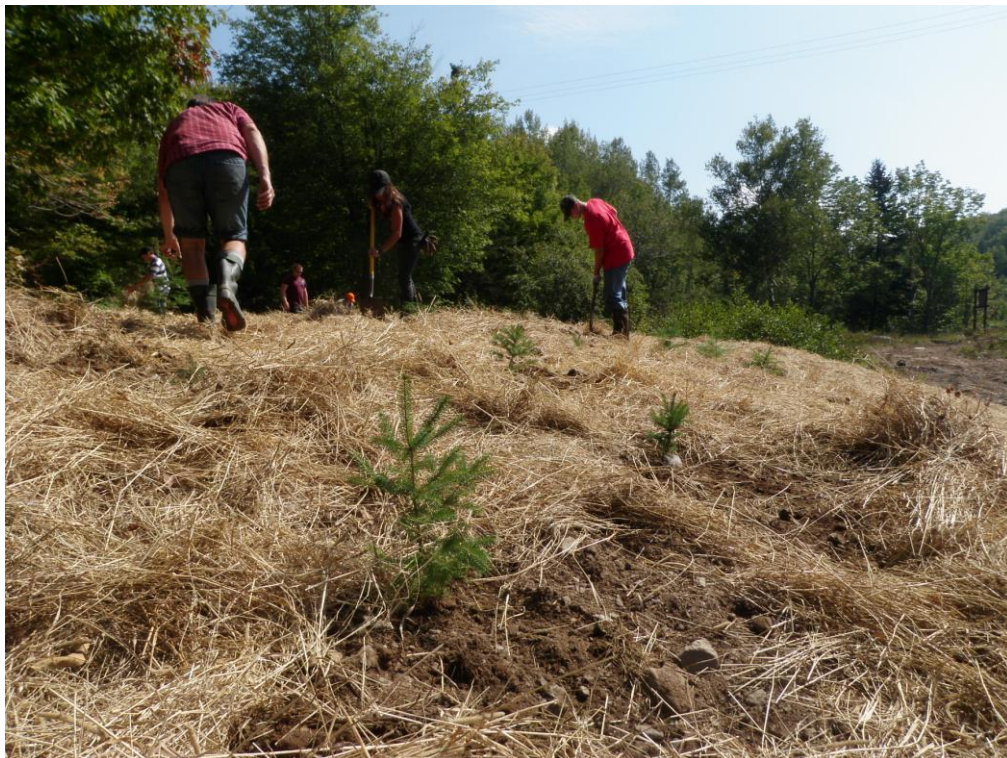
Figure 9 | Volunteers assisting with re-vegetation work in September 2011.

In addition to floodplain restoration activities, re-vegetation of exposed soils in the former impoundment area was started, and will be continued in the spring of 2012. A group of 10 volunteers donated their time and efforts to assist with the re-vegetation work (see Figure 9). One hundred and twenty willow stakes were planted to help accelerate vegetative growth. Exposed soils in the former earthen embankment area were covered with hay and 45 white spruce seedlings were also planted.
