# Ecological Monitoring of the Clementsport Dam Removal Project

*Results of pre and post-restoration monitoring undertaken at  
the Clementsport Dam Removal Site on the Moose River,  
Clementsport NS*

Levi Cliche, Lindsey Freeman  
and Robert Mayhew  
August 19, 2013

## **Clean Annapolis River Project**

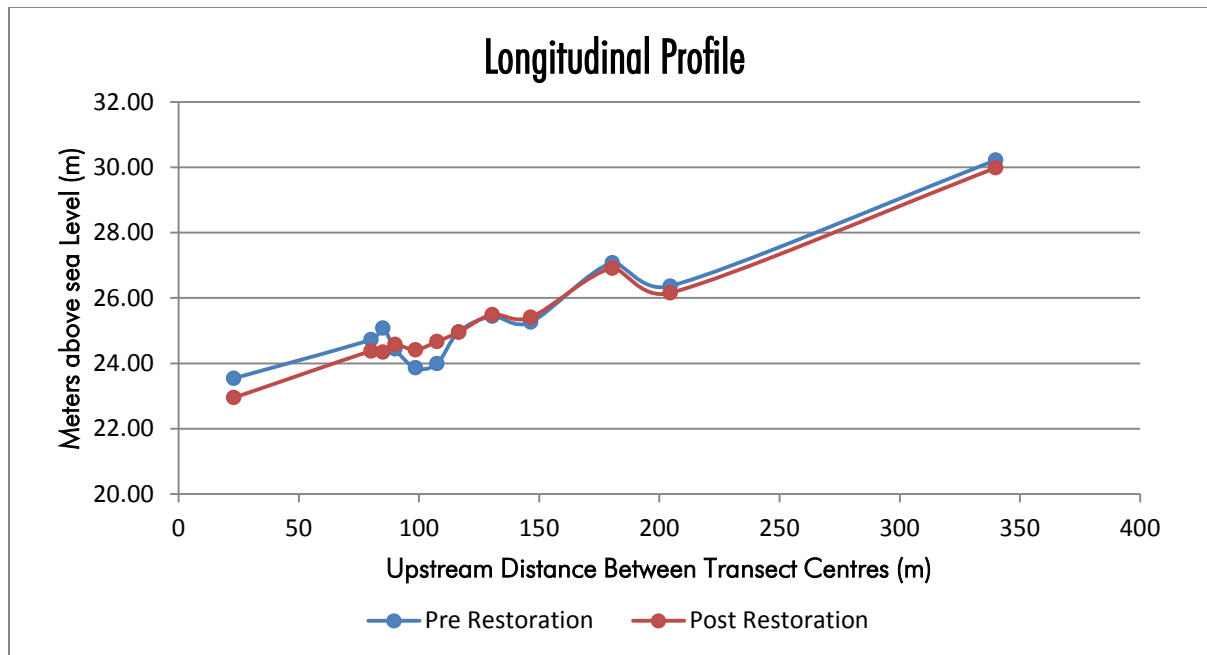
Figure 8: Longitudinal Profile

The longitudinal profiles pre and post restoration are relatively consistent, indicating little overall change in the channel slope due to the restoration work undertaken. A slight decrease at the third point upstream (transect 4) is in the portion of the channel immediately upstream of the former dam, and likely represents the removal of the accumulated sediments behind the dam. The increase in elevation upstream of that point is likely due to the former impoundment filling in with material transported from upstream.

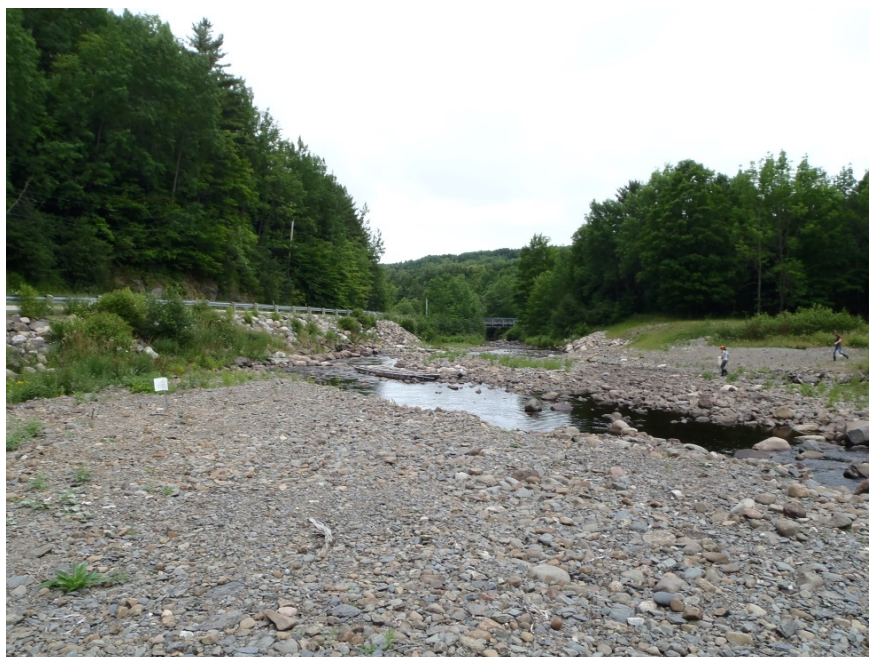
Figure 11: Station 1 Post-Restoration July 6, 2012

Changes in riparian vegetation are quite apparent in this series of photos. The presence of scattered shrubs and herbaceous vegetation can be seen in Figure 9 prior to the disturbance caused by the dam removal and channel work. Little change is noted between Figures 10 and 11. Figure 12 shows a dramatic change in vegetative cover. Shrubs and herbaceous vegetation appear to be colonizing the exposed soils in the former impoundment quite aggressively.

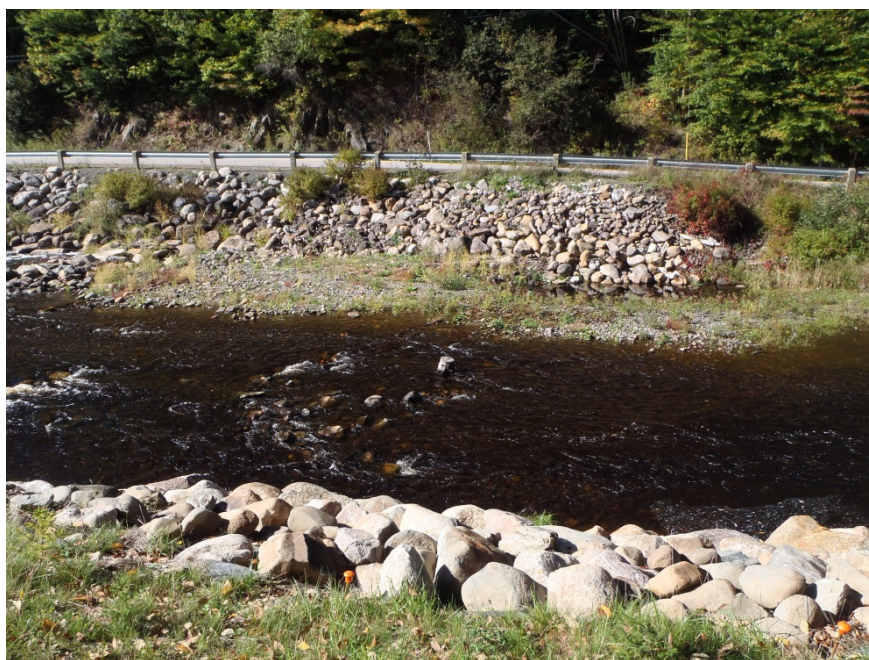
Figure 15: Station 2 Post-Restoration October 2, 2012

Figure 13 shows the dam and accumulated sediments in the headpond at low flow. Figure 14 shows the site immediately after the dam and the majority of the accumulated sediments were removed. The prevalence of fine substrate material behind the former dam is apparent in Figure 14, as is the presence of a pool at the former tailwater. Figure 15 shows the establishment of the channel at station 2, and a shift in substrate to a cobble/boulder composition that is more consistent with the substrate found in reaches outside of the former impoundment. Figure 15 also shows that the plunge pool below the dam has been filled in.

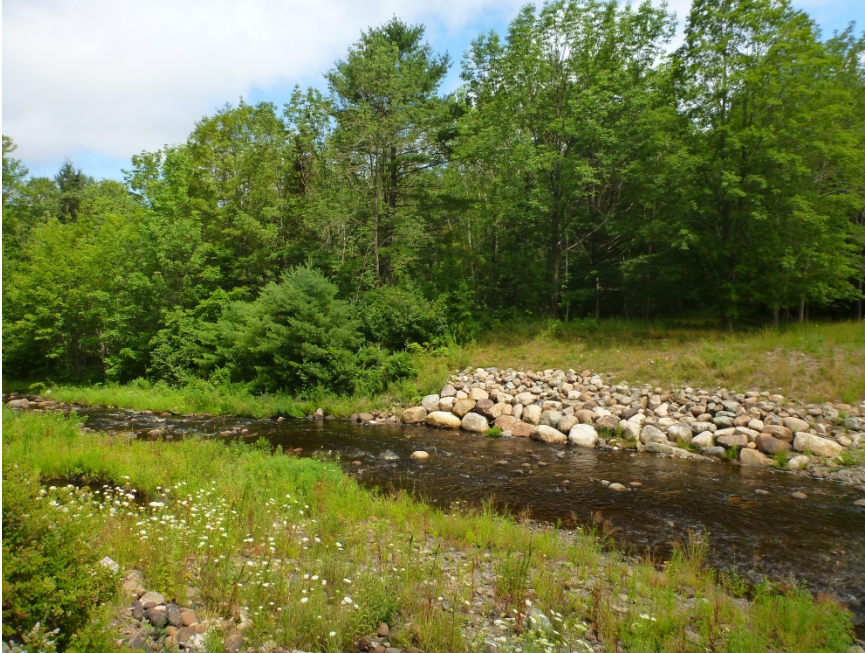
**Figure 19:** Station 3 Post-Restoration July 29, 2013

Figure 16 shows the dam and the presence of the headpond. Figure 17 shows the site immediately after the dam was removed and the prevalence of fine substrate material behind the former dam, as well as the presence of a pool at the former tailwater. Figure 18 shows the establishment of the channel at Station 2, and a shift in substrate to a cobble/boulder composition that is more consistent with the substrate found in reaches outside of the former impoundment.

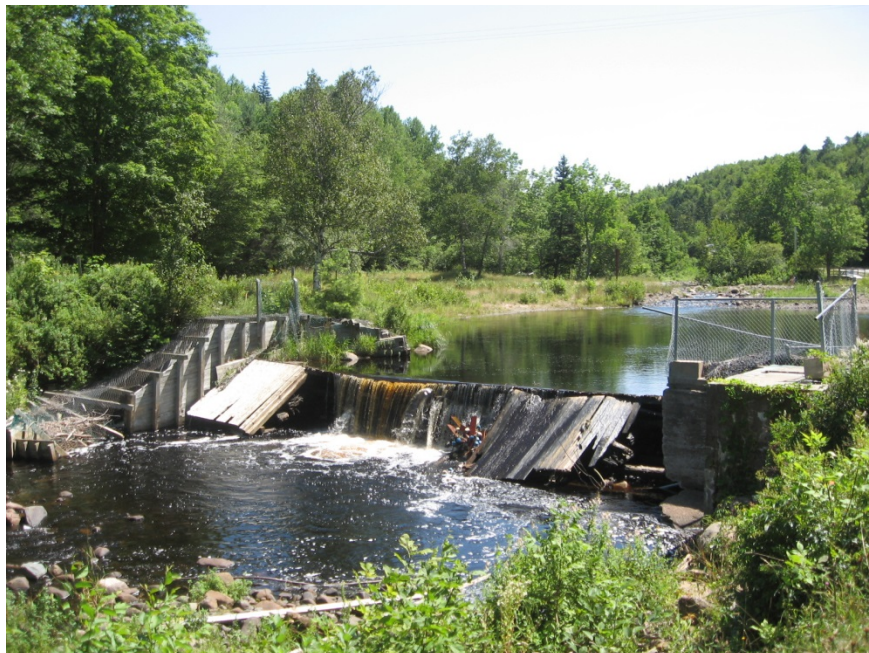
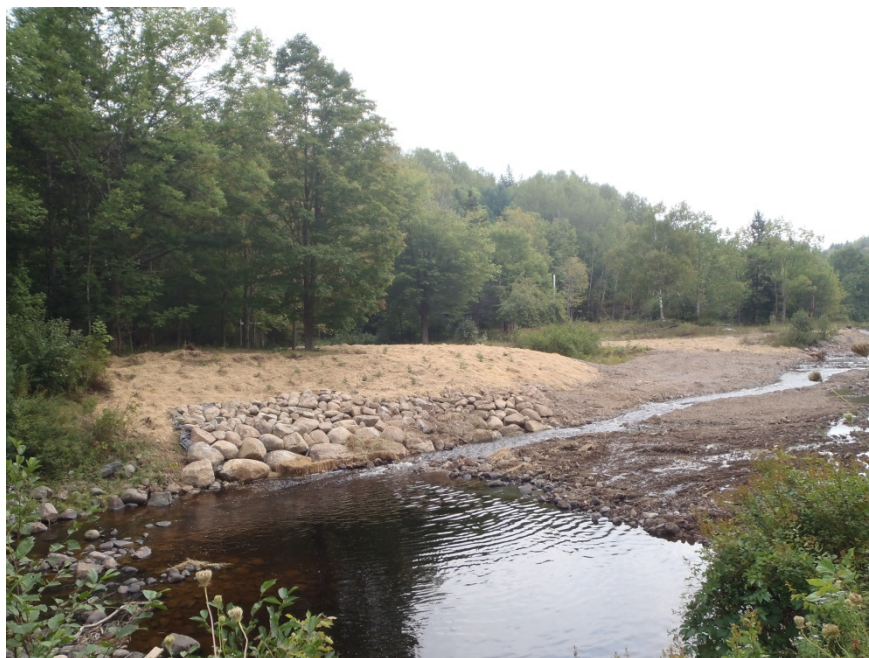
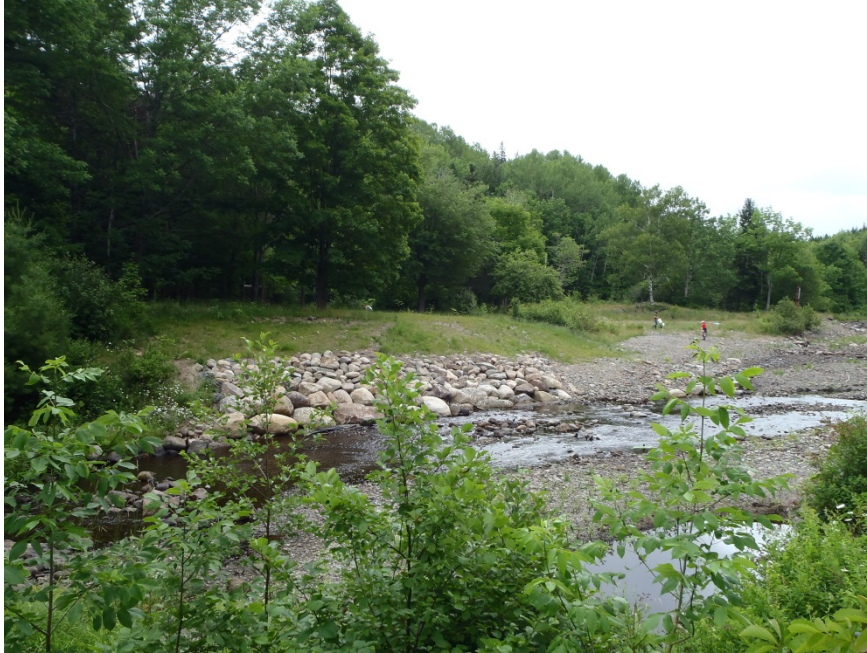
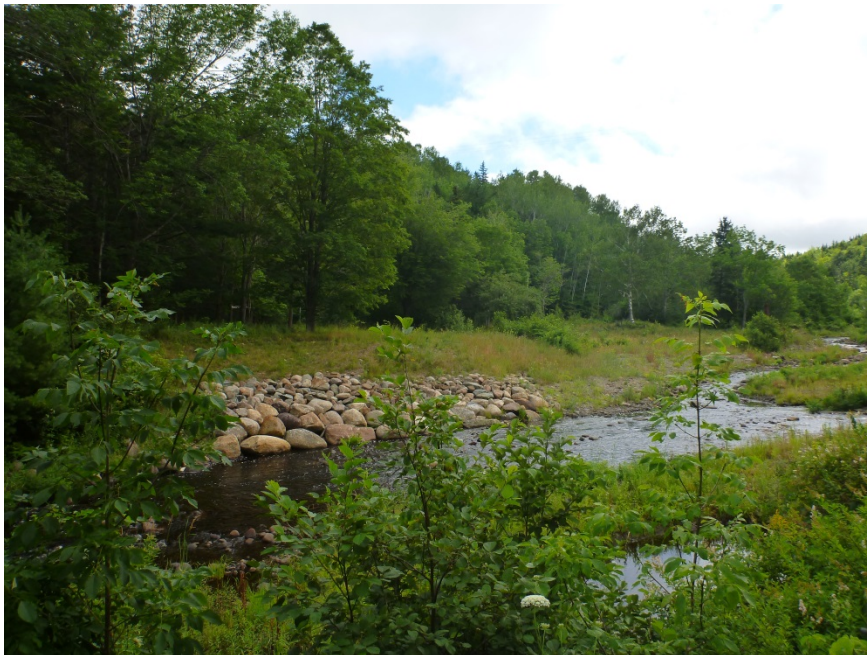
The series of photos at Station 4 depict the changes at the site of the former dam, looking upstream. The same observations can be made as for Stations 2 and 3 from an alternate perspective.

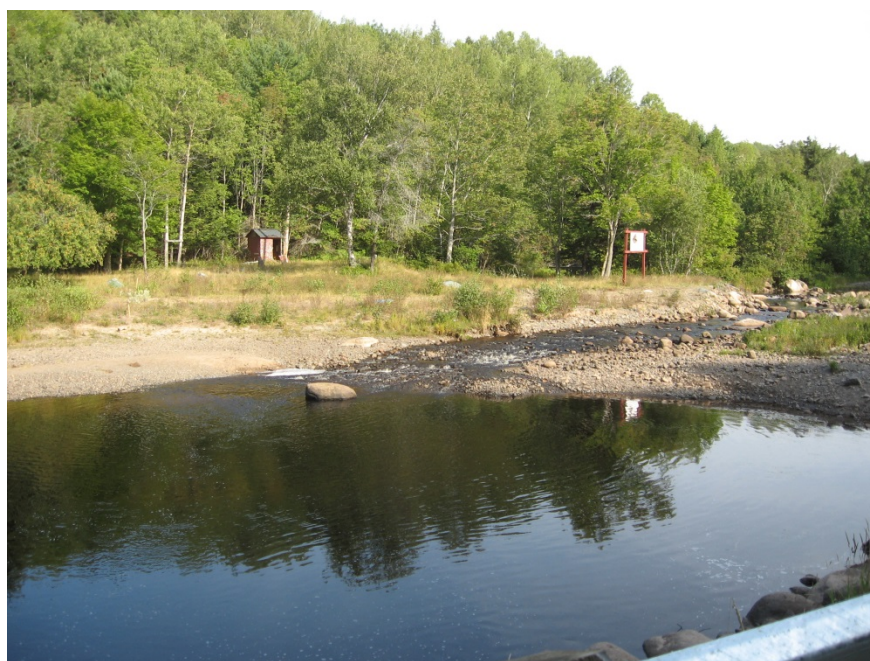
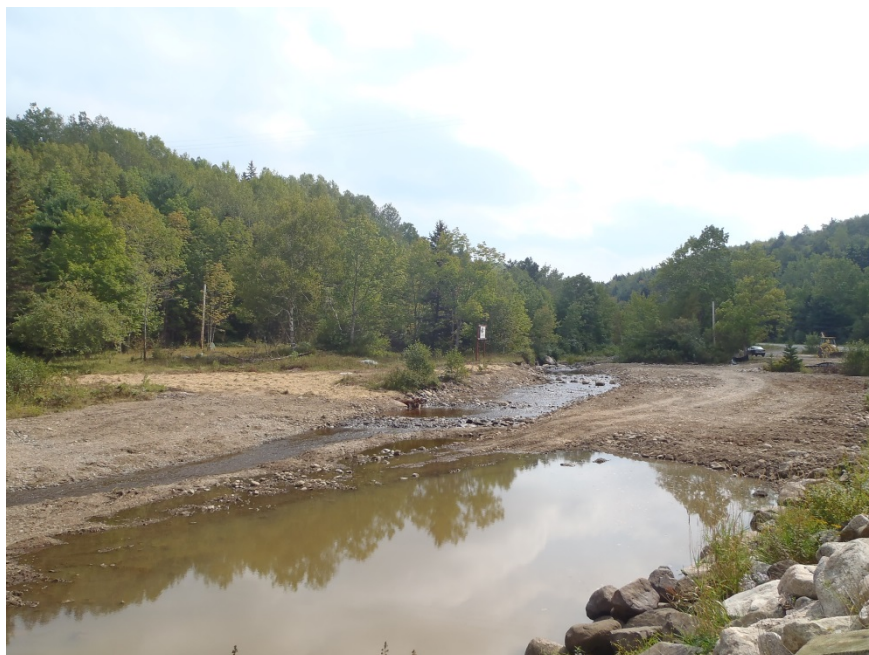
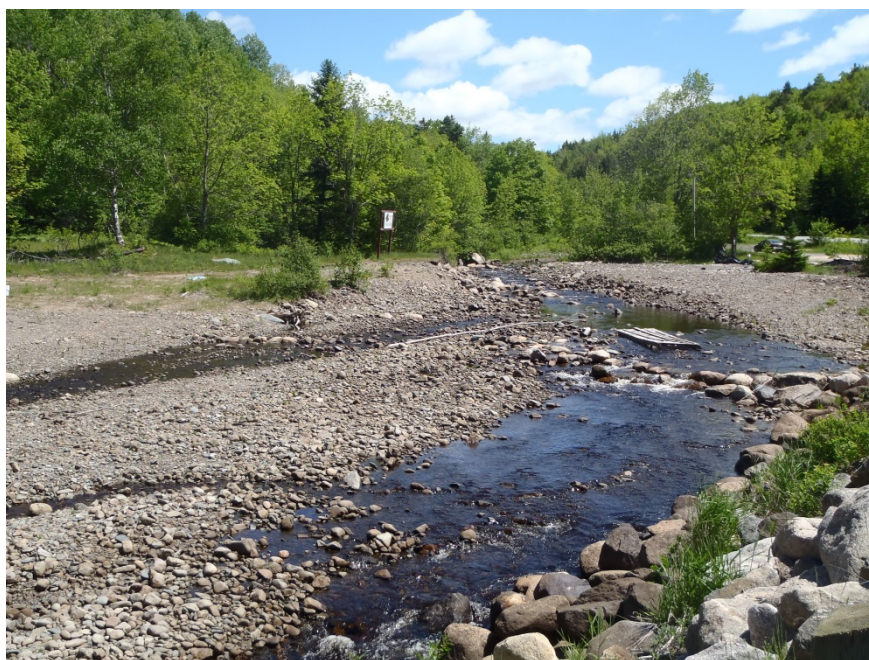
As is observed at Station 1, the channel is establishing itself along the left side (facing downstream) of the former impoundment over the constructed weirs, resulting in a pool/riffle sequence.

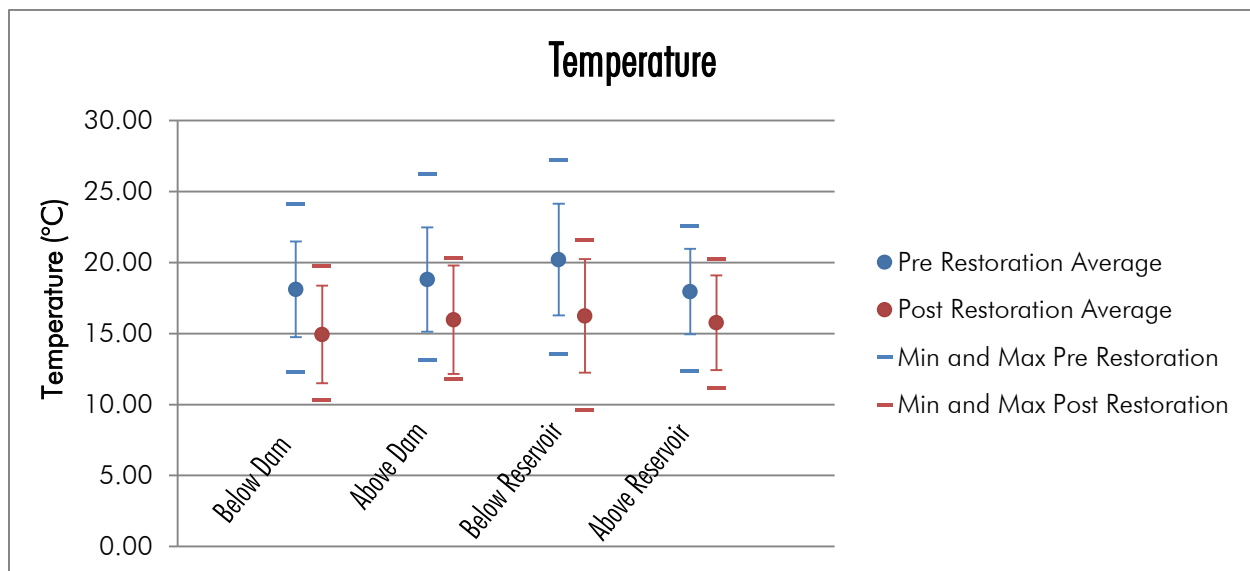
Figure 32: Temperature Data Collected at the Clementsport Dam Removal Site Pre and Post-Restoration.

The water samples taken prior to the dam's removal in 2011 showed overall higher average temperatures across all sites, as compared to the post-restoration samples, which had lower average temperatures. The sites monitored above and below the reservoir showed the same temperature decrease, and these were well removed from the site of the dam's removal. Therefore, it is likely that the observable overall decrease in average temperatures post-restoration is more likely a result of climactic fluctuations between monitoring years. There is a consistent temperature increase from the Above Reservoir and Below Reservoir sites. This is most likely attributable to the design of the reservoir, which draws upon the warmer surface waters and transfers them downstream.

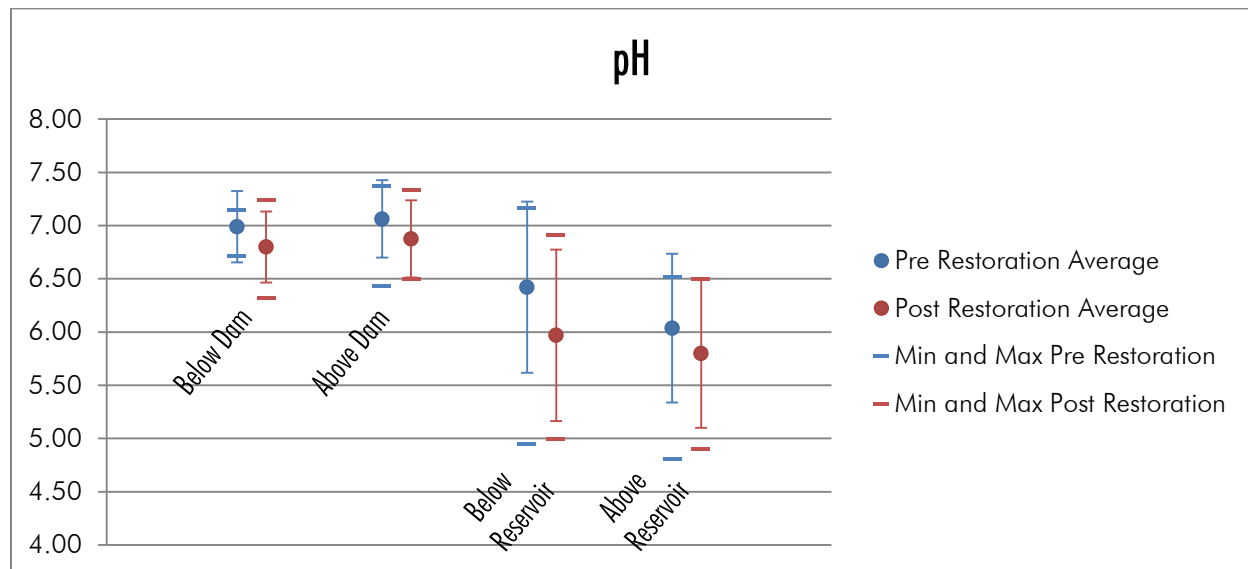
**Figure 33:** pH Data Collected from Sites Monitored on a Monthly Basis Pre and Post-Restoration.

Figure 33 shows the average, as well as minimum and maximum pH values recorded from the water quality monitoring at the Clementsport Dam and Reservoir sites. The pH data collected at the four monitoring sites did not display a significant change between pre-restoration and post-restoration average values. However, the sites downstream (Above and Below Dam) displayed a higher pH average than further upstream. The pH ranges upstream near the reservoir displayed a much higher range of values than those near the dam.

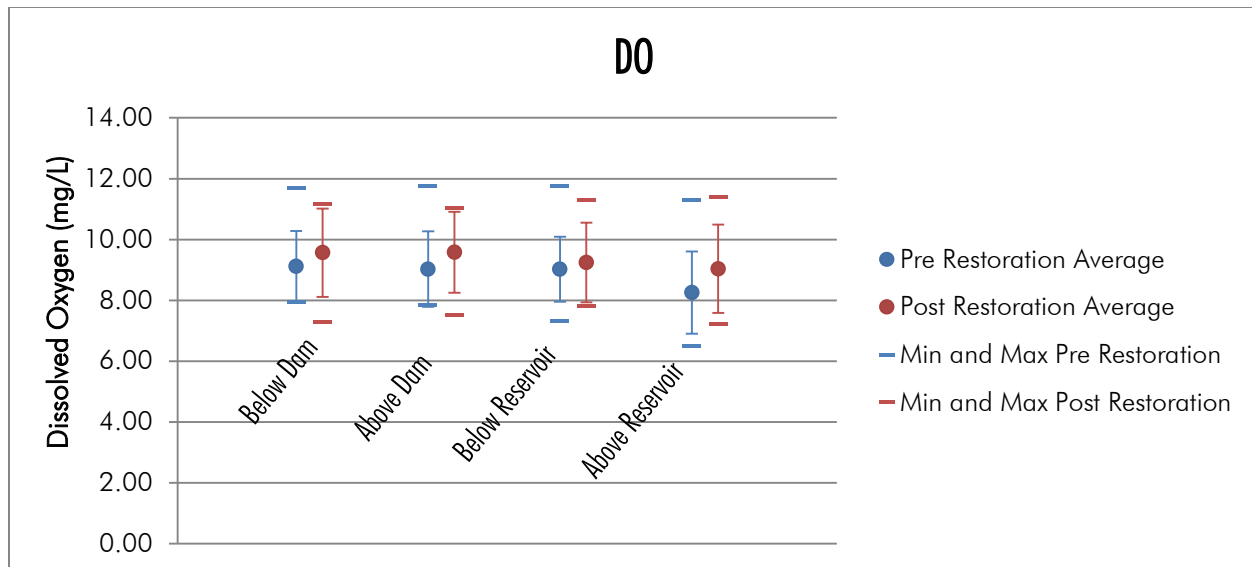
**Figure 34:** Dissolved Oxygen Average Values for Sites Monitored Pre and Post-Restoration.

Figure 34 shows the DO (mg/L) levels recorded as part of the water quality monitoring regime at Moose River. There was no significant observable change in the DO levels between sites or from the pre-restoration and post-restoration data sets. DO levels were well above the acceptable limit of 6.5 mg/L for cold water species. The slight observable increase between the average values recorded pre-restoration versus post-restoration are more likely attributable to the noted decreased in water temperature between years, which would have allowed a greater quantity of oxygen to dissolve into the water column.

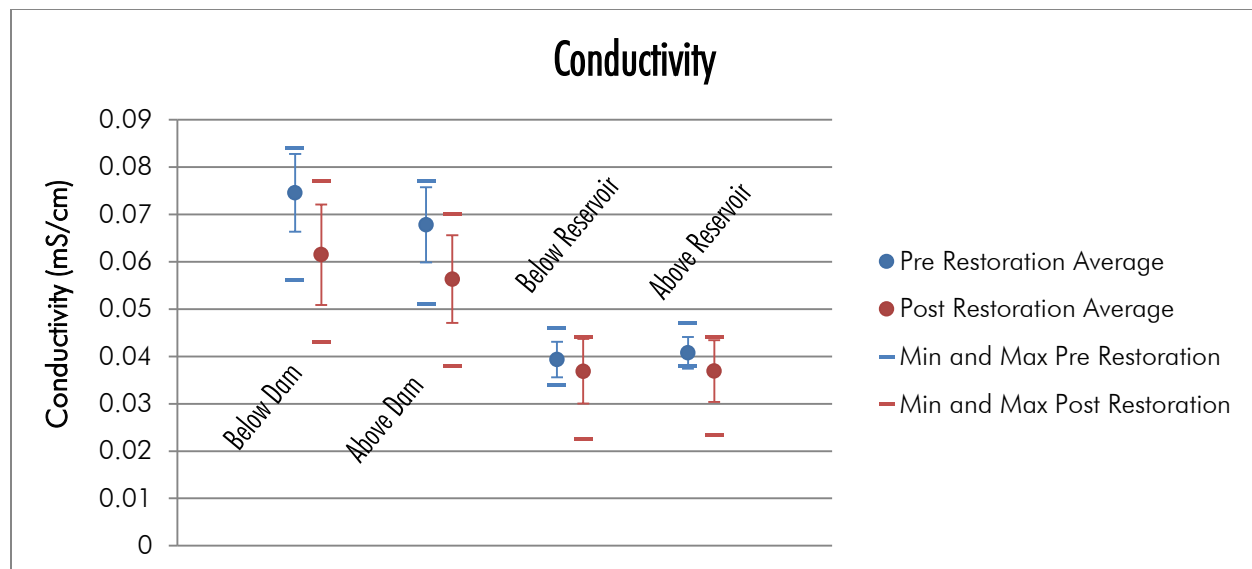
Figure 35: Average Conductivity Values for Sites Monitored Pre and Post-Restoration.

The conductivity results of pre and post-restoration monitoring at the Clementsport Dam removal site are displayed in Figure 35 in the 'Above Dam' and 'Below Dam' sets of monitoring data. The average conductivity values that were measured prior to the dam's removal were higher both above and below the dam, as compared to the post removal averages, but not significantly different. It is possible that the decrease may be attributable to the loss of fine sediments from the dam removal site. Comparatively, relatively little change was observed upstream in the conductivity values recorded above and below the reservoir.

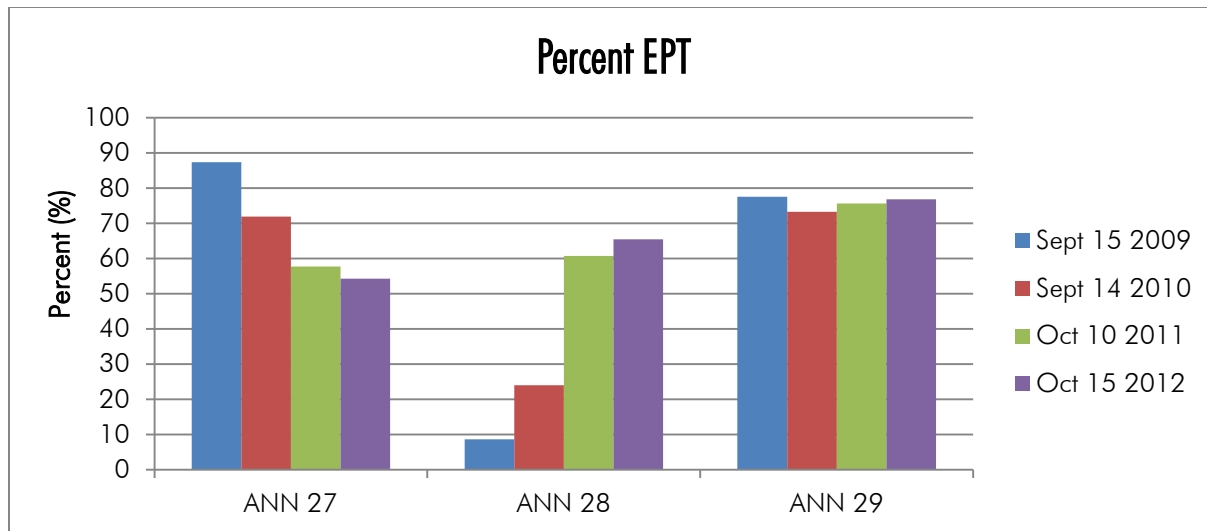
**Figure 36:** Percent EPT Values for Each Invertebrate Monitoring Site 2010-2012

The percent EPT value at ANN28 (within the former impoundment) shows a dramatic increase approximately one month post-restoration when aquatic invertebrate samples were collected. In comparison, ANN27 (upstream control site) exhibits a decline in percent EPT over the same period. ANN29 (downstream of former dam) exhibits little change over the monitoring period. Additionally, percent EPT values at ANN28 appear to have increased to levels more consistent with those found at ANN27, the upstream control site. The shift in EPT values potentially indicates that the habitat characteristics and water quality within the former impoundment improved, becoming more consistent with adjacent reaches upon removal of the dam and related restoration work.

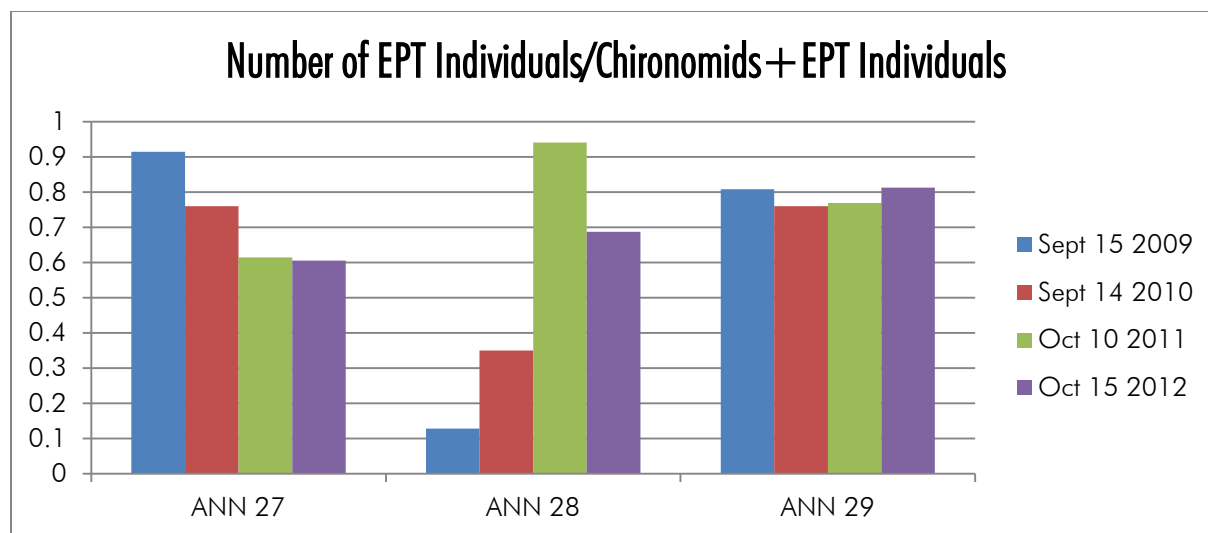
**Figure 37:** EPT/Chironomids + EPT for Each Invertebrate Monitoring Site 2010-2012

Similar to percent EPT, a sudden increase is noted at ANN28 for EPT/Chironomids + EPT. This is followed by a slight decrease between 2011 and 2012 to levels that fall more closely in line with those observed at ANN27 and ANN29 for both years. ANN27 exhibits a decrease in EPT/Chironomids + EPT that may suggest an increase in chironomids rather than decrease in EPT taxa present. This would also explain the decrease in percent EPT noted at the same location. ANN29 exhibits little change in EPT/Chironomids + EPT. The overall increase in EPT/Chironomids + EPT noted in the restoration area indicates a higher proportion of pollution intolerant taxa vs. pollution tolerant taxa suggesting a general improvement in water quality within the former impoundment.

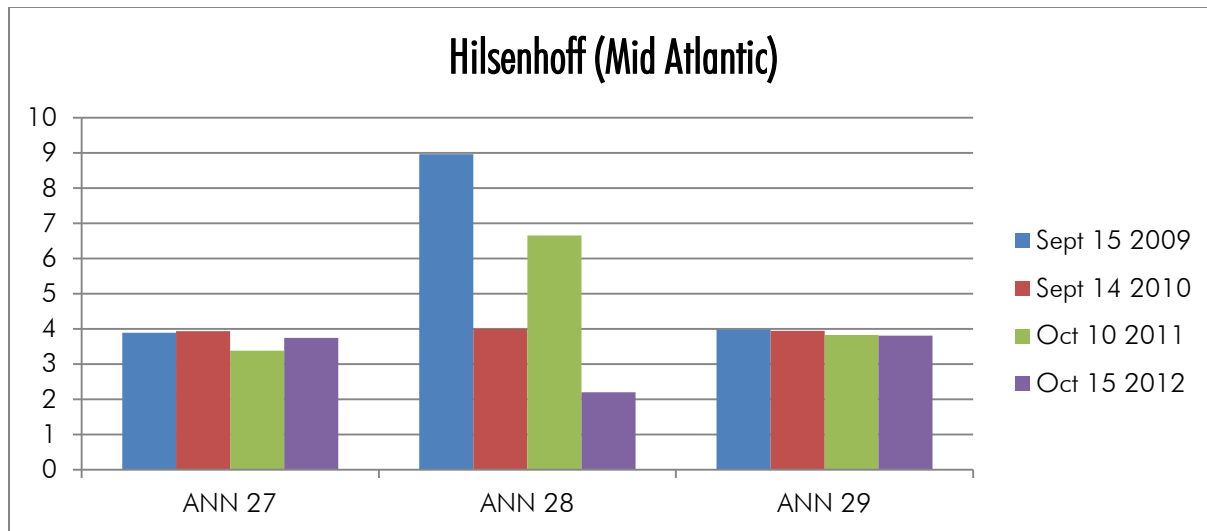
**Figure 38:** Hilsenhoff Index Values for Each Invertebrate Monitoring Site 2010-2012

ANN 27 and 29, respectively upstream and downstream of the restoration area, indicate little change in Hilsenhoff Index values over the monitoring period. ANN28, conversely, exhibits marked changes in Hilsenhoff Index values between each monitoring year. The improvement between 2009 and 2010 may be due to the dam becoming undercut, allowing more flow through. The higher index in 2011 may be attributable to disturbance from the dam removal and restoration activities. The general improvement in the Hilsenhoff Index at ANN28 indicates a shift in the invertebrate community toward a higher proportion of pollution intolerant taxa. This suggests a general improvement in water quality within the former impoundment.
