# Fish Passage Restoration and Habitat Enhancement

*A project to address fish habitat restoration and  
enhancement in the Annapolis River watershed*

Hayley Purcell Doyle, Fisheries Technician  
December 2018

**Clean Annapolis River Project**

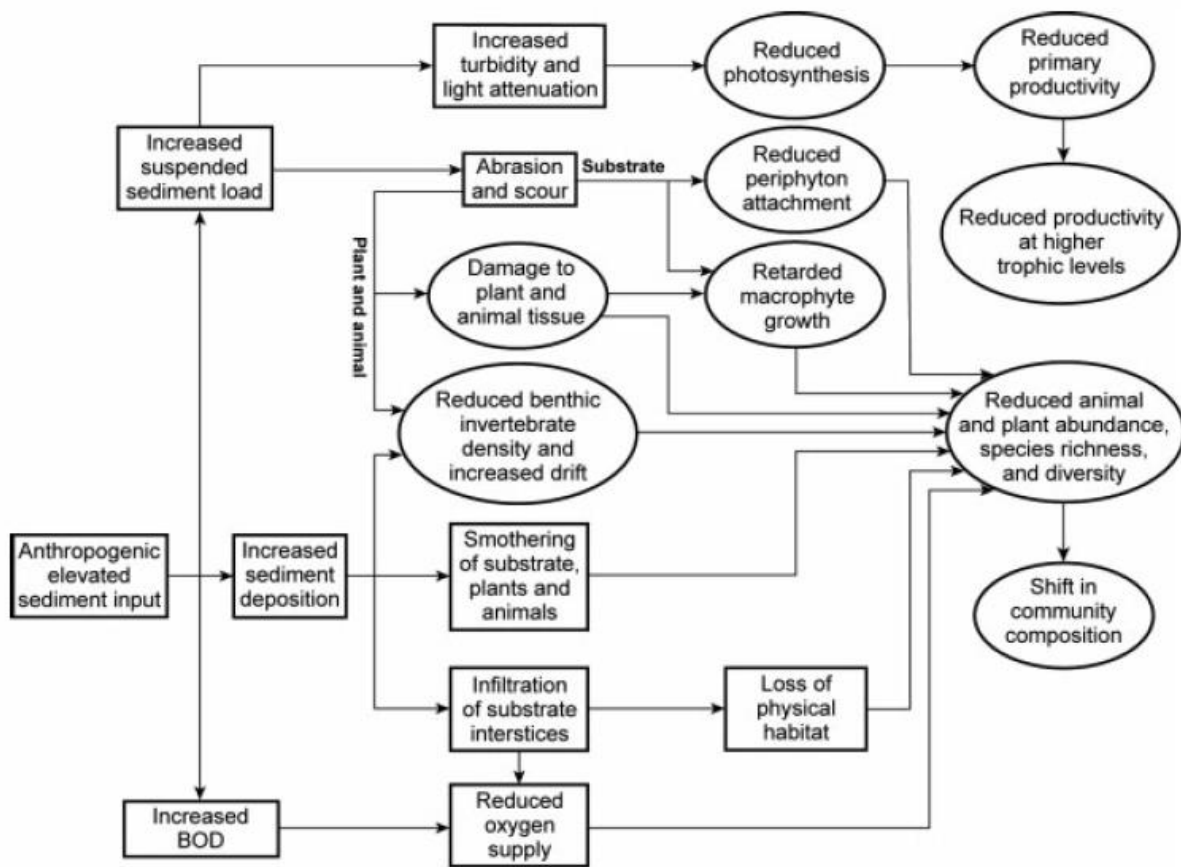
Figure 2. Negative impacts of anthropogenically enhanced sediment input (Kemp et al., 2011).

Substrate surveys, as part of habitat suitability assessments were conducted as a pre-restoration assessment. Consultations with partners and experts were also conducted to help identify additional activities for in-stream habitat enhancement work. It was identified that much of the available spawning habitat in the portion of the river accessible by salmonids was impacted with fine sediments, likely impairing successful spawning. Over several decades, the river has filled in with fine sediments from land-use impacts and bank erosion (see figure 1 for an example). Fine sediment accumulation ( $< 2$  mm in size; Louhi *et al.*, 2008) has been widely recognized to pose detrimental effects to river ecosystems (see Figure 2). Salmonid species prefer coarse gravel and stone bottoms for spawning and are particularly vulnerable to sediment accumulation (Hendry and Cragg-Hine, 2003; Klemensten *et al.*, 2003). As a result, the focus of 2018 in-stream habitat enhancement was targeted at fine sediment removal.

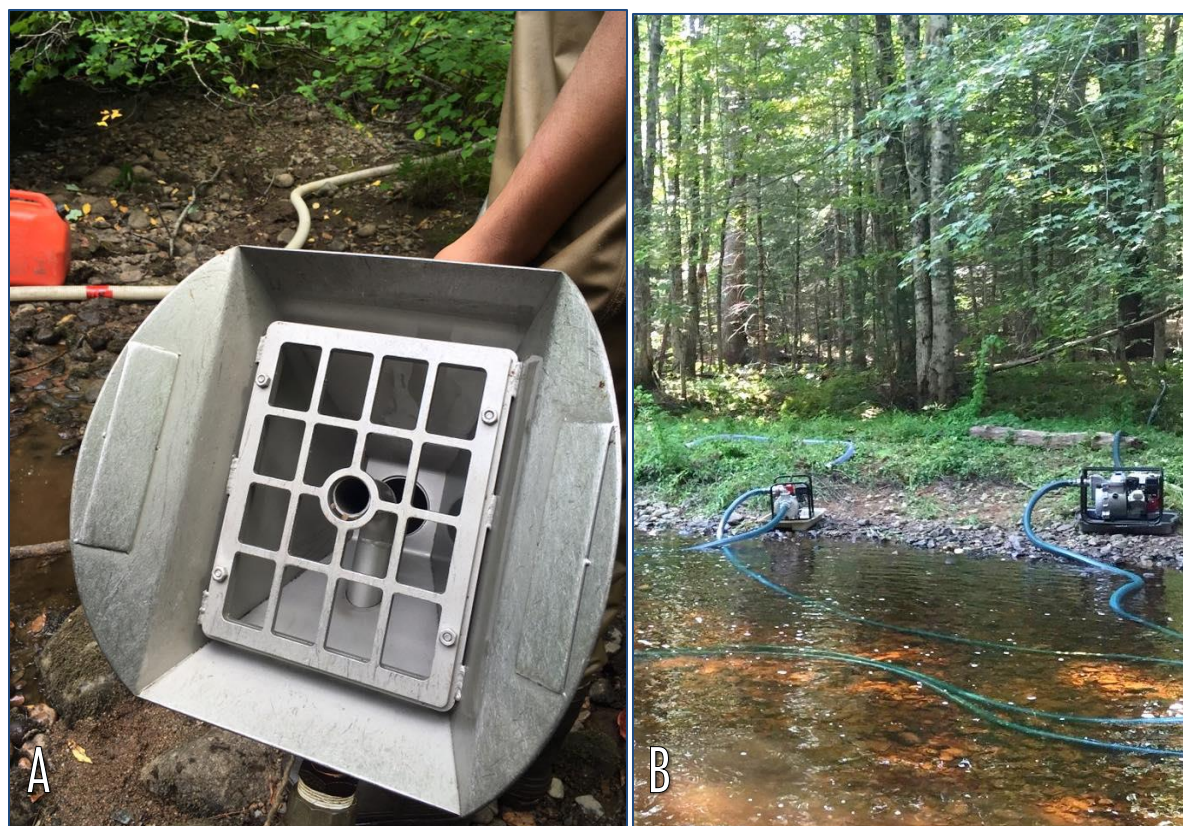
**Figure 3.** Photographs of the SandWand head (A) and pump generators on river bank (B).

The SandWand head (Figure 3A) features a center hole which provides a water jet pointed at the riverbed. The water jet suspends the fine sediments, which are then vacuumed through the grate and into the trash hose. Sediments from the trash hose are deposited well away from bankfull levels to ensure that they are not carried directly back into the river with the first high flows. The nature of this operation allows for the realization of immediate results; however, longer impacts due to changes in embeddedness and sediment transport should also be monitored.

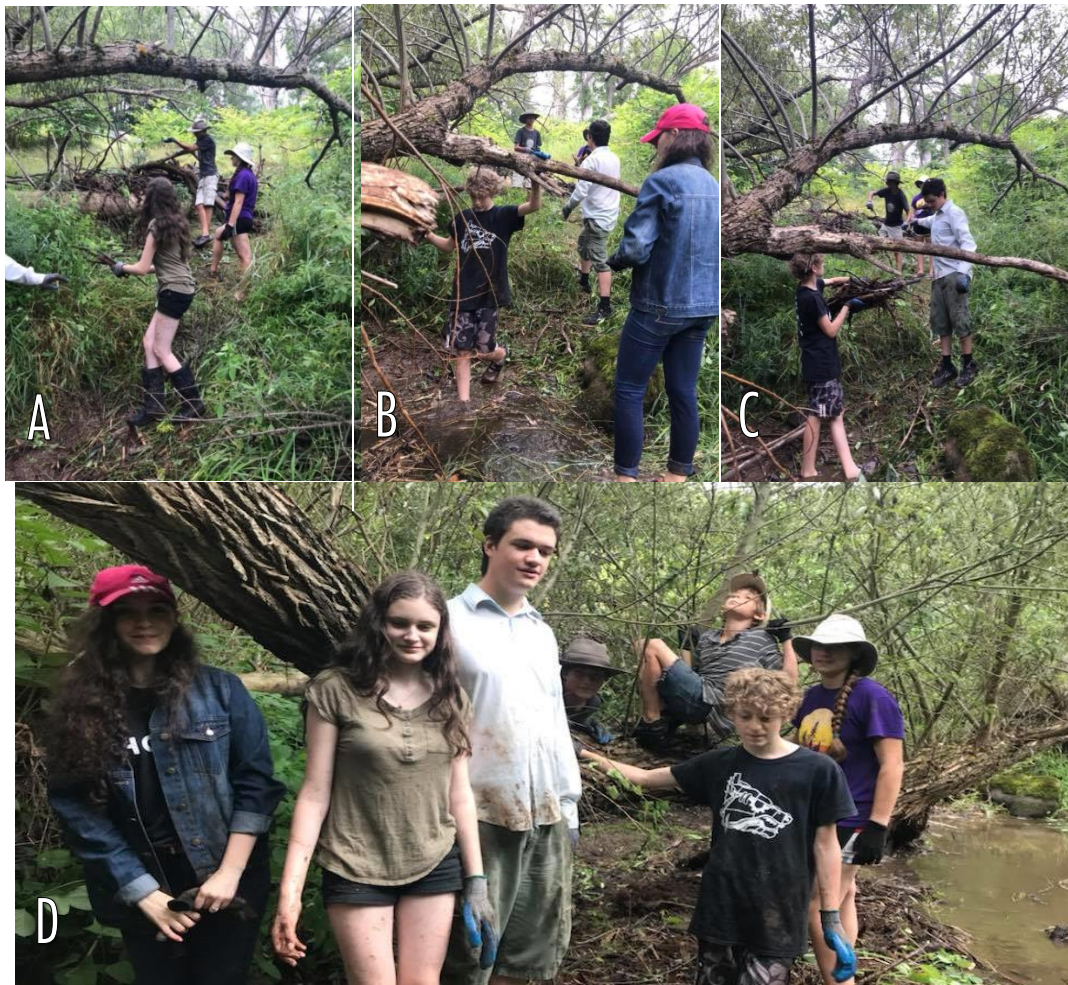
**Comments:** MCG009 is a large, concrete culvert that was newly installed in 2012. Found along the McGee Brook, with a main stem that runs approximately 6.86 km long, this natural bottom culvert is located downstream of a large pond. There was no debris blockage directly at the inflow, but fallen trees and debris upstream was impeding fish passage to the 6.86 km of habitat beyond the culvert (Figure 10). Staff and volunteers removed the blockages allowing for free flowing water to reach the culvert and therefore increasing connectivity to the rest of the brook (Figure 11).

**Figure 11.** Volunteer students assisting in the debris removal at MCG009.
