Fish Passage Restoration and Habitat Enhancement

*Anadromous fish passage assessment and remediation
in the Annapolis and Cornwallis River Watersheds*

Rachel Walsh
March 2024

Clean Annapolis River Project

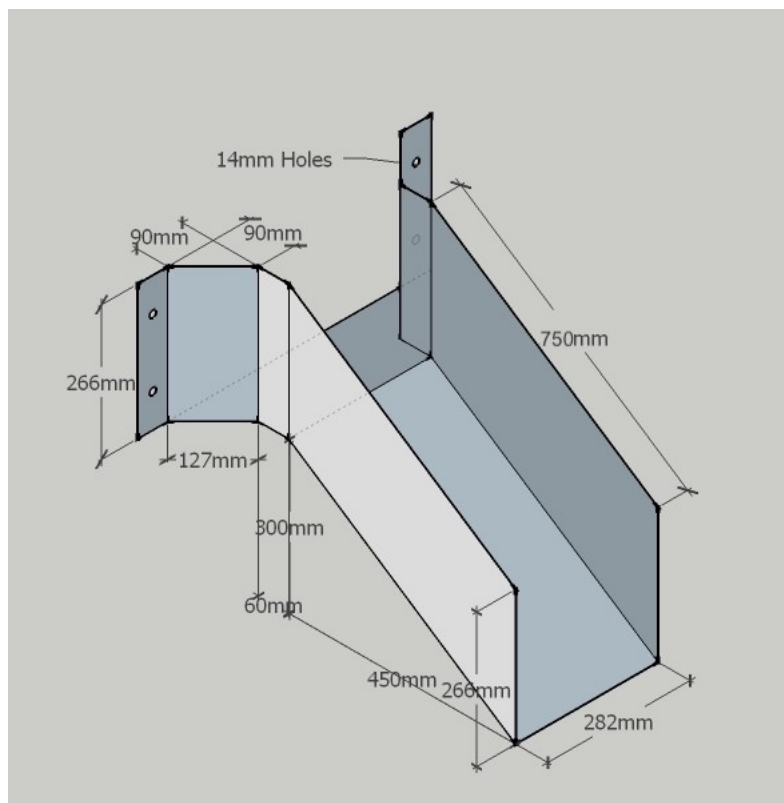
Figure 1. Fish chute design and dimensions.

Fish chutes are another feature, often used in addition to other culvert remediation actions, that are added to the outflow of a culvert to assist in reducing the effects of a large outflow drop. In 2016, a fish chute was installed in combination with a tailwater control structure to alleviate an outflow drop of over 50 cm. Culvert measurements were used to calculate the required chute dimensions using a formula for determining baffle notch sizes. Unfortunately, upon re-assessing the site in 2023, the chute had detached from its affixed baffles and was no longer attached to the culvert.

Using the same design as in 2016, a new chute was ordered from RKO Steel Ltd in Dartmouth, NS. The chute was made from 6.35 mm galvanized steel plate, and the length of the chute itself was increased from 540 mm to 750 mm. A wooden frame was constructed around the outflow of the culvert using pressure-treated 4x4 lumber. The fish chute was affixed to the wooden frame using galvanized lag bolts. Stainless steel corner braces were also attached to add additional reinforcement to the structure.

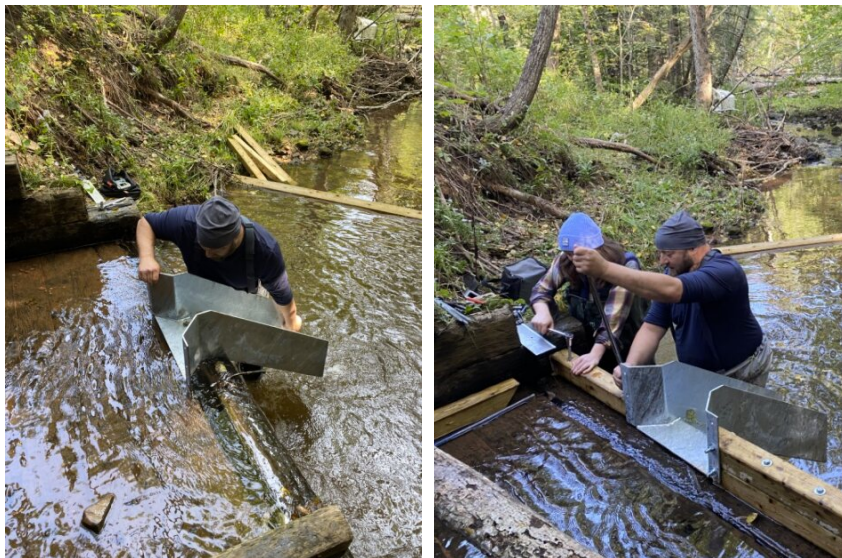
Figure 33. CARP staff, Levi Cliche and Shauna Forrestall installing the fish chute.
