Assessing and Restoring
Aquatic Connectivity in the
Annapolis River Watershed

Prepared By Chelsae Postma
Ecological Restoration Technician
November 2011

Clean Annapolis River Project

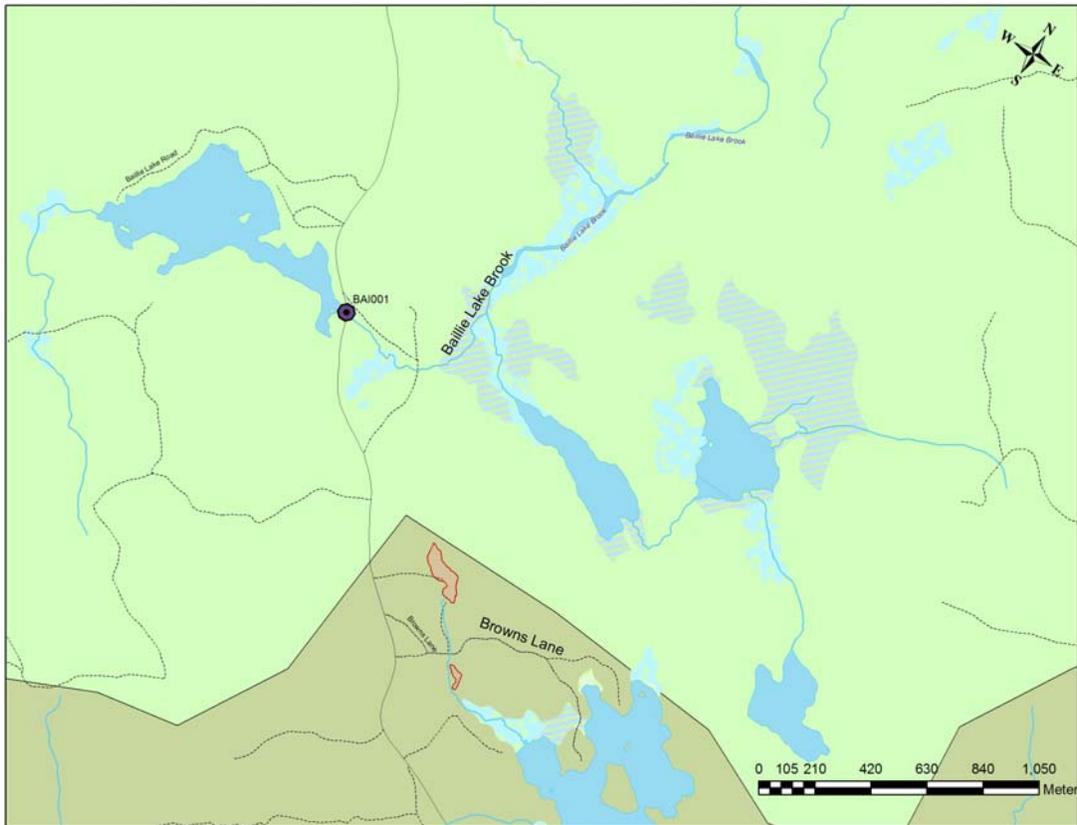
Figure 3. Map indicating location of Ballie Lake and the partial barrier culvert (BAI001).

BAI001 is a system of two steel culverts emptying Ballie Lake into Ballie Lake Brook. It is located on Virginia Road, near Milford (Figure 3). This is one of three road-watercourse crossings located on Ballie Lake Brook. One of these is located on a trail 400 m downstream and will need to be assessed as it was not previously identified in GIS. The other two restrict approximately 100 m and 800 m of upstream habitat. Ballie Lake Brook connects over 13 km of brook, wetland and lake habitat before emptying into Grand Lake. The lakes in this system include Springhill Mud Lake, Cranberry Lake and Little Annapolis Lake. The remediation of BAI001 restored access to 2.65 km of upstream habitat.

There is a debris cage located at the inflow of this culvert system that had collected a large quantity of material from the lake (Figure 4). Most of the debris was beaver sticks, root clumps, and decaying vegetation that was caught by the cage. The debris was approximately 3 ft high creating a partial dam with a high velocity drop making both a physical and velocity barrier. Figure 5 shows the water discharging from the outflow of the culvert before and after the remediation.

The restriction the barrier presented on lake flow was evident by the water level drop observed when CARP staff returned the following day (Figure 6). Due to the debris cage, it is likely that material will continue to collect at the inflow of BAI001. It is recommended that the owners of the roadway remove the cage or check yearly for obstruction.

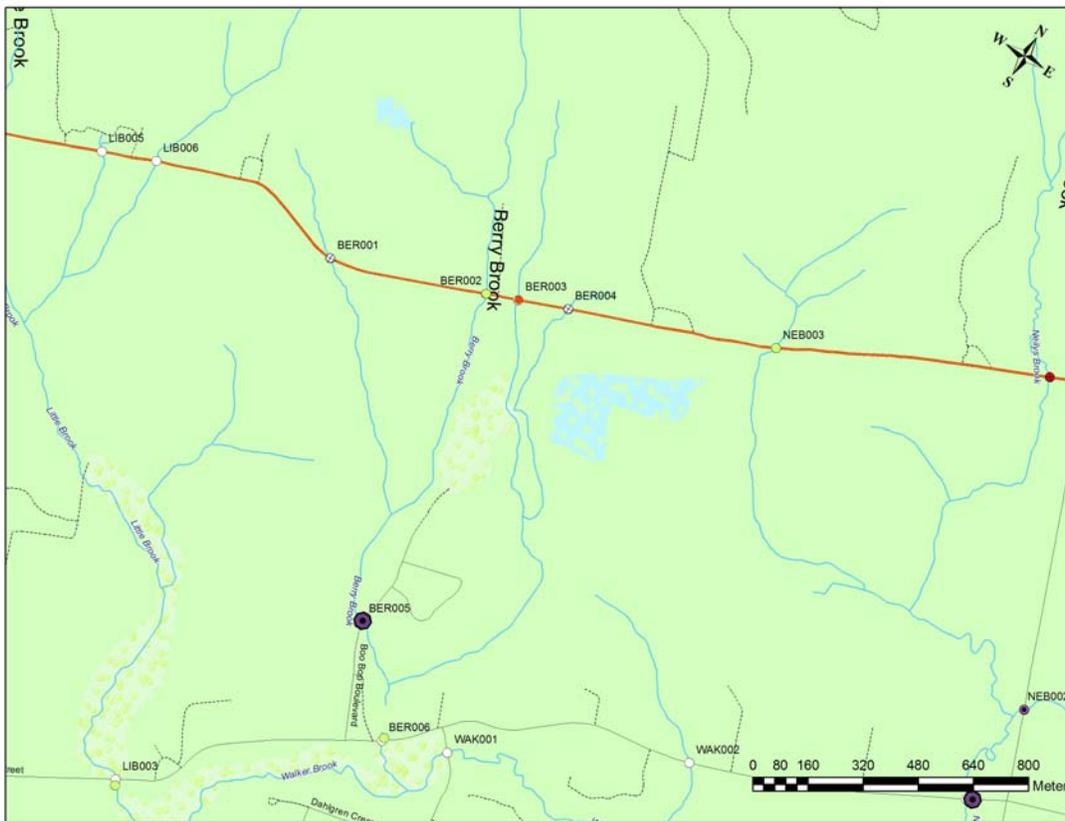
Figure 7. Map indicating location of Boo Boo Boulevard and the partial barrier culvert (BER005).

BER005 is one of six road-watercourse crossings on Berry Brook (Figure 7). Of these culverts, two are passable, two are not in fish habitat and one is a barrier. The road crossing directly downstream

BER005 is located on a privately owned road and consists of two cement culverts and a steel culvert that form a double base with a cement culvert situated on top, perhaps to act as an overflow culvert. It appeared that trees had fallen into the brook at the inflow of the culverts, trapping other debris (Figure 8). The right bank was quite eroded which may have been the result of the rerouted water hitting the bank as it could not flow through the culverts. It is recommended that the owners assess the bank stability, as much of the lower support is lost.

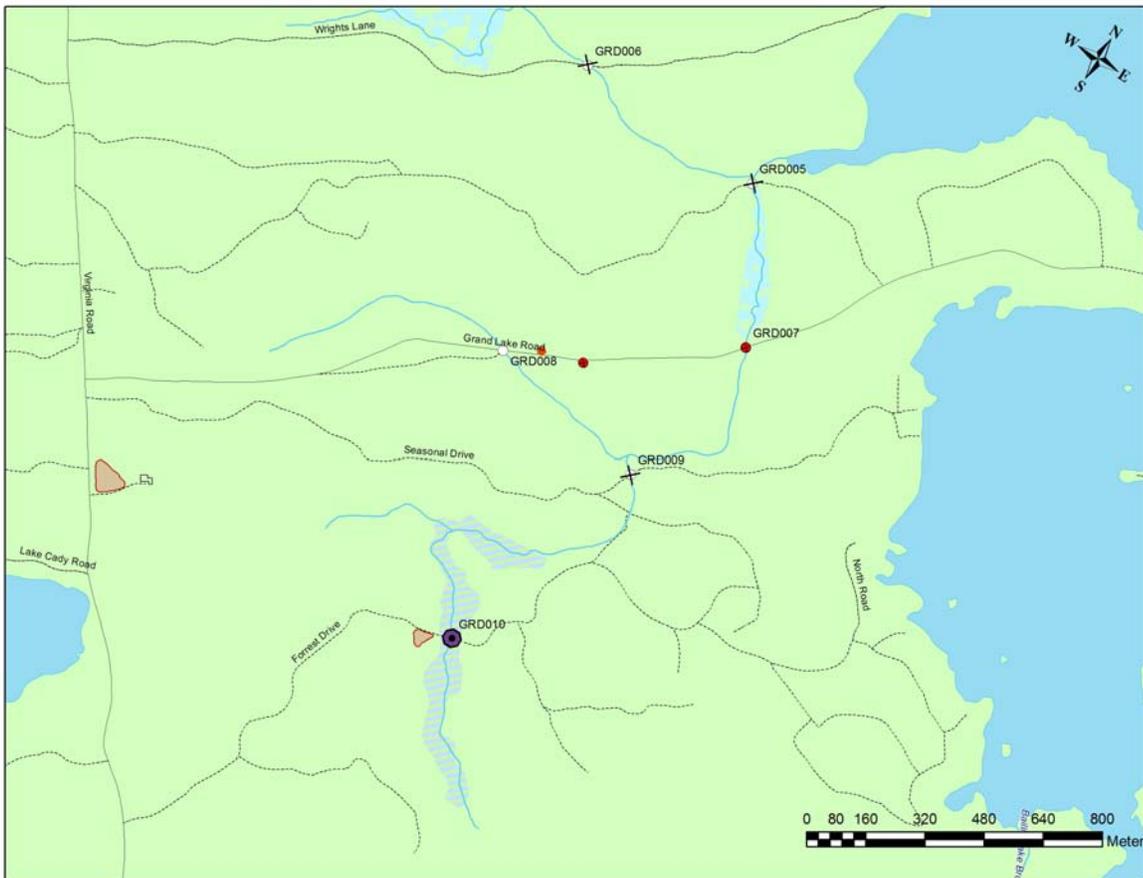
Figure 10. Map indicating location of Grand Lake and the partial barrier culvert (GRD010).

GRD010 is located on an unnamed watercourse that empties into Grand Lake. This branching brook contains seven road-watercourse crossings; three are not accessible, three are barriers and one is unidentified on GIS (Figure 10). The total length of the stream is 5.79 km and GRD010 restricted 560 m of upstream habitat including wetland.

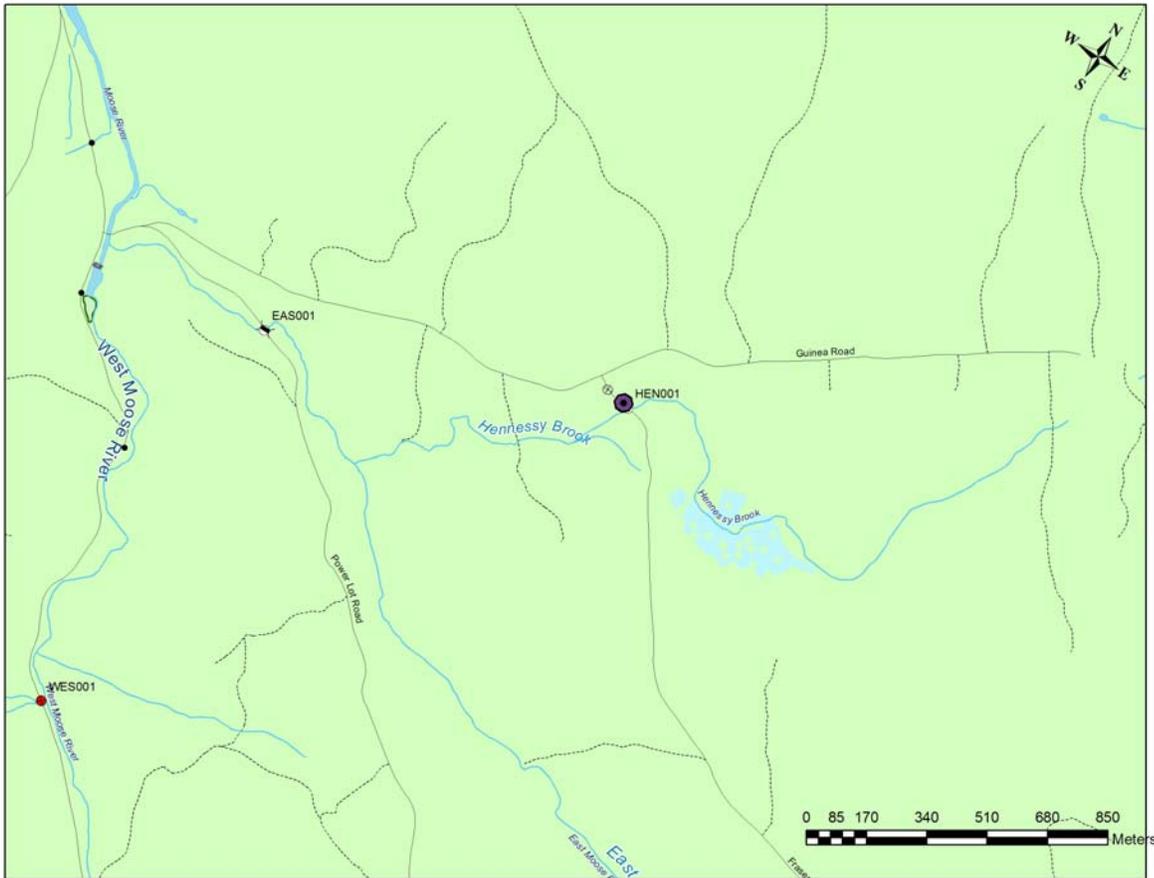
Figure 13. Map indicating location of Hennessey Brook and the partial barrier culvert (HEN001).

HEN001 is located on Fraser Road and Hennessey Brook, which is a tributary to the East Moose River (Figure 13). It has approximately 3 km of habitat, 1.8 km of which was not accessible to fish due to the barrier at HEN001. There are three road crossings on this brook; one (HEN001) is a partial barrier and the other two are located on trails which were not previously identified with GIS.

A debris cage is located at both the inflow and outflow of the steel, circular culvert. Large sticks and woody debris had collected at the base of the debris cage not allowing small vegetative material to pass (Figure 14). This blockage dammed a significant amount of the stream. After CARP staff removed this debris (Figure 15), there was a noticeable drop in the water level upstream of the culvert (Figure 16).

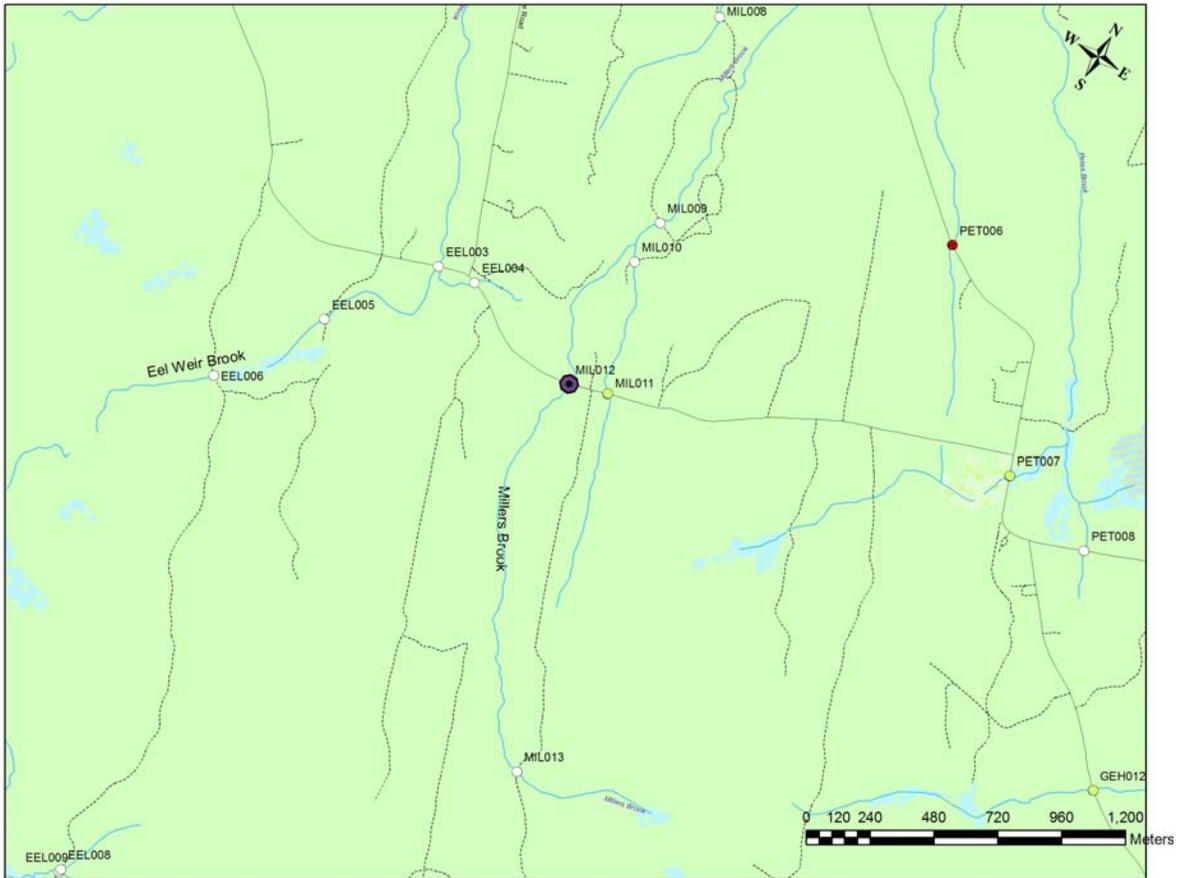
Figure 17. Map indicating location of Millers Brook and the partial barrier culvert (MIL012).

Millers Brook is a 10.3 km watercourse that flows directly into the Annapolis River near Lawrencetown from the South Mountain (Figure 17). There are twelve road crossings along the length of this brook; four are assessed as passable, five are located on trails and have not been visited, and two have not been previously marked on GIS. The only marked barrier is MIL012 which is a barrier bridge. Small trees and branches along the road and brook had recently been cut and left in the brook, creating an obstacle for migrating fish (Figures 18 and 19). CARP Staff removed the woody debris to allow a clear route for fish to swim.

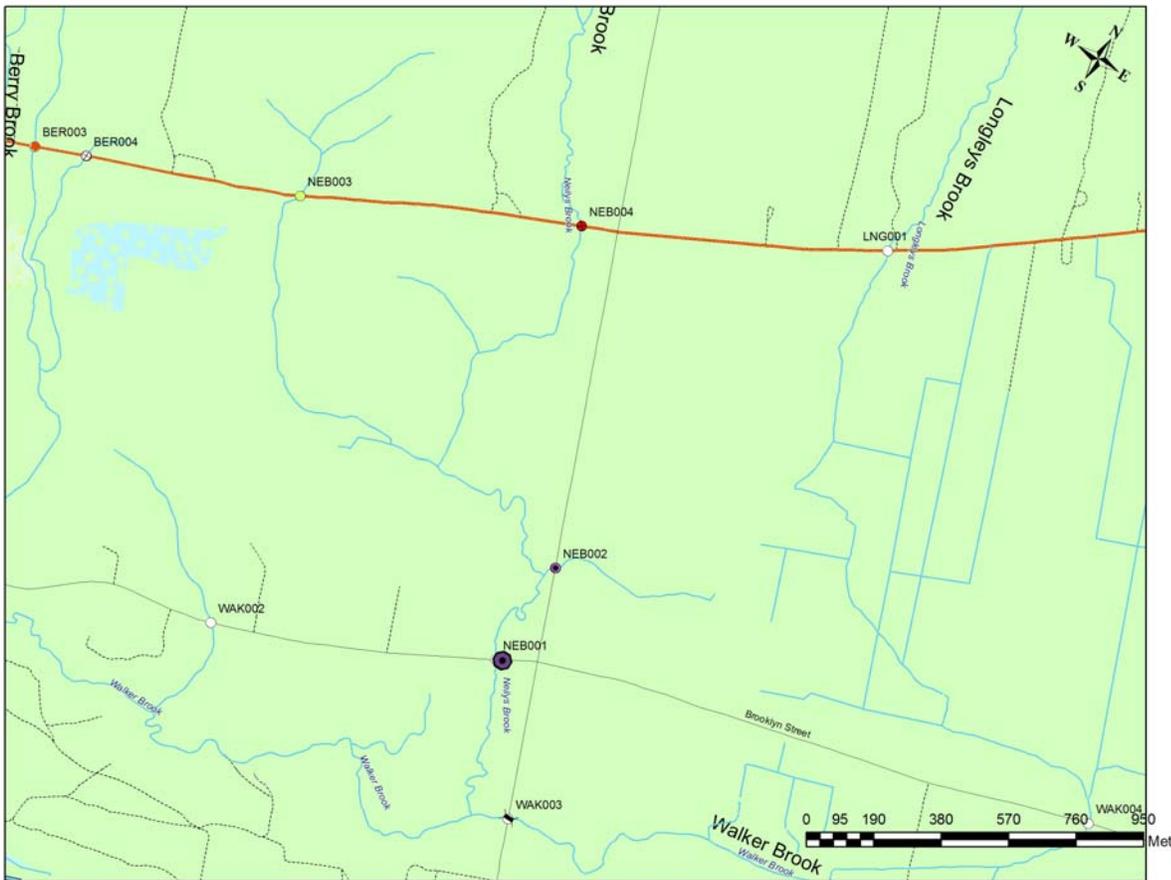
Figure 20. Map indicating location of Neilys Brook and the partial barrier culvert (NEB001).

NEB001 is located at the intersection of Neilys Brook and Brooklyn Street near Kingston (Figure 20). Neilys Brook is 7.4 km in length flowing from the North Mountain down to Walker Brook, which is a large watercourse that drains into the Annapolis River. There are seven road-watercourse crossings on Neilys Brook; one is passable, three are barriers, two are unmarked on GIS maps and one site near the headwaters still needs to be visited. By removing debris from NEB001, 3.4 km of upstream habitat (as well as access to the larger Walker Brook) was made available for migrating fish.

Two debris removals were accomplished at this site. The first was the removal of an abandoned beaver dam from branches overhanging the inflow of the main culvert. The material was removed from the tree to prevent it from continuing to fall into the inflow and blocking the culvert (Figure 21). The second removal was to restore flow through the main culvert. Material from the beaver dam that had floated downstream was caught at the culvert's entrance (Figure 22). CARP staff removed this debris to ensure continuous water flow through the culvert.

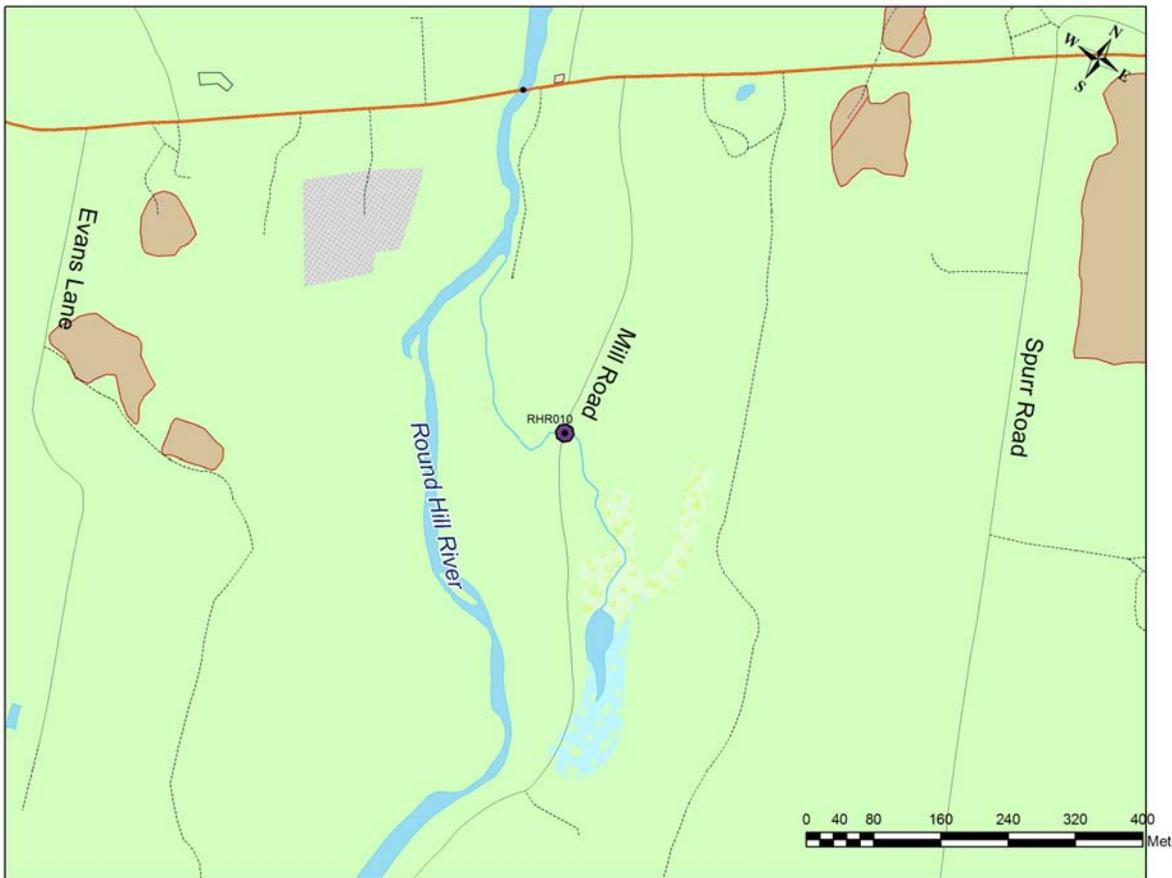
Figure 23. Map indicating location of Roundhill River and the partial barrier culvert (RHR010).

RHR010 is a steel culvert located on Mill Road where a tributary of the Roundhill River intersects Mill Road (Figure 23). This watercourse is about 660 m in length and the culvert restricted access to 360 m of upstream wetland, pond and watercourse habitat. This is the only culvert on this particular tributary. Small trees from the surrounding ditch were cut and left in the ditch, partially blocking access upstream of RHR010 (Figure 24). CARP staff cleared this debris as well as woody material caught on a low hanging branch downstream of the culvert.

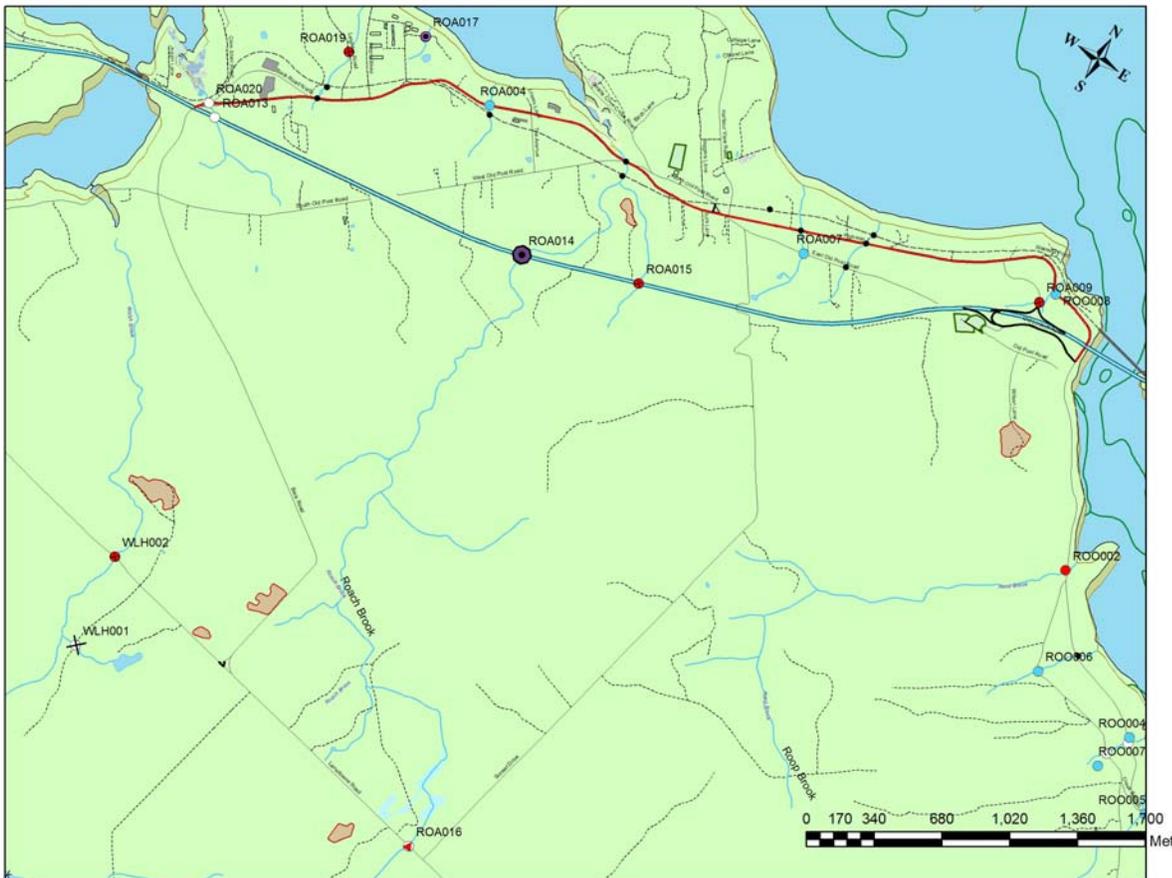
Figure 25. Map indicating location of Roach Brook and the partial barrier culvert (ROA014).

Roach Brook is a large watercourse that empties into the Annapolis Basin at Smiths Cove (Figure 25). ROA014 is a large, baffled culvert with a fish ladder at the outflow. It diverts Roach Brook under HWY 101. This brook has a total length of approximately 10 km, 6.2 km of which was restricted by

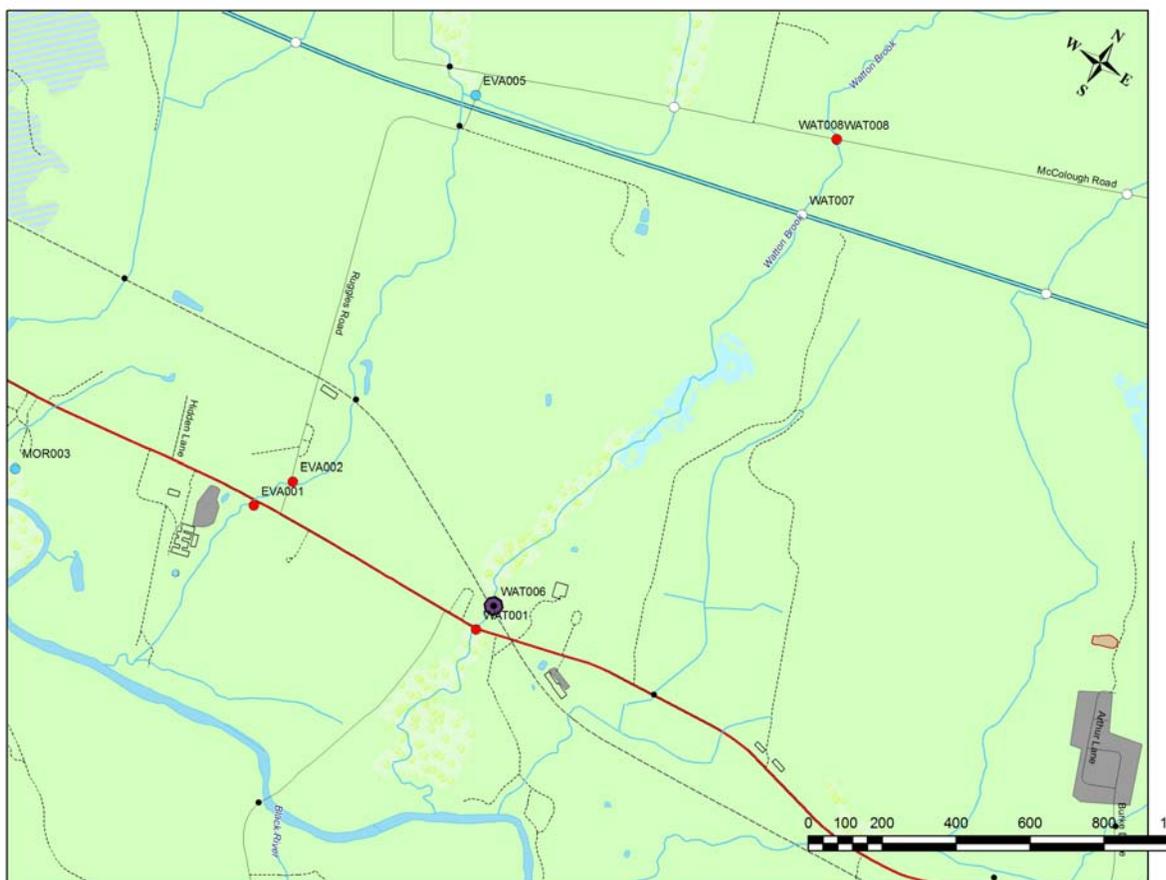
Figure 28. Map indicating location of Watton Brook and the partial barrier culvert (WAT006).

WAT006 is a culvert first assessed during the 2010 field season. It is a double-box, stone culvert located on the old rail bed in Wilmot (Figure 28). Watton Brook flows directly into the Annapolis River and is approximately 10.1 km in length. There are nine road-watercourse crossings on this brook, two were unmarked on GIS maps and therefore were not assessed, three have not yet been visited, and four were deemed barriers to fish passage.

The remediation at Watton Brook will require a multi-year initiative. A very large amount of material had accumulated at the inflow of this double culvert system (Figure 29). In part, it was caused by an abandoned beaver dam. However, there was evidence of illegal dumping into the brook (eg: horse stall doors). In addition, large logs and other woody debris had collected at the inflow, trapping smaller material. Due to the extent of built up sediment from prolonged blockage, staff only removed part of the barrier (Figure 30).

The site was re-visited approximately one month after the debris removal (Figure 31). Passage was possible through the right culvert, though the beaver dam material from the left bank had eroded into the brook, again blocking the left culvert inflow. It is recommended that the remainder of the beaver dam, as well as the material dumped on the bank above the culvert, be removed in 2012.

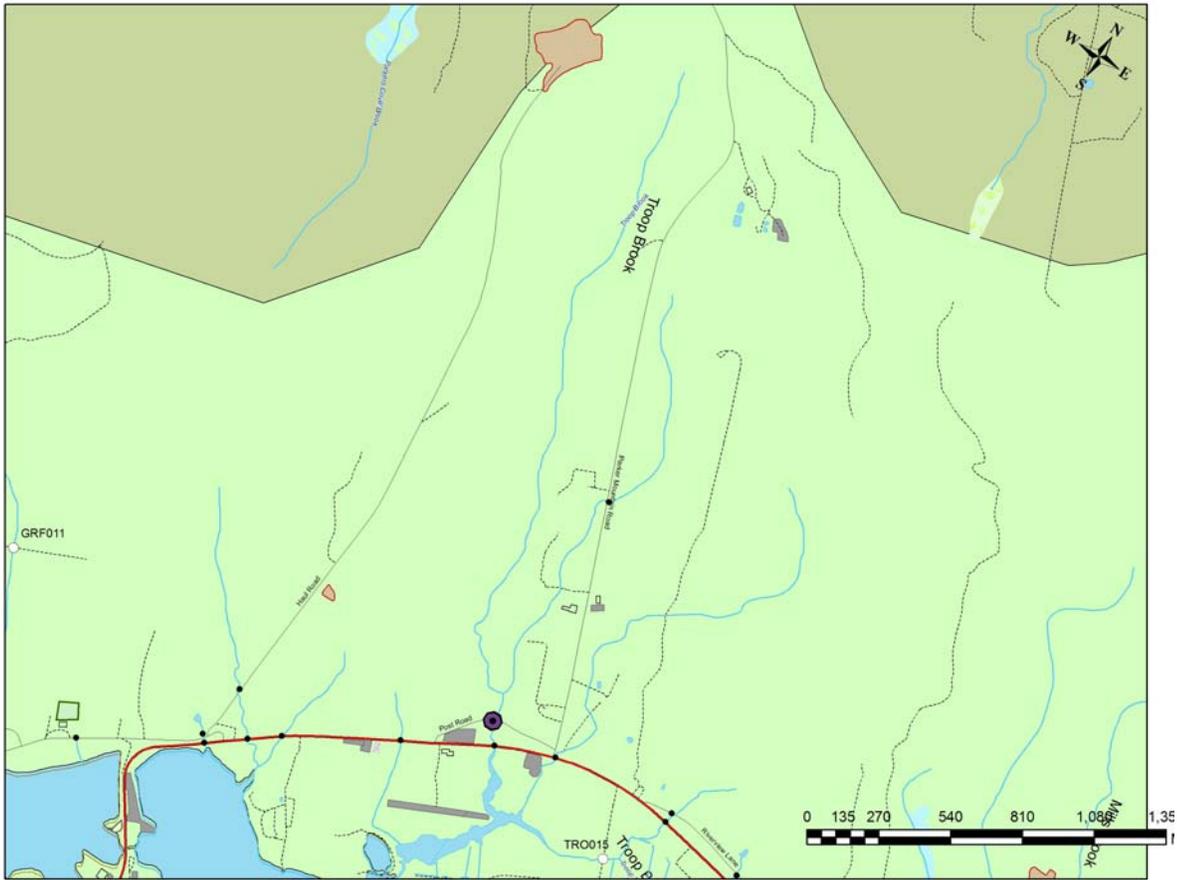
Figure 33. Map indicating location of Troop Brook and the full barrier culvert (TRO010).

Troop Brook is located in Granville Centre (Figure 33). Last season, a tailwater control weir was installed to reduce the outflow drop. It succeeded in bringing the pool surface to the culvert outflow and eliminating the drop. However, the slopes of the culverts are quite substantial at 1.6% and 1.9%, which is over the 1.0% guideline in the Fish Passage Index (Appendix D). To accommodate this slope, a second weir was installed further downstream creating a step-up pool type system, so the first weir could be raised slightly. The weir installed in 2010 (Weir A) also underwent maintenance to replace dislodged rock.

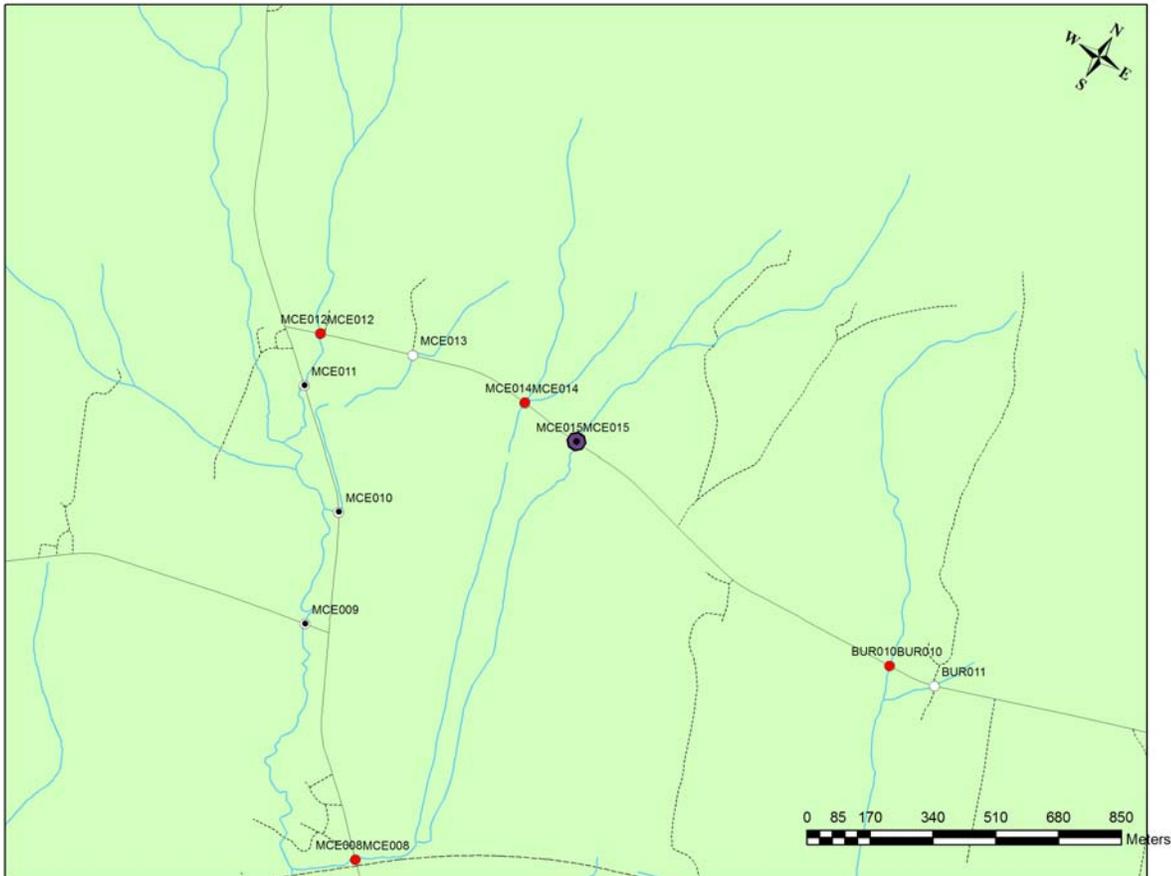
Figure 37. Map indicating location of McEwan Brook and the full barrier culvert (MCE015).

MCE015 is located on McEwan Brook in Brooklyn, NS (Figure 37). This branching brook is over 24 km in length with 1.7 km of fish habitat restricted due to an outflow drop and steep slope at MCE015. McEwan Brook has 21 road-watercourse crossing sites; 6 are passable, 5 are barriers, 2 were not assessed because of limited upstream habitat and 8 were on trails and not identified in GIS. MCE015 was chosen as a site for rock weir installation because it is easily accessible and contained quality brook habitat. The plunge pool at the outflow of the culvert was larger than necessary. Part of the restoration included shortening the pool length and filling in the sides of the pool to raise the water level in the culvert.
