# Fish Passage Restoration and Habitat Enhancement

*A project to address fish habitat fragmentation and degradation in the Annapolis River Watershed*

Rachel Walsh  
December 2023

## **Clean Annapolis River Project**

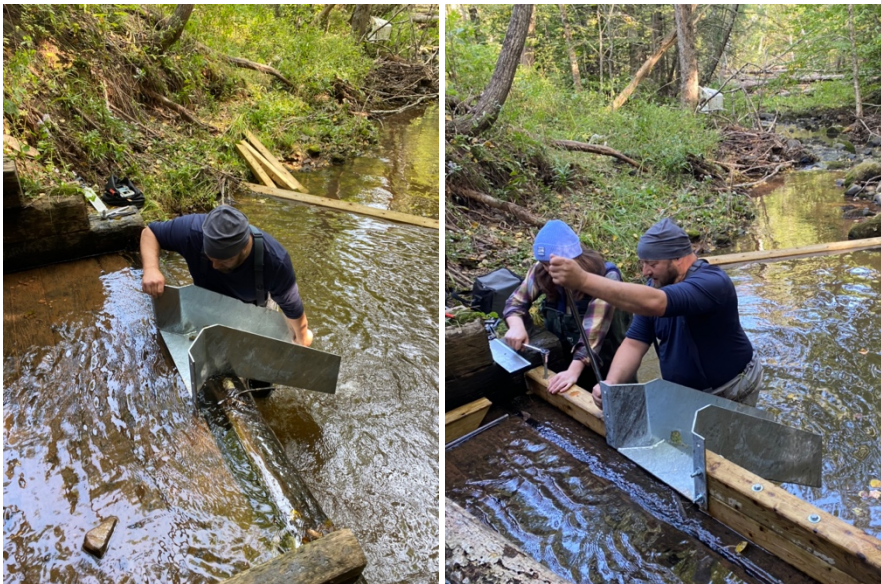
*Comments:* WAT004, located on Watton Brook, consisted of a double wooden box culvert. In 2016, several enhancements were made to the site, including the installation of baffles, a low-flow barrier, a fish chute, and a tailwater control structure. However, during the 2023 site revisit, it was discovered that the fish chute had detached from the culvert and couldn't be located. A replacement chute was ordered and successfully installed in September 2023 to rectify the culvert's excessive outflow drop of more than 50 cm.

Figure 12. CARP staff Levi Cliche and Shauna Forrestall installing the fish chute.

Using the same design as in 2016, a new chute was ordered from RKO Steel Ltd in Dartmouth, NS. The chute was made from 6.35 mm galvanized steel plate, and the length of the chute itself was increased from 540 mm to 750 mm. A wooden frame was constructed around the outflow of the culvert using pressure-treated 4x4 lumber. The fish chute was affixed to the wooden frame using galvanized lag bolts. Stainless steel corner braces were also attached to add additional reinforcement to the structure.
