# Fish Passage Restoration and Habitat Enhancement

*A project to address fish habitat fragmentation and degradation in the Annapolis River watershed*

Hayley Doyle  
Fisheries Technician  
December 2019

## Clean Annapolis River Project

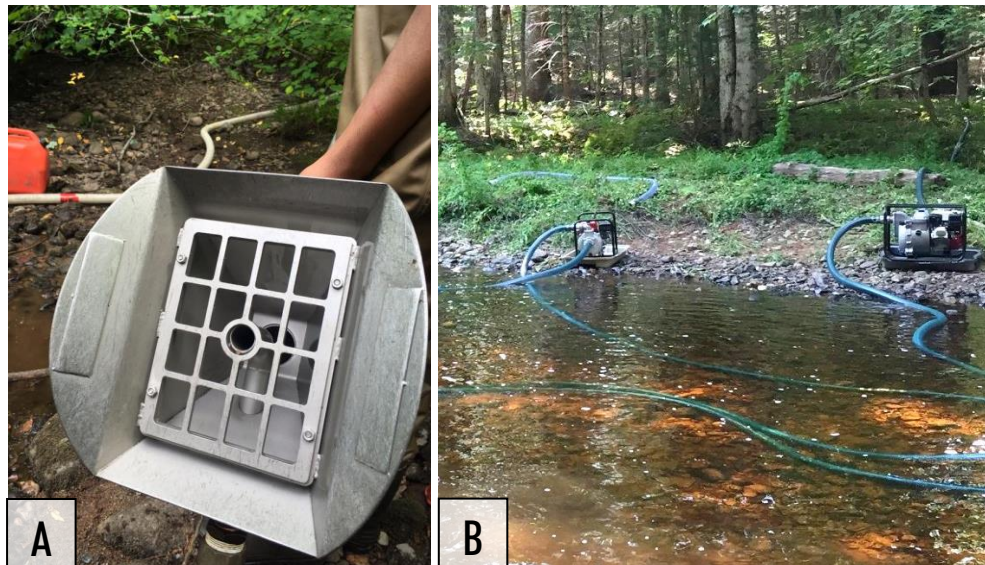
**Figure 3.** The SandWand head (A) and pump generators (B) used to remove fine sediment from the Fales River.

The SandWand head (Figure 3A) features a center hole which provides a water jet pointed at the riverbed. The water jet suspends the fine sediments, which are then vacuumed through the grate and into the trash hose. Sediments from the trash hose are deposited well away from bankfull levels to ensure that they are not carried directly back into the river with the first high flows. The nature of this operation allows for the realization of immediate results; however, longer impacts due to changes in embeddedness and sediment transport should also be monitored.

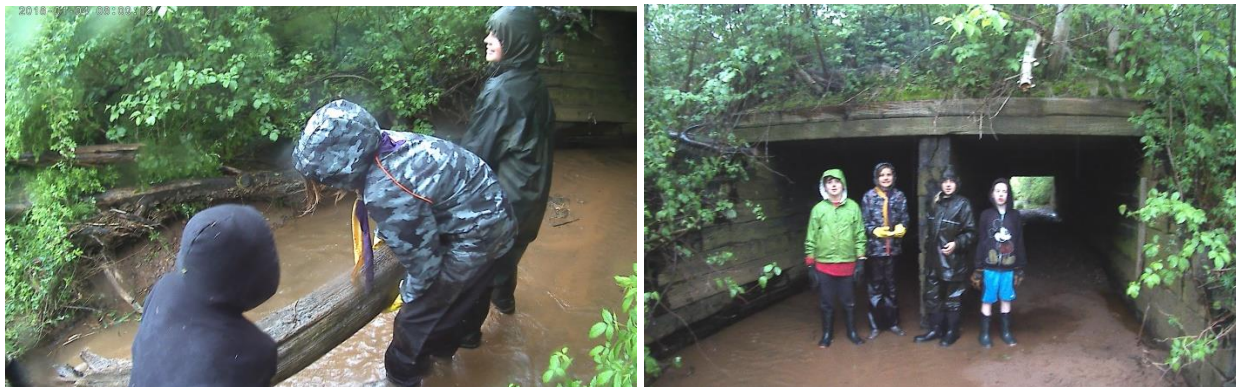
**Figure 9.** Volunteers with the 1<sup>st</sup> Kingston Scouts Cubs helping to remove large woody debris from LIB003.

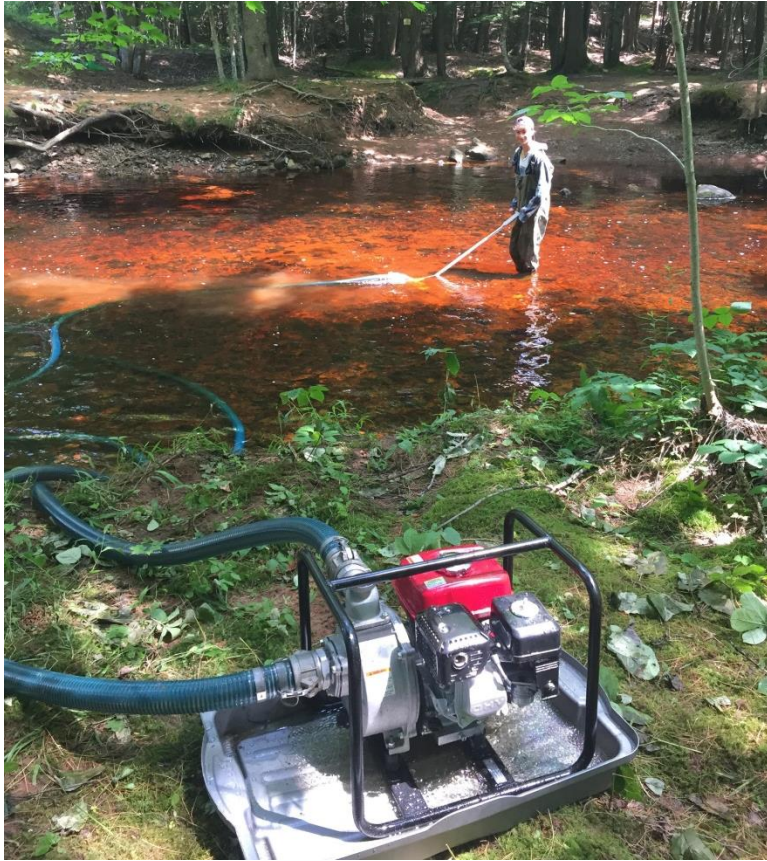
**Figure 15.** Summer student Sebastian Conyers SandWanding in the Fales River.

SandWanding occurred during the 2019 season to enhance in-stream habitat within the Fales River, which has been prioritized for its good quality habitat for salmonids. The SandWanding was started at the head of a pool just below a natural riffle and run along a 43 m stretch. The fine sediment being removed from the river was deposited far from the river's edge to prevent the sediment from re-entering the river and a clean riverbed was noted when no fine sediments were moving through the SandWand hoses. SandWanding efforts resulted in approximately 150 m<sup>2</sup> of in-stream habitat enhancement. Refer to Appendix 6.9 for the location and distance measurements of the SandWanding sections conducted on the Fales River in 2019.

Immediate benefits of fine sediment removal were visually observed after the use of the SandWand. By targeting restoration activities to key areas of habitat, conditions in available spawning areas have been improved for the use of salmonid species. However, the results only show a snapshot of impacts to the physical habitat, and whether the treatment will have long term benefits is unknown. The changes to embeddedness and sediment transport as a result of the fine sediment removal via SandWanding may be altered or regressed from seasonal high flows. Therefore, the site will need to be reassessed in future years to document the long term impacts of restoration activities.

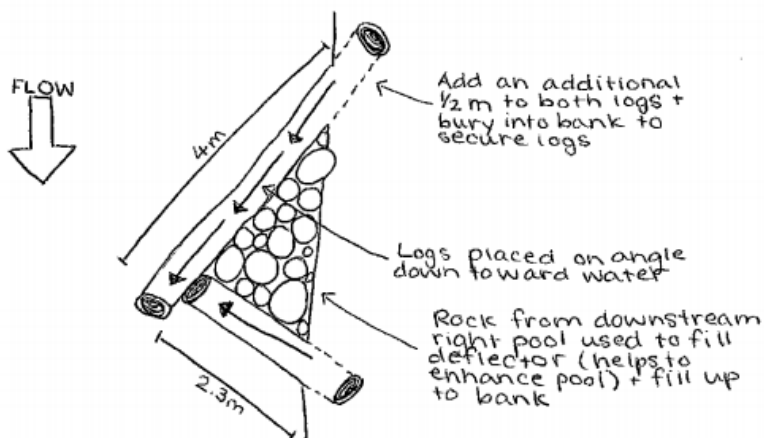
*Site:* Round Hill River, Round Hill, NS

*Structure:* Single log deflector

The Round Hill River received a single, log deflector during the 2019 field season (Figure 18). The deflector was installed to help concentrate flow as well as narrow and deepen the channel of an area of stream over-widened by approximately 2 m. The cobble and boulder rock from within the stream that was used to fill the frame of the deflector assisted in stabilizing the bank in addition to accentuating the natural pool downstream from the new structure. This single log deflector installed on the Round Hill River restored a linear length of approximately 65 m and an area of 706 m<sup>2</sup>.
