# Fish Passage Restoration and Habitat Enhancement

*Atlantic salmon habitat restoration on the Fales River*

Rachel Walsh  
December 2024

## ***Clean Annapolis River Project***

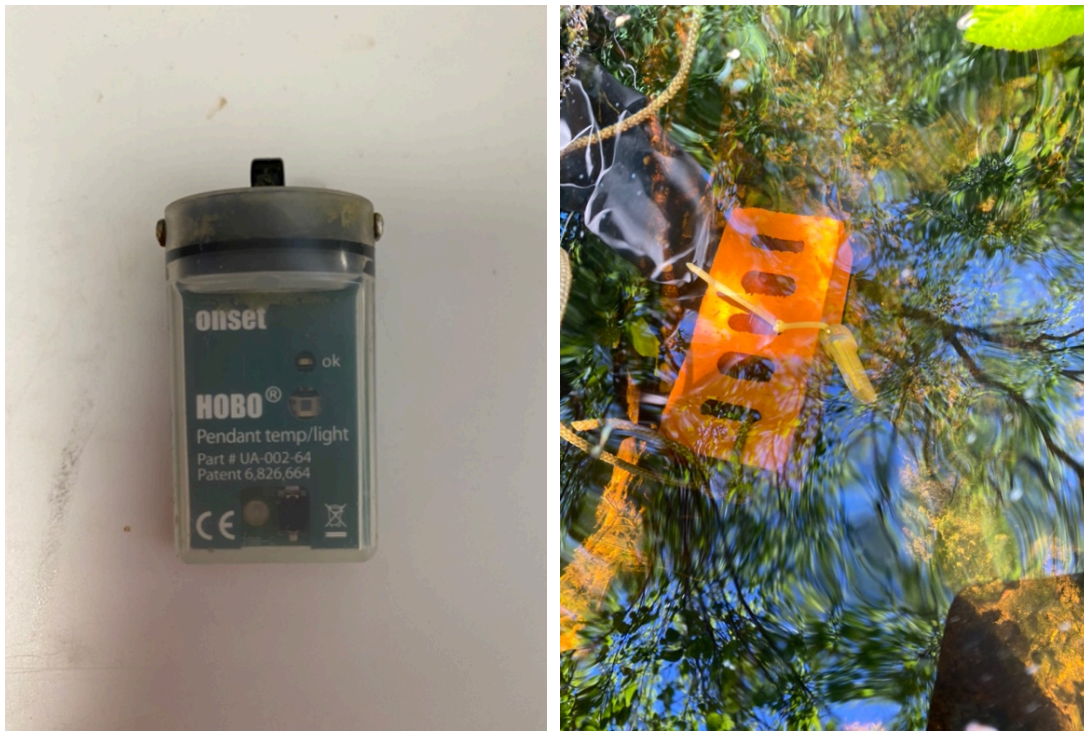
Figure 6. (Left) HOBO pendant temperature logger. (Right) Temperature logger deployed in the Fales River.

Temperature data loggers were deployed at five sites along the Fales River from May 24 to October 18, 2024, covering the crucial summer season. The loggers were programmed to record data at 30-minute intervals to track annual temperature trends, identify areas needing restoration to address thermal pollution and pinpoint critical thermal refuge areas for protection.

Loggers were placed in pools, which serve as cool-water refuges for fish. Each logger was secured to a brick and tethered to a nearby tree to ensure stability and prevent displacement, maintaining data accuracy throughout the monitoring period.

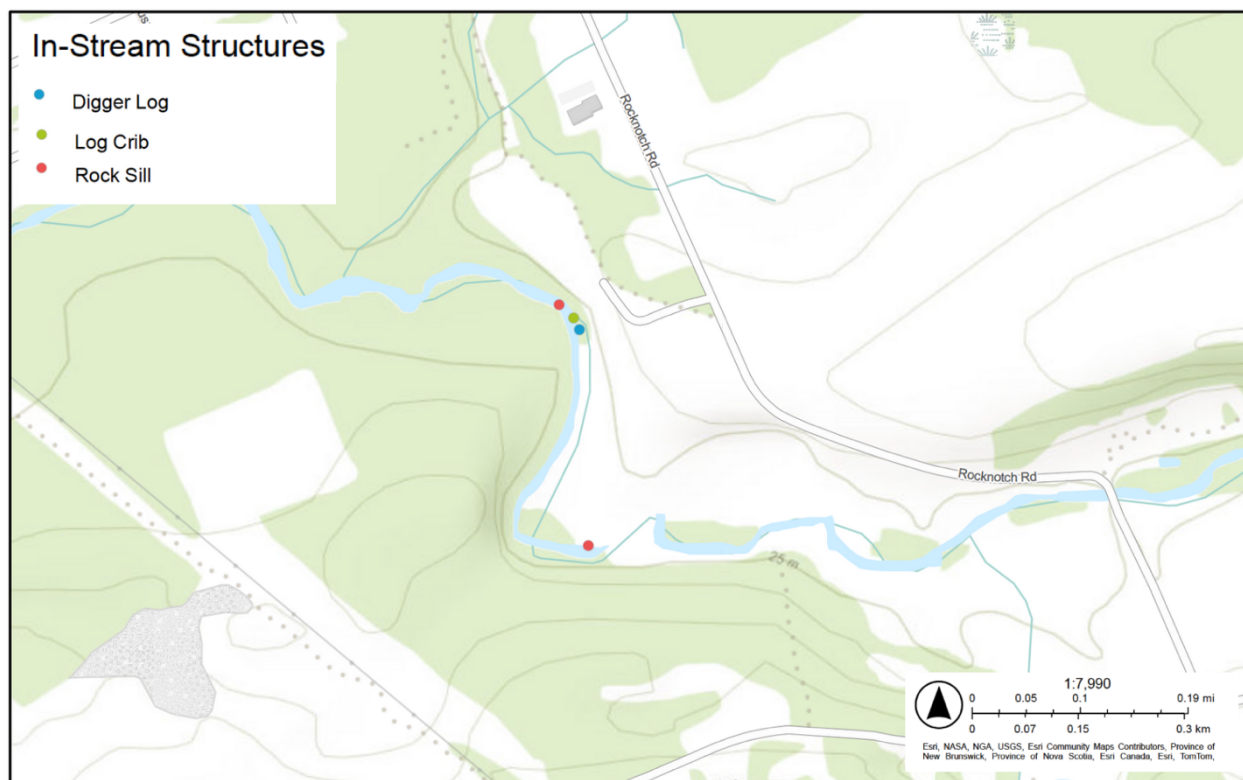
Figure 7. Map of 2024 in-stream structure locations

Restoration efforts during the 2024 season significantly improved fish habitat along the Fales River. Habitat productivity increased across 2,601.4 m<sup>2</sup> of the river through the installation of one digger log, one log crib, and two rock sills.

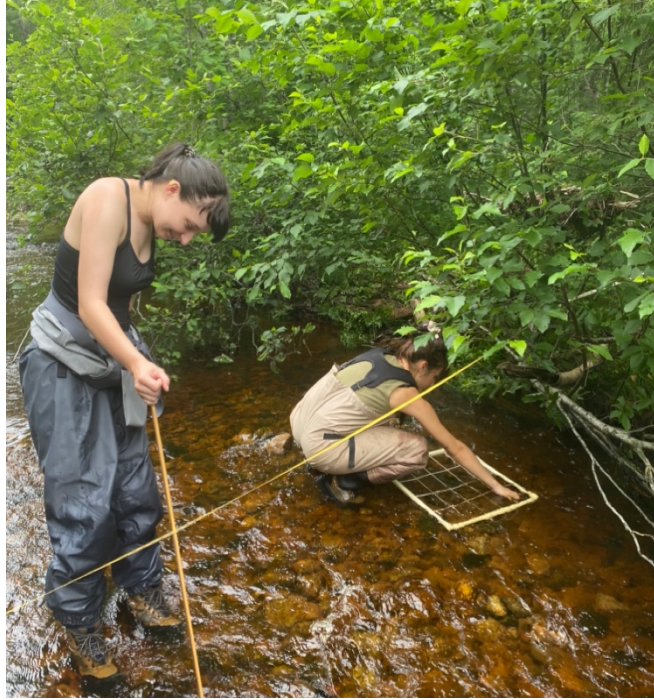
**Figure 11.** CARP staff conducting HSI survey measurements.

HSI surveys were conducted to assess salmonid habitat quality before and after restoration. Ten sites were surveyed: six downstream of the restoration area, three upstream (unaffected by restoration), and one directly at the restoration site (Site 7). This was undertaken to identify comparable measures between the sites and to quantitatively assess the impact of restoration actions.

Results indicated minimal changes in HSI scores between pre- and post-restoration assessments for both brook trout and Atlantic salmon. This limited change is likely due to the timing of the post-restoration survey, conducted only one week after restoration activities concluded.

Notable improvements were observed at Site 7, where most restoration efforts were concentrated (Tables 2 and 3). The percentage of pools suitable for brook trout and Atlantic salmon increased, attributable to the rock sill and digger log installations, which created downstream pools and upstream spawning habitats. Additionally, the percentage of in-stream cover for juvenile fish showed significant improvement. The full pre- and post-restoration HSI results can be found in Appendix 6.4.

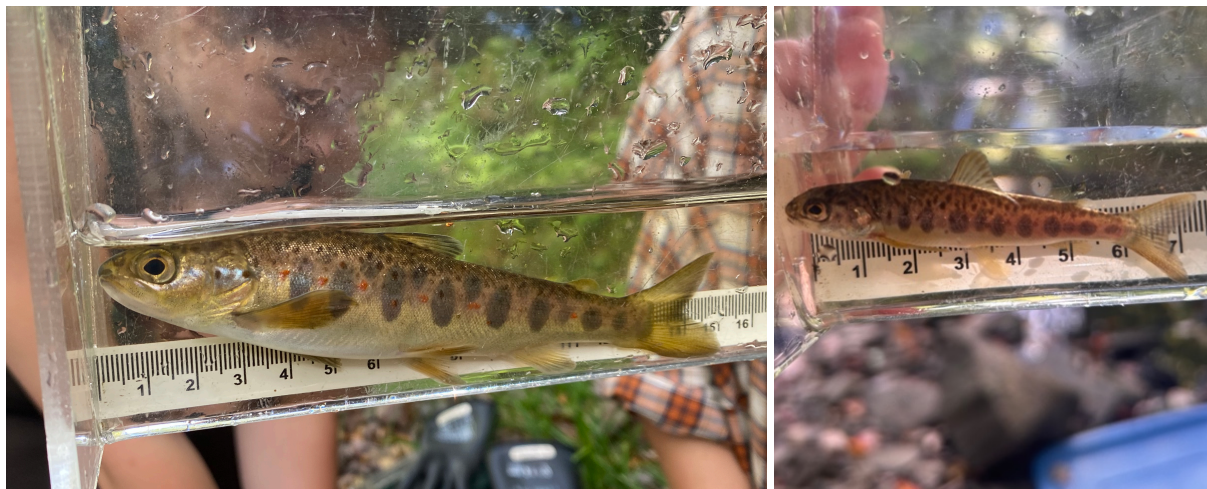
**Figure 12.** Atlantic salmon caught on the Fales River.

Electrofishing surveys were conducted at three sites, revealing two cohorts of Atlantic salmon alongside eight other native fish species.

Pre-restoration assessments captured four Atlantic salmon: three at Site 2 and one at Site 3. Post-restoration assessments captured five Atlantic salmon: one at Site 2 and four at Site 3. However, post-restoration electrofishing could not be conducted at Site 1 due to unsafe conditions caused by a newly formed beaver dam downstream, which raised water levels.

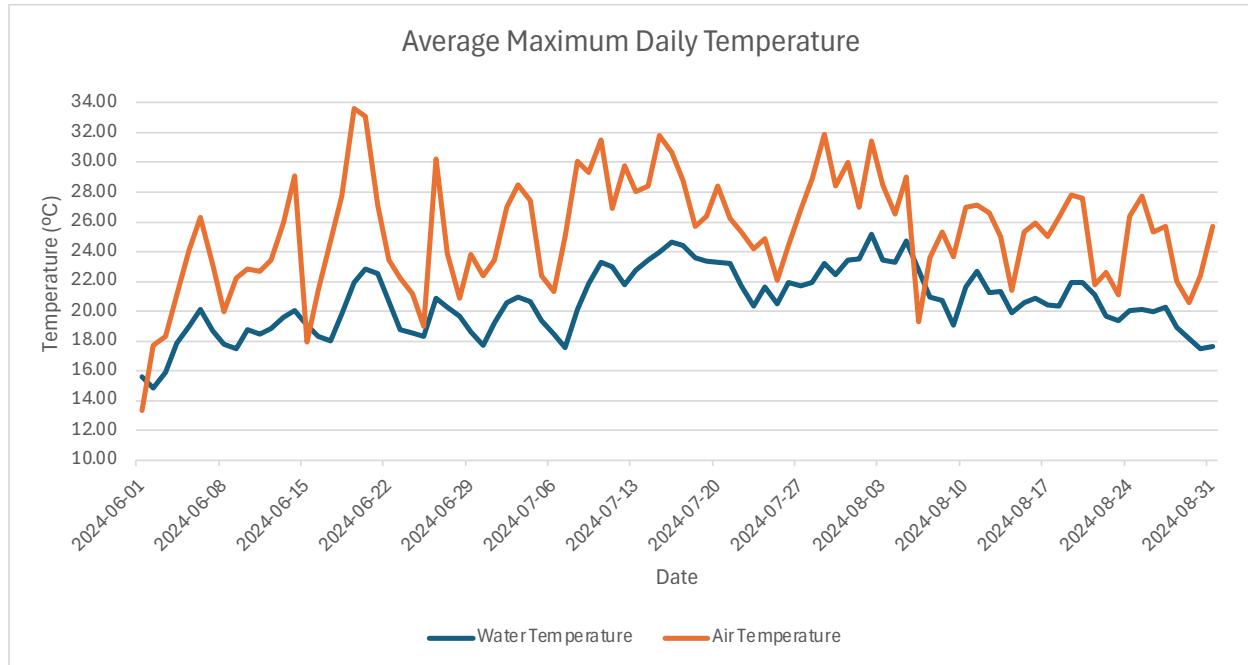
**Figure 13.** Comparison of daily maximum water and air temperatures recorded on the Fales River.

From June to August 2024, the average water temperature was 20.6°C, with values ranging from a low of 14.9°C in early June to a peak of 25.2°C in early August. While water temperatures showed moderate variability, the majority of readings fell between 19.0°C and 22.1°C, indicating stable yet warming conditions as the summer progressed. In comparison, air temperatures were significantly higher, averaging 25.3°C, and fluctuated widely from a minimum of 13.3°C to a maximum of 33.6°C, reflecting typical summer weather patterns (Figure 13).

The rising water temperatures observed in late July and early August are particularly noteworthy given their implications for Atlantic salmon, a species known to be sensitive to temperature. Atlantic salmon thrive in water temperatures ranging between 12°C and 20°C, and temperatures above 23°C can induce thermal stress. Prolonged exposure to temperatures exceeding 25°C can be lethal for this species, potentially disrupting feeding and growth while forcing them to seek cooler refuges in deeper waters or tributaries. During the monitoring period, several instances of water temperature surpassing 23°C were recorded, suggesting that Atlantic salmon in the Fales River may have faced stressful conditions during peak summer heat.
