Fish Passage Restoration and Habitat Enhancement

*Addressing habitat
fragmentation and
productivity in the Annapolis
River watershed*

Jamie McCamon
December 2015

Clean Annapolis River Project

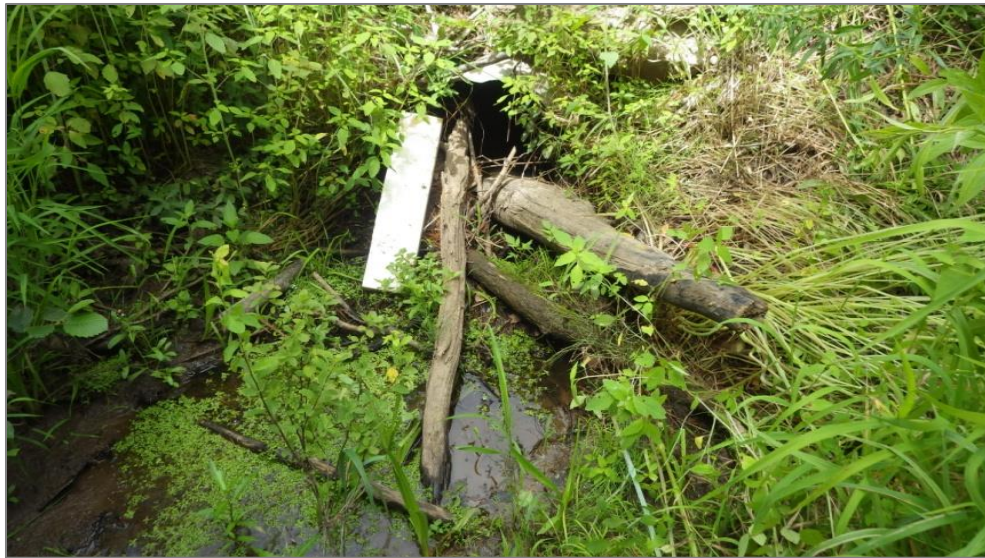
Comments: A culvert on a tributary of the Annapolis River near Lawrencetown had debris built up at the inflow that completely restricted fish passage. All that was needed were some gloves and a coordinated effort to restore fish passage to 1.75 km of upstream habitat. Figures 10 through 12 show photos of the debris removal.

Figure 10. ANN004 Before debris removal.

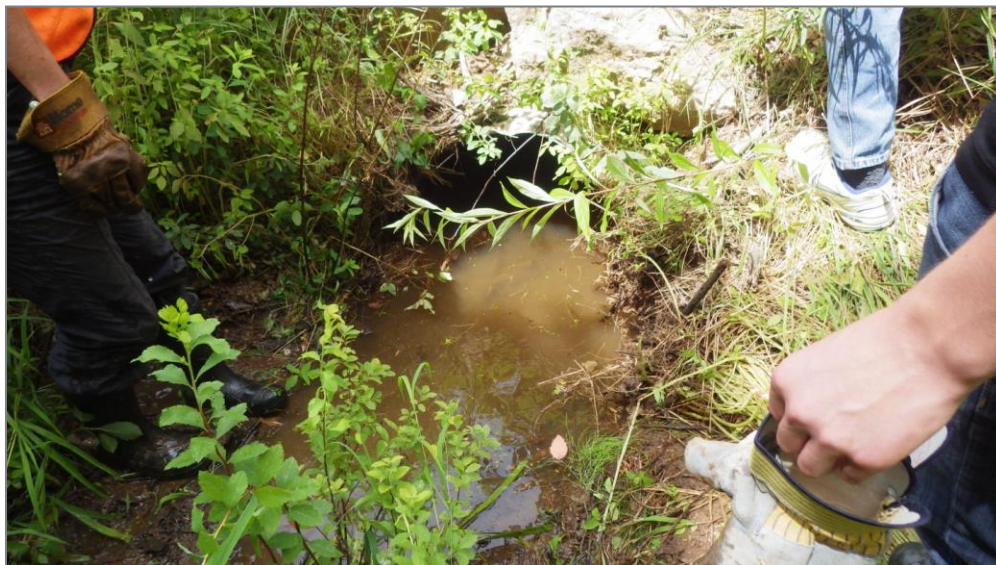
Figure 11. ANN004 After debris removal.

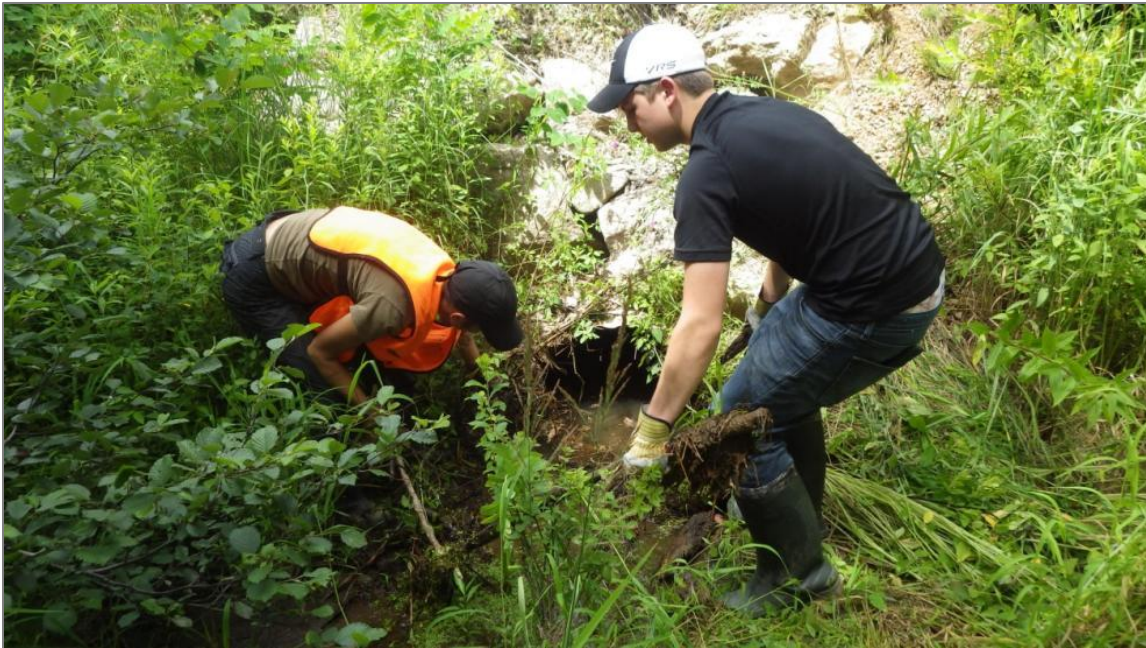
Figure 12. ANN004 Crews removing culvert debris.

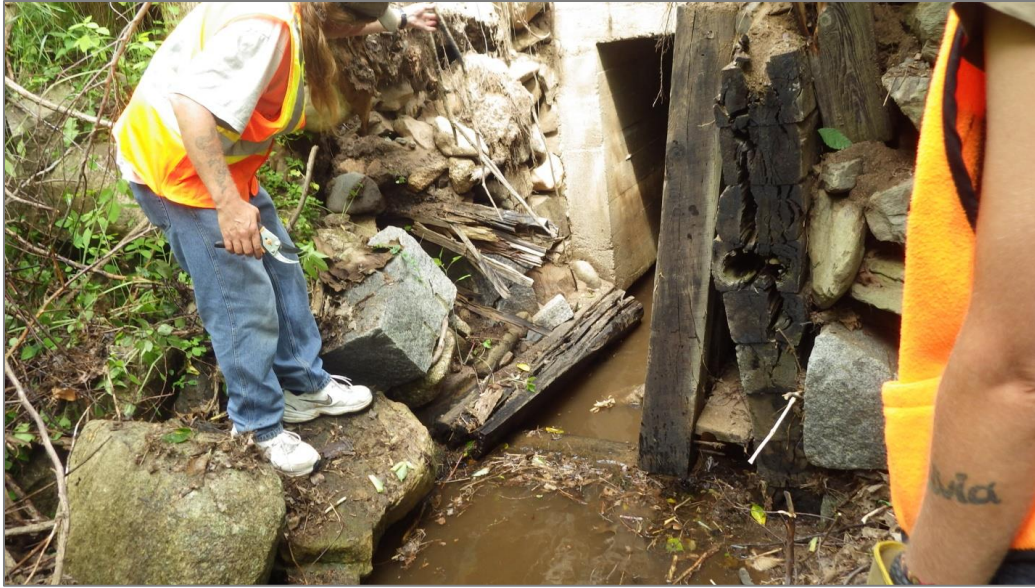
Comments: Located on a tributary of the Annapolis River called Pete's Brook, PET004 was a square box wooden culvert falling apart at the inflow. Debris was removed to restore fish passage however major structural work or replacement is still required to address impending culvert failure. Figures 13 through 15 show the inflow prior to and after debris removal.

Figure 14. PET004 After debris removal.

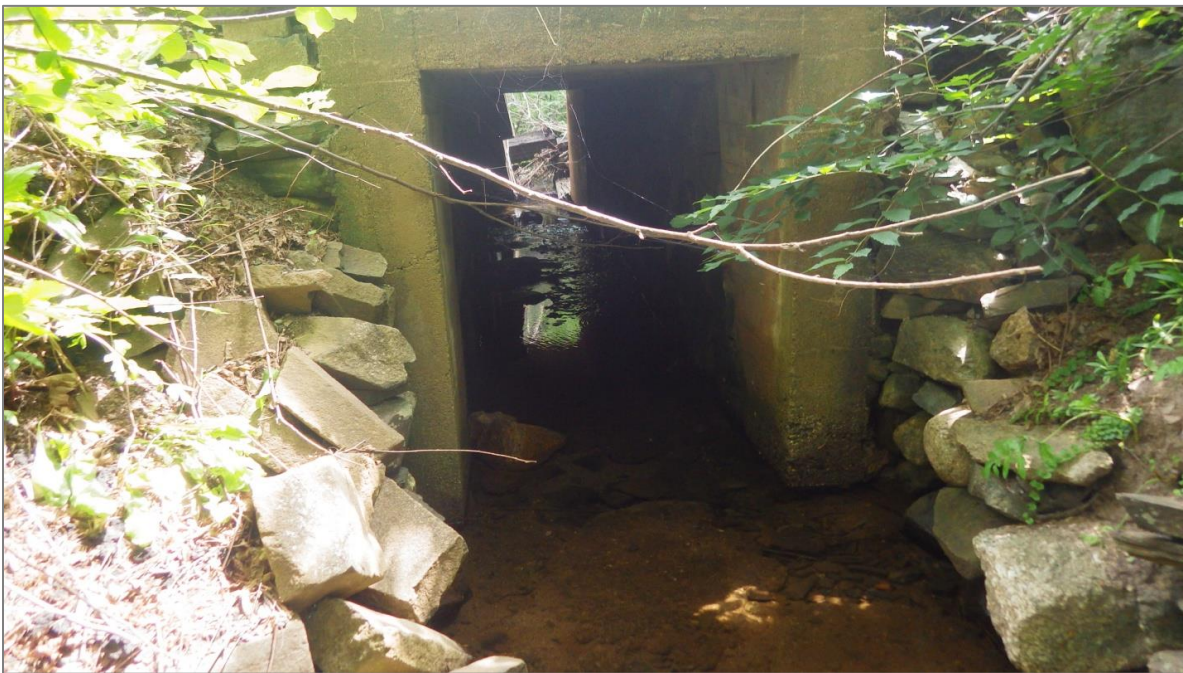
Figure 15. PET004 looking upstream through culvert after debris removal.

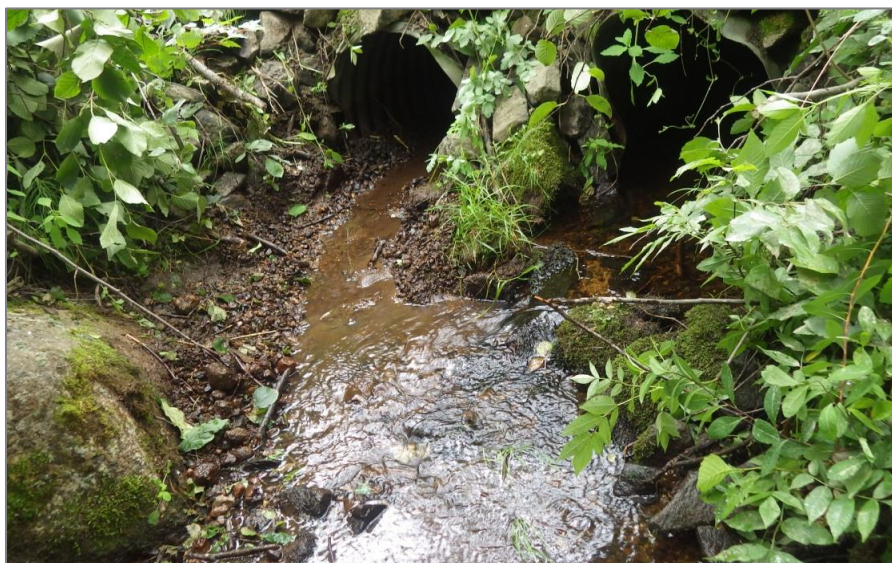
Comments: One of two culverts at RHR022, located on a tributary of the Round Hill River, a sub-watershed of the Annapolis River, was found to be plugged solid with rocks and debris. Shovels, a few pairs of hands, and some team work made this a working culvert conducive for fish passage. Figures 16 and 17 show before and after photos of the site.

Figure 17. RHR022 After debris removal.

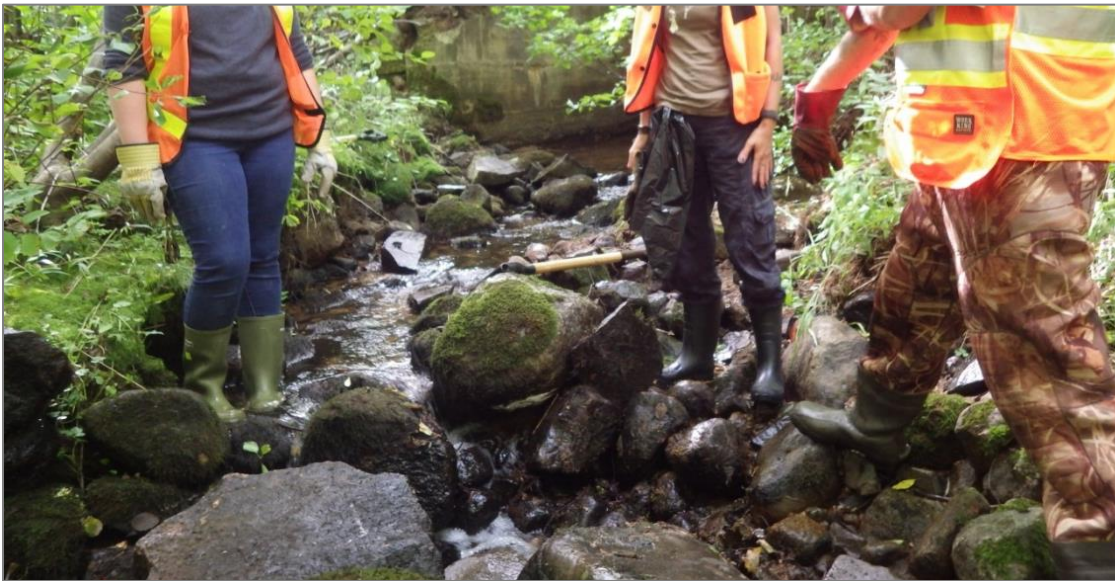
Comments: This culvert, on a tributary of the Annapolis River, required more of a channel clean up than a debris removal. Rocks were blocking access to the culvert at the outflow and were restricting passage in the stream. Pry bars, and shovels were used to create better in-stream passage, making 1.5 km of upstream habitat available. Figures 18 through 20 show before and after photos of the site.

Figure 18. SHE004 Before debris removal, looking upstream.

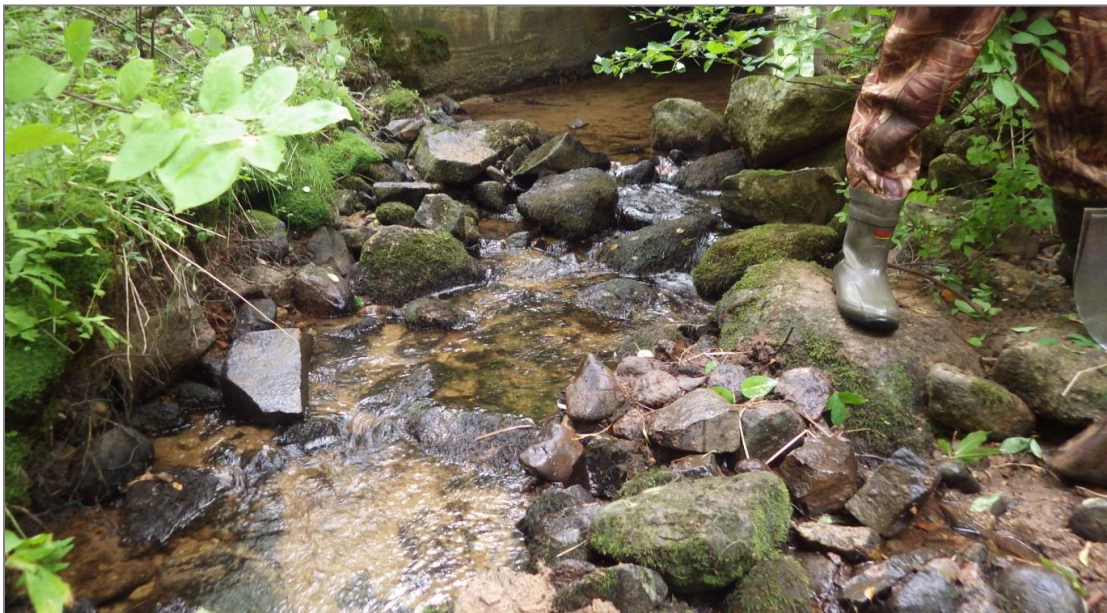
Figure 19. SHE004 After debris removal, looking upstream.

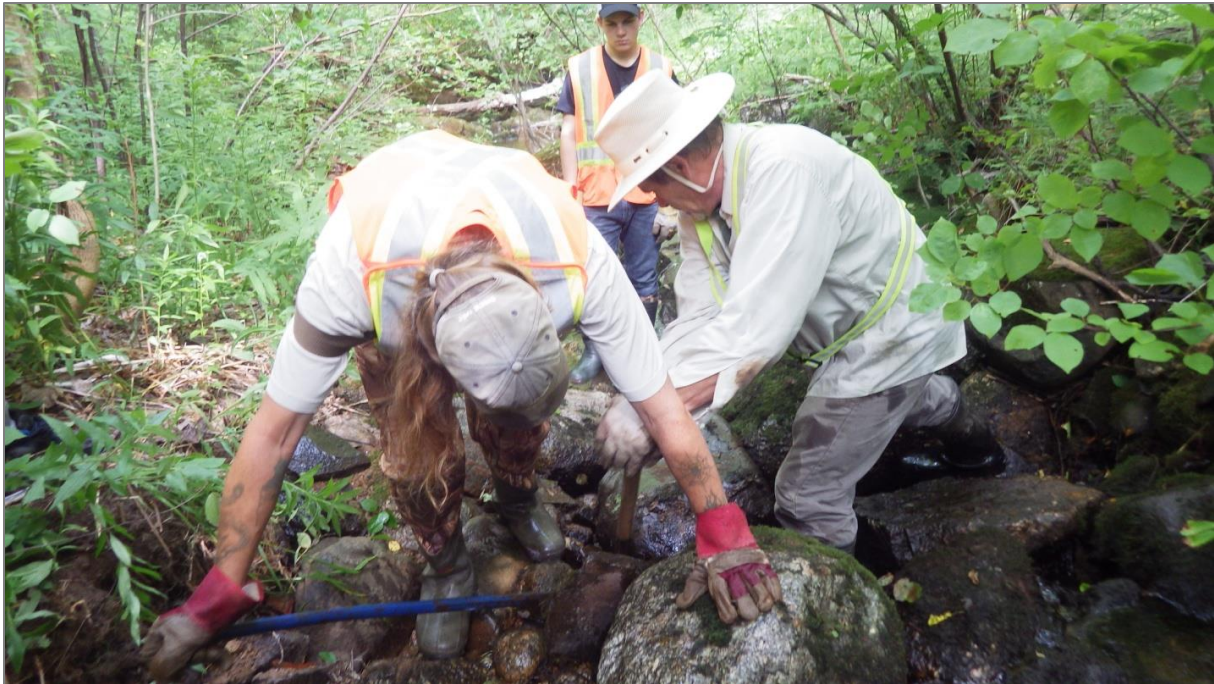
Figure 20. Removal of in-stream debris at SHE004.

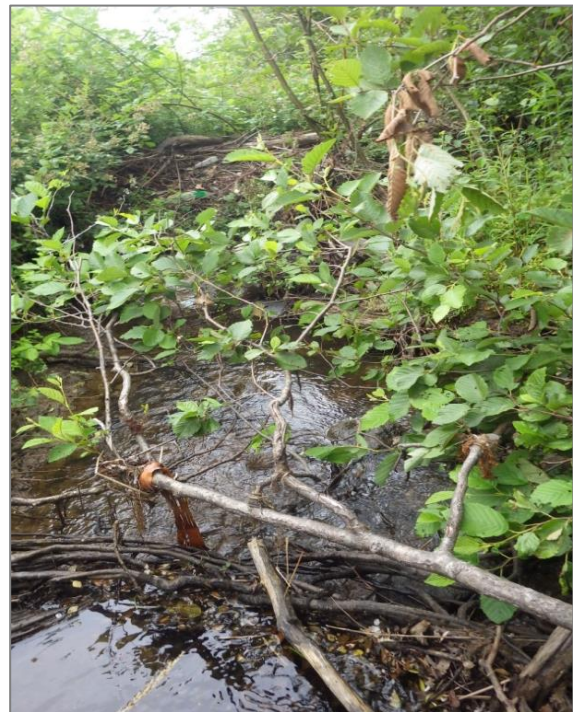
Comments: BAL001 was the location of multiple restorations including an in-stream debris clean-up (For a description of other restoration activities, please see Section 3.2.3). At the site, there was a huge pile of accumulated sticks, branches, leaves, and small trees present which were altering the stream's direction. The jam was cleared using hand tools such as saws, brush cutters and shovels to restore the stream. Additional remediation activities at the site included the installation of two rock weirs, a fish chute, baffles and a low flow barrier, to improve fish passage through the culvert. Figures 21 through 23 show images of the debris removal activities at BAL001.

Figure 21. BAL001 Before debris removal, showing debris blockage in the stream.

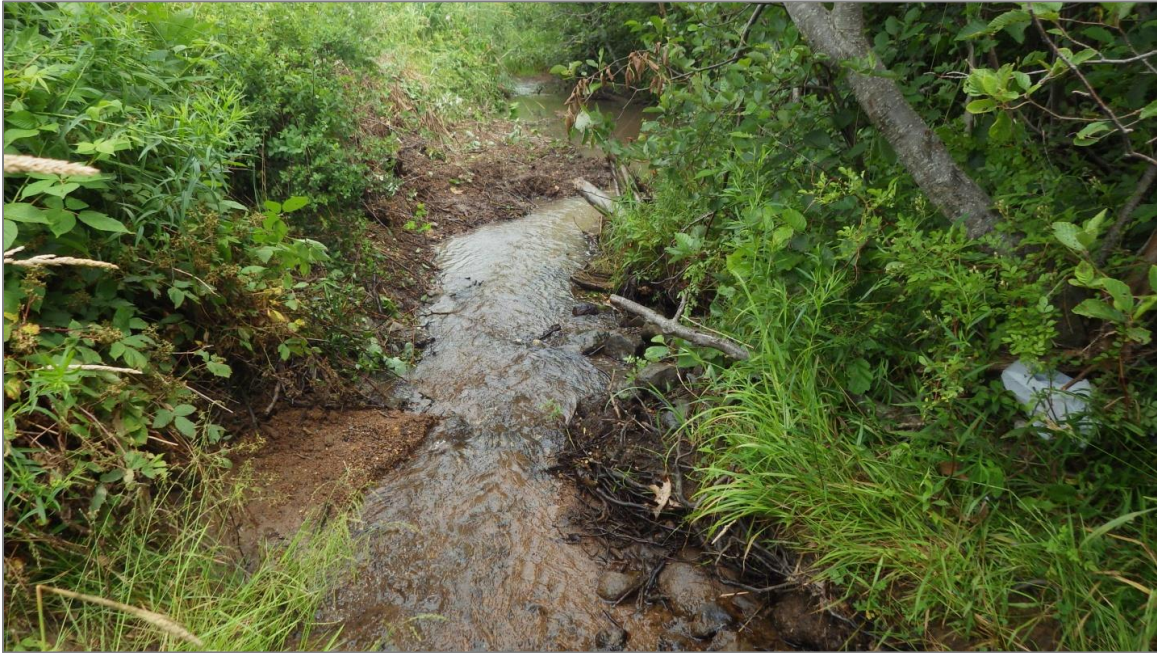
Figure 22. BAL001 stream after debris removal.

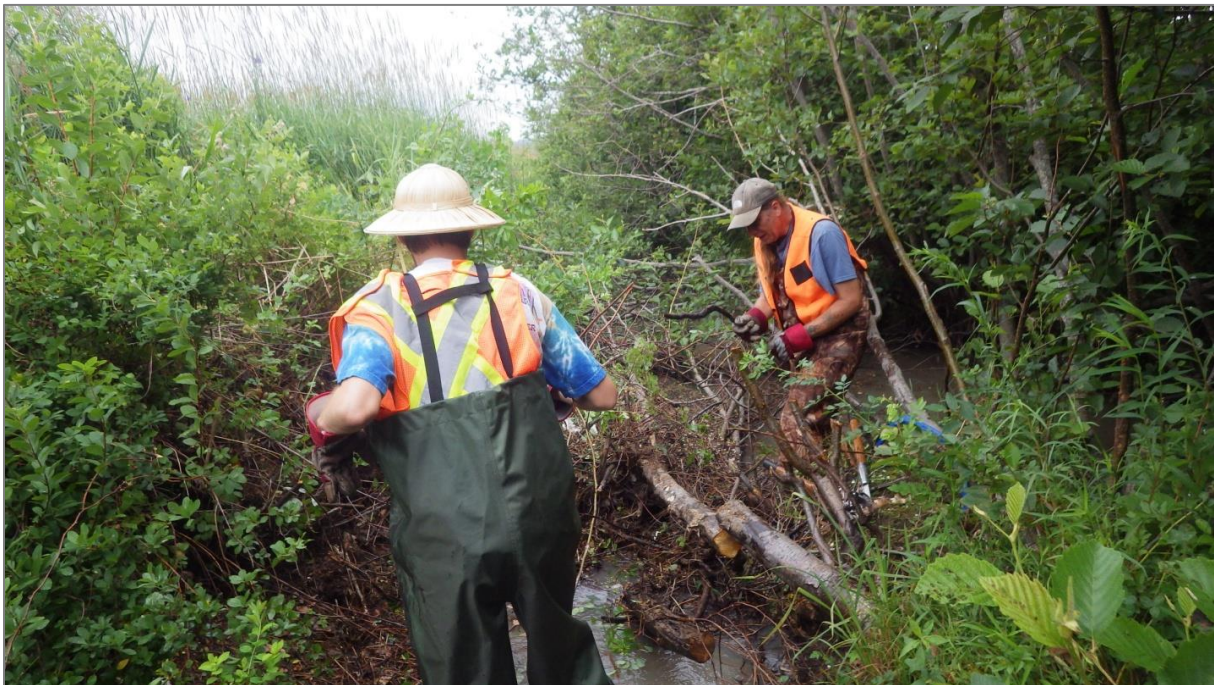
Figure 23. BAL001 during debris removal activities.

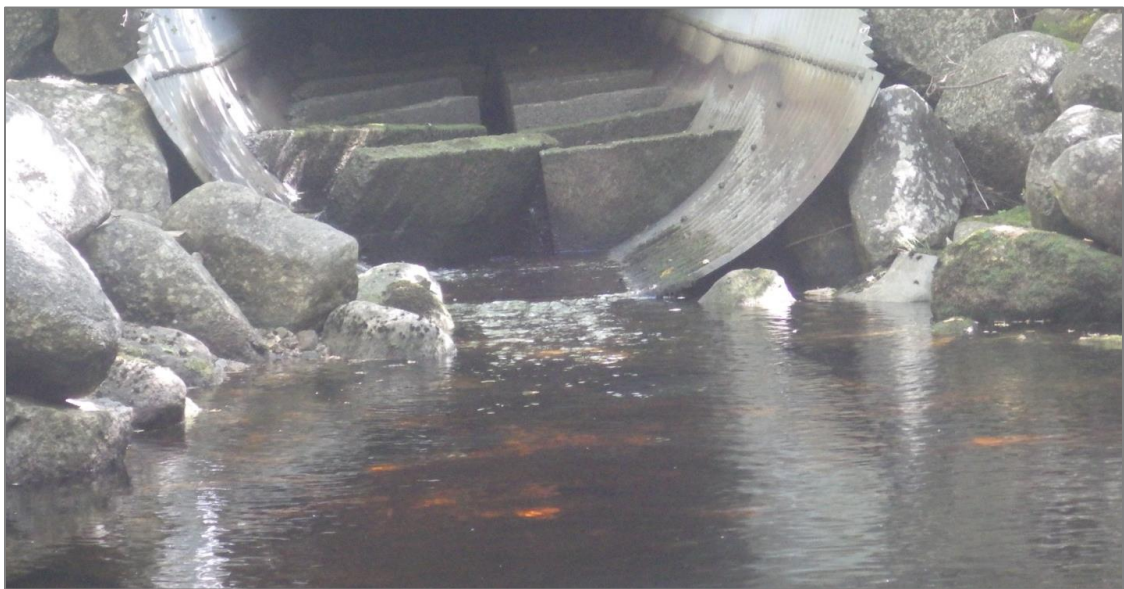
Figure 28. BUT006 Closer finished view showing derelict baffles.

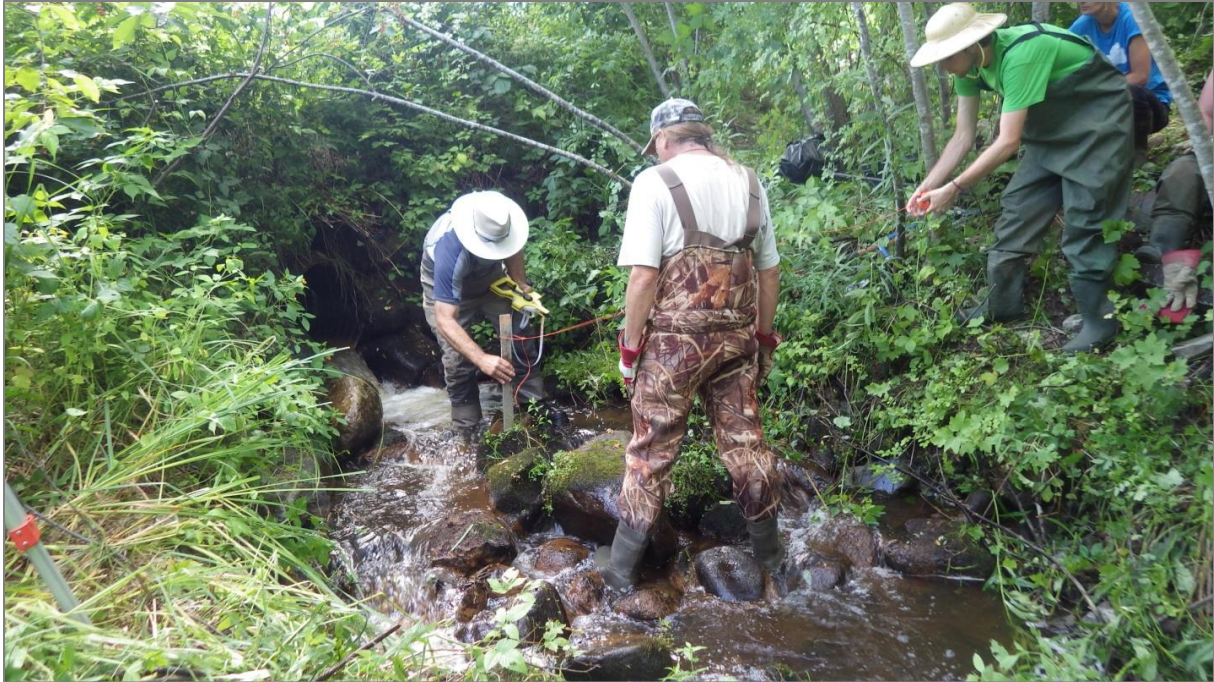
Figure 31. Mapping out the tailwater control weir prior to construction.

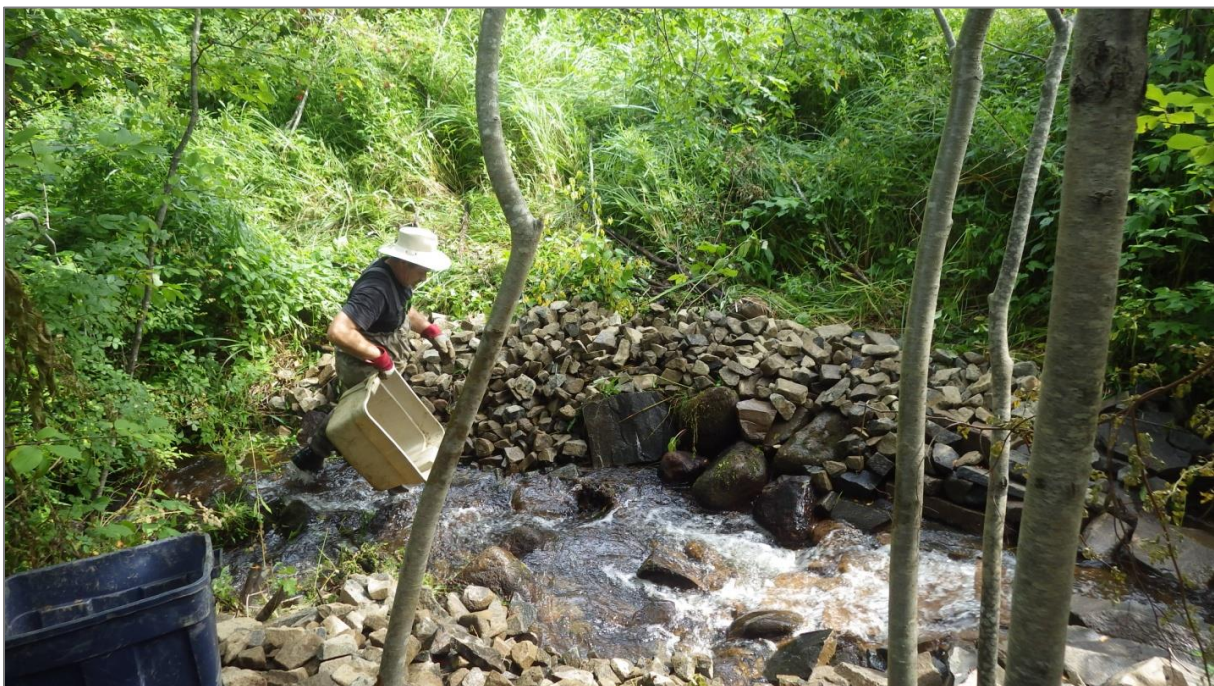
Figure 32. Reinforcing the banks at site NIC002.

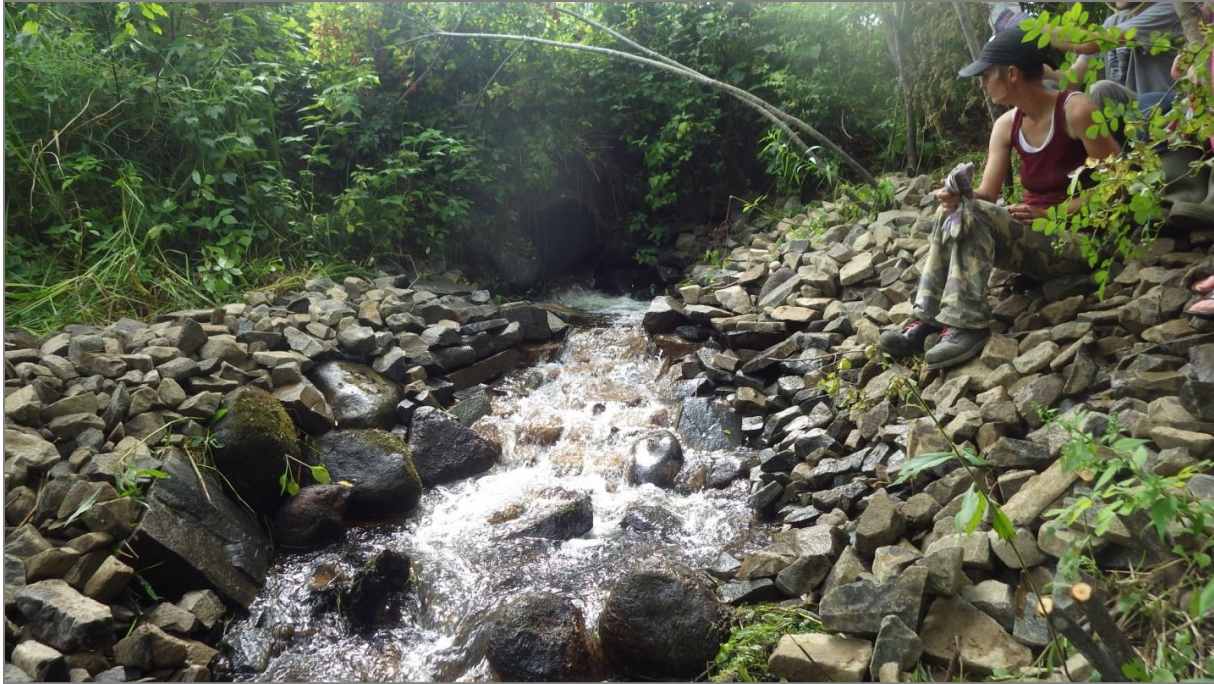
Figure 33. Completed tailwater control and bank reinforcement.

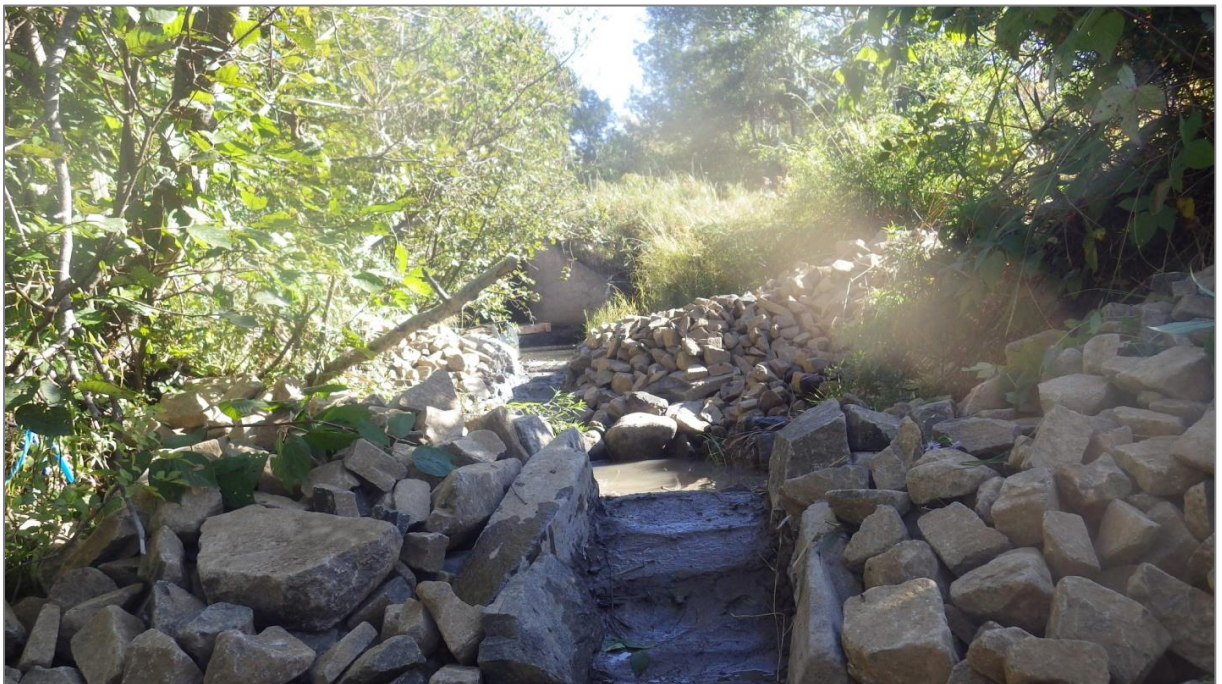
Figure 39. BAL001 View upstream towards culvert from completed weirs.

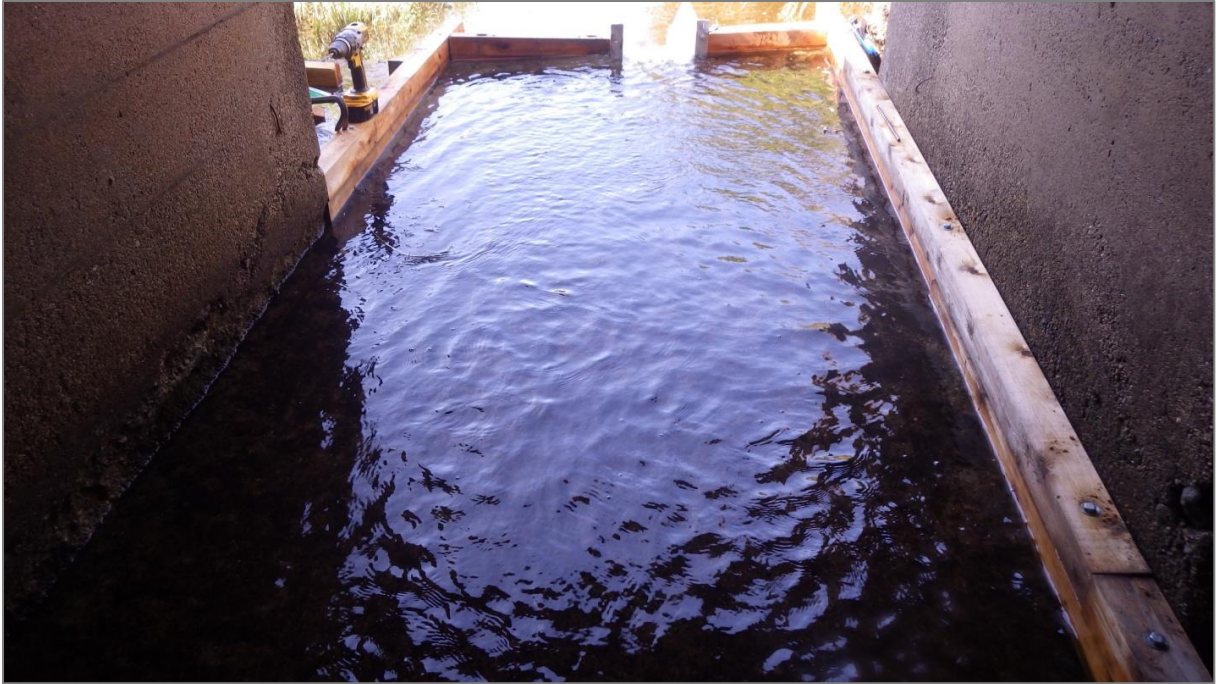
Figure 40. BAL001 Newly created divider, ready for baffles and fish chute installation.

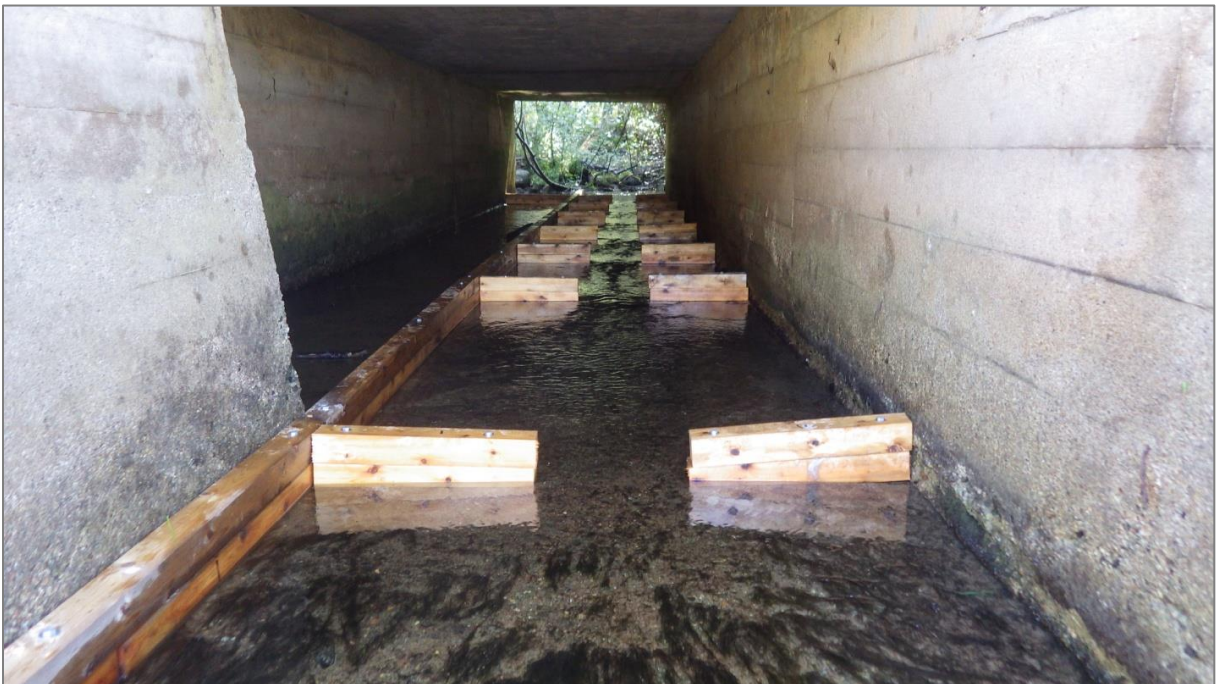
Figure 41. Baffles after installation at BAL001.

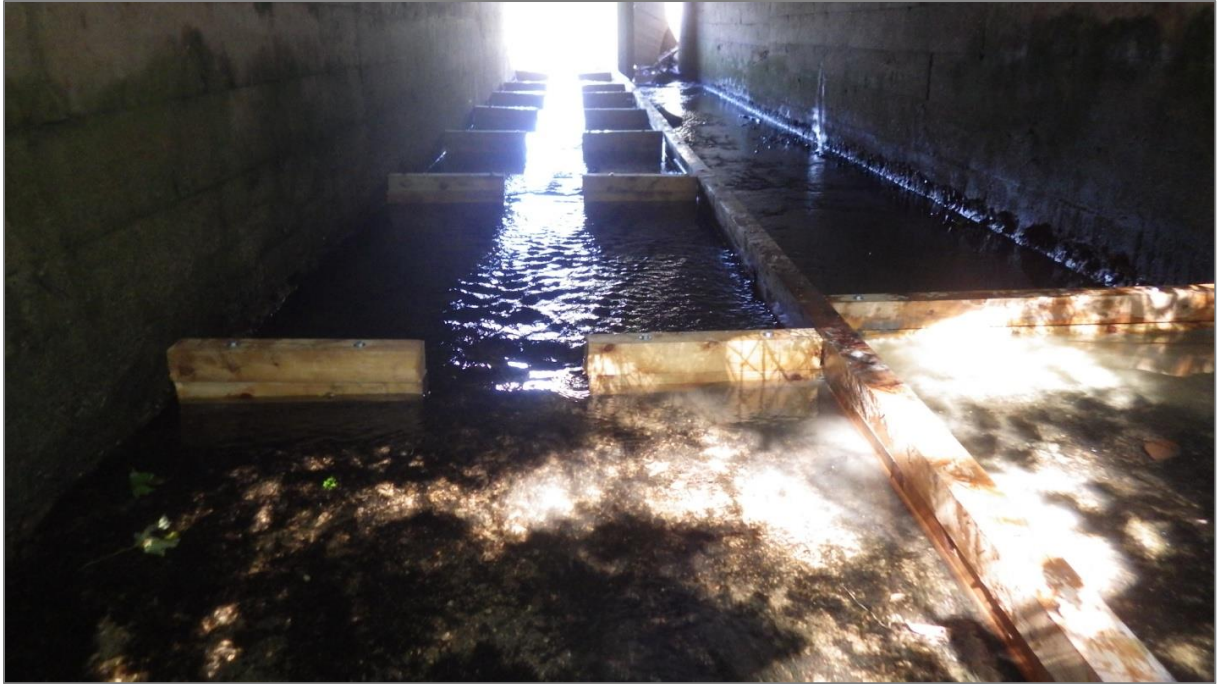
Figure 42. BAL001 Downstream view of baffles, divider, and low flow barrier.

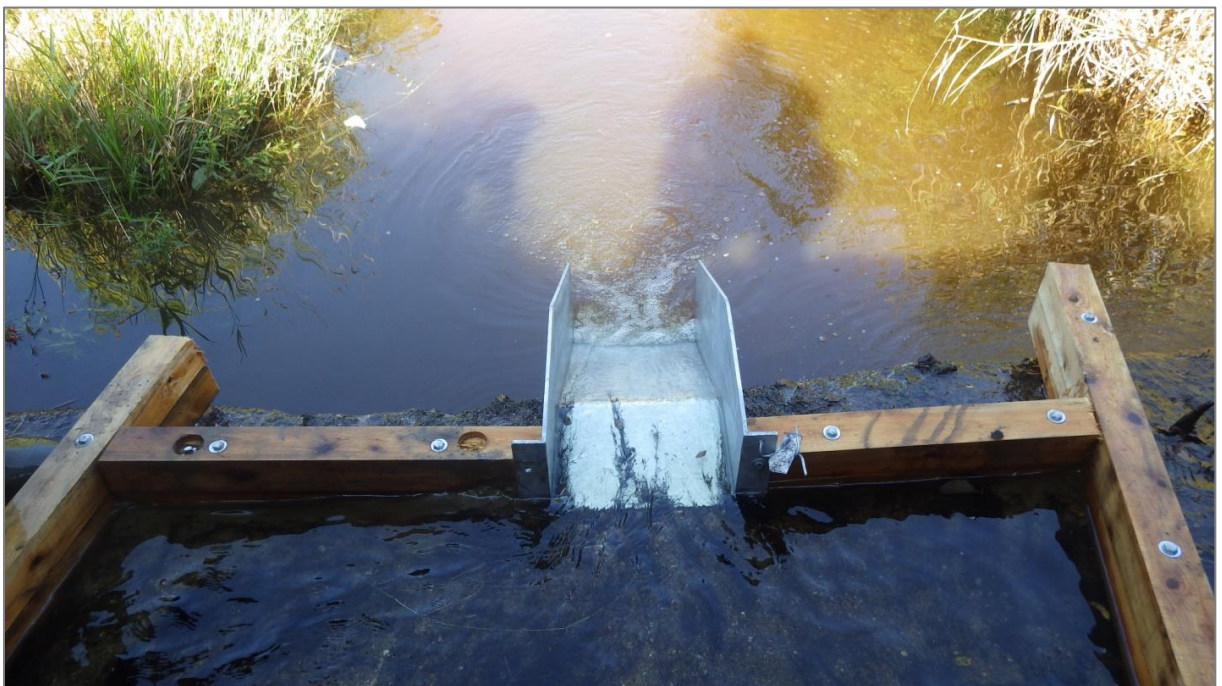
Figure 43. Fish chute after installation.

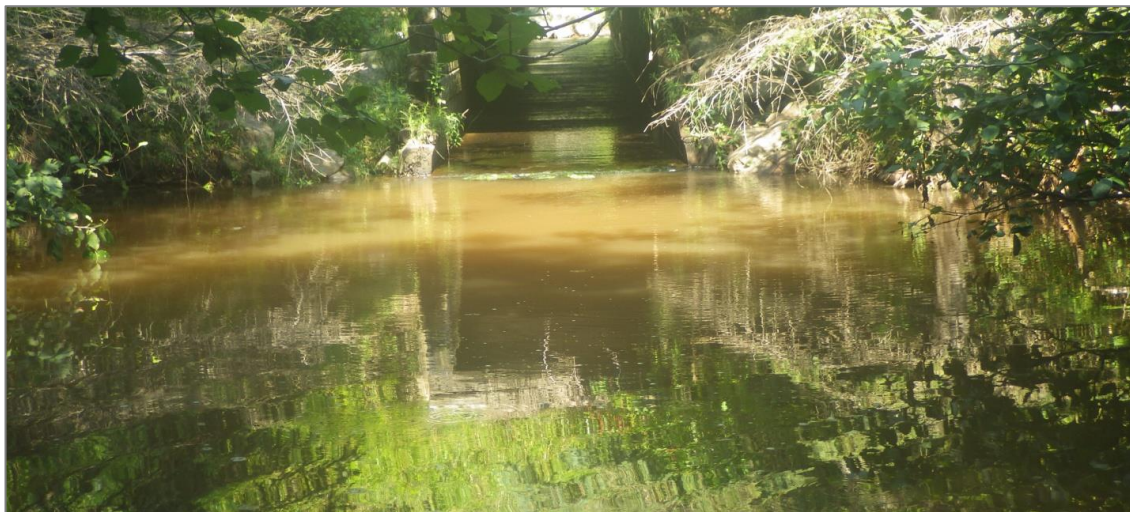
Comments: Most of the materials used to construct the rock weir were found on site, except for the larger footer stones. Clay, grass and fine gravel from on-site were used to seal the upstream side of the weir. Installation of a tailwater control structure restored fish passage through the culvert, opening up access to 1.6 km of upstream habitat (See Figures 44 through 48).

Figure 45. MOR008 After tailwater control installation.

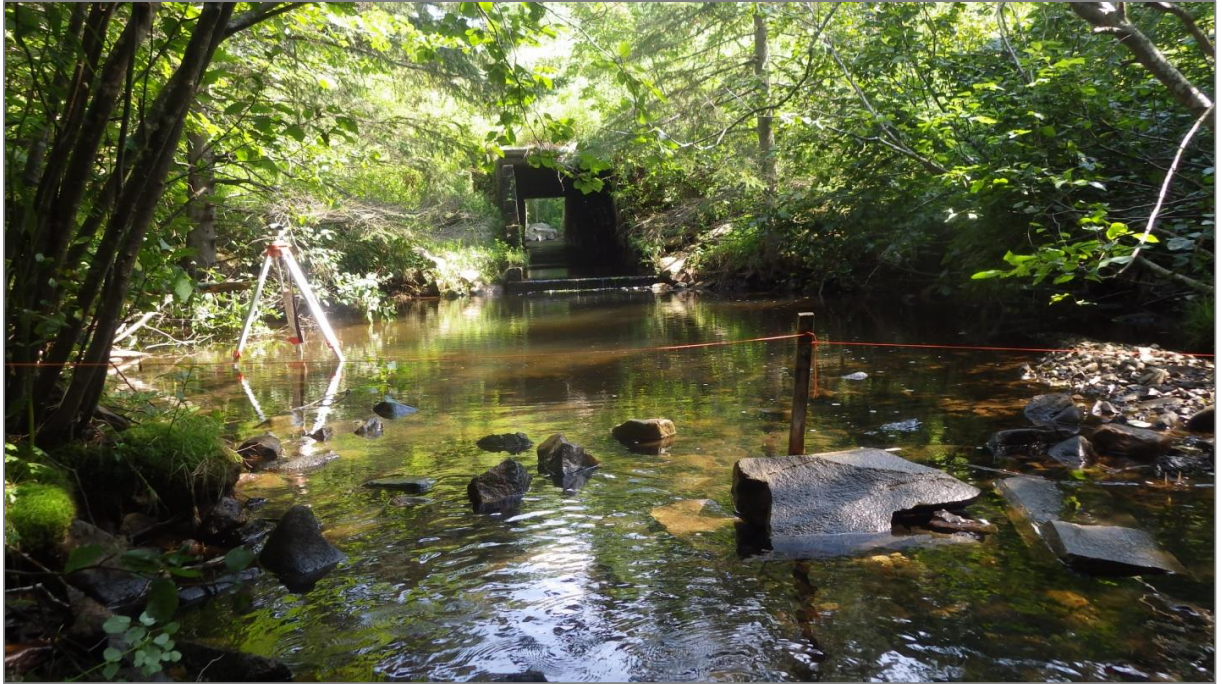
Figure 46. Measuring out the placement of the downstream rock weir.

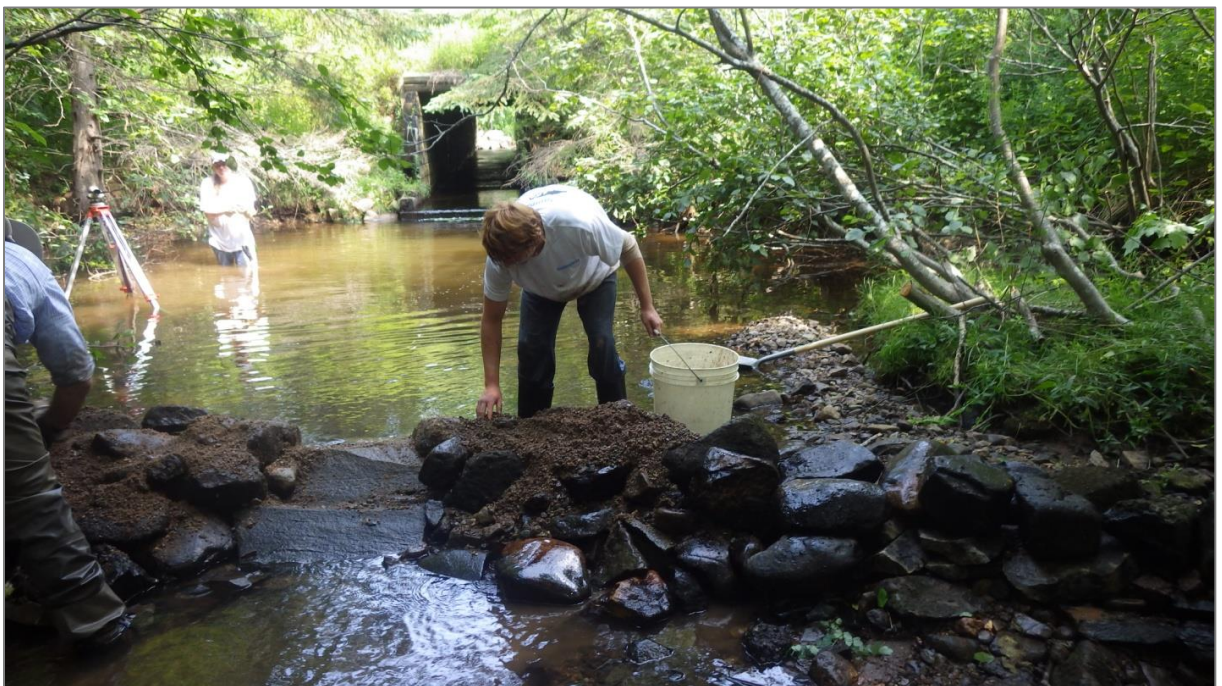
Figure 47. Construction of the tailwater control structure at MOR008.

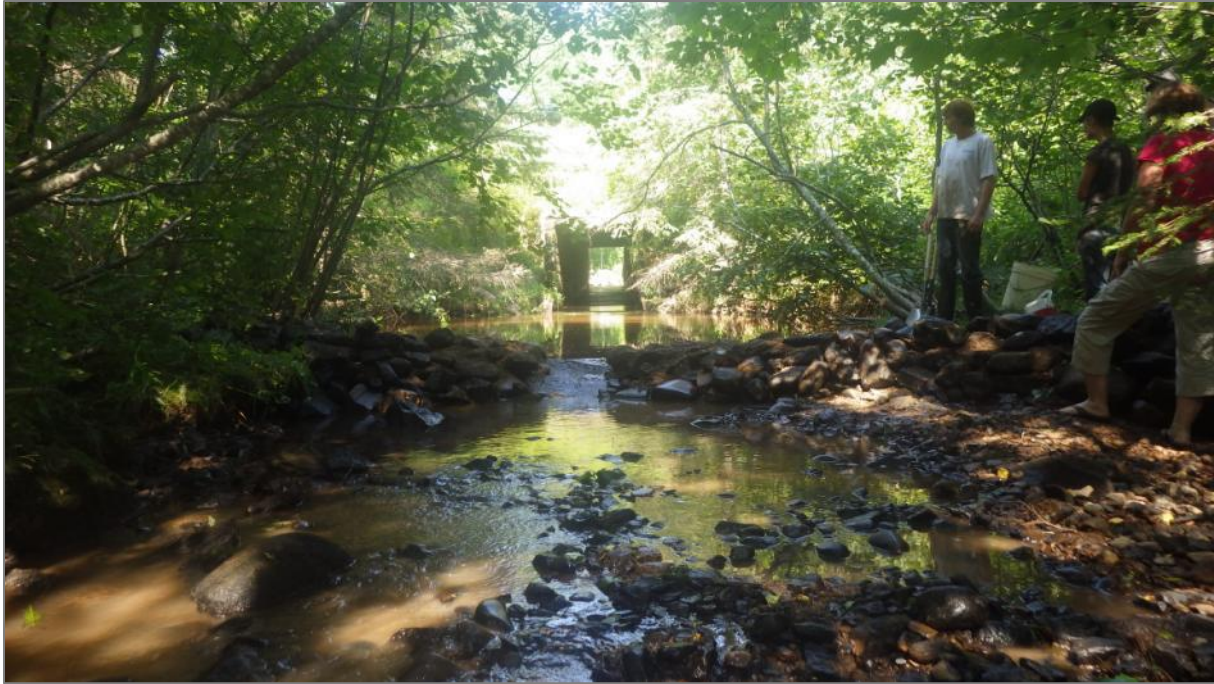
Figure 48. Completed tailwater control structure.

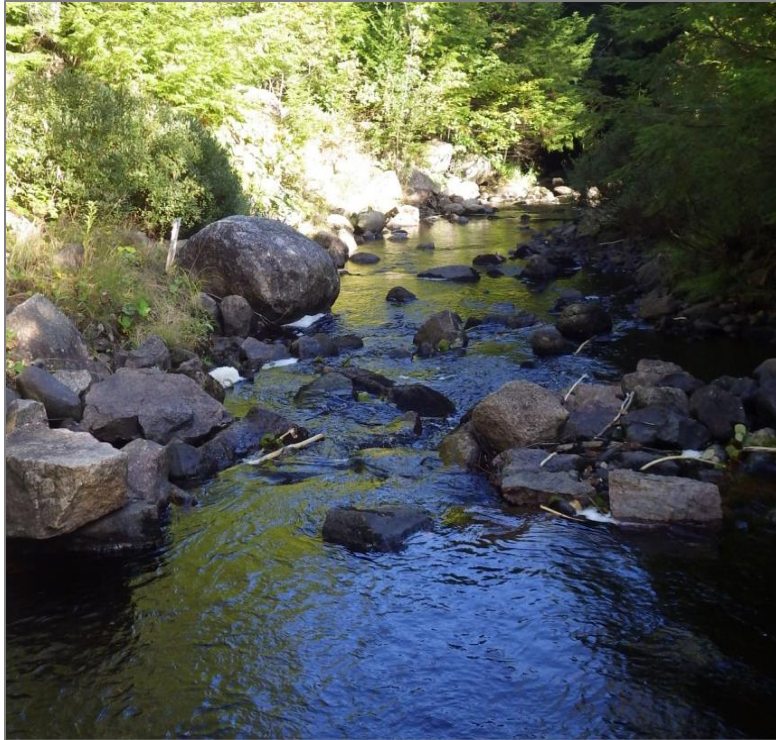
Comments: This culvert is located on a flashy system, subject to very high, rapid flows, and very low flows. A rock weir was constructed on site in 2013 (Figure 49) as a tailwater control structure and was partially removed by a high flow event. This year a fish chute was installed along with a shorter weir to allow fish access to the culvert and more than 13 km of upstream habitat. Instead of the standard 30 degree angle for the wings of the weir a roman arch style or a half a circle weir was built to improve redirection of pressure from high flow events. A fish chute was installed at the culvert outflow notch using electrical tools and a generator. The baffle installation planned for the inflow of one of the culverts was not completed due to high water flows when the fish chute was installed and the removal of the large rocks was not completed due to time constraints when manpower was available. The site will need to be revisited in future to complete these actions. Figures 49 through 55 show some of the restoration activities that took place in 2015.

Figure 49. Remnants of weir built in 2013.

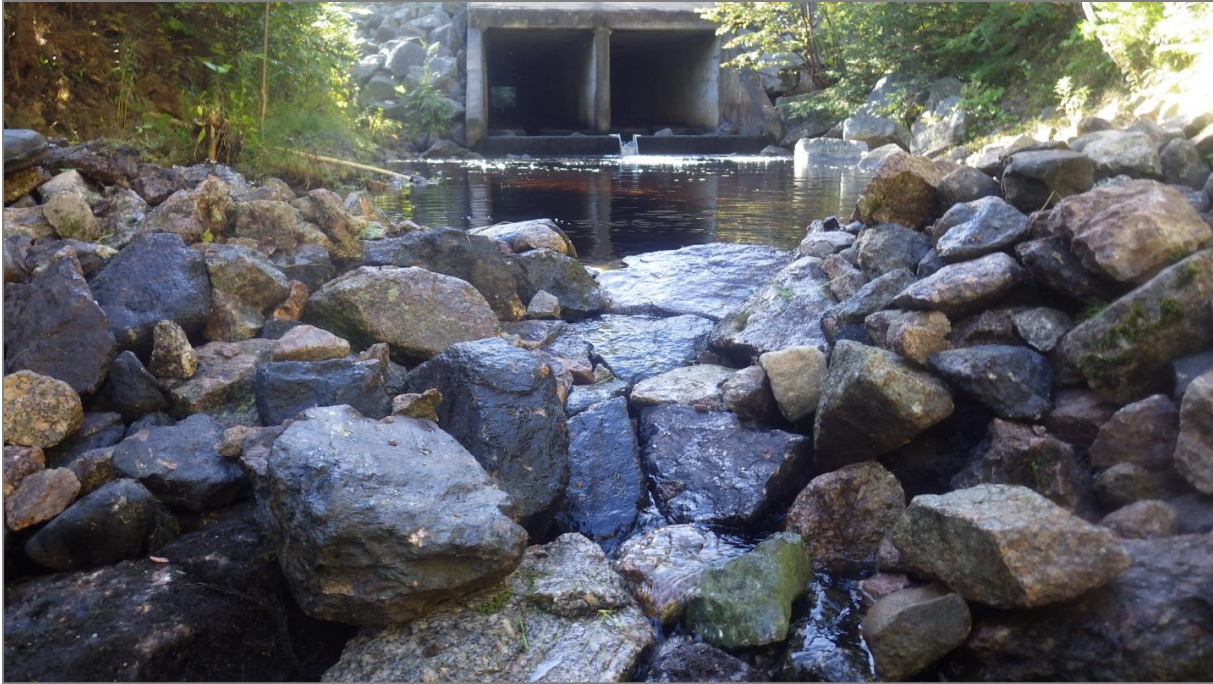
Figure 51. After weir reconstruction.

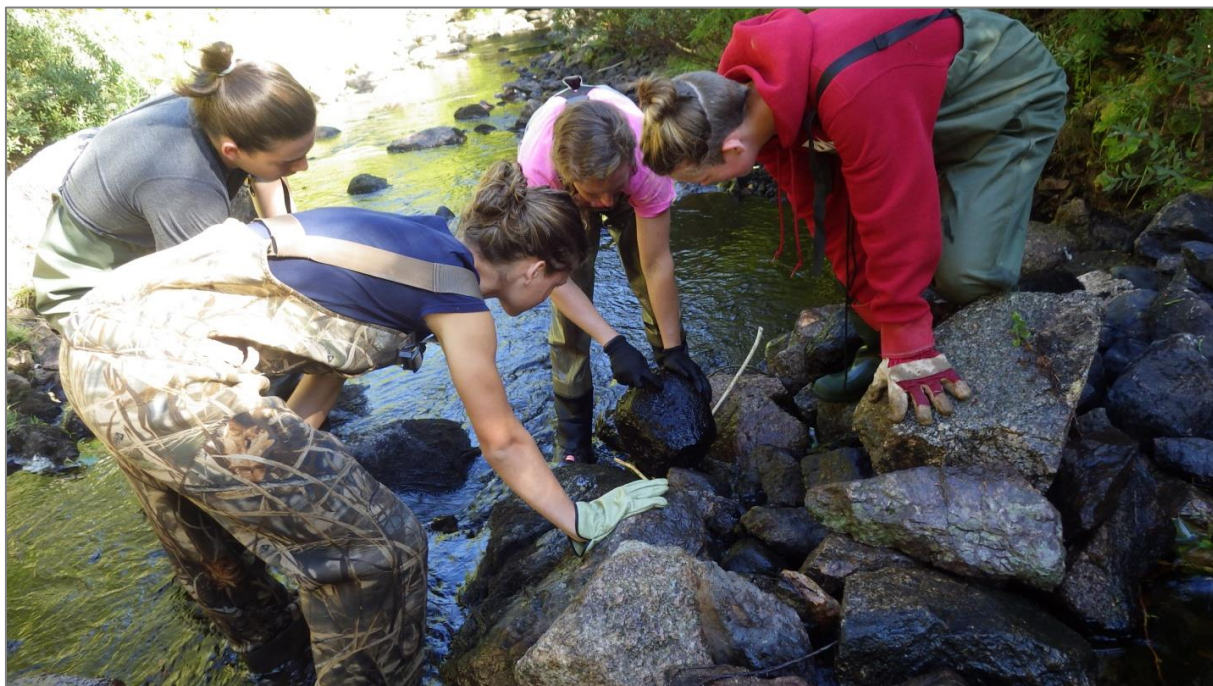
Figure 52. RHR013 Volunteers helping to construct a rock weir.

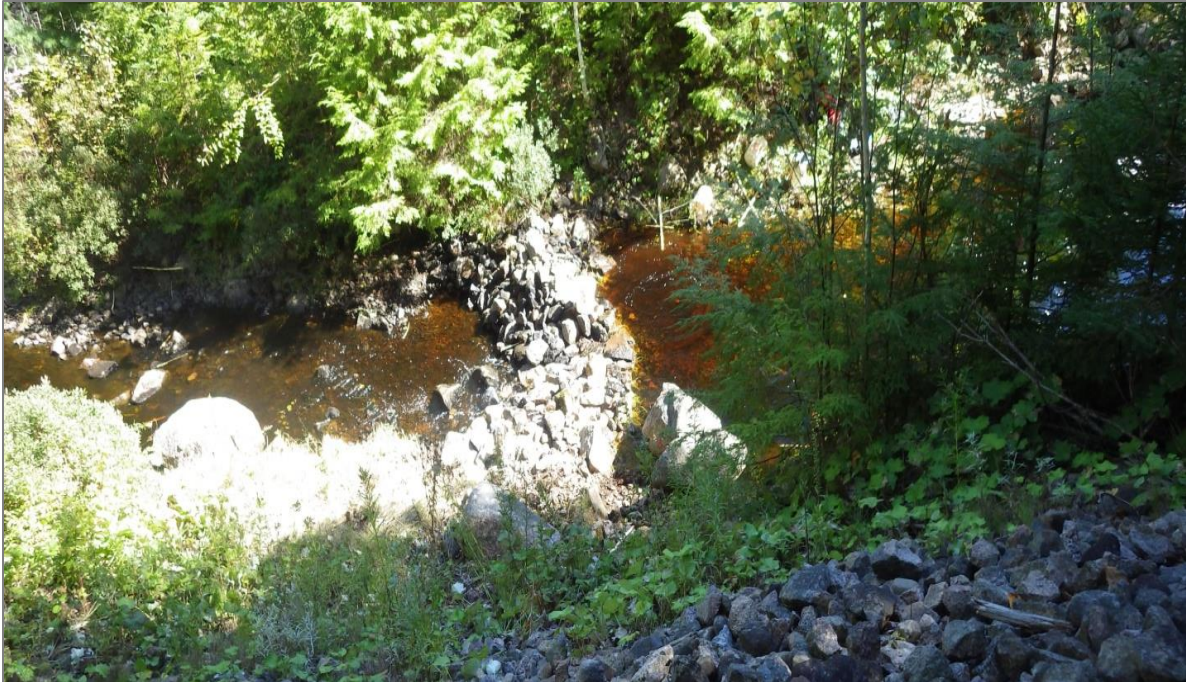
Figure 53. Completed weir structure at RHR013.
