Fish Passage Restoration and Habitat Enhancement

*Addressing habitat
fragmentation and
productivity in the Annapolis
River watershed*

Jamie McCamon
December 2015

Clean Annapolis River Project

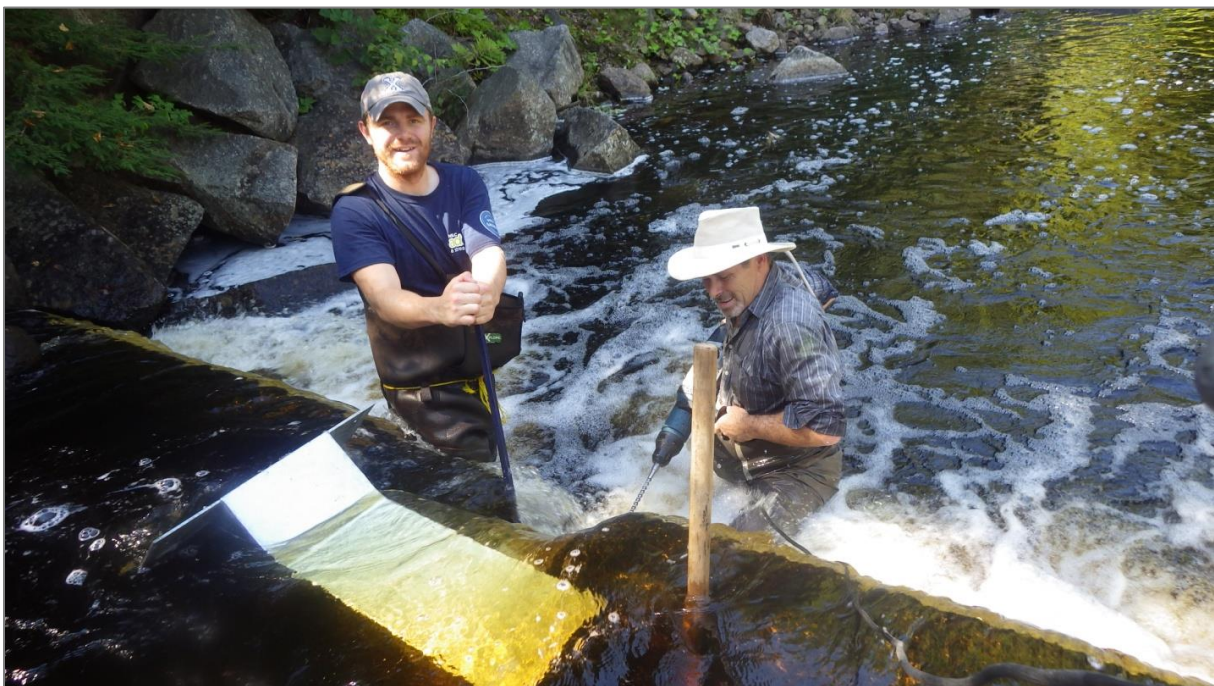
Figure 54. Preparing to install the fish chute.

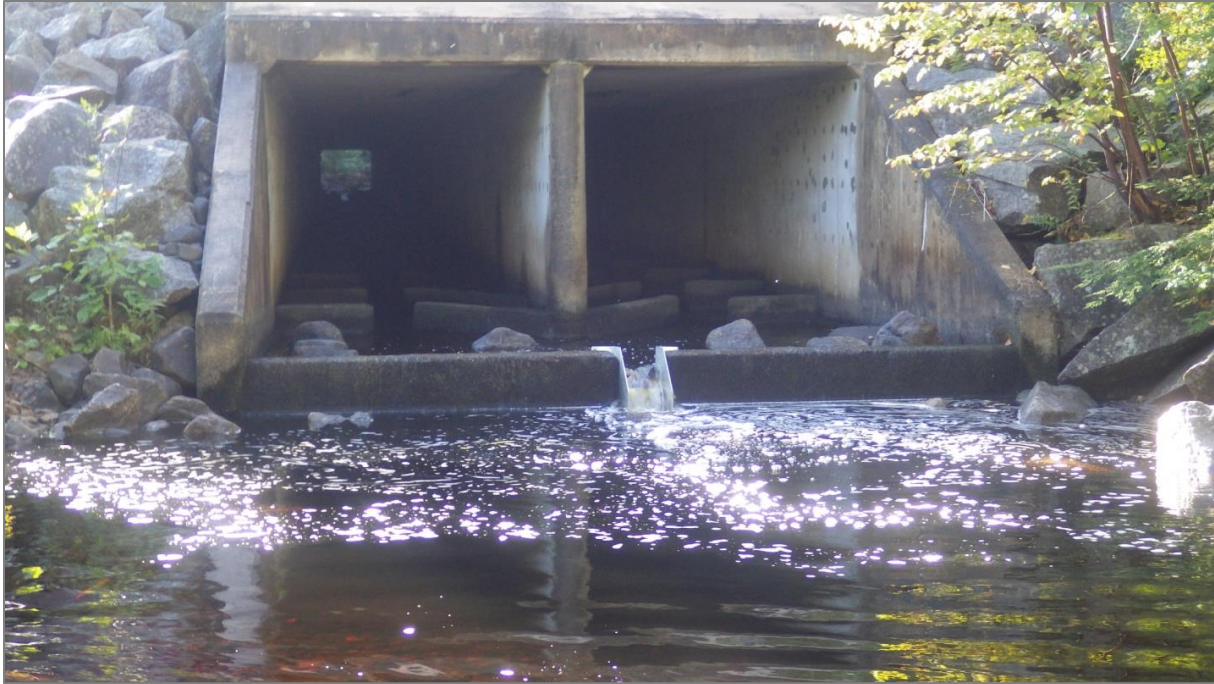
Figure 55. RHR013 after tailwater control and fish chute installation were complete.

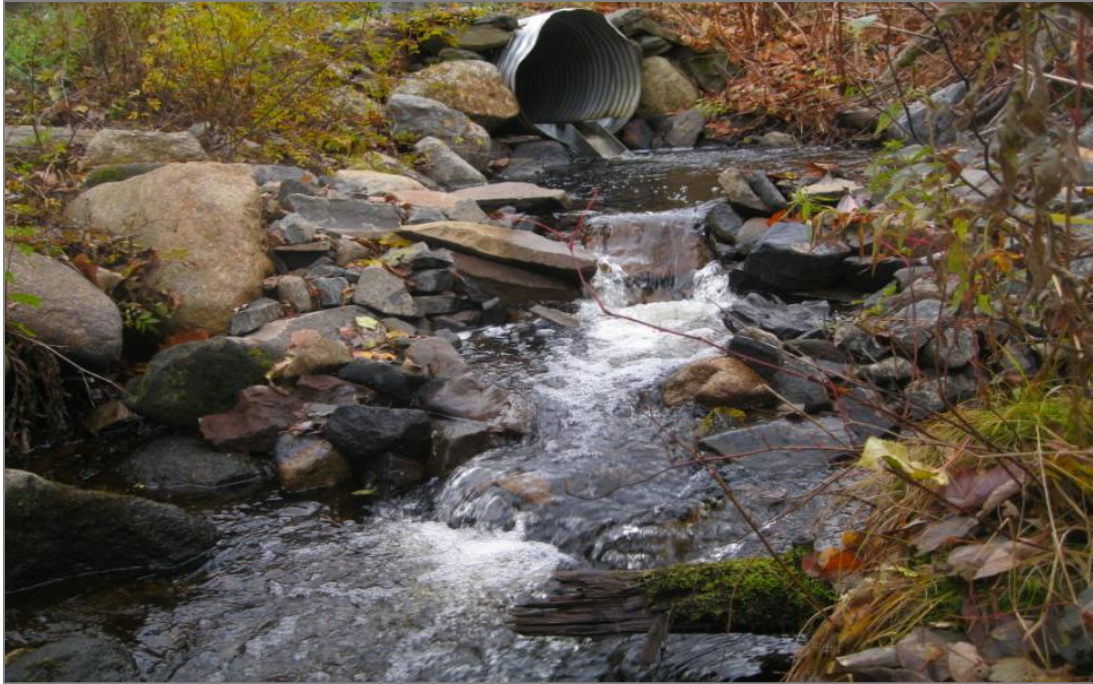
Figure 58. EAS009 After construction of tailwater control and fish chute installation.

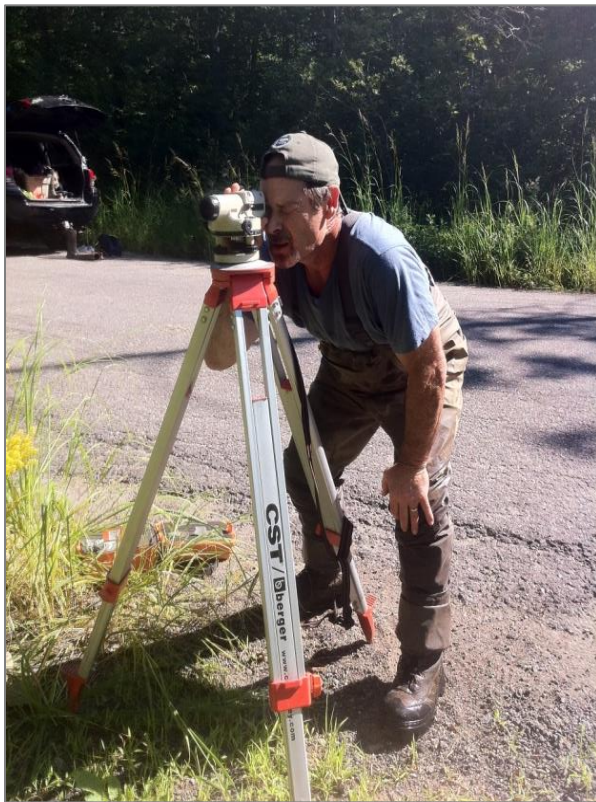
Figure 59. Checking height of culvert to set notch stone.

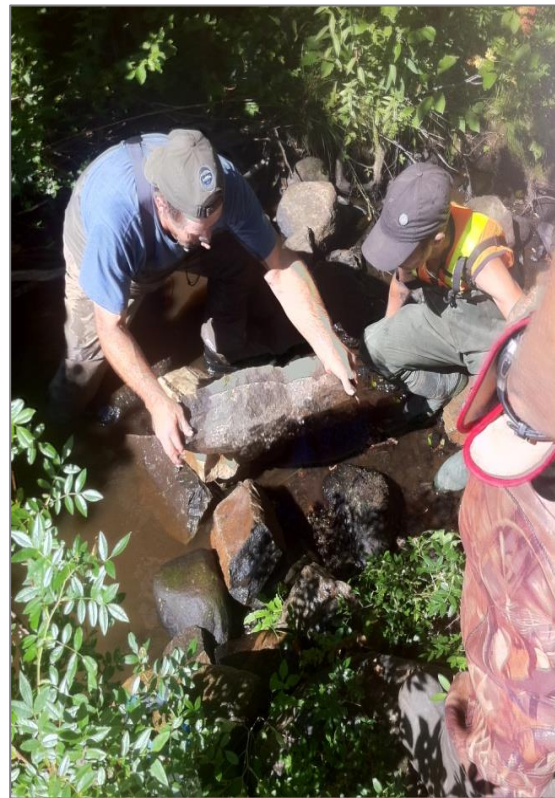
Figure 60. Construction of the tailwater control weir at EAS009.

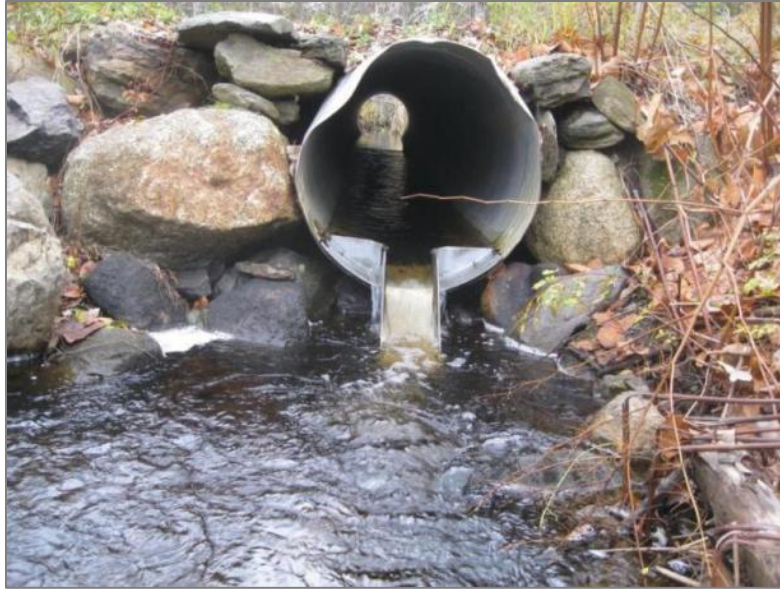
Figure 61. View of functioning fish chute after installation at EAS009.

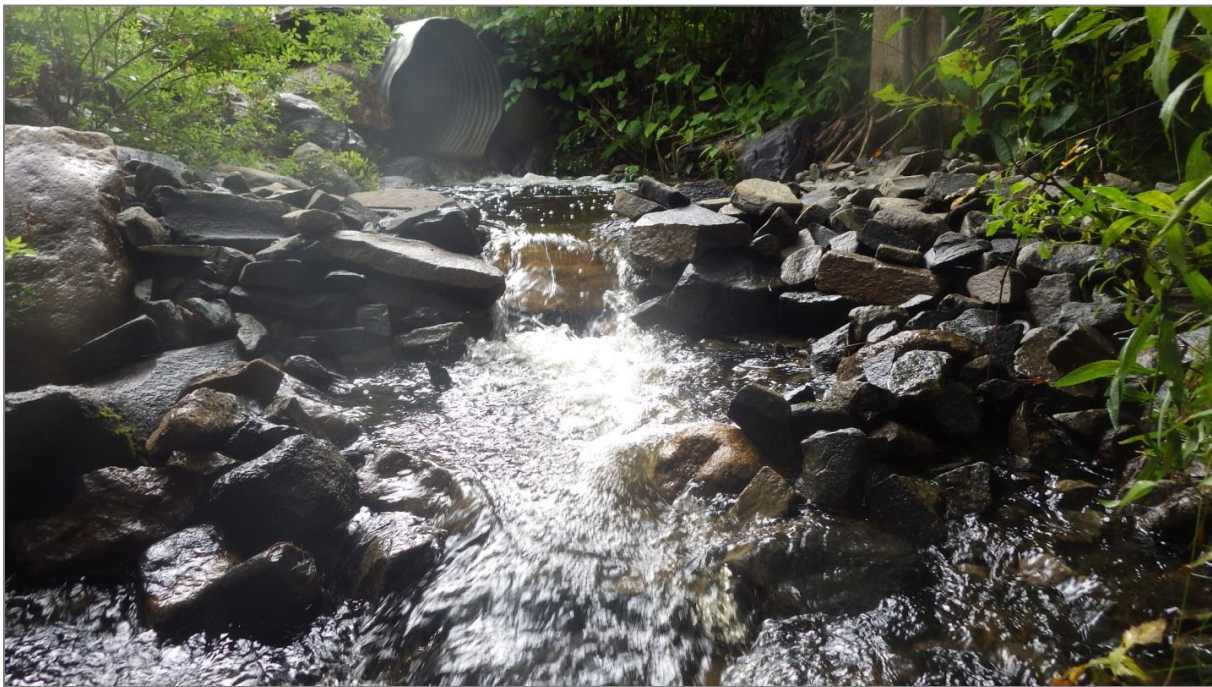
Figure 62. A small pool was created below the weir at EAS009 to improve fish access.

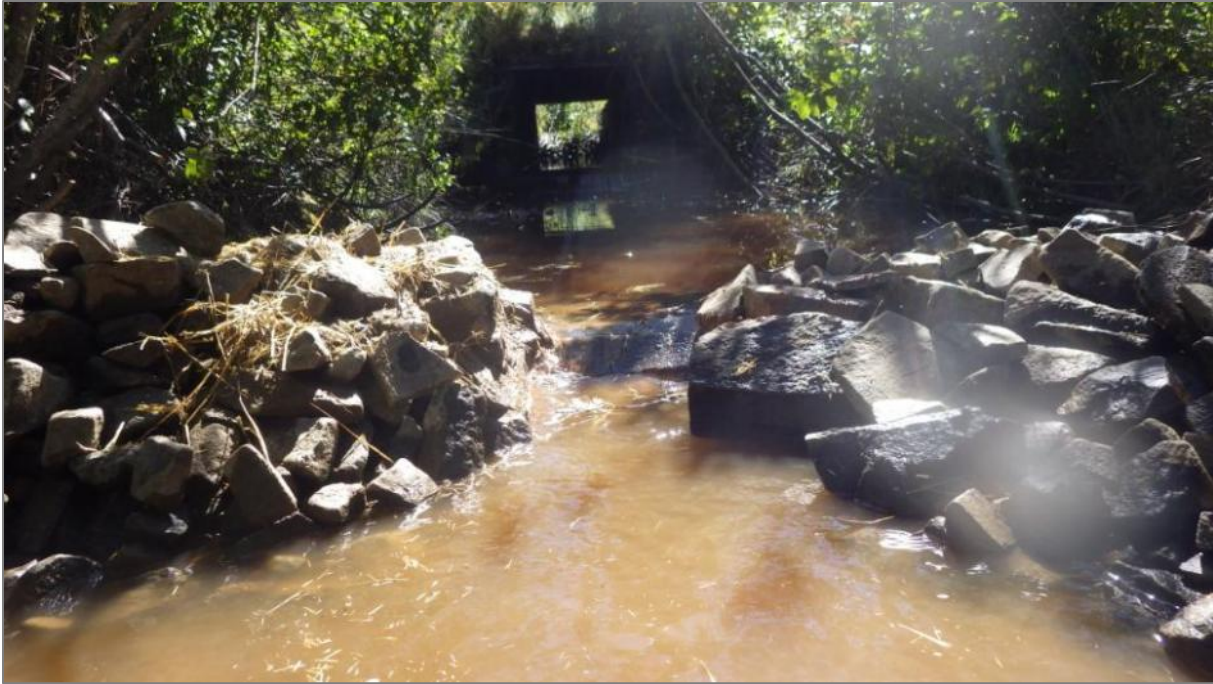
Figure 64. BLK006 After tailwater control weir construction.

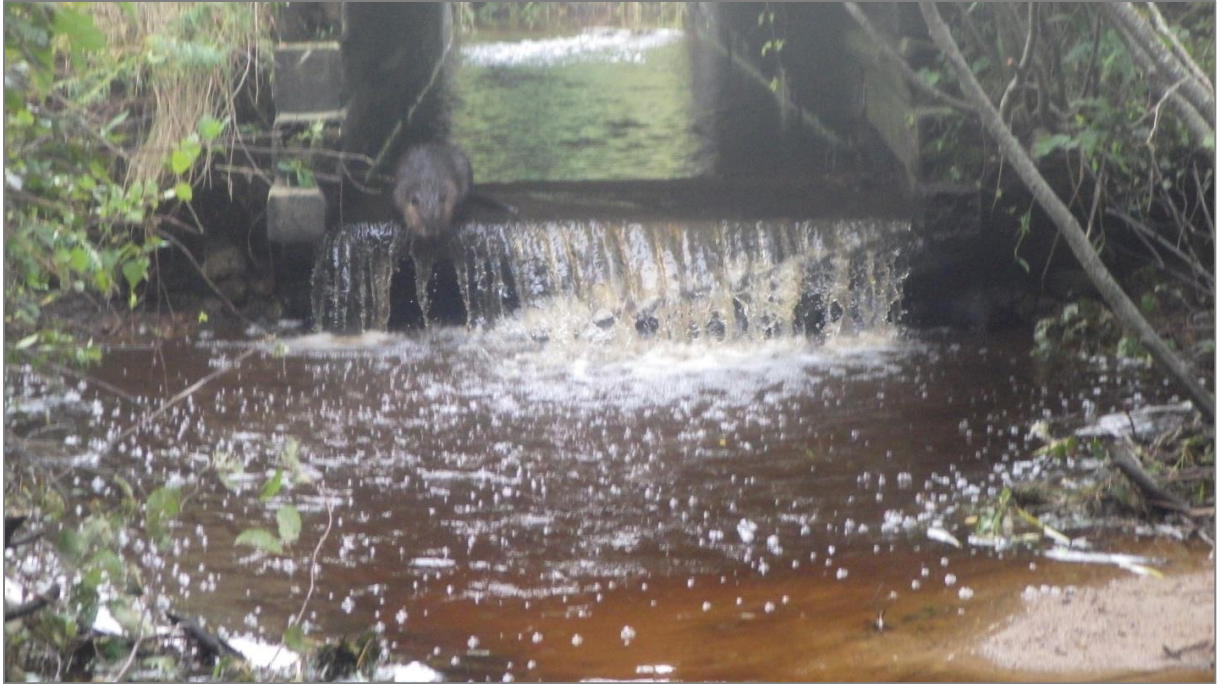
Figure 66. Beaver at the inflow and outflow of BLK006.

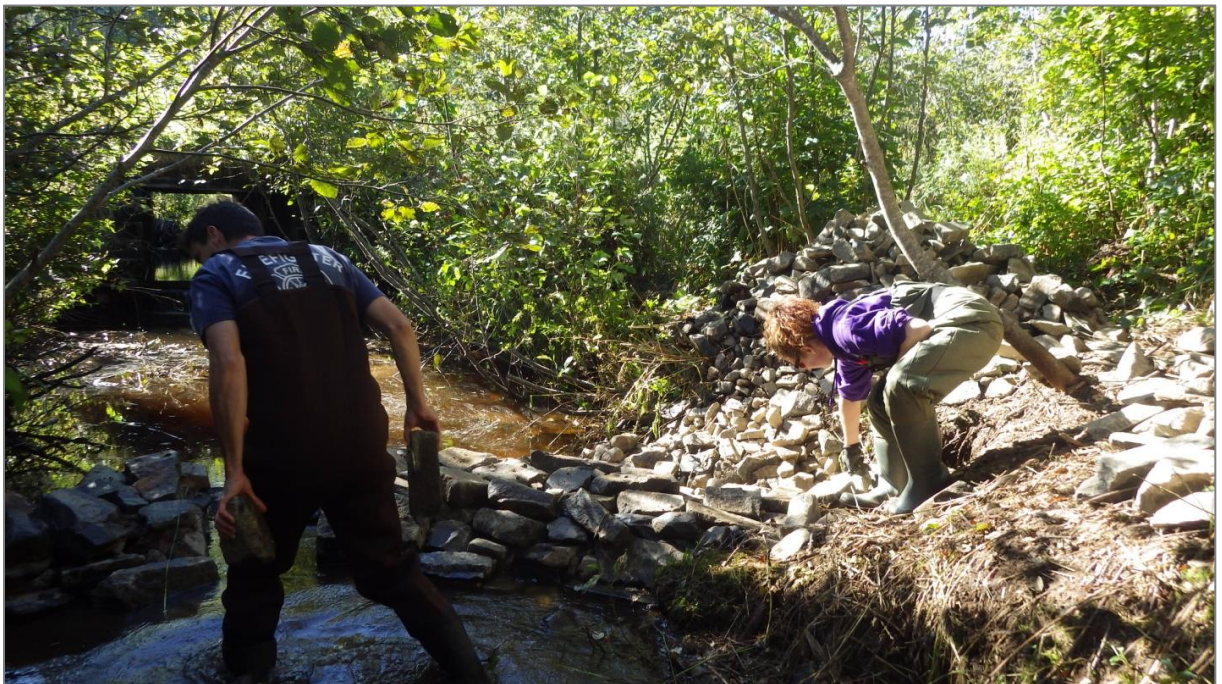
Figure 67. BLK006 Volunteer and staff building the tailwater control weir.

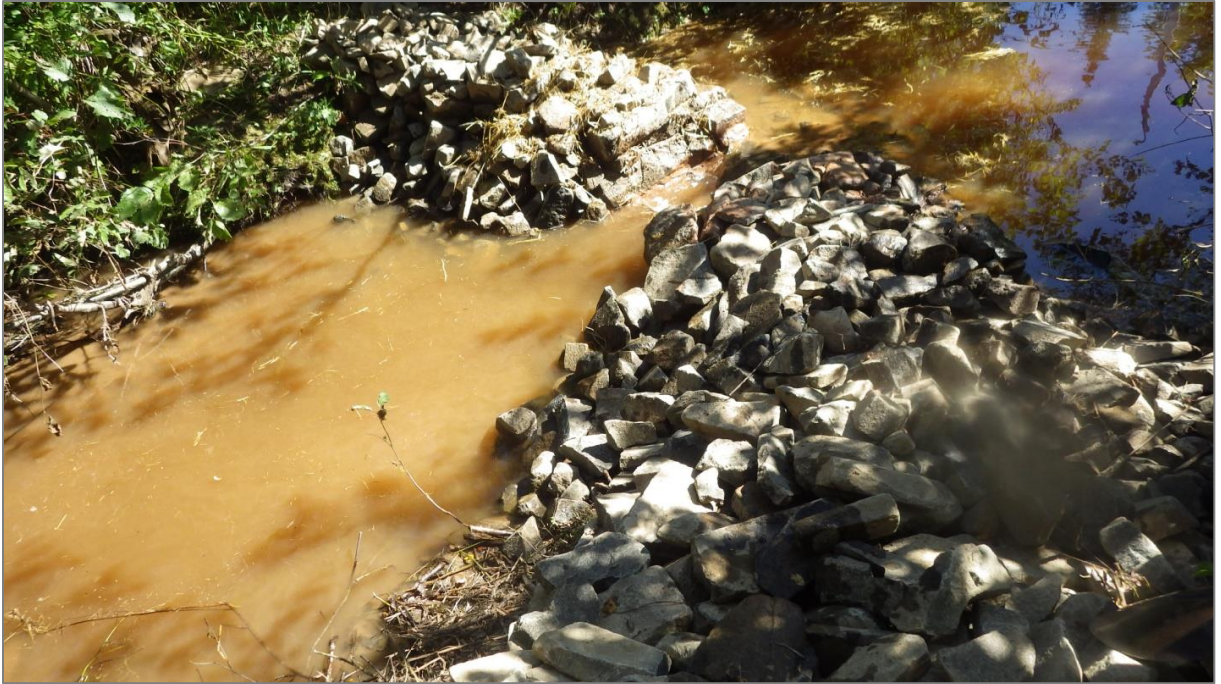
Figure 68. The completed tailwater control weir at BLK006.

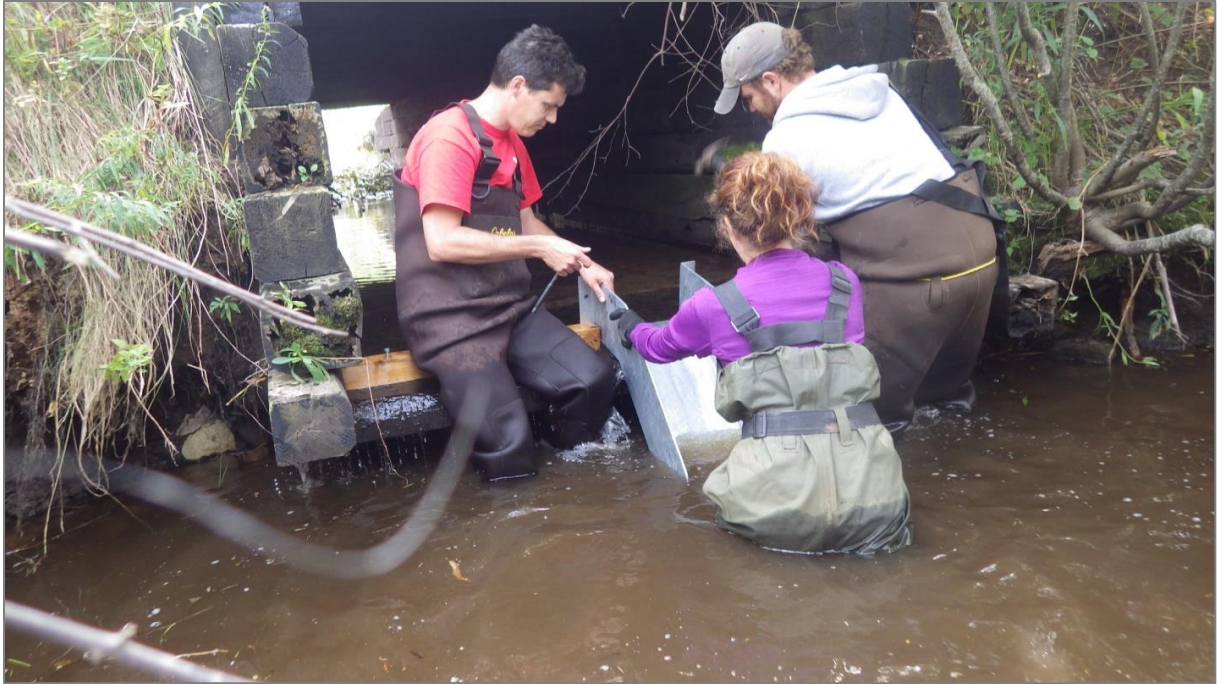
Figure 70. Installing the fish chute at BLK006 with help from Adopt-A-stream staff.

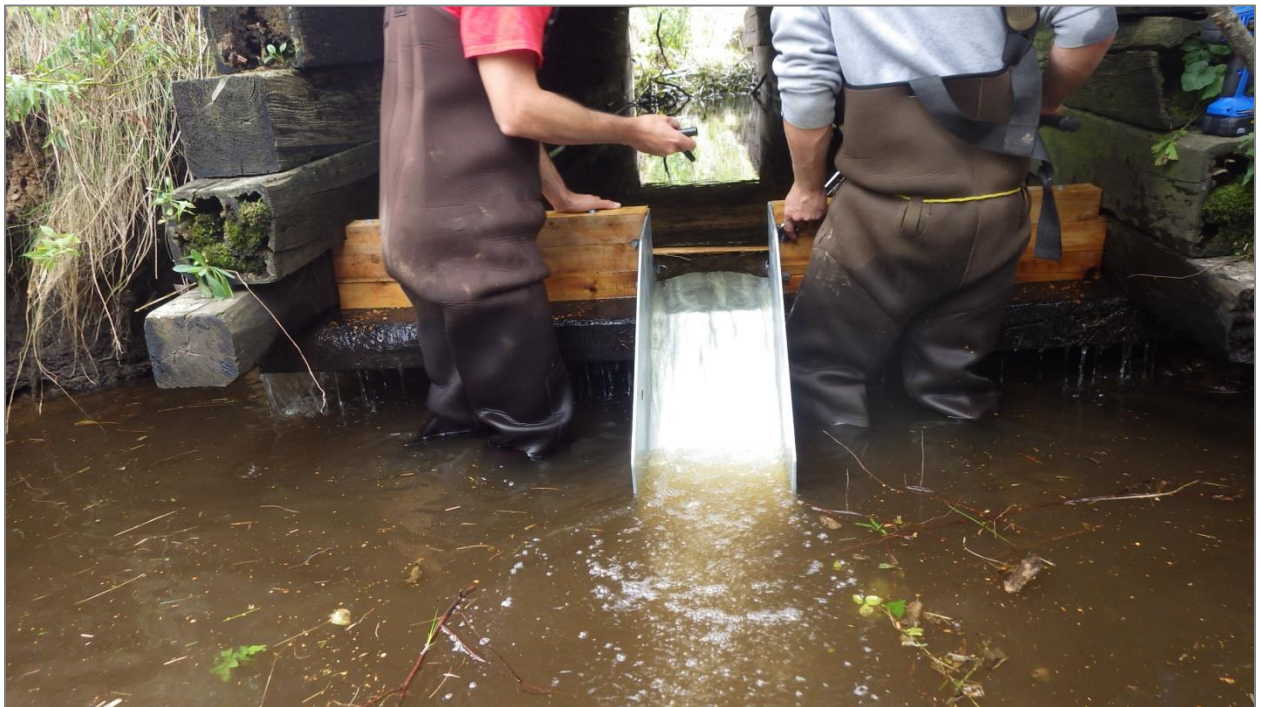
Figure 71. Fish chute at BLK006 after installation.

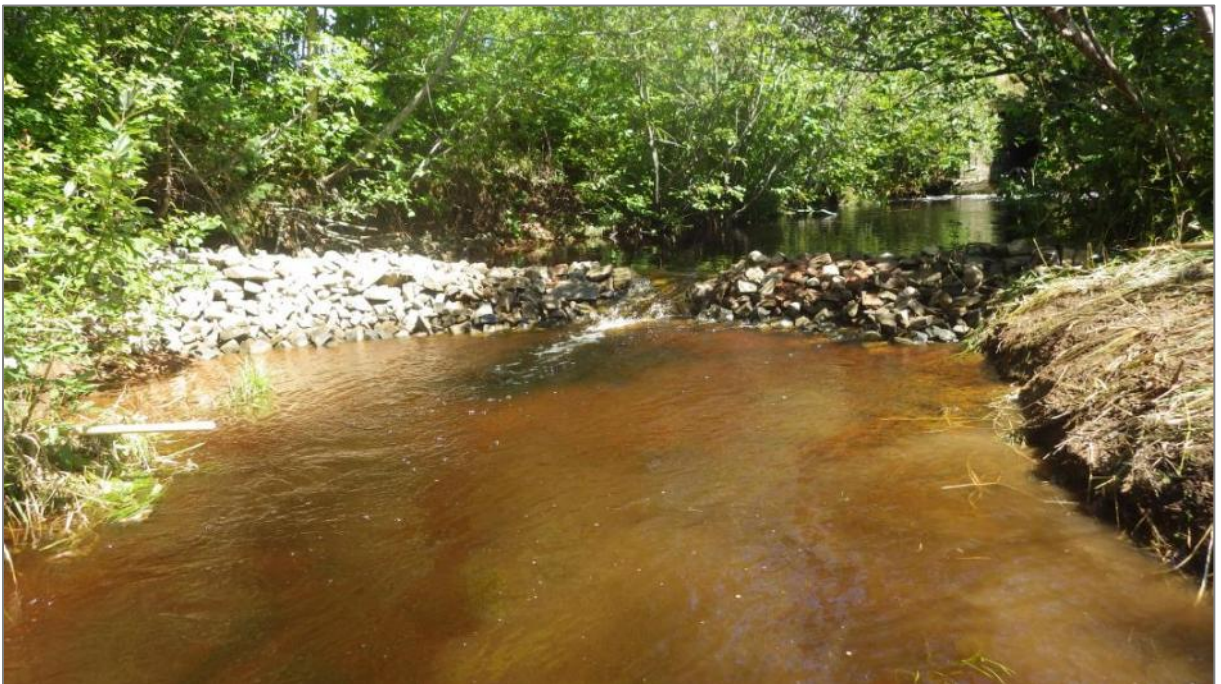
Figure 74. ROC004 Completed tailwater control weir.

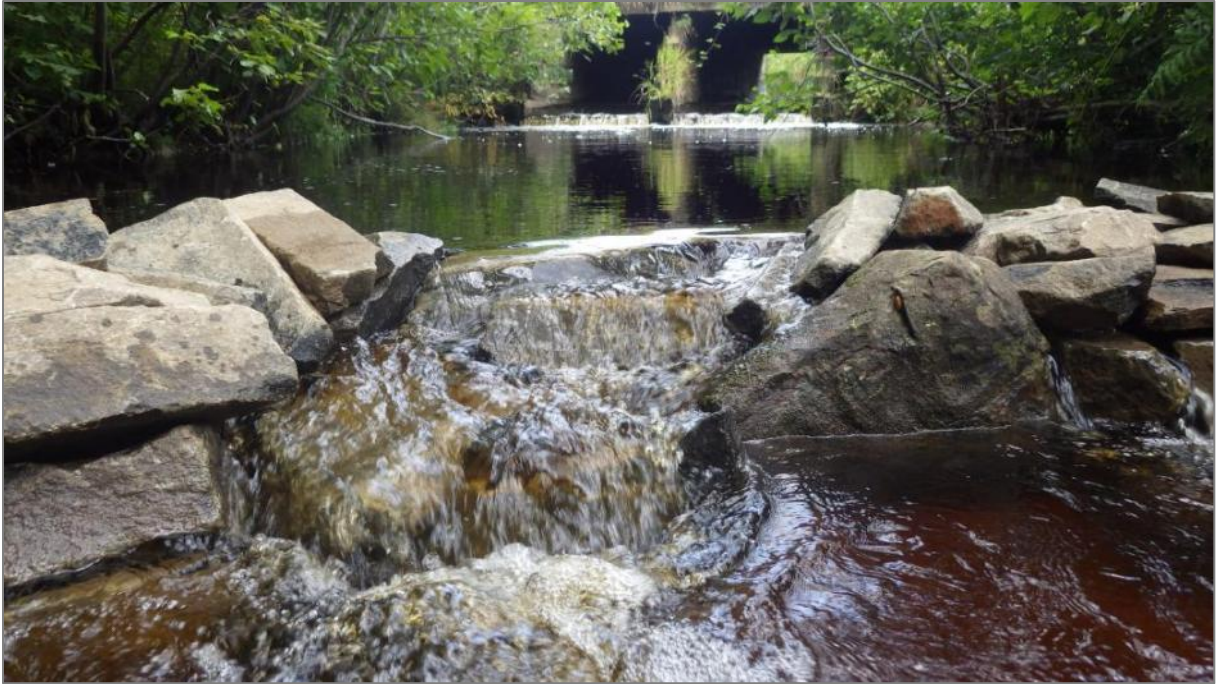
Figure 75. ROC004 Looking upstream through the weir notch towards the culvert outflow.

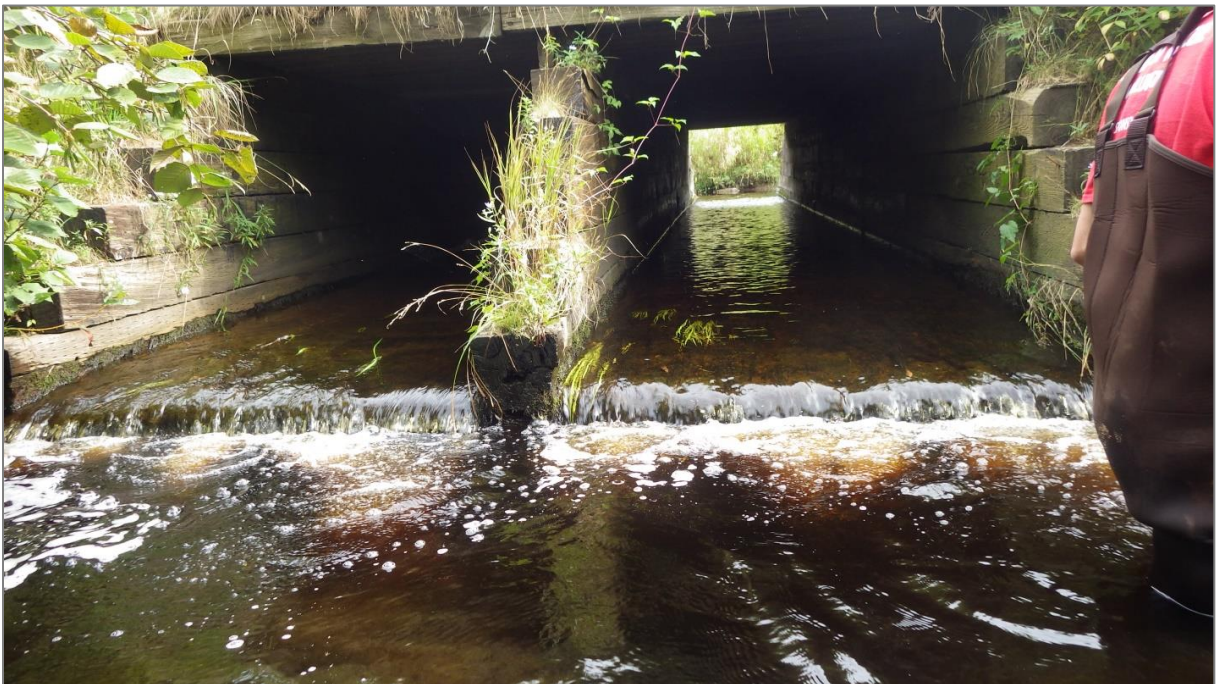
Figure 76. ROC004 Culvert after weir construction, before chute installation.

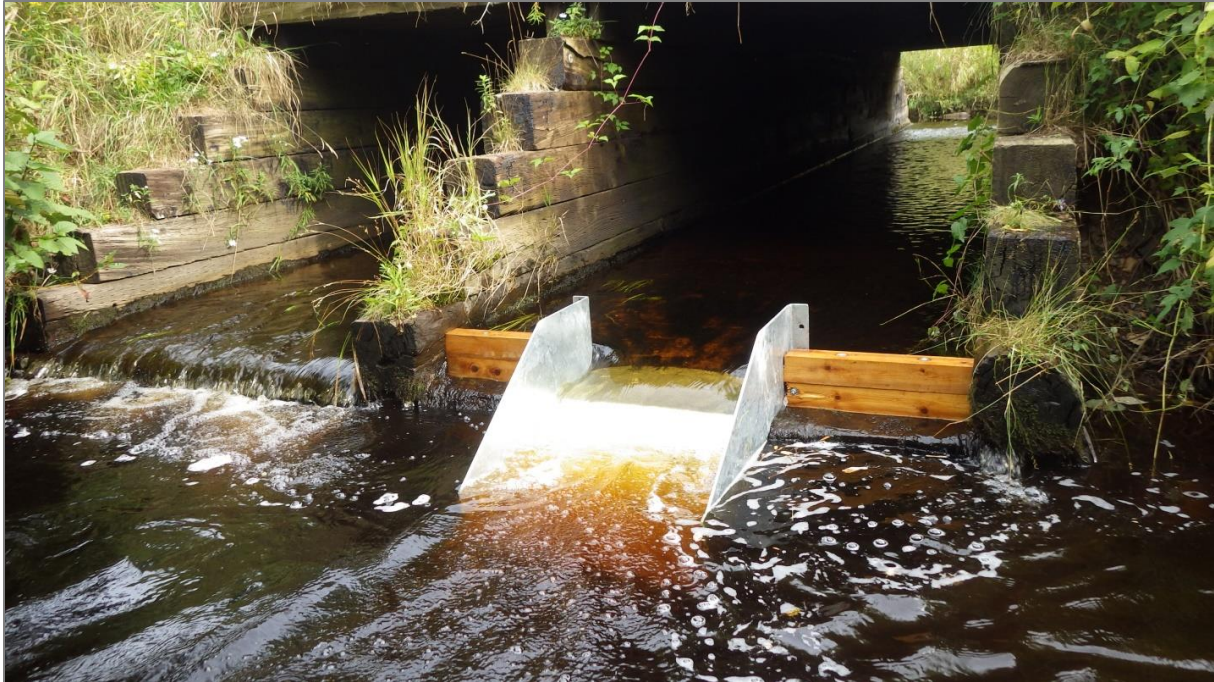
Figure 77. ROC004B After fish chute installation.

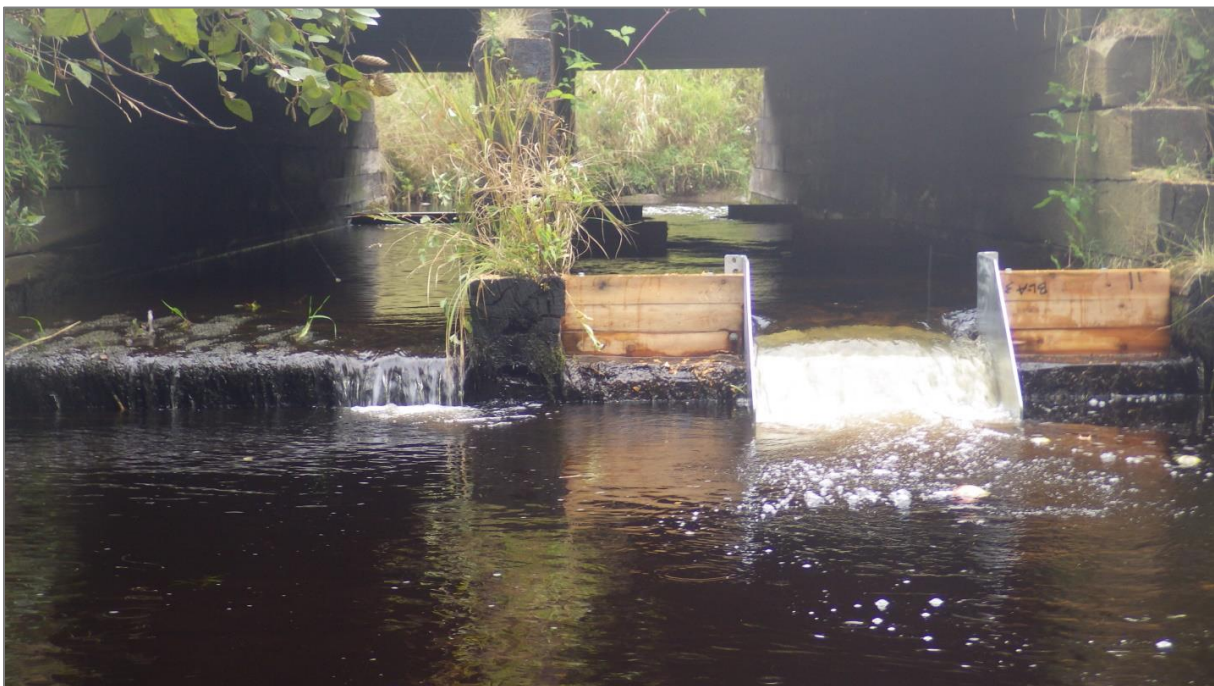
Figure 78. ROC004 Fish chute, baffles in right side, and low flow barrier at left inflow.

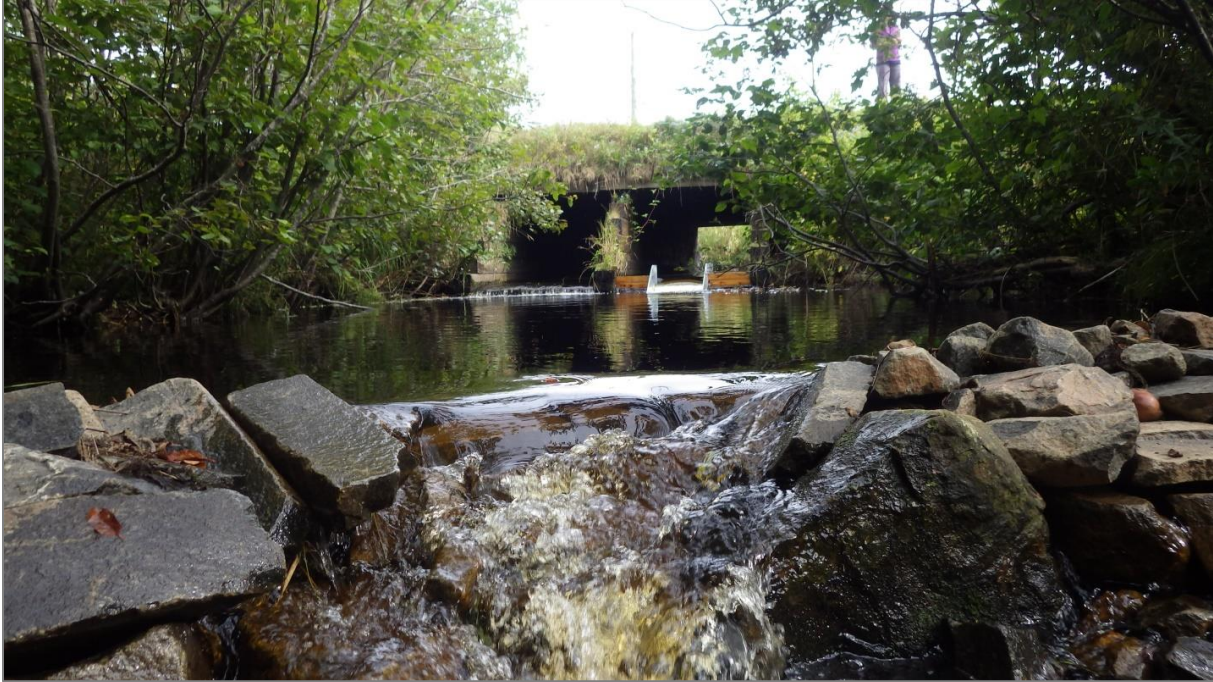
Figure 79. View of ROC004 after all remediation activities were completed.

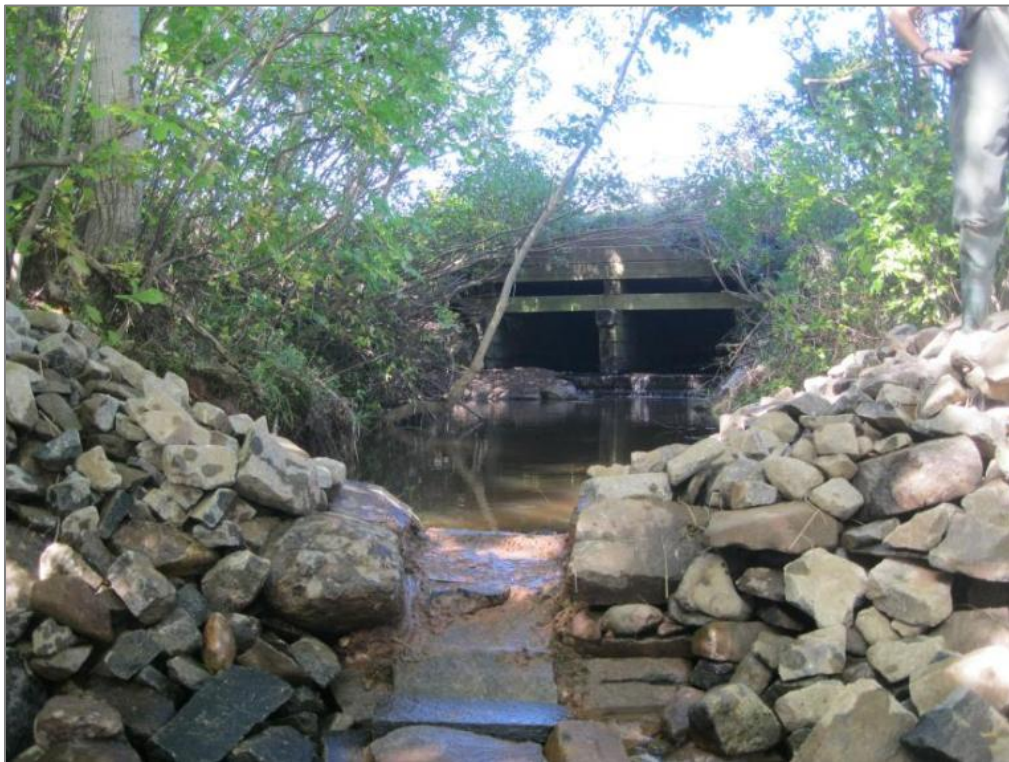
Figure 81. NEB004 After tailwater control weir installation.

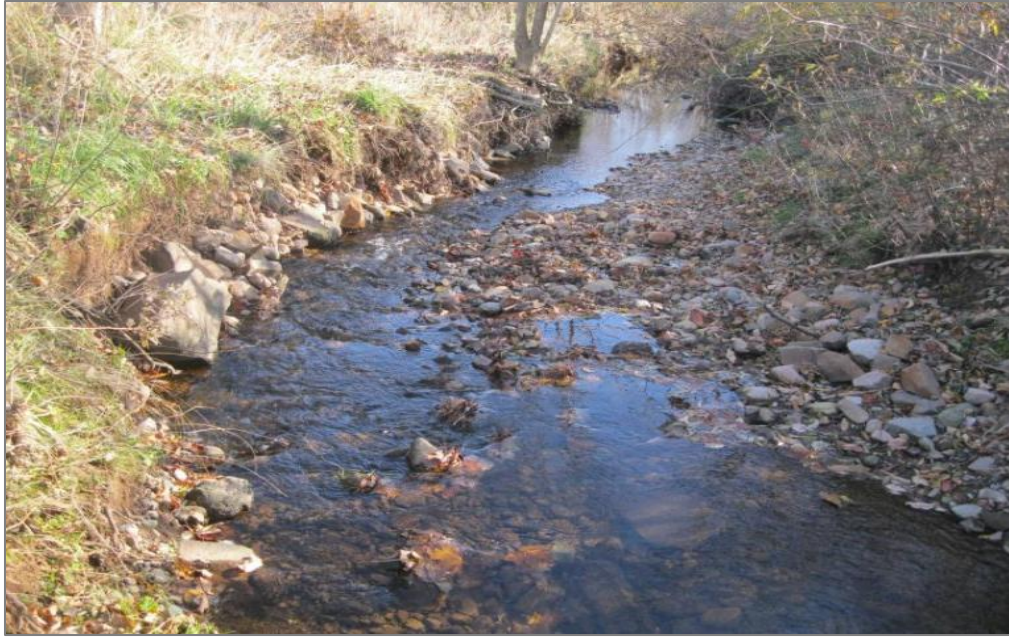
Figure 82. NEB004 Downstream after bank reinforcement.

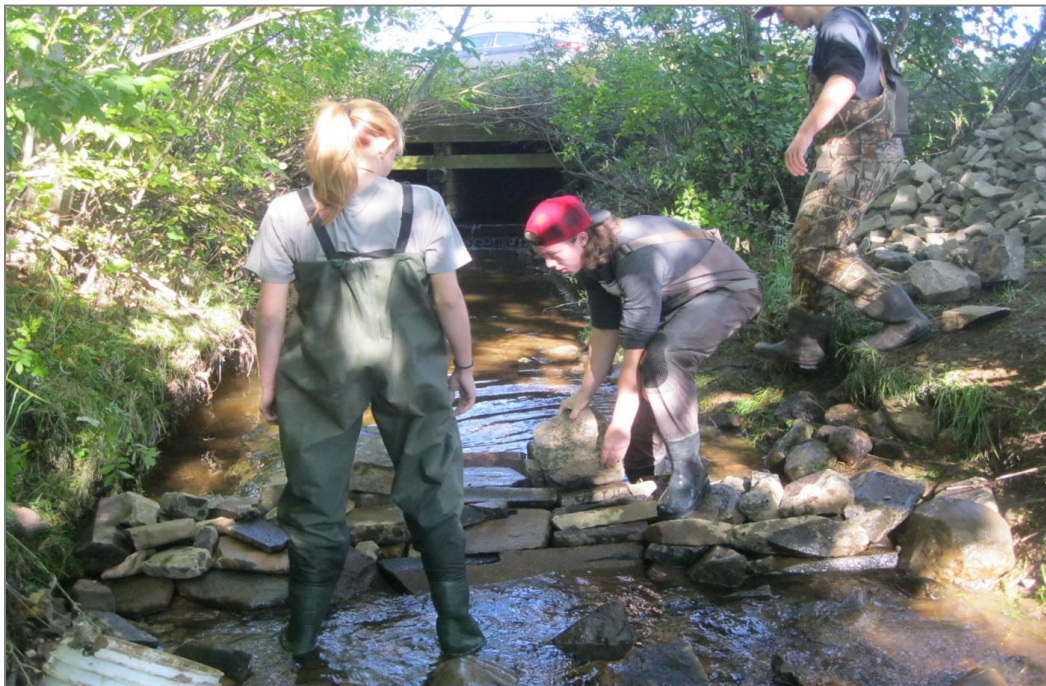
Figure 83. Volunteers hard at work constructing a rock weir at NEB004.

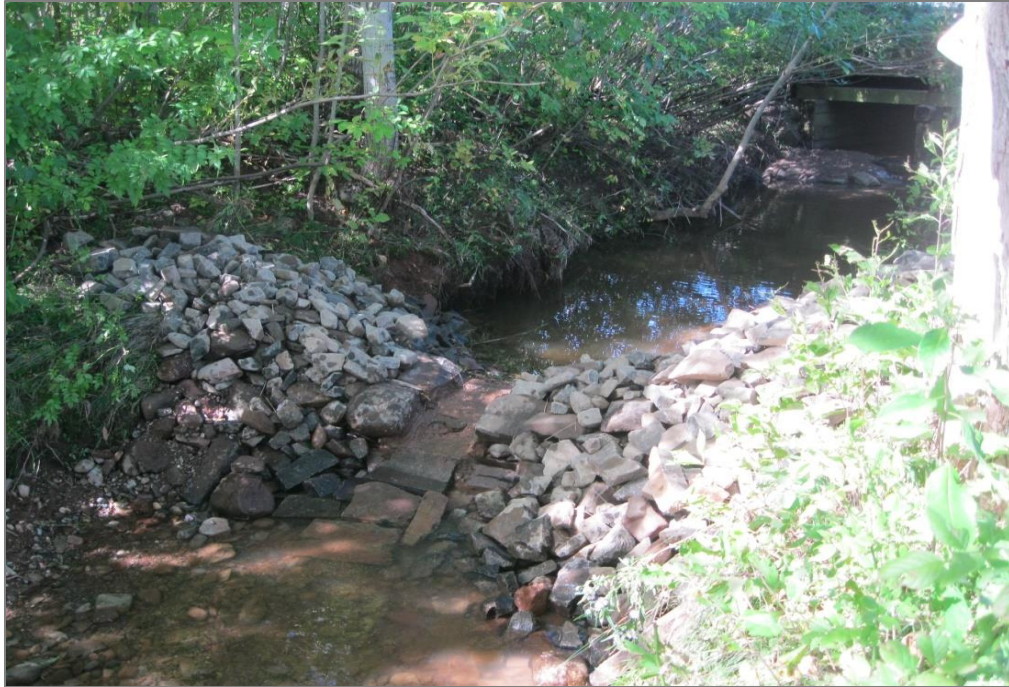
Figure 84. Finished tailwater control weir at NEB004.

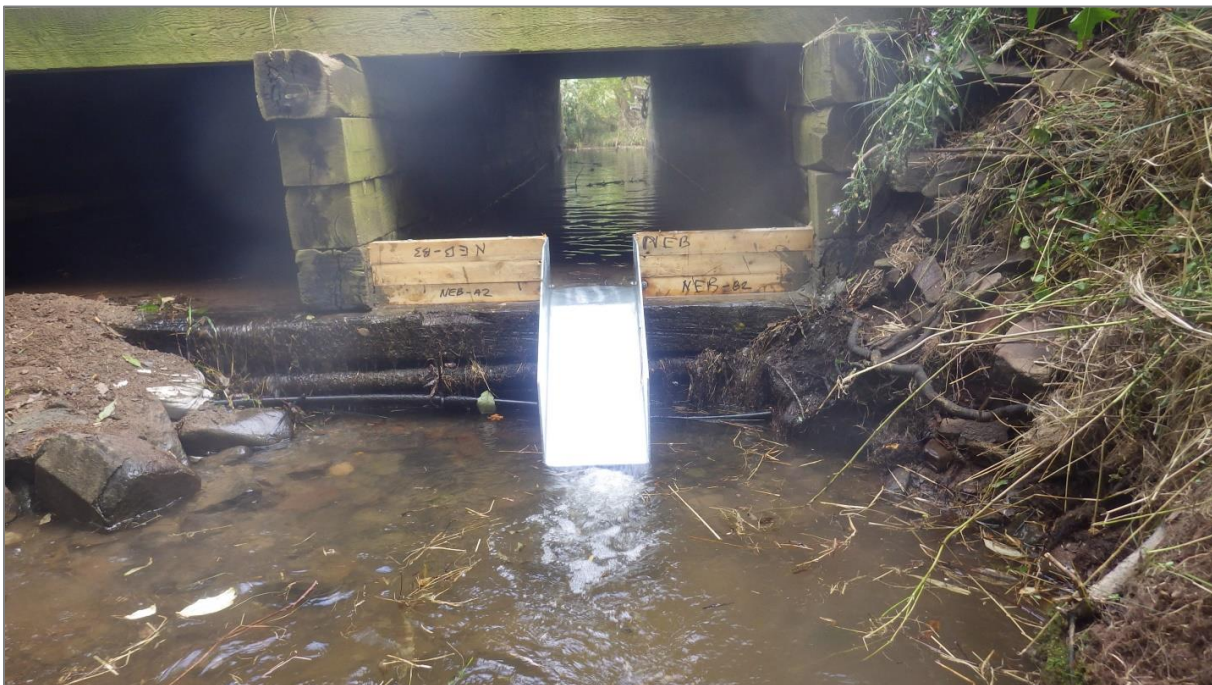
Figure 85. NEB004 after fish chute installation.

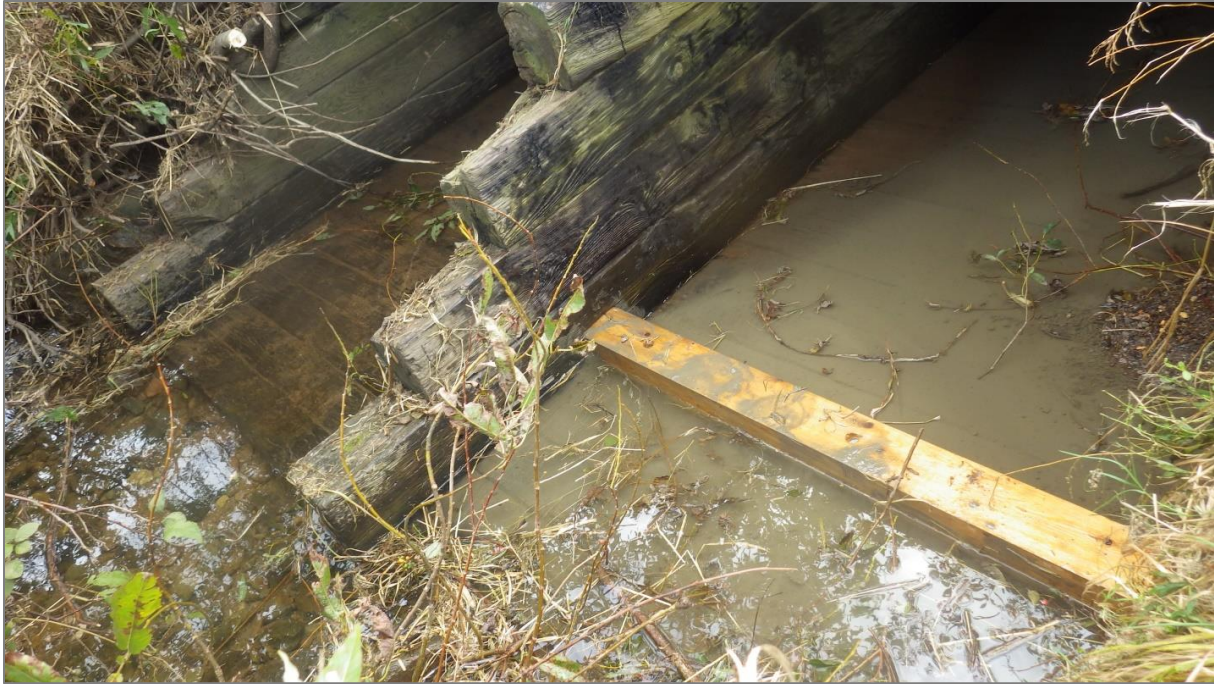
Figure 86. NEB004 after installation of a low flow barrier at the inflow.

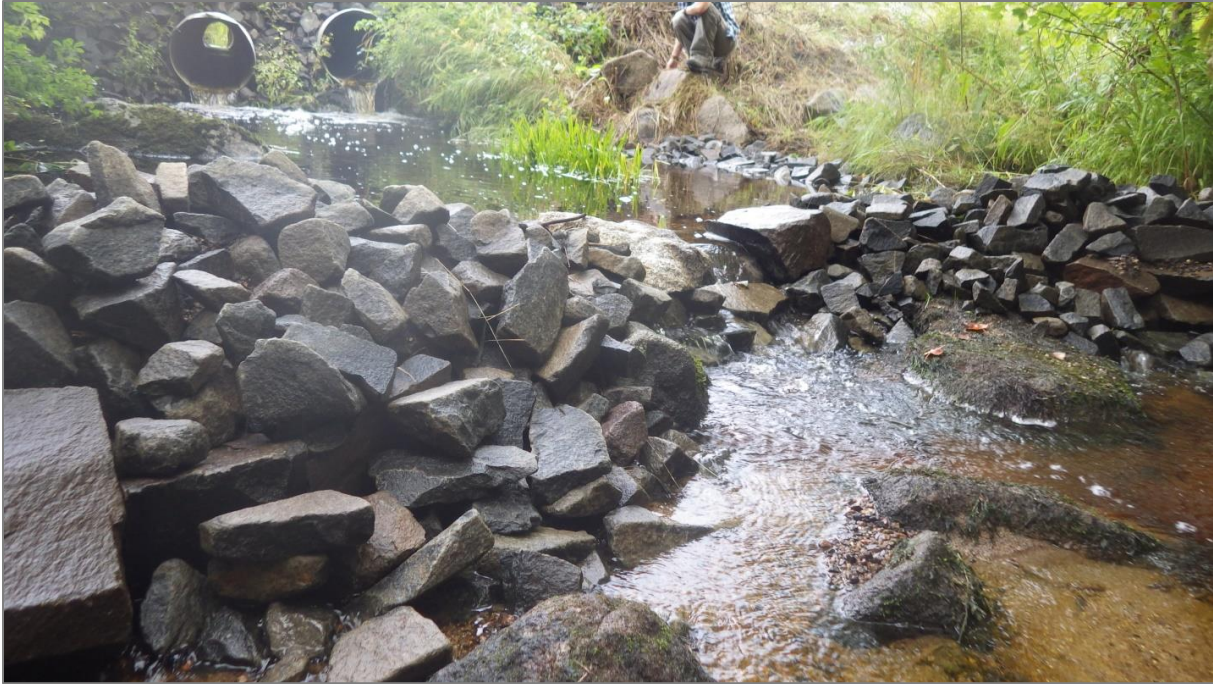
Figure 89. ALL017 Finished tailwater control weir.

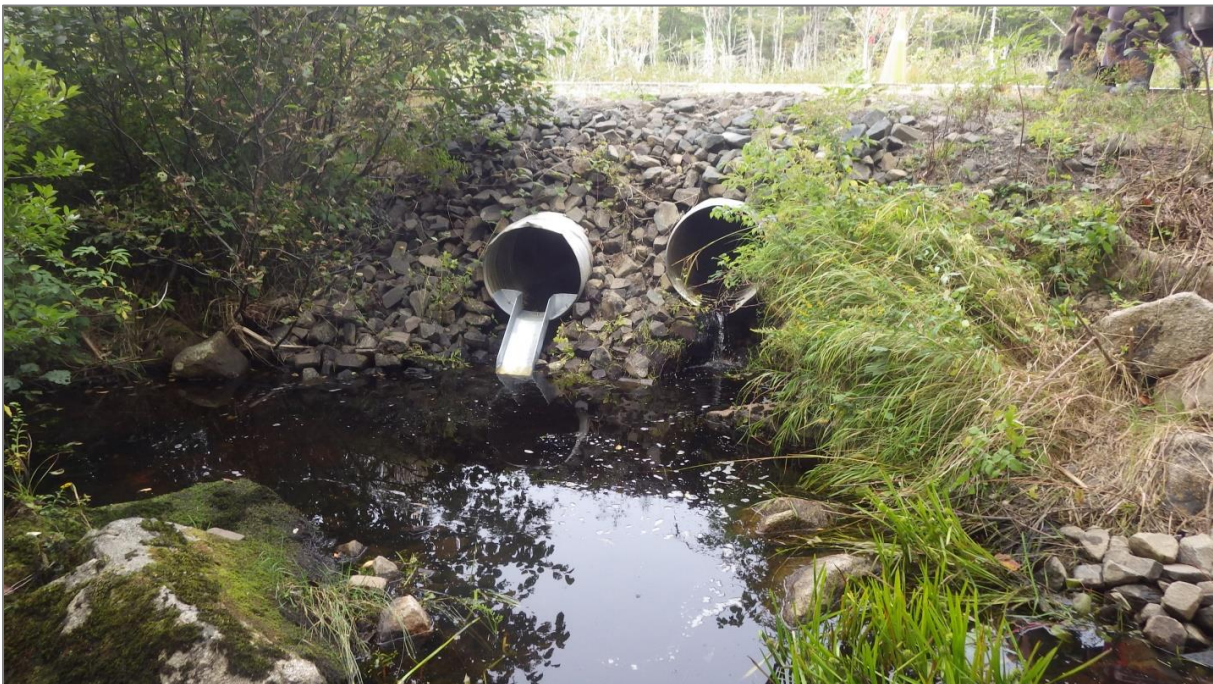
Figure 90. ALL017 after fish chute installation.

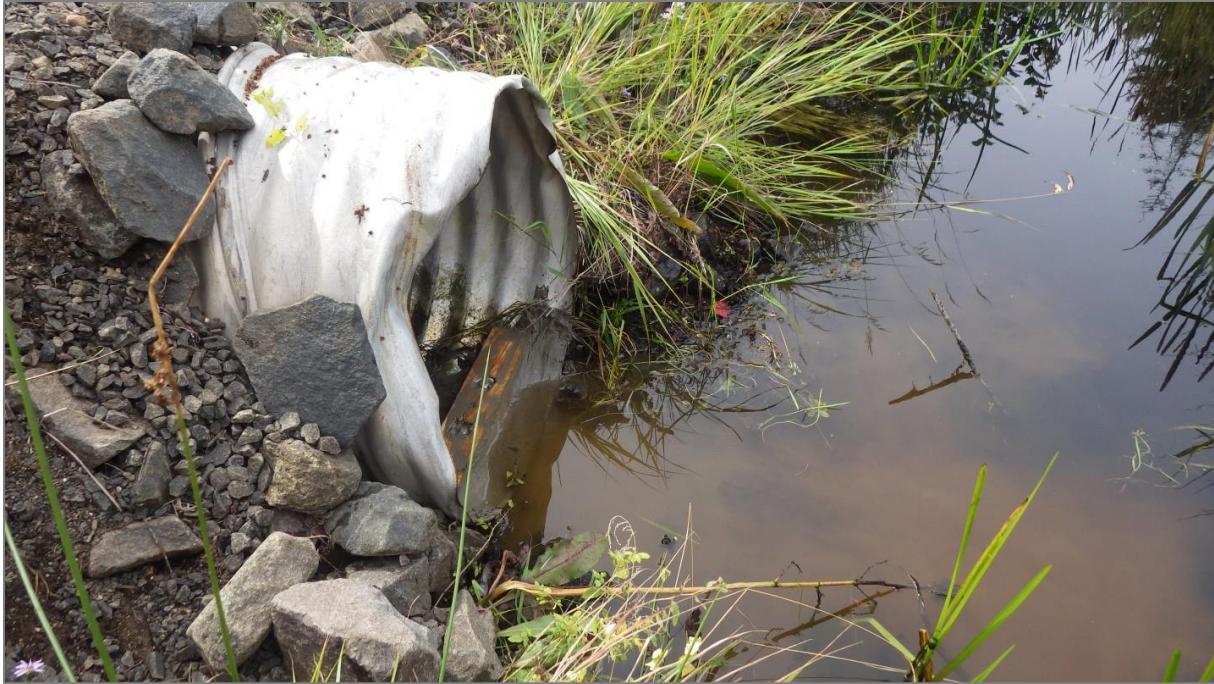
Baffles Required: No baffles were required. A short piece of cedar was used as a low flow barrier in one of two culverts to increase the flow in the adjacent culvert during low flow conditions.

Figure 91. ALL017 Installation of low flow barrier at culvert inflow (culvert without the fish chute).

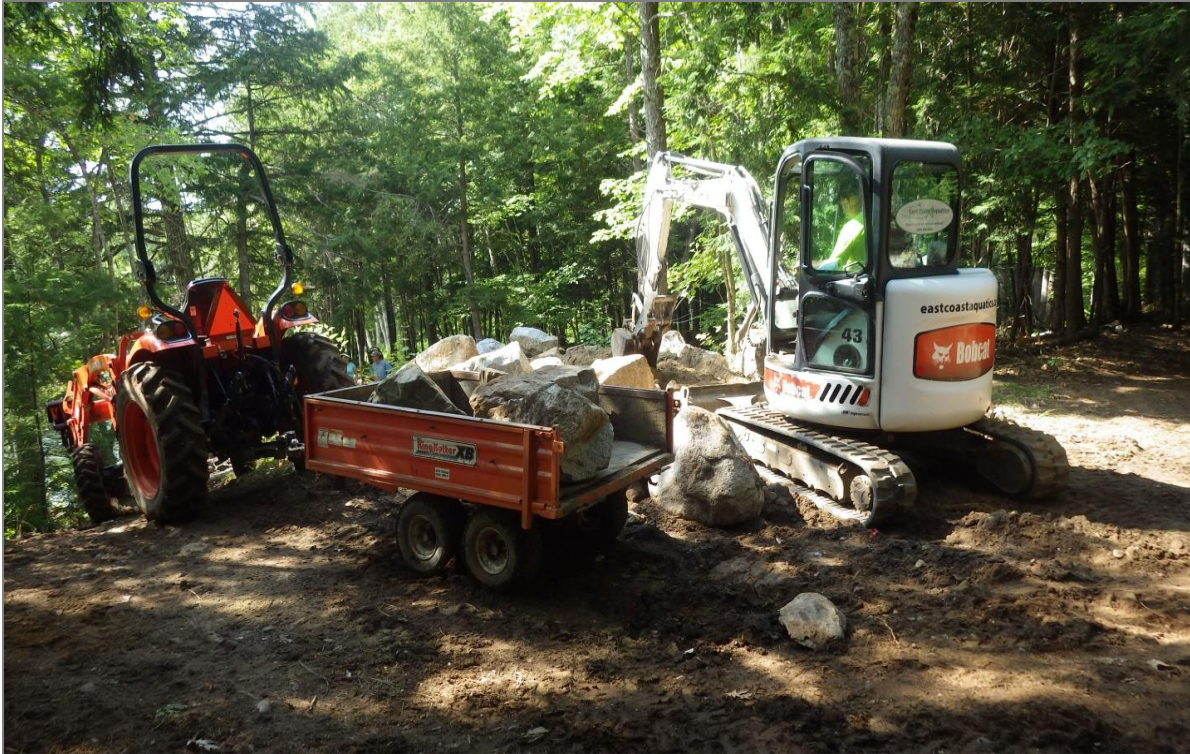
Figure 92. Excavator and tractor used to move weir rocks to weir sites.
