Fish Passage Restoration and Habitat Enhancement

*Addressing habitat
fragmentation and
productivity in the Annapolis
River watershed*

Jamie McCamon
December 2015

Clean Annapolis River Project

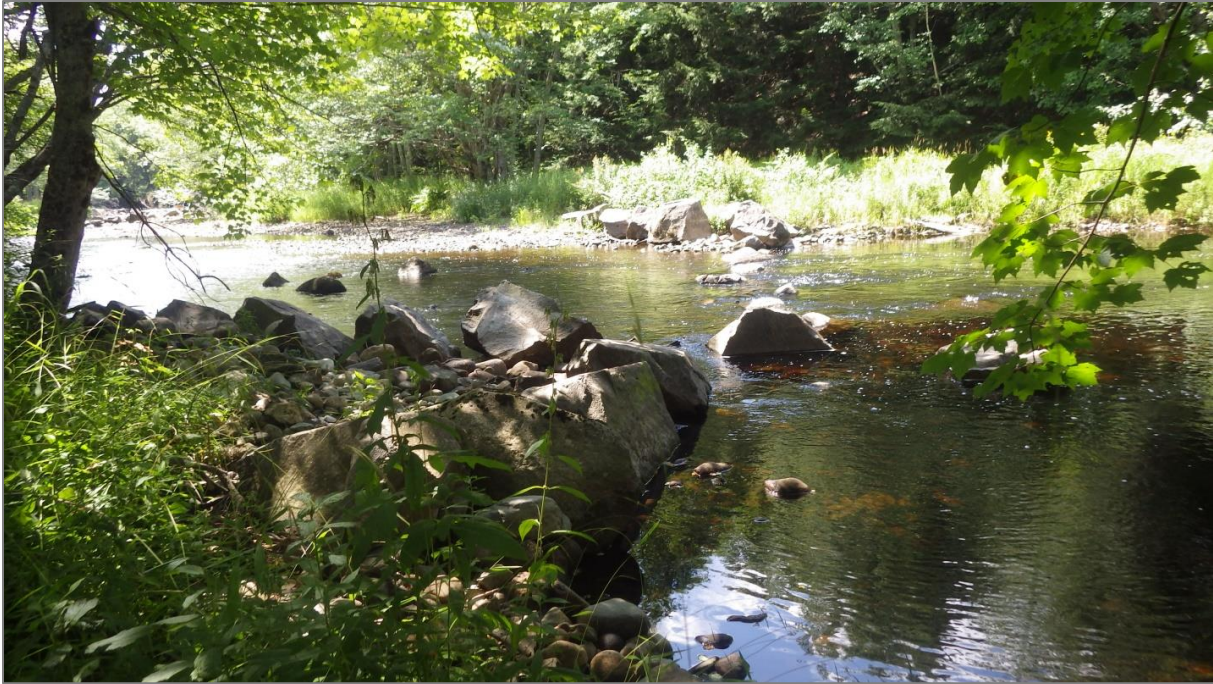
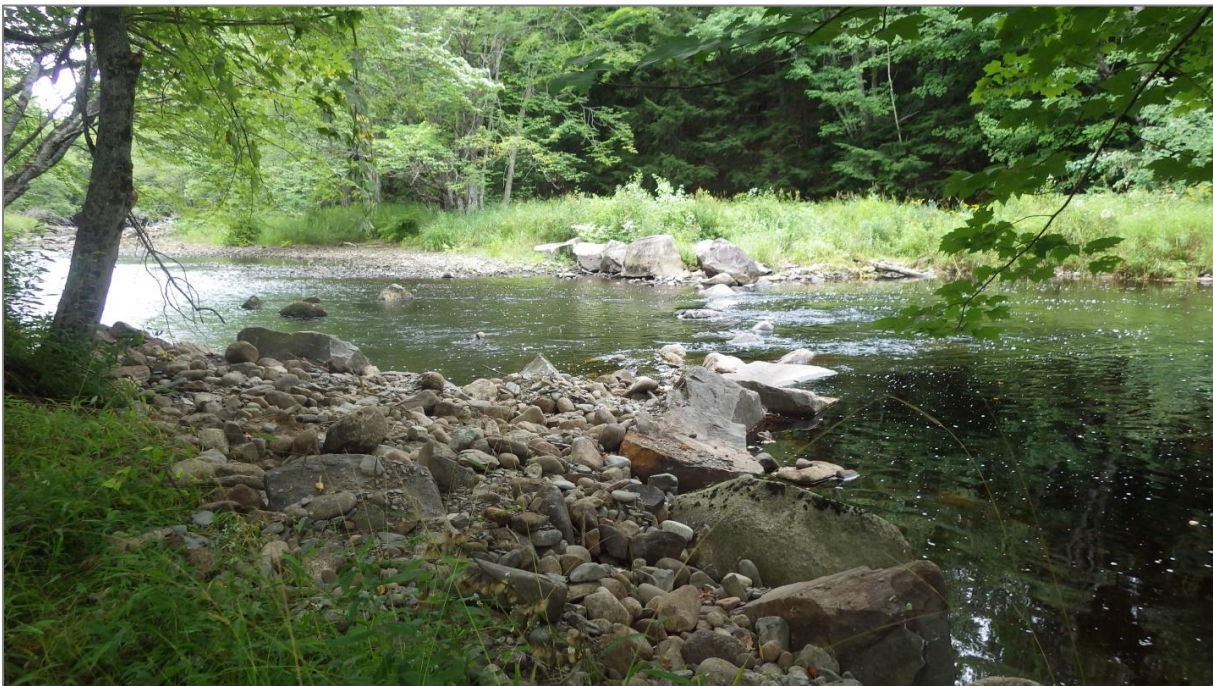
Figure 94. Weir “A” before adjustments to right wing deflector.

Figure 95. Weir “A” after all adjustments were completed.

Figures 94 and 95 show Weir A before and after adjustments were completed. The right wing deflector was bolstered and slightly reshaped using both large and small rocks. Additionally, one or two of the weir rocks had been displaced by high flows, and were repositioned and reinforced with additional rock.

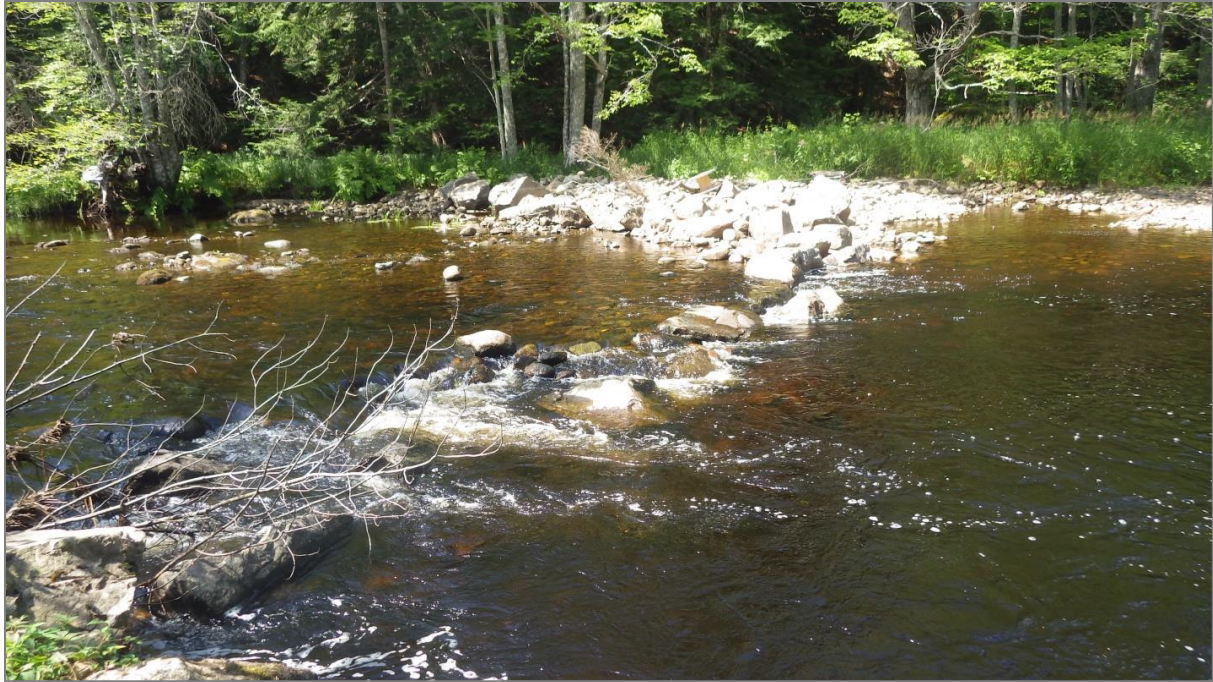
Figure 96. Weir "B" Before additional bolstering activities.

Figures 96 and 97 show restoration activities that occurred at Weir B in 2015. The majority of adjustments were made to the left wing deflector with the addition of some bigger rocks downstream and smaller stones were used for backfill. The right wing deflector had a couple of new large rocks added and was bolstered with smaller stones.

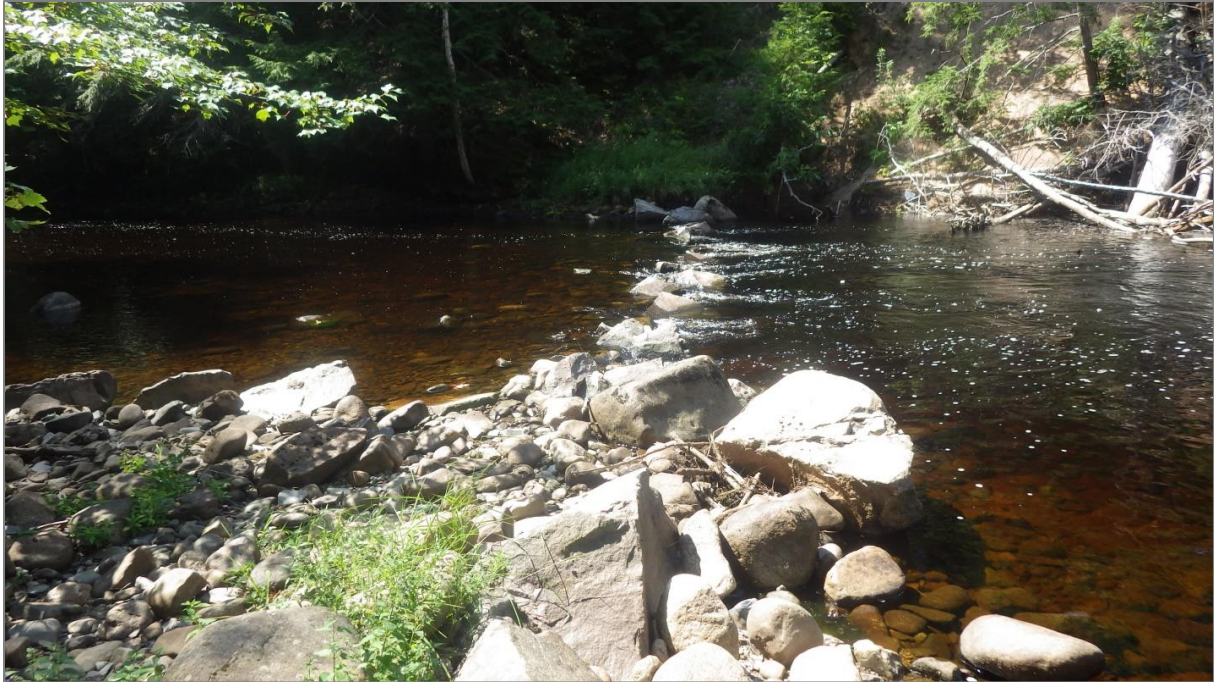
Figure 98. Weir "C" Before wing deflector adjustments.

Weir "C" (see Figures 98 and 99) required some rearrangement of weir rocks to reinforce and direct the flow away from the left bank. A wing deflector was also created to achieve this effect, and a trench was dug to accommodate the placement of the log used to construct the deflector (See Figure 109). Re-shaping and addition of more material to the right wing deflector was also completed. The log deflector was installed and backfilled by hand by CARP staff after the weir excavation work was completed.

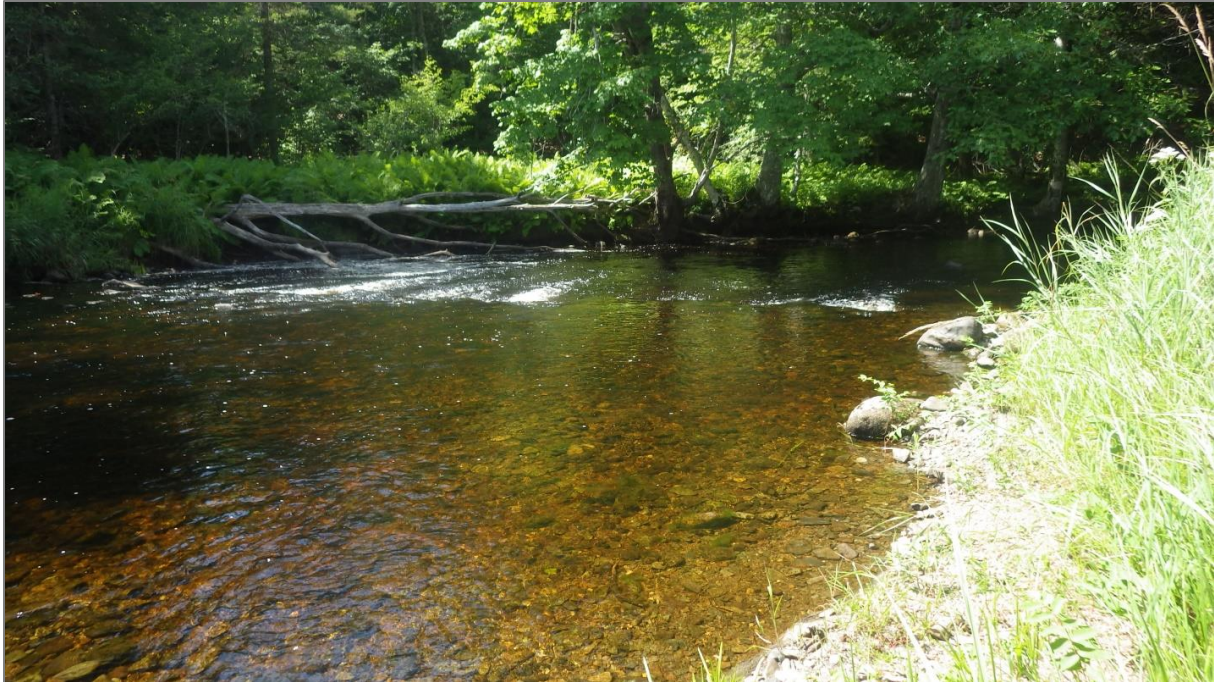
Figure 100. Weir "E" Before restoration activities.

Weir "E" required re-construction work in 2015 (see Figures 100 and 101). After consultation with experts, it was decided that the in-stream weir rocks were well placed, but that the structure required two deflector weirs: a left wing deflector to direct flows away from the bank downstream, and a right wing deflector. Large rocks were added on-site to create the deflectors, which were backfilled as well.

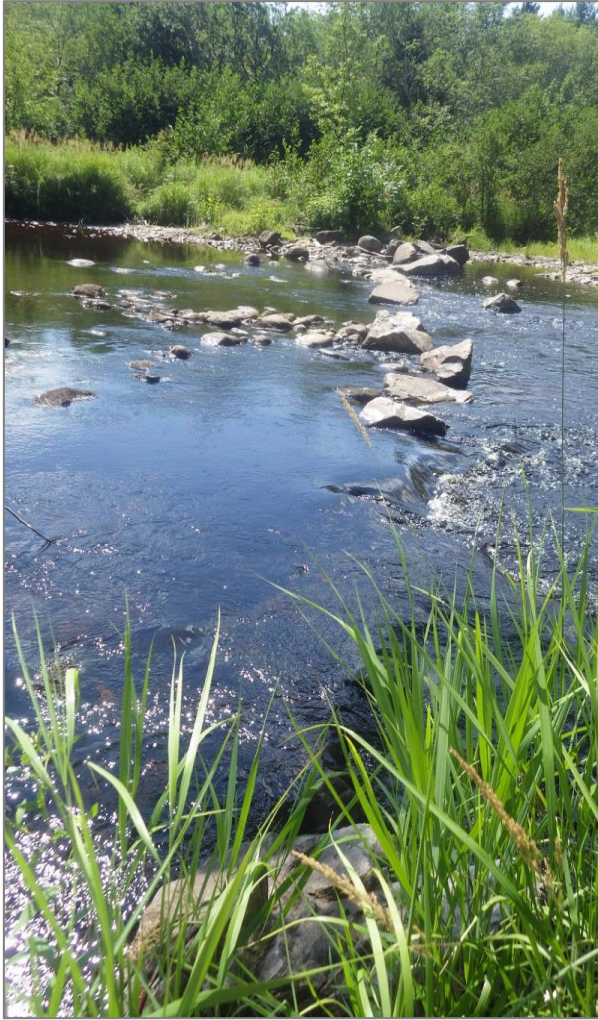
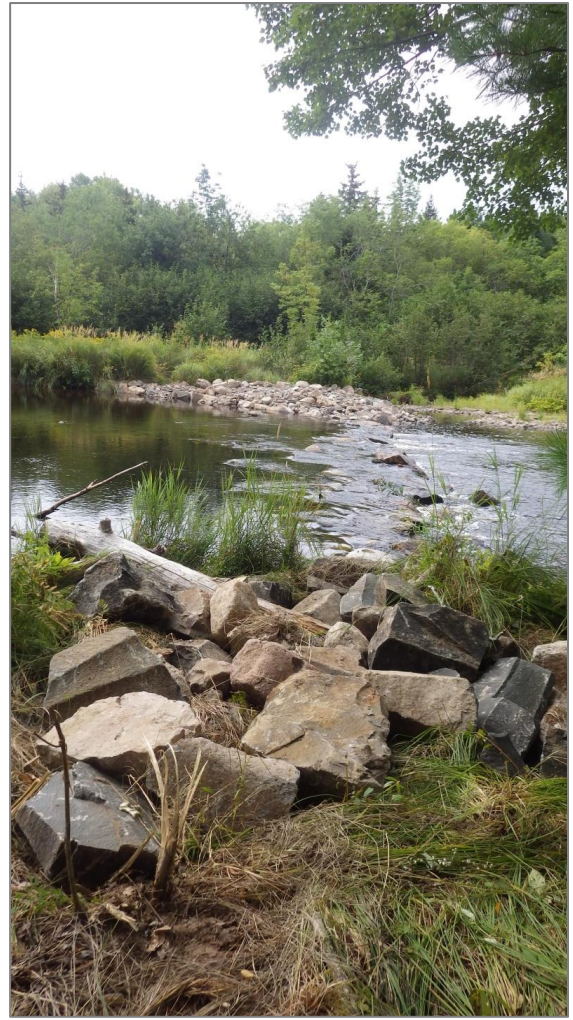
Figure 102. Weir "F" before instream restoration work.

Figure 103. Weir "F" after instream restoration work.

Weir "F" required reshaping of the left bank wing deflector, which was repositioned, and large rocks were added to it. Rocks were added to the right bank to improve its stability and minimize bank erosion. The main part of the weir was also adjusted and reset. Figures 102 and 103 show the before and after photos of the restoration activities that occurred at Weir F.

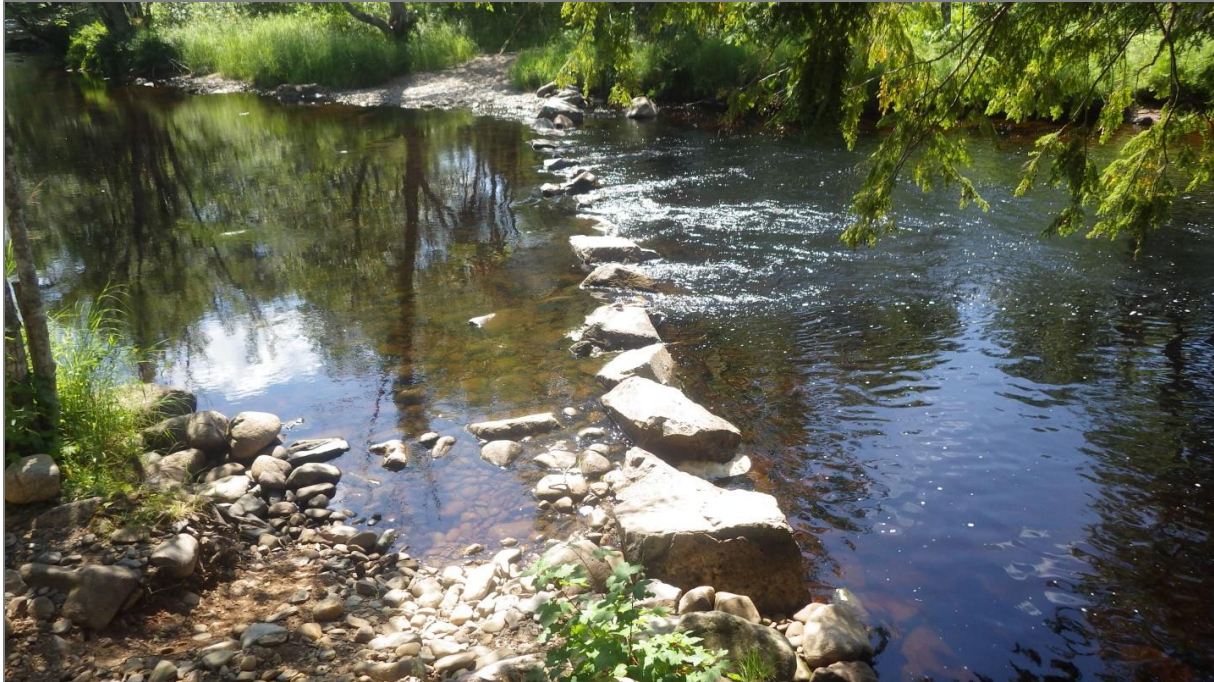
Figure 104. Weir "G" before remediation activities.

Weir G did not require a lot of re-construction work. Some large rocks were used to reshape and rebuild the right wing deflector, and were backfilled with rubble. A deflector was not required on the opposite bank, and the in-stream portion of the weir required little remediation. Figures 104 and 105 show the work before and after completion.

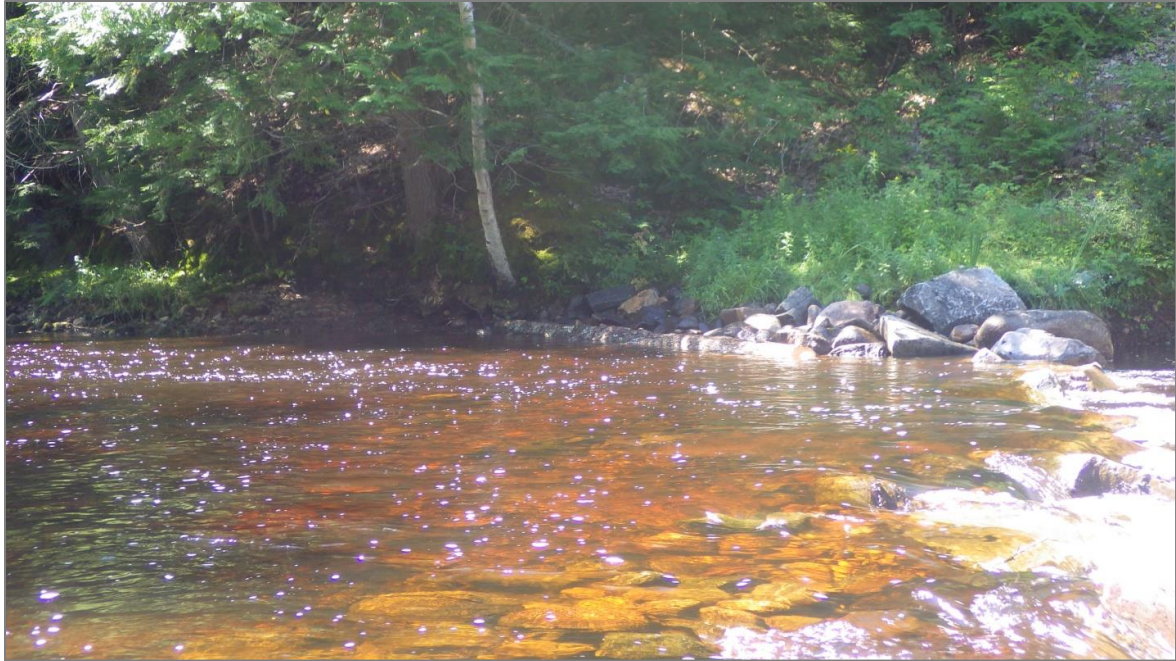
Figures 106 and 107 show before and after photos of the left bank of Weir C, prior to and after the installation of the left wing deflector. Figures 108 through 110 show some of the installation process that took place to secure the deflector and backfill it with rocks. This was a single log structure backfilled with rocks. A suitable tree found just upstream of the weir was cut down, trimmed, and cut to length for the deflector weir. The unused end of the tree was floated downstream and used in the digger log structure wing deflectors.

Figure 107. After log deflector installation.

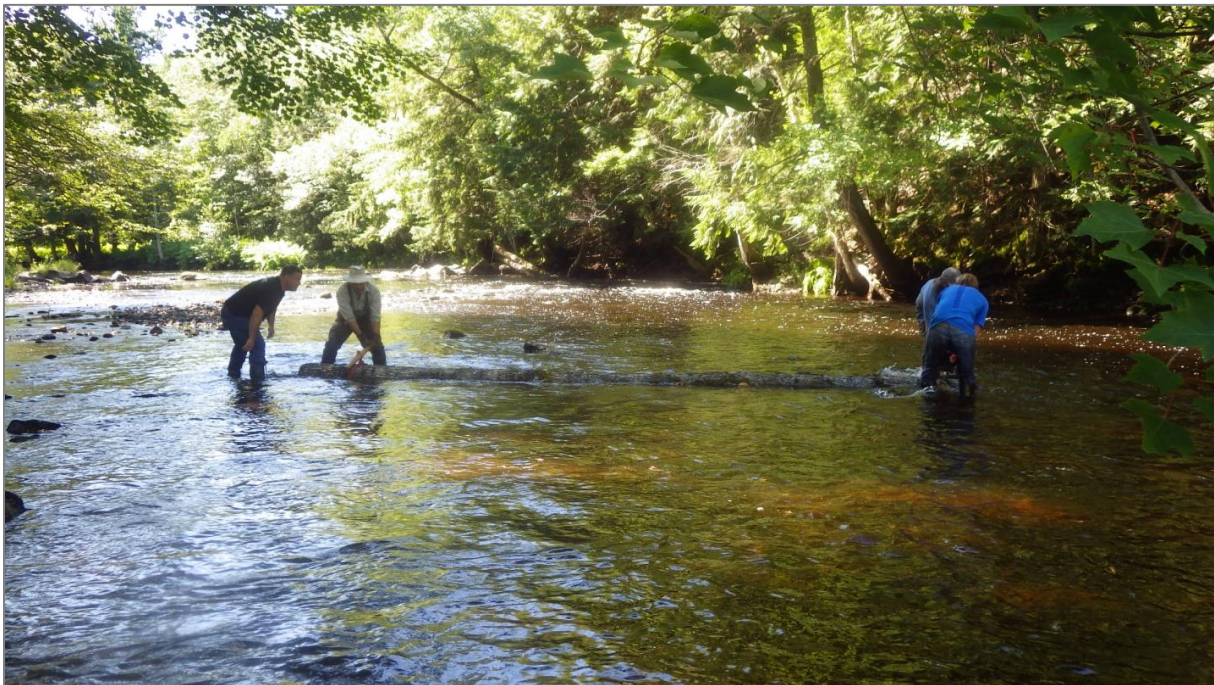
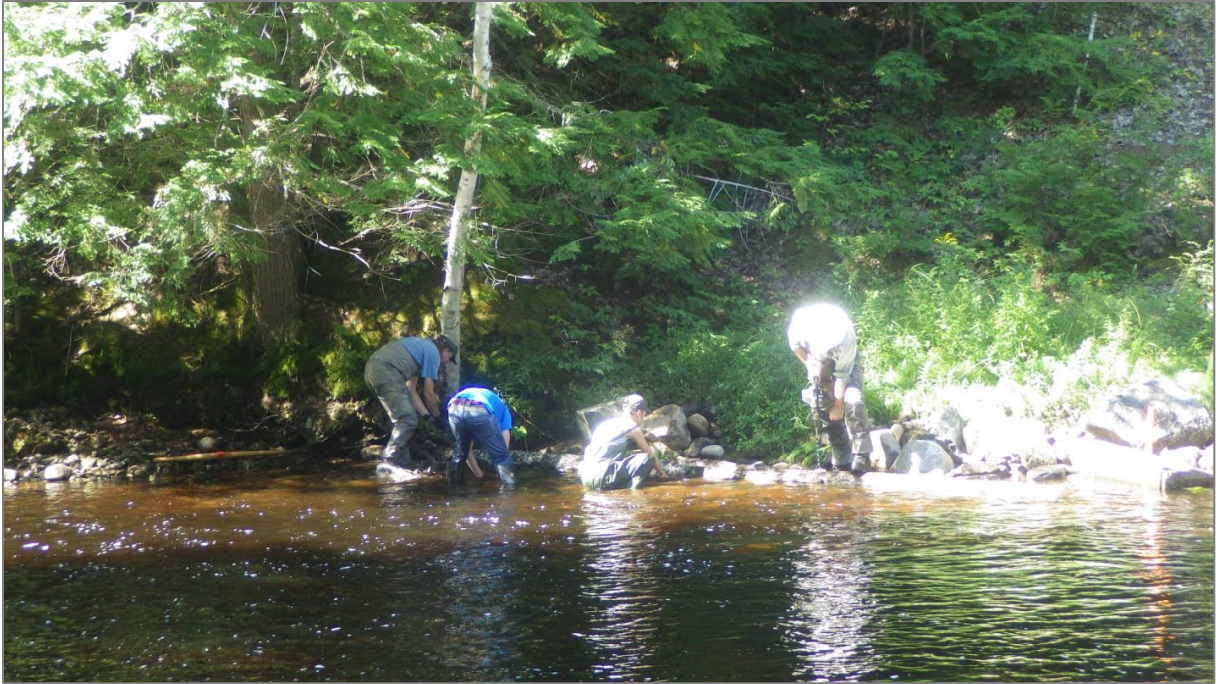
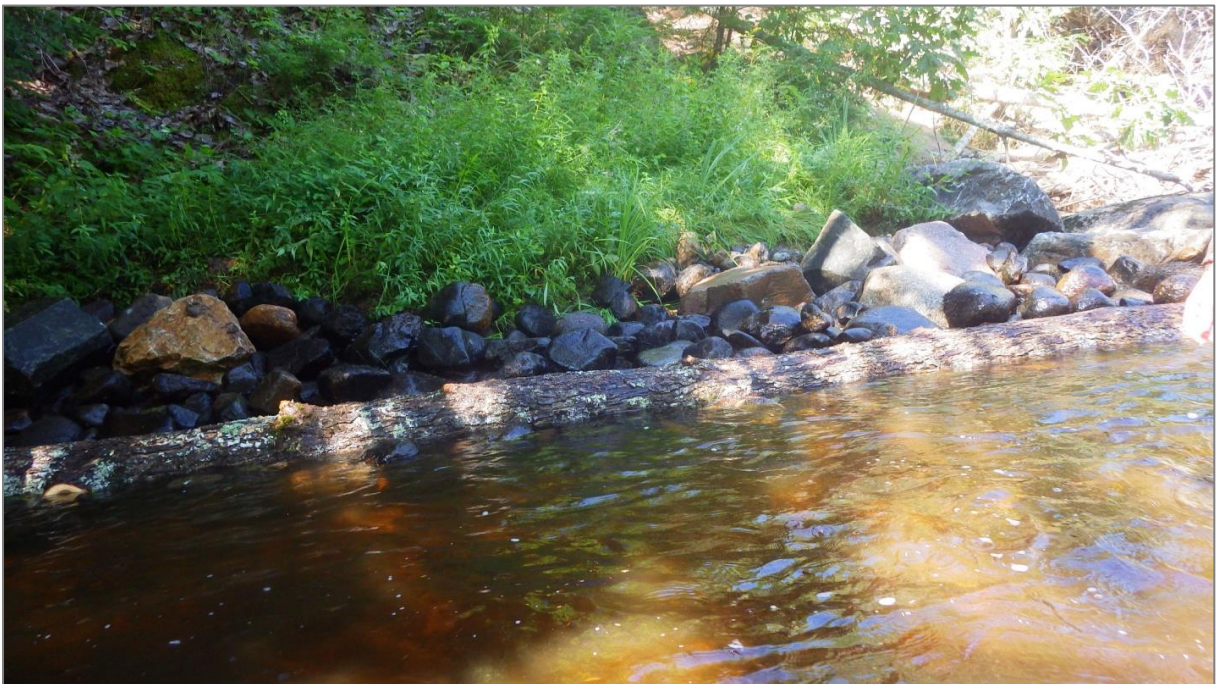
Figure 108. Log carried/floated/dragged to weir.

Figure 109. Crew members securing a log to the streambed as part of the installation of a wing deflector at Weir C.

Figure 110. Finished wing deflector.

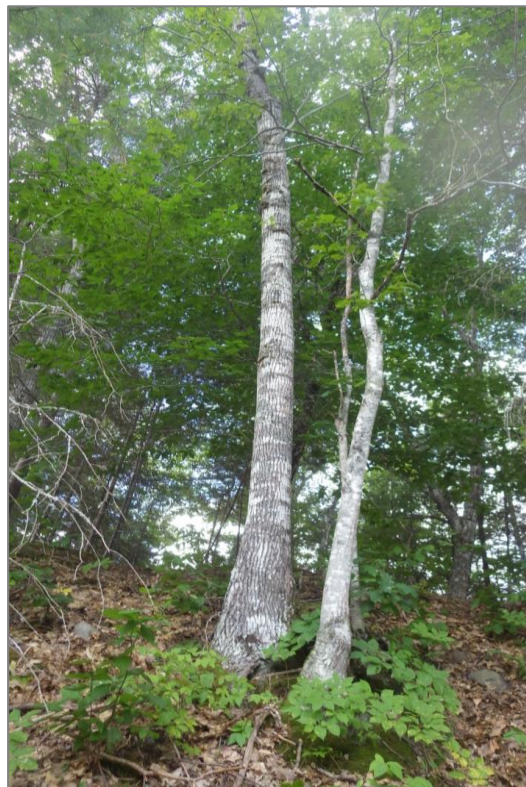
Two ten meter oak logs, cut from nearby trees, were placed end to end to create a digger log structure (Figure 111). The narrower ends were faced away from the banks to aid in directing the flow of the river towards the center of the river. Prior to installation, the location where the logs were installed was a wide stretch of very shallow water whose thalweg was closest to the right bank, resulting in serious river bank erosion. The shallow water was also restricting fish passage during low flows. Figure 113 shows how the installed digger log has directed the flow towards the middle of the river, taking pressure off the right bank. The erosion on the right bank can be seen in this picture as well.

Figure 111. Straight trees were used to create the digger logs. Conifers are the most ideal.

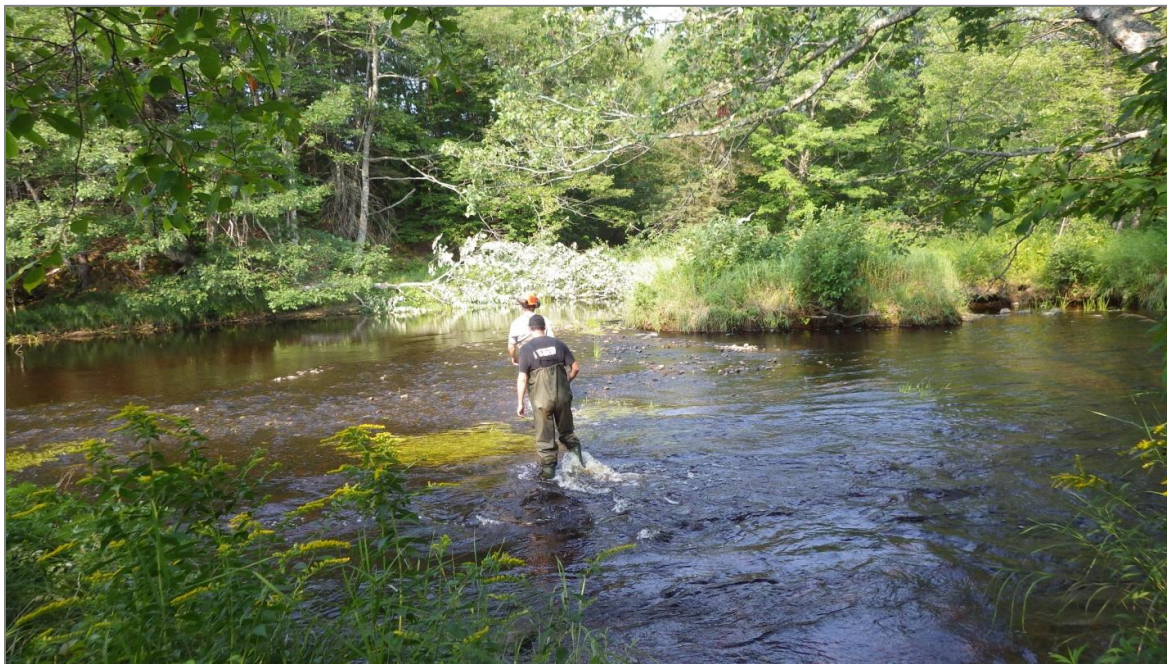
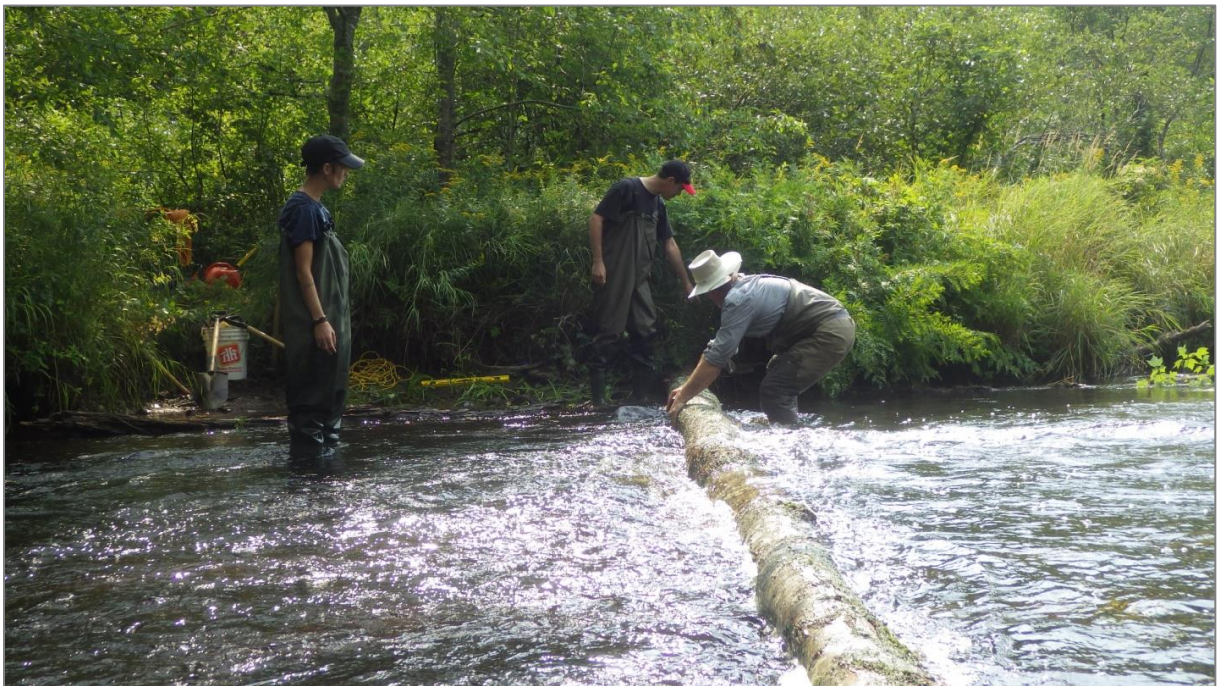
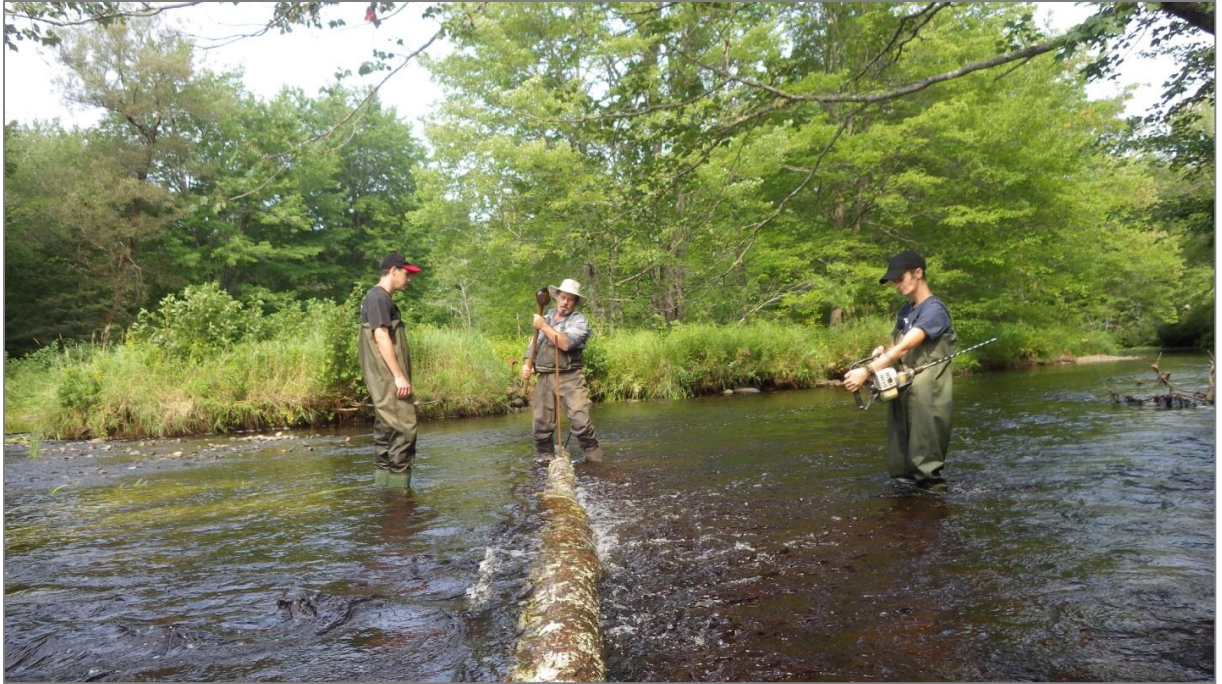
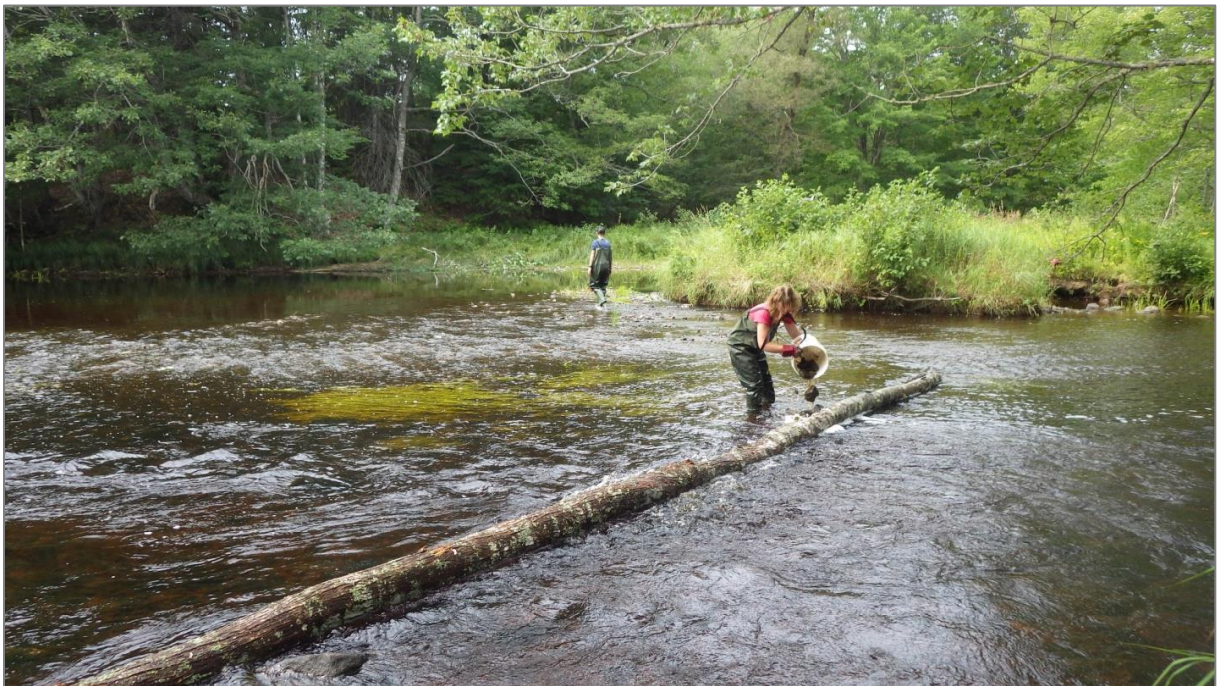
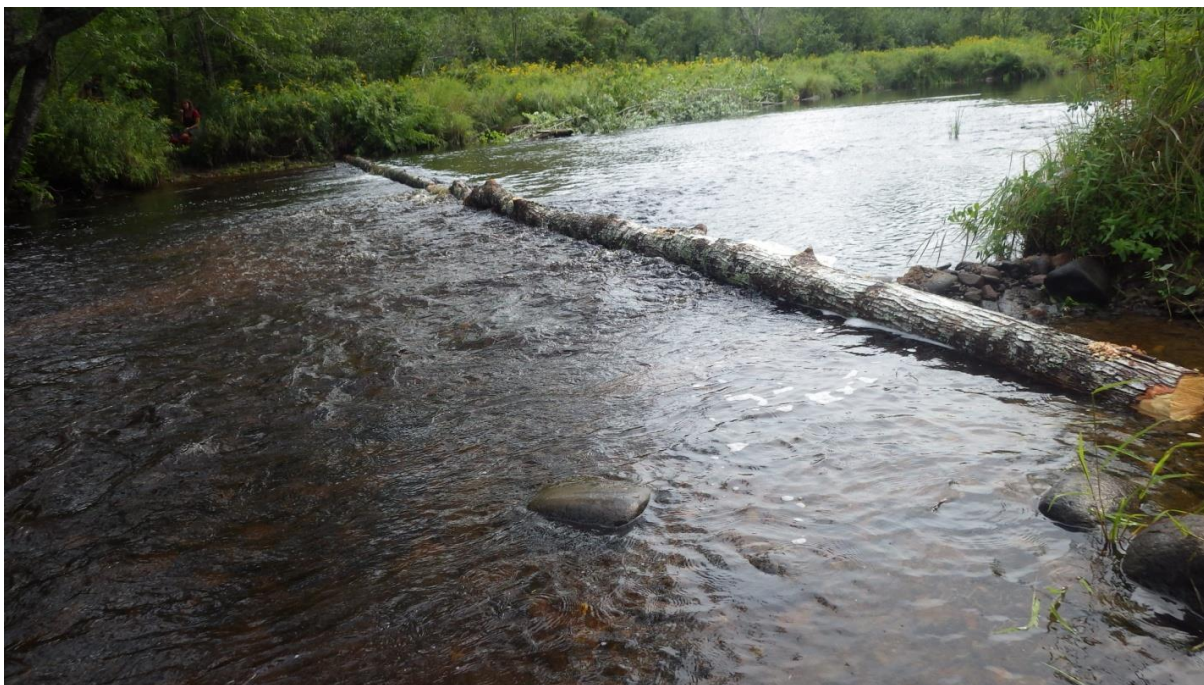
Rocks from the streambed were packed in around the digger logs to start creating a downstream pool. Three deflector weirs were added to this structure to aid in directing flow to the middle and to help prevent erosion of the riverbanks. Figures 112 to 117 show some of the work that was completed in the installation of the double digger log structure.

Figure 112. Before, showing tree cut (one of three needed), ready for trimming.

Figure 114. Fitting the log tight to the bank.

Figure 115. Logs were secured to the streambed using re-bar.

Figure 116. Placing rocks on the upstream side of the digger log.

Figure 117. Finished double digger log structure, prior to installation of wing deflectors.

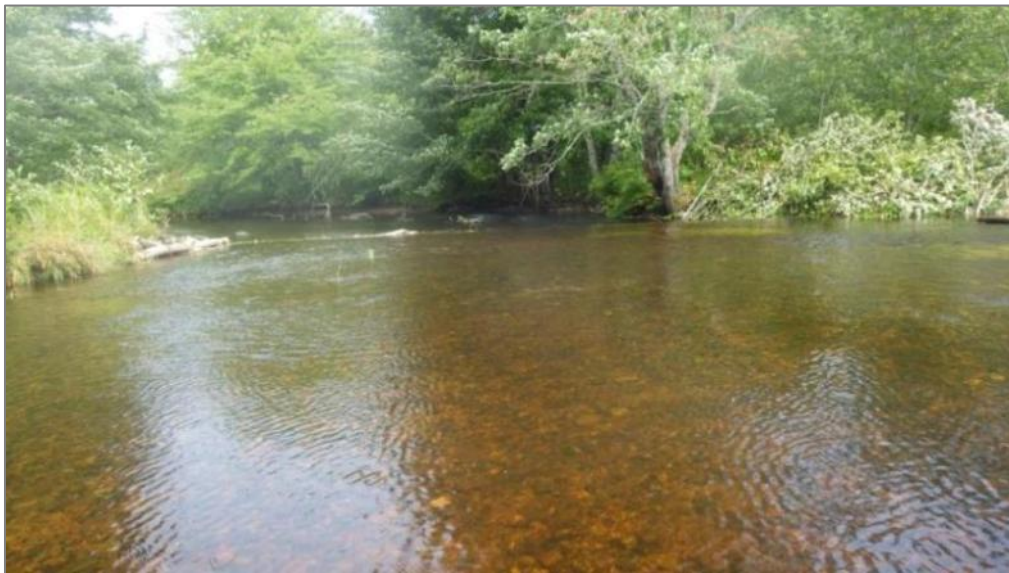
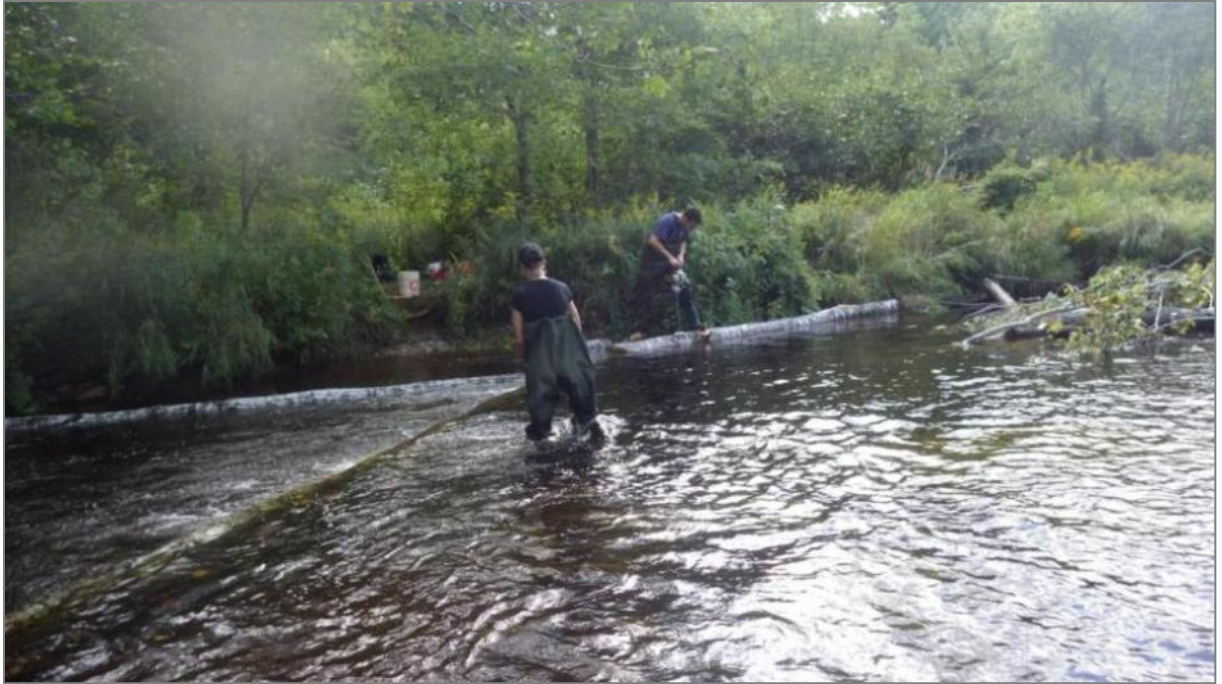
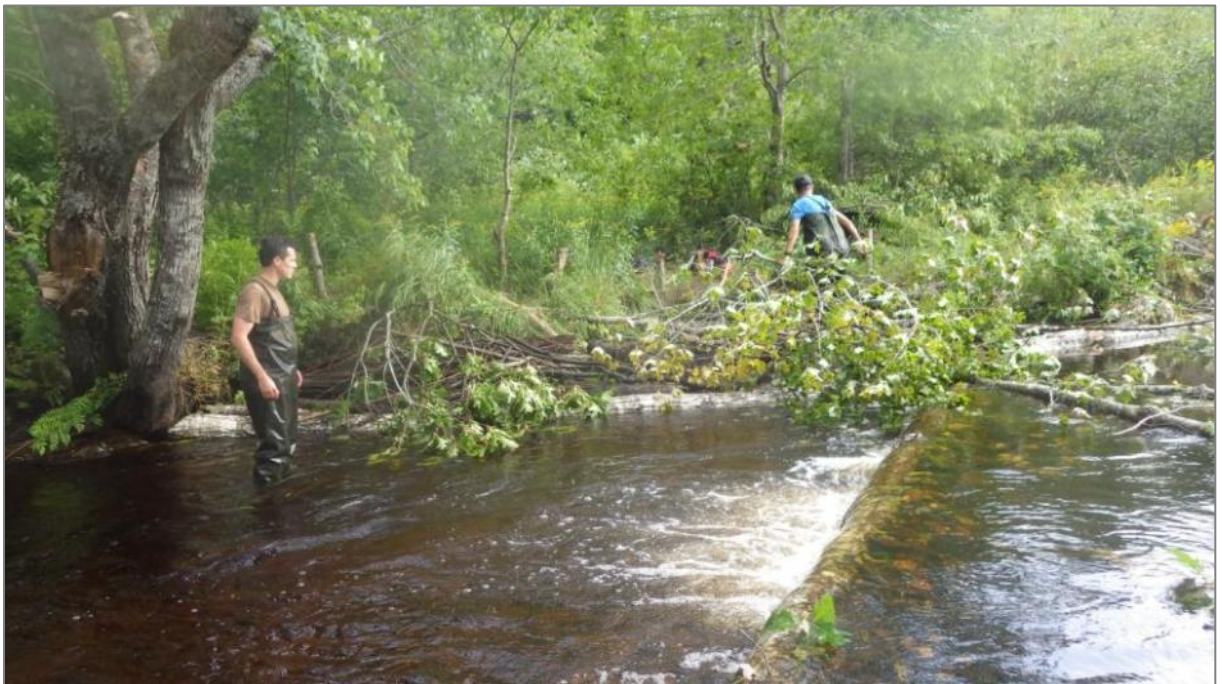
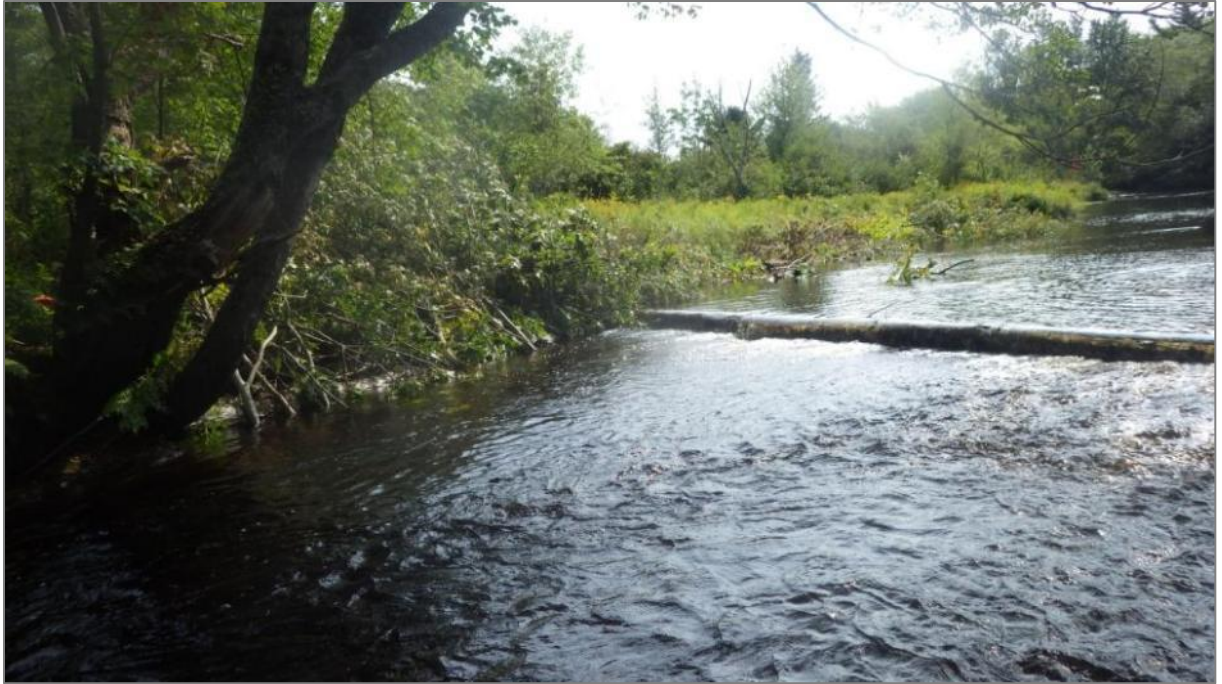
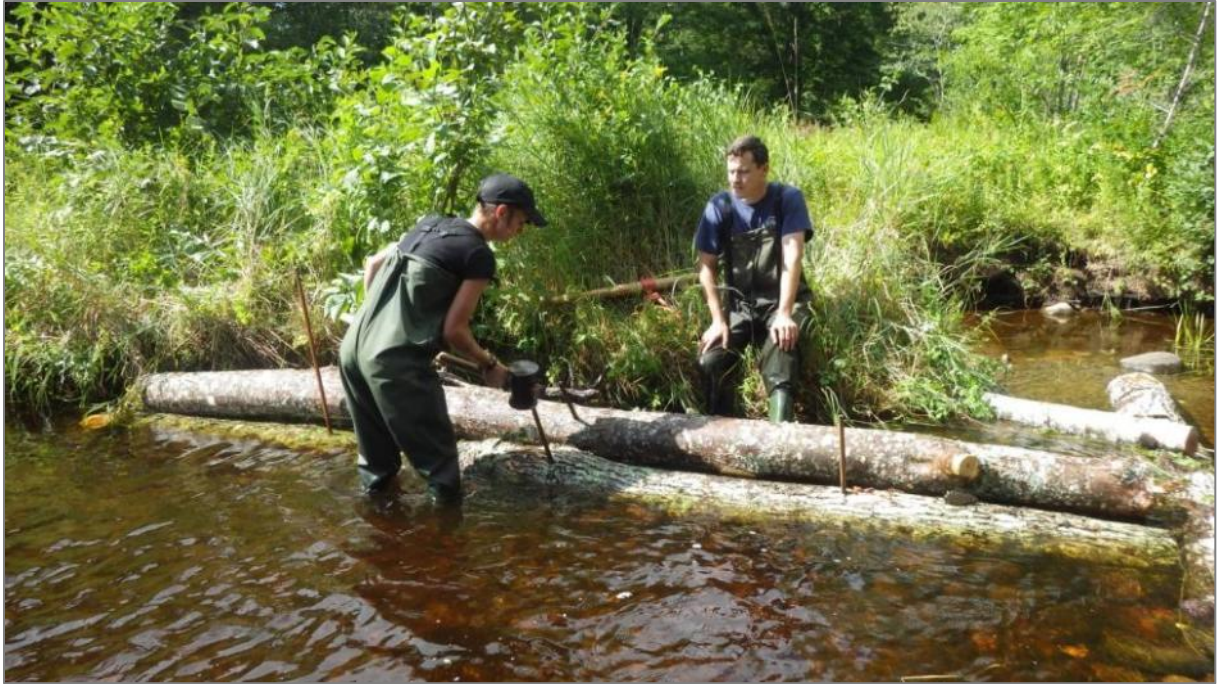
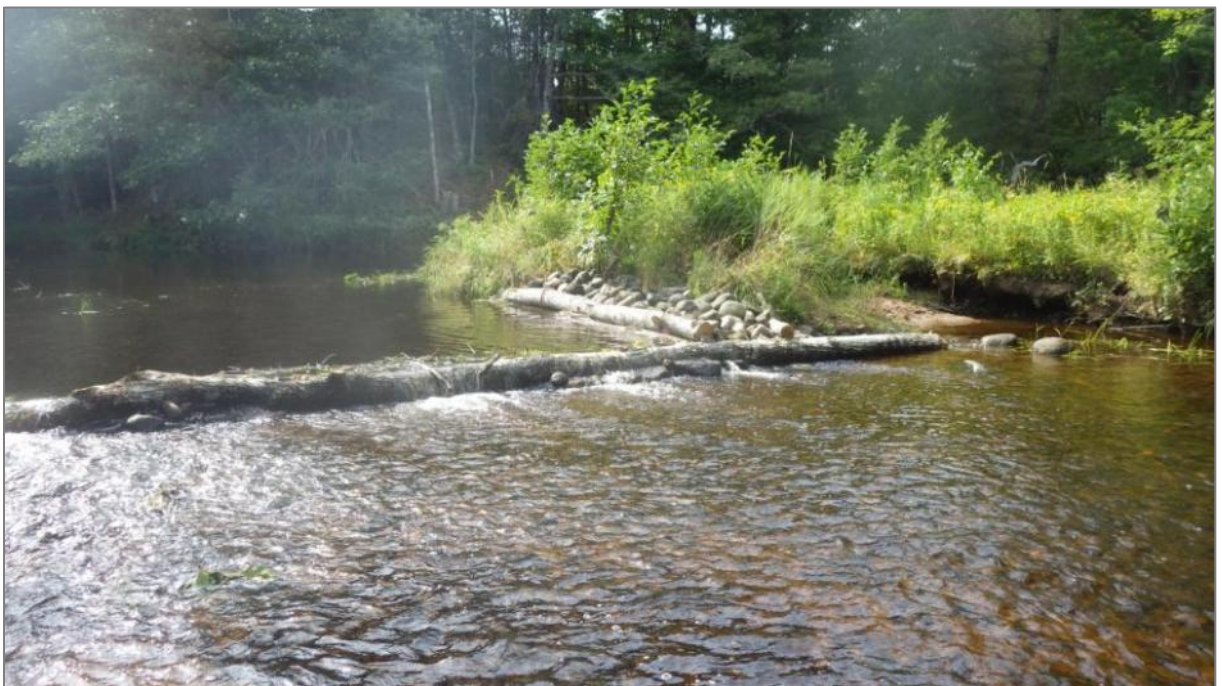
Left and right wing deflectors were installed along with the double digger logs. A full wing deflector was installed on the right bank (both upstream and downstream), while the left wing deflector had a structure installed on only the upstream side of the digger log. The one on the left bank, made with a pyramidal arrangement of three logs (two on bottom one on top), was backfilled with rocks found nearby on the river bottom. The right deflector upstream of the digger log was also pyramidal, backfilled with medium and large woody debris cut up from nearby dead trees and left over wood from the trees cut for the weirs and digger logs. The downstream deflector weir was made from one large log and backfilled with woody debris as well. Both the upstream and downstream parts of the right deflector had large branches from cut trees attached to them and which were staked into the riverbank to allow them to better absorb the energy from high flow events. Figures 118 to 125 show the digger log wing deflector installations.

Figure 119. After digger log and wing deflector installation, downstream view.

Figure 120. Upstream triple log portion of the left wing deflector during the installation process.

Figure 121. Reinforcing wing deflectors with trees and branches tied into the banks with stakes.

Figure 122. Completed right bank deflector.

Figure 124. Securing the left bank pyramidal log structure in place.

Figure 125. Left bank deflector finished.
